## Preliminary Roost Assessment

Inglemere Metals LTD, 50-62 Cowley Road, Blackpool, FY4 4NE

Inglemere Metals LTD

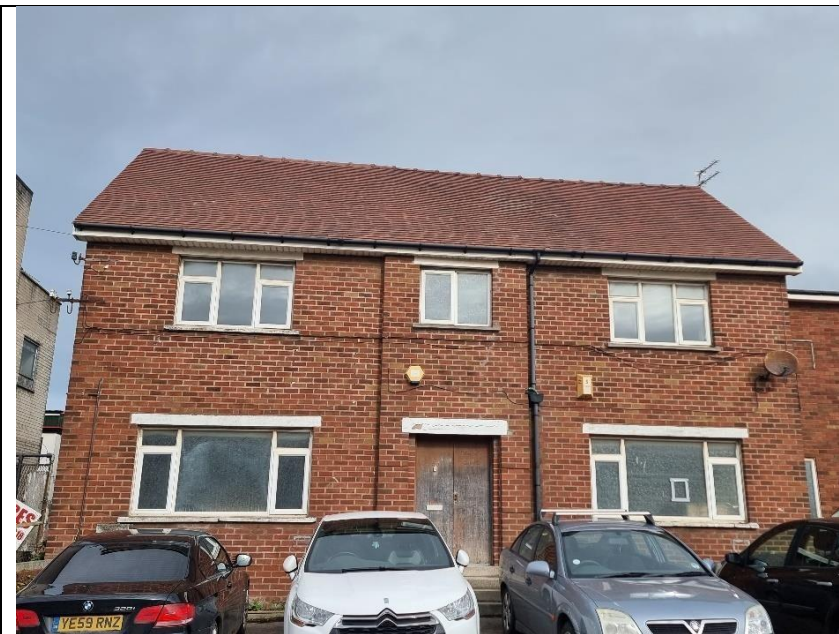
B1 – south-eastern and south-western elevations (pictured opposite).

The gable end of the property is in very good condition with no gaps in the brickwork and a secure UPVC soffit and fascia. The tiles are in good condition with no gaps underneath that would allow ingress into the building.

The windows on these elevations are secure and in good condition with no gaps around the frames that would allow ingress.

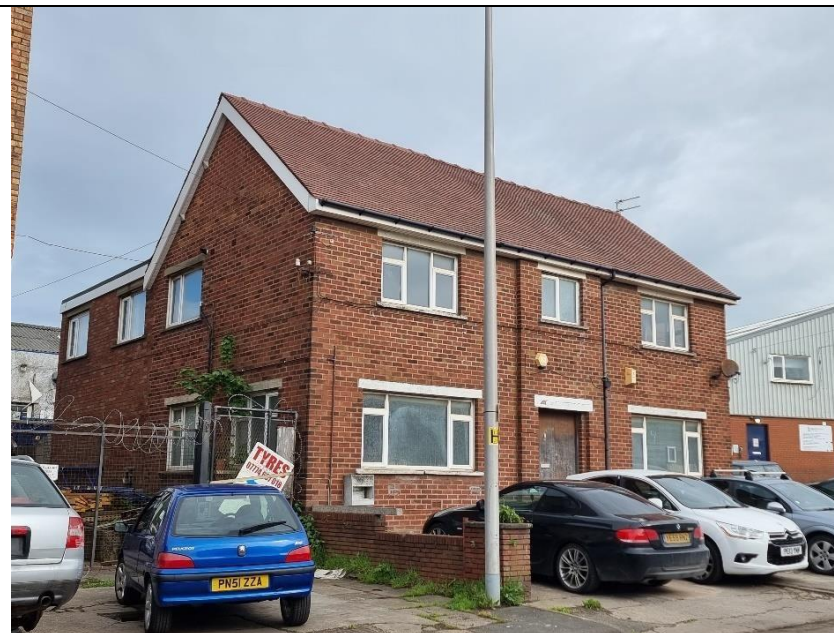
B1 – north-eastern elevation (pictured opposite).

The north-eastern gable end is also in good condition. The main roof of the building is in great condition with no slipped or missing tiles.

There are three flat roofs present on the building, which are observed within this image. There is a dormer window present on the rear of the property, an extension on the north-eastern elevation and another extension present on the north-western elevation. The flat roofs are bitumen felt and are in good condition, lying flush to the building with no gaps present. The bargeboards around the extensions are in good condition offering no suitable habitat for crevice dwelling bats.

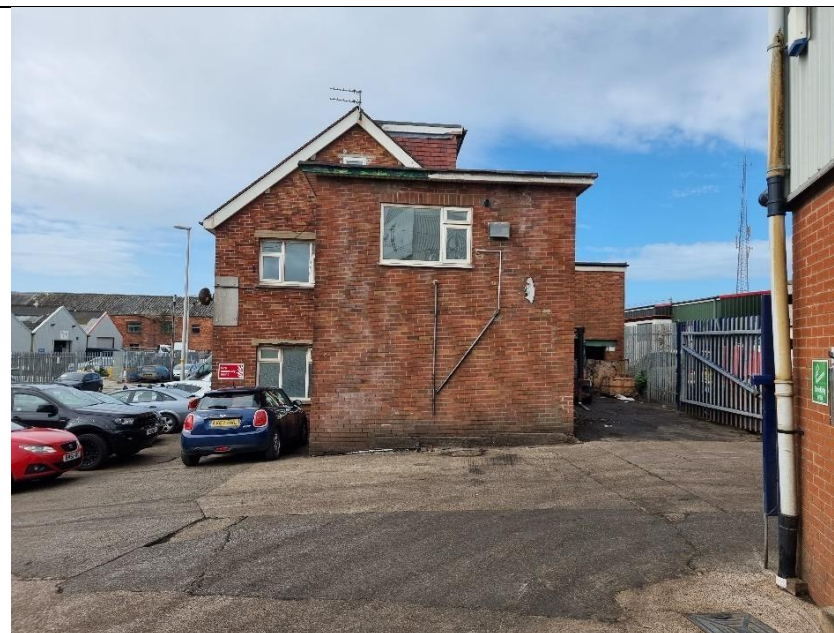
B1 – northern elevation (pictured opposite).

The rear of the property has the tree flat roofs visible on the dormer window and two extensions. These roofs are in good condition. The brickwork on the rear of the property is also in good condition.

The windows on this elevation are in poor condition with some stuck open and some smashed. This could allow animals entry into the building. The vacant nature of the property, there are no curtains or blinds and therefore surrounding light enters the building freely and inclement weather would enter through the windows also.

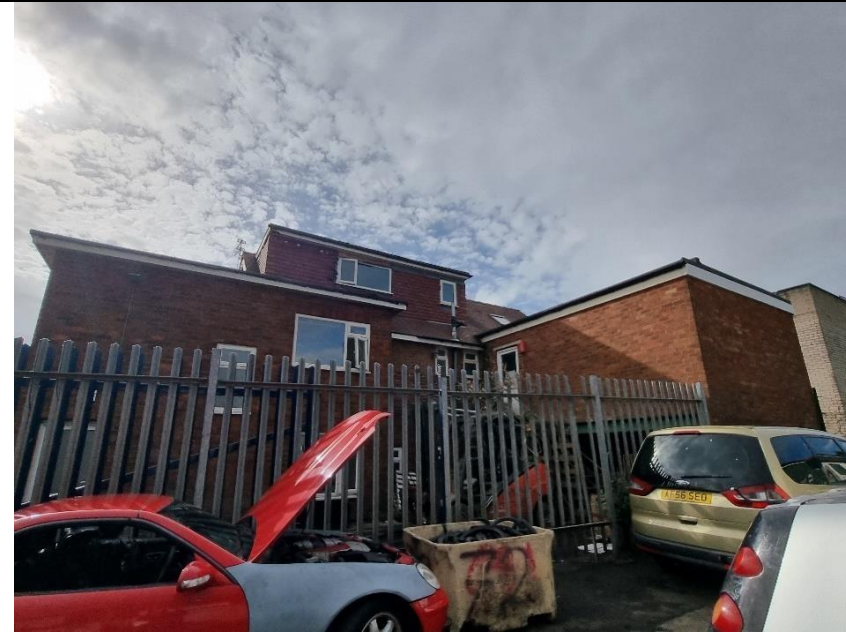
B1 –northern elevation (pictured opposite).

The dormer window has hanging tiles present on the front and sides. The tiles that are present are in very good condition and lie flush to each other. However, below the window which is open, there have been hanging tiles absent and there is a large, exposed section of the dormer. This could allow crevice dwelling bats to utilise the gaps under the exposed tiles, but this property is exposed to large levels of potential disturbance daily with noise, vibrations, and light. The immediate surroundings also lack suitable foraging habitat which would entice bats into this industrial estate.

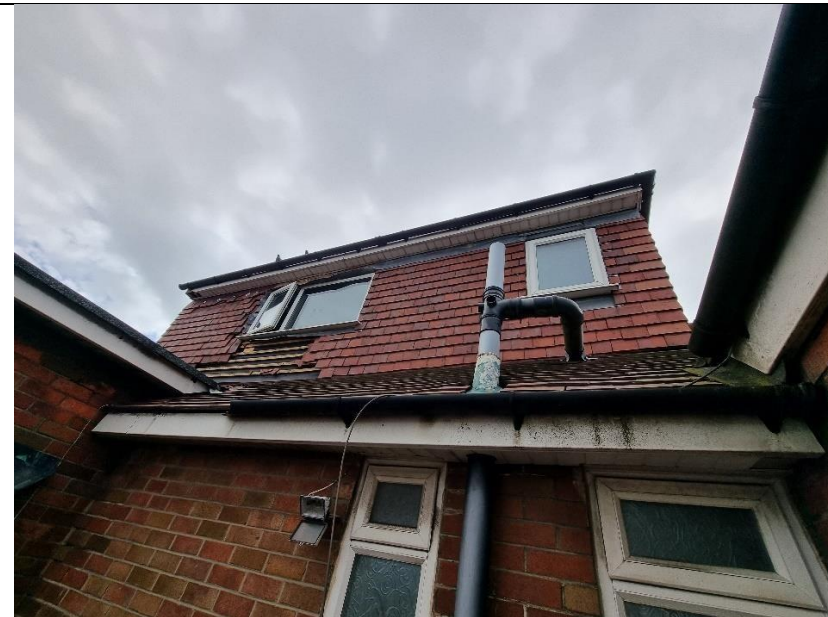
B1 – north-western elevation (pictured opposite).

Underneath the north-western extension of the property, there is an overhanging, open and exposed section where materials and debris have accumulated.

The open nature exposes this section to inclement weather, noise, and high light levels. The nature of the ceiling and space lacks any suitable roosting features for crevice dwelling bats.

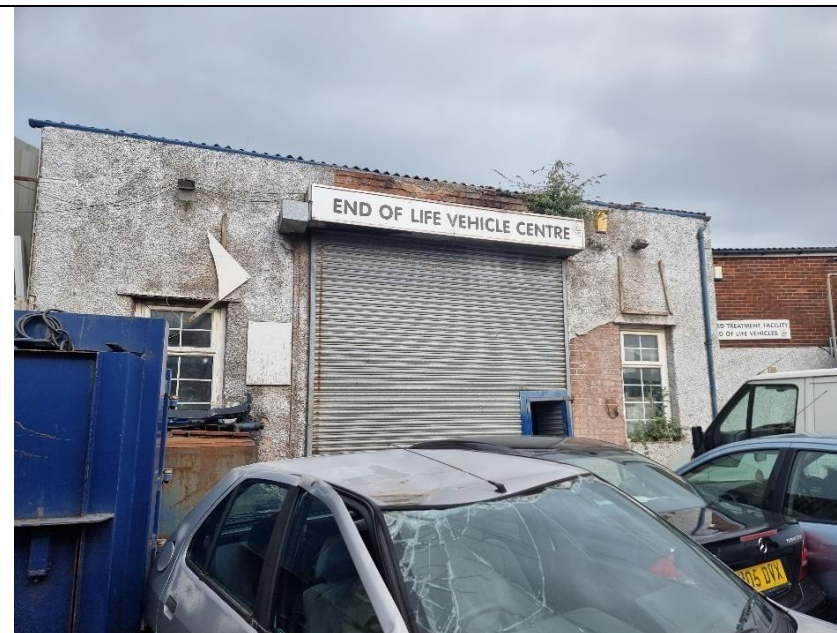
B2 – north-eastern elevation (pictured opposite).

The rendering of the brickwork continues around the property and appears to be in good condition on the gable end of the property.

The windows on this elevation are also in good condition with no means of ingress.

The roof is asbestos cement sheeting with clear plastic inserts within. The sheeting is in good condition and there are no gaps or lifted sections that would be suitable for roosting bats.

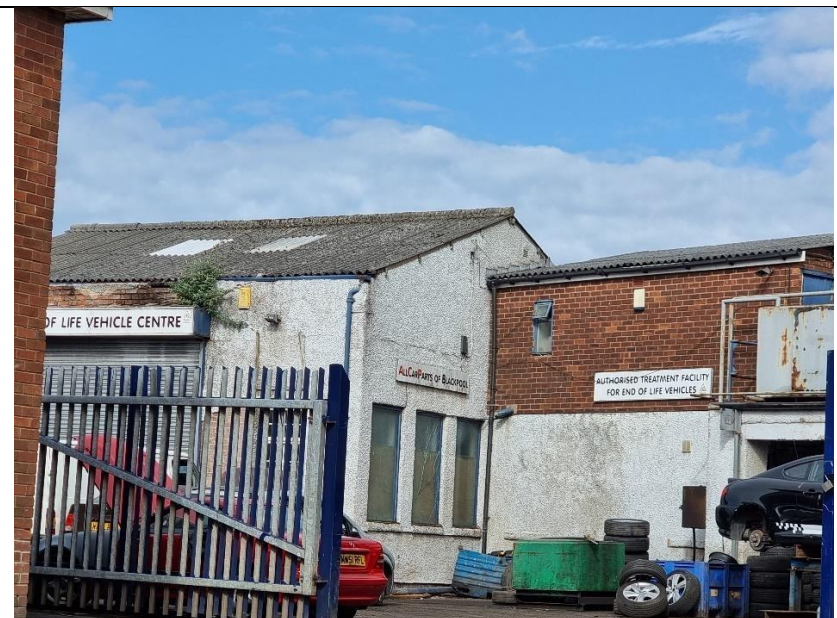
B2 – Roof of the building (pictured opposite).

The roof has no lining or membrane present on the rear and the ceiling is vaulted. The openness of the building would be unsuitable for void-dwelling bats due to the exposure to varied temperatures and the lack of a more suitable microclimate often observed in loft spaces.

The clear inserts within the roof also allow large levels of light to enter the building.

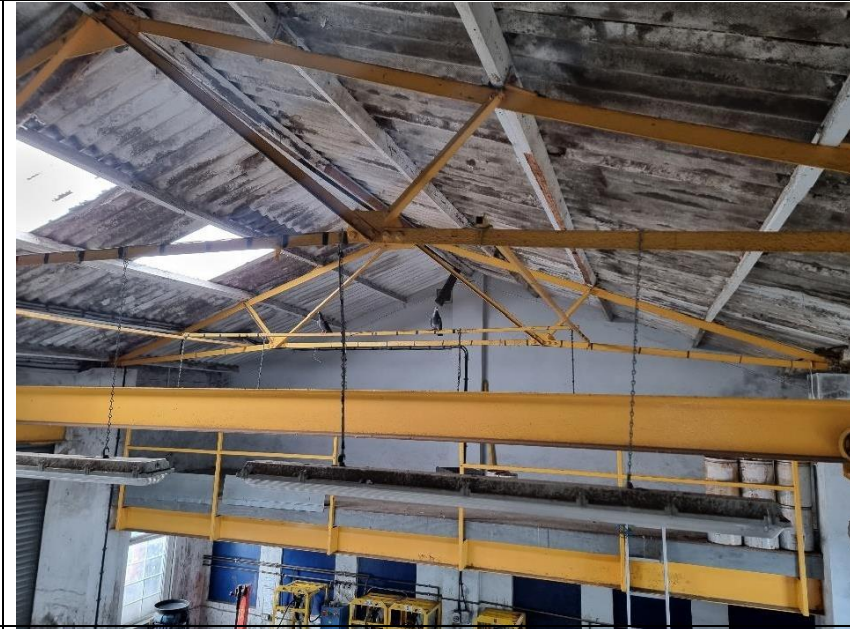
B2 – Interior (pictured opposite).

The brickwork of the elevations that were not visible from outside appear to be in very good condition within, with no gaps or cracks present at all.

This building connects internally to building three via the steps and door present on the left-hand side of the image.

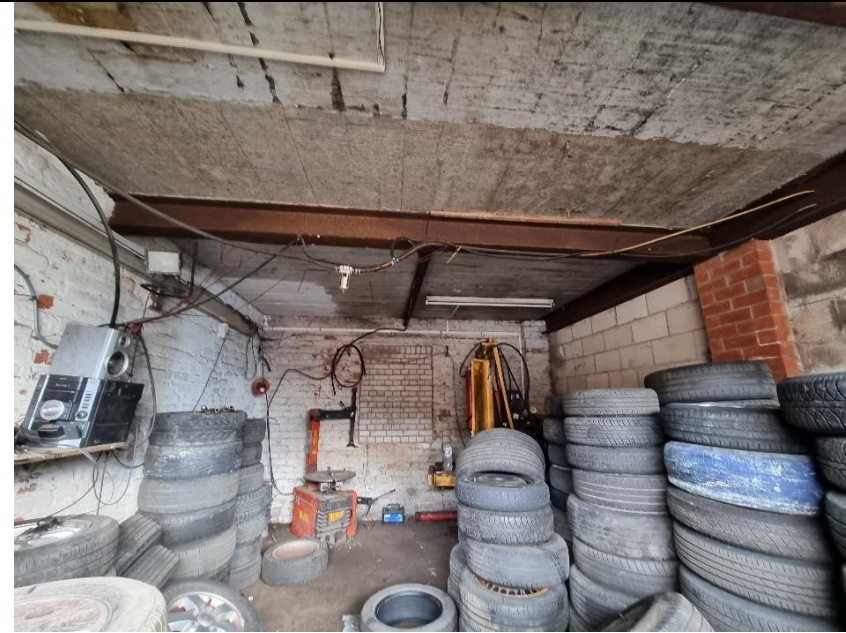
B3 – interior – second storey (pictured opposite).

The interior of B3 has a sloped roof, with a boarded suspended ceiling within. The space has some stored items which were searched for evidence of bats, but no droppings or feeding remains were observed within the building.

Large amounts of light enter through the windows of the building.

| Nesting birds (B3) | The building contains historical evidence of nesting birds with an old bird's nest observed in the secondstorey. | The proposed development could result in the destruction or the disturbance and subsequent abandonment of active bird nests. | An inspection of building 3 should be undertaken by a suitably qualified person prior to works commencing. Alternatively, works can be undertaken outside the nesting bird period 1 <sup>st</sup> March to 31 <sup>st</sup> August. All active nests will need to be retained until theyoung have fledged. | The installation of two bird boxes on retained buildings will provide additional nesting habitat for birds e.g.<br>Schwegler No 17 Swift Nest Box (buildings)<br>Schwegler 1SP Sparrow Terrace (buildings)<br>Or a similar alternative brand.<br>Swift and sparrow boxes should be positioned at the eaves of a building ideally at the highest point of the building. |

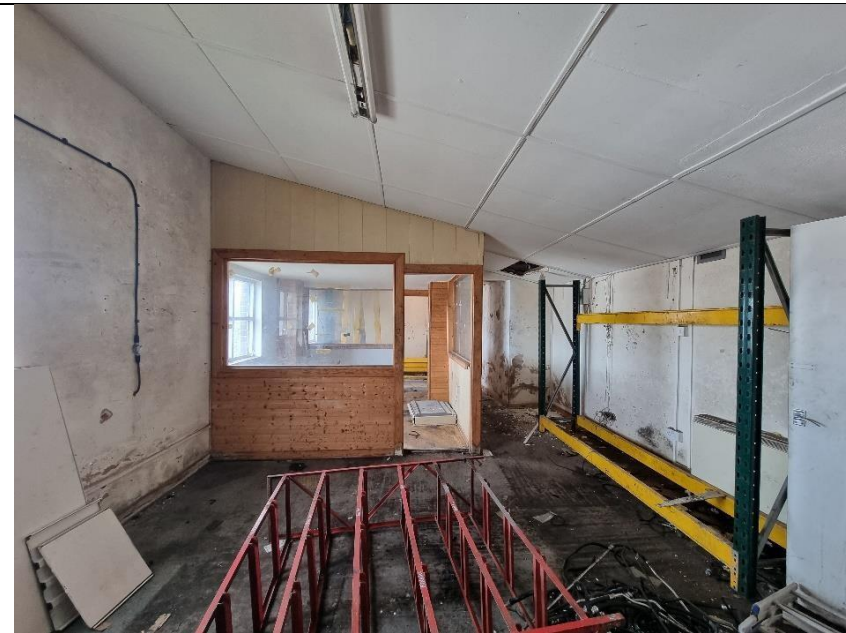
B3 – Interior (pictured opposite).

Though this allows entry into a small space of the roof, there are clear panels in the roof which illuminate the space within the roof.

Due to the internal access between B2 and B3, there was historical evidence of nesting birds within B3 with an old nest at top of a set of ladders in the building.

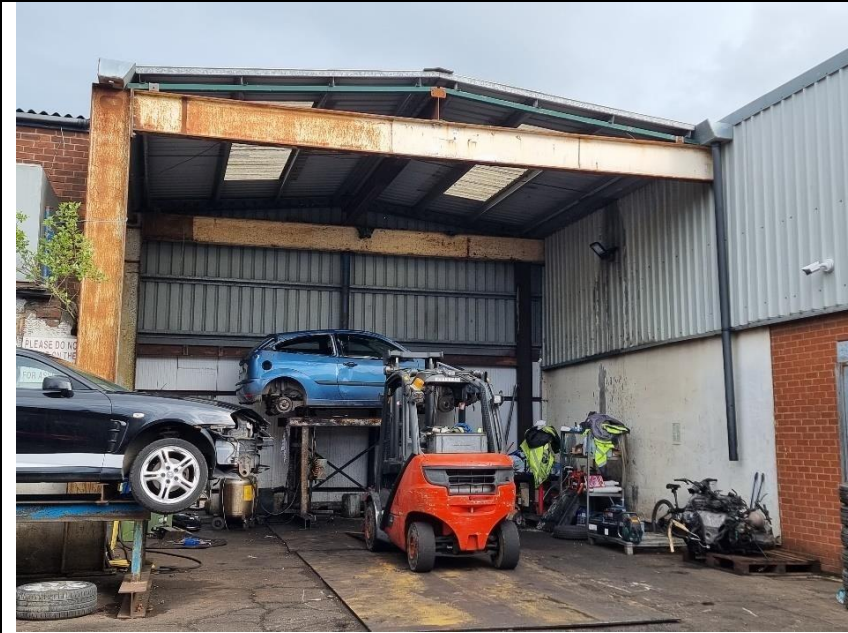
B4 is a large metal corrugated structure with a fully open frontage and partially open side. The metal roof has clear plastic inserts and metal beams for the structure.

This is exposed to high levels of light and inclement weather, with temperature fluctuations which make this structure unsuitable for roosting bats.
