Heritage Statement: 7 Manor Close Shincliffe Roof Replacement

Existing Heritage Asset

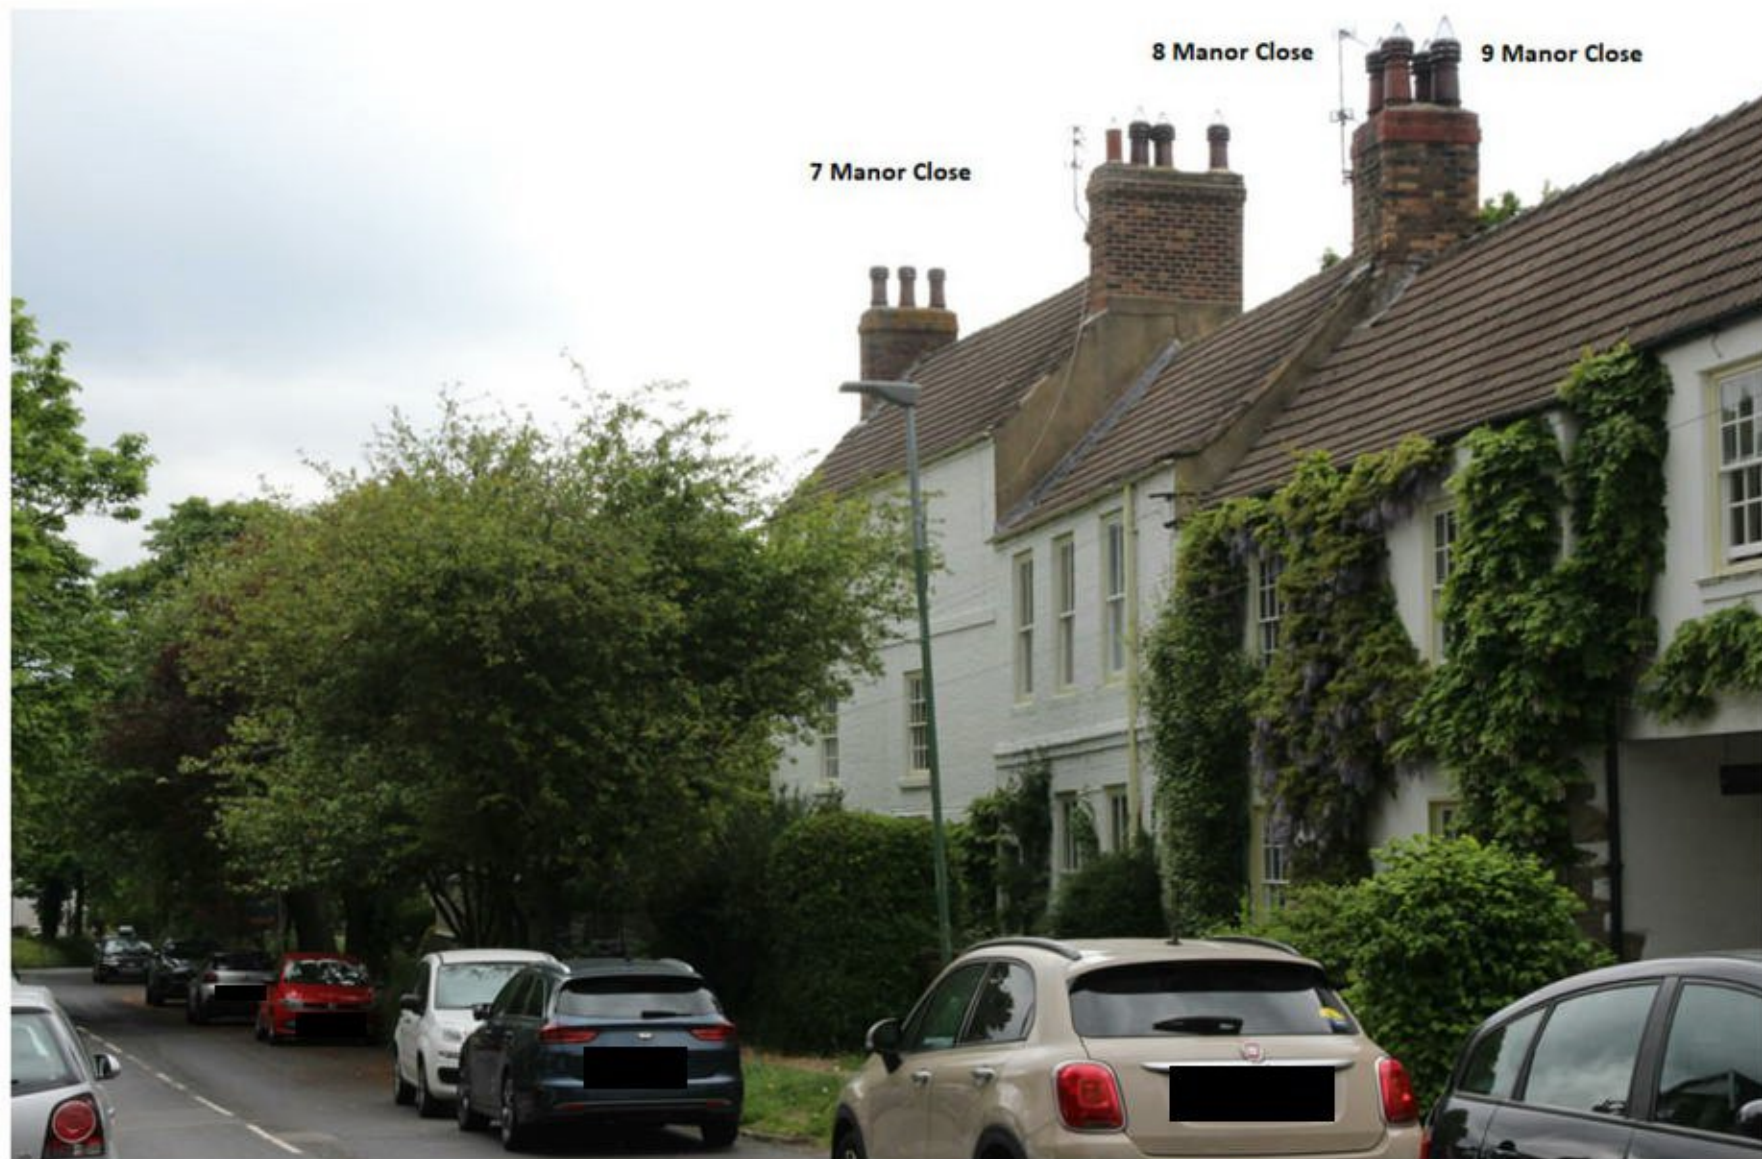
Image 1: View Westwards Down Main Street, Former Manor House Properties on Right

Shincliffe is a conservation area, without Article 4 Direction. The village history is that it remained agricultural during the 19th century and the Manor House was one of the four farms present at that time. As such, it is an important and prominent property in the village, significantly contributing to the rural character of the main street (Image 1).

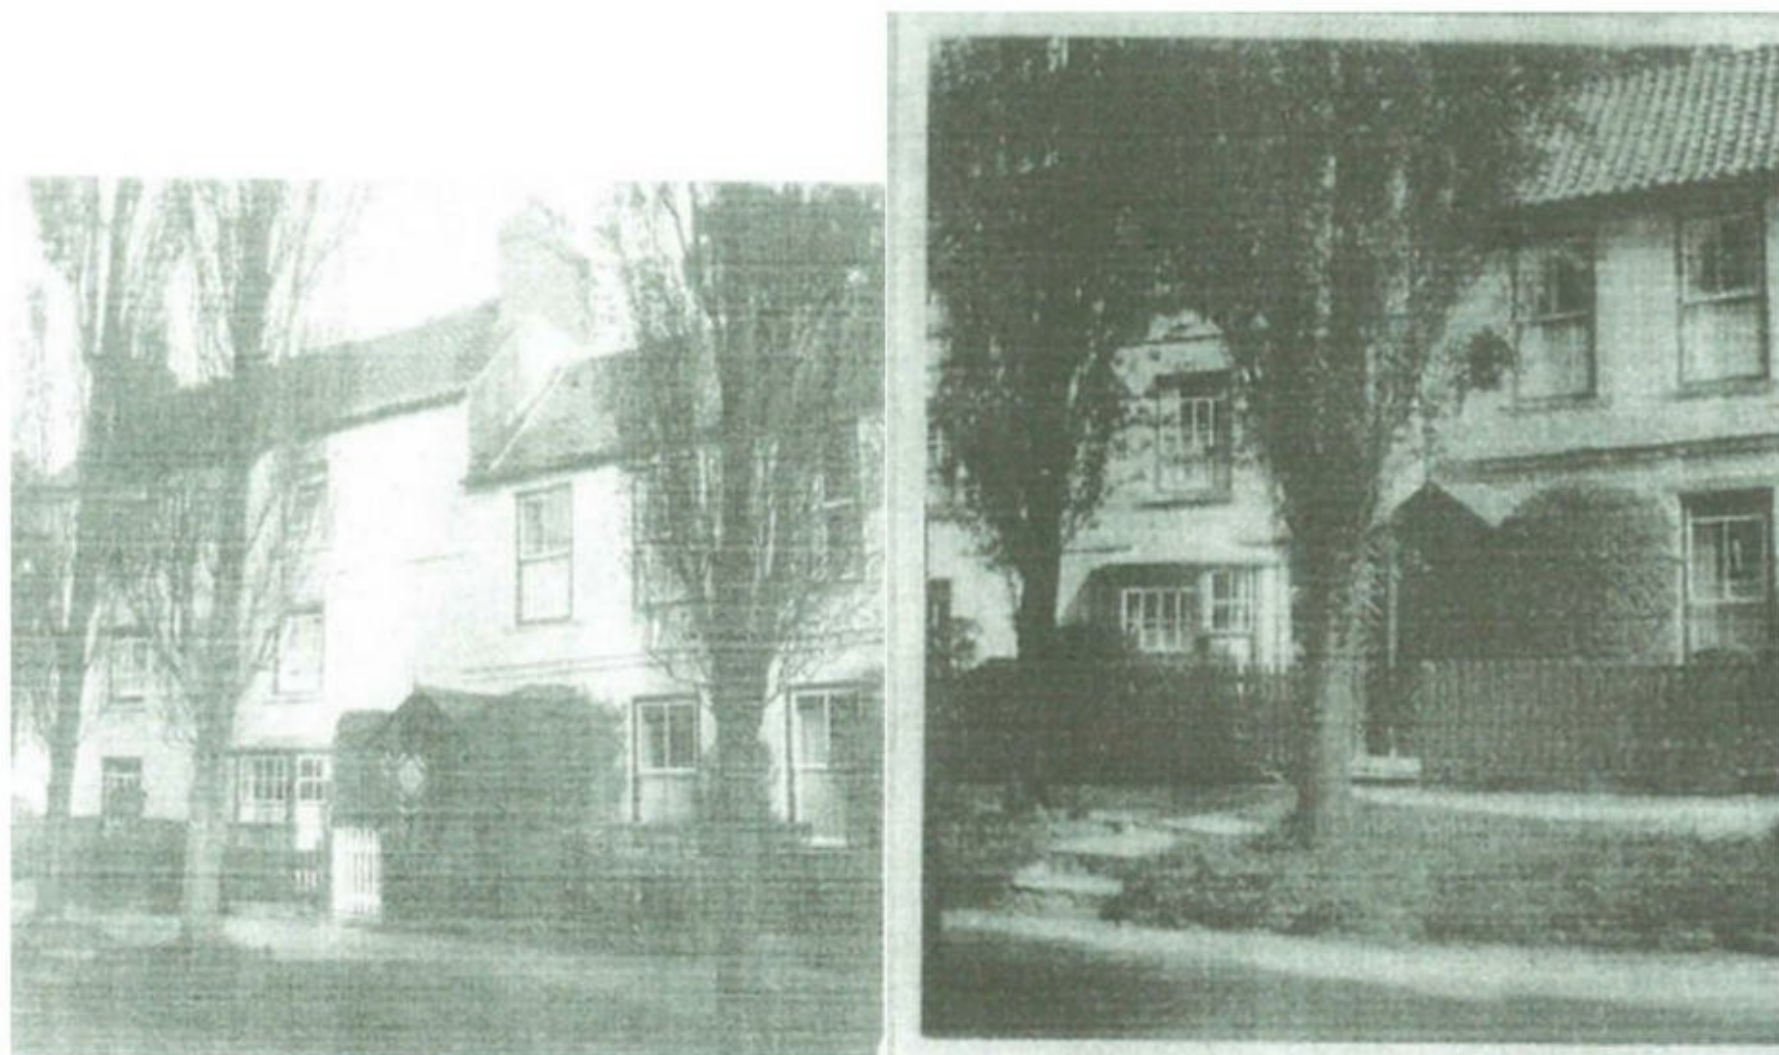
Images 2 and 3: Manor House in June 1926

7 Manor Close forms the main block of the old Manor House, which is now divided into three properties, 7 – 9 Manor Close (Image 1). All three properties have the same roof covering facing the main street, these being concrete Redland 51 tiles. It is believed this covering dates from the 1950's when it was installed by the Dean and Chapter, who owned all three properties at that time. Photographs of the house from June 1926 (Images 2 & 3) appear to show a roof similar in appearance to the existing. Internally, roof trusses, purlins and rafters are most likely original, while the lathes are modern (eg Image 4).

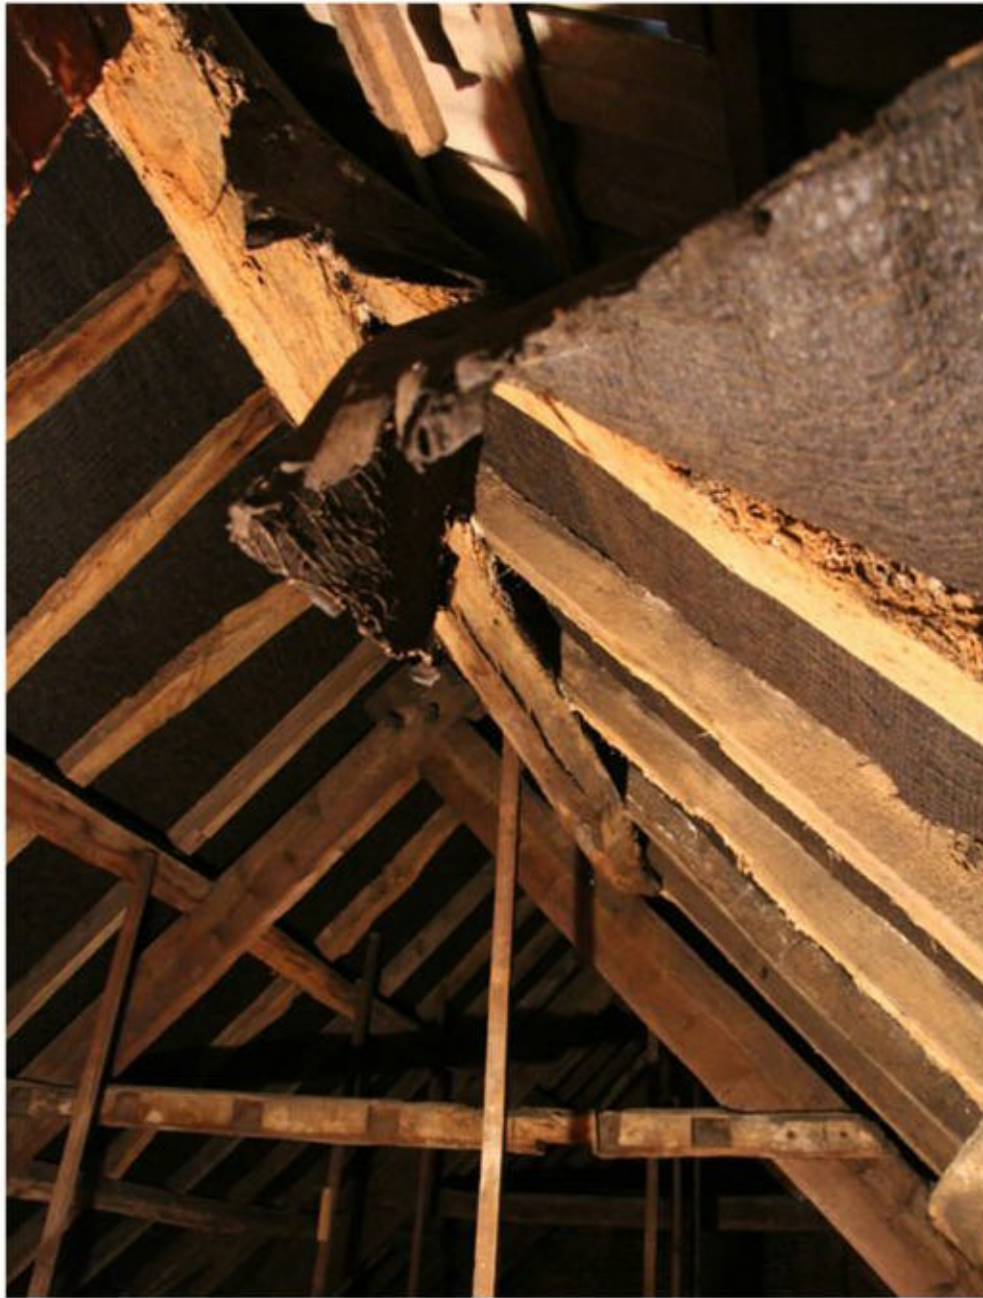
Image 4: Main Roof Internal View

The underfelt of the roof coverings requiring replacement has deteriorated to the point that it is brittle and has broken in a number of places, leaving some large holes with tiles exposed on the internal side (eg Image 4). This has already caused tiles to be blown off and fall to ground level in strong winds, a situation which will only worsen with time. In any case, at about 60 - 70 years old, the concrete tiles themselves are at the end of their serviceable life.

When the roof failed, we were unsure about what replacement roof covering would be appropriate, so contacted a Design and Conservation Officer for advice. The replacement tiles selected (Sandtoft modula double roman clay) have been chosen with the help of the officer because they are appropriate to the age of the property, with clay tiles in common use in the area at the time the property dates from. The double roman design is similar to the existing, matches nearby roofs (Images 1, 5 and attachment 7 Manor Close Roof Replacement Images 8May22.pdf) and as far as can be discerned those on the property in the 1920's (Images 2 – 3). It should not be necessary to alter any of the original parts of the roof structure, such as the roof trusses, purlins and rafters.
