HERITAGE, DESIGN AND ACCESS STATEMENT FOR PROPOSED ALTERATIONS TO ONE OF THE RENDERED ELEVATIONS OF BOURNE HALL – (APPLICATION IN ADDITION TO DC/22/00405)

1 INTRODUCTION

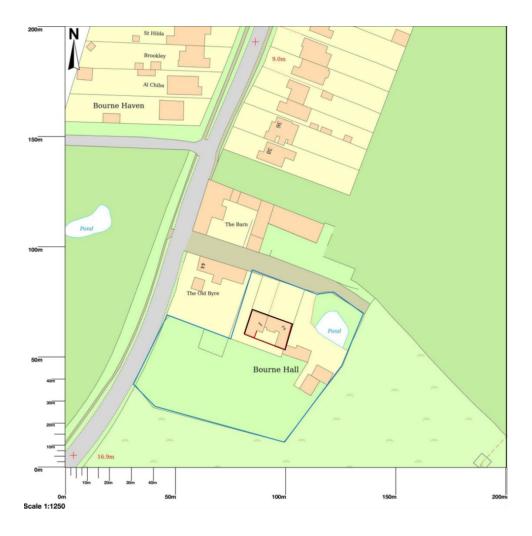
Blue Line is curtilage of Bourne Hall, bold black line is property boundary, and the red line is the Courtyard Return Wall. This is shown more clearly in picture below.

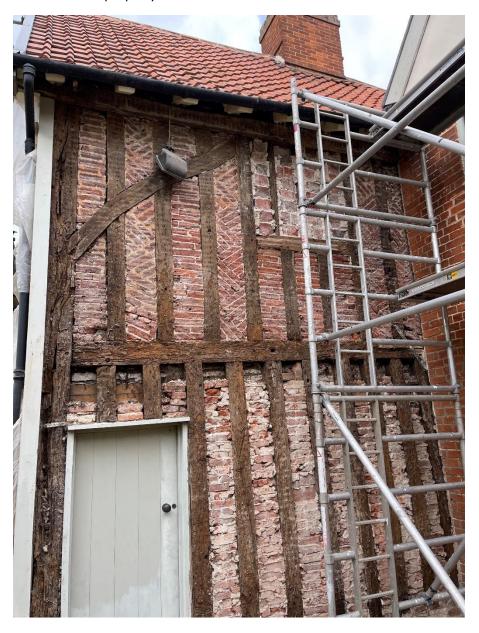
Wall after render has been removed. Window clearly visible with new bricks filled in. Also lower half of the building the unattractive newer brick infill is shown. Plan is to render lower half with lime plaster on larch laths, and to leave upper brick infill exposed, repoint where necessary with lime and reinstate window.

The aim of the proposed work is to reinstate a historic mullioned window which has been uncovered by removal of existing concrete render, along with leaving the attractive herringbone brick infill on the top half of the wall exposed and repointing the brickwork with lime where necessary.

The bottom half of the wall is filled with later brick infill which is not as attractive so the plan will be to apply larch laths over the existing vertical studs and brick infill and then render with haired lime plaster using Limecoat from Best of Lime. A small pentice board will be added above the lower rendered section to protect the lime render.

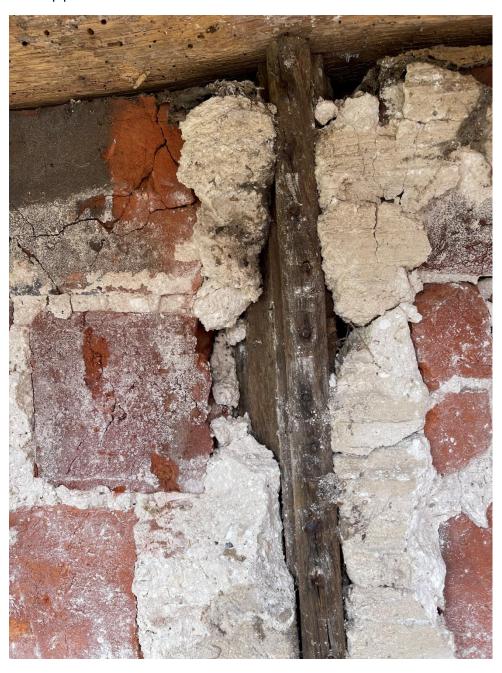
Close up picture of the mullion

The mullions look in good order but the full extent of their condition will not be know until the brick infill has been removed. If the mullions are in good order the plan will be to directly glaze the window within the mullions, using oak batons to secure the window with Hodgson Sealant Heritage Putty. Glass will be handmade cylinder glass from Tatra Glass.

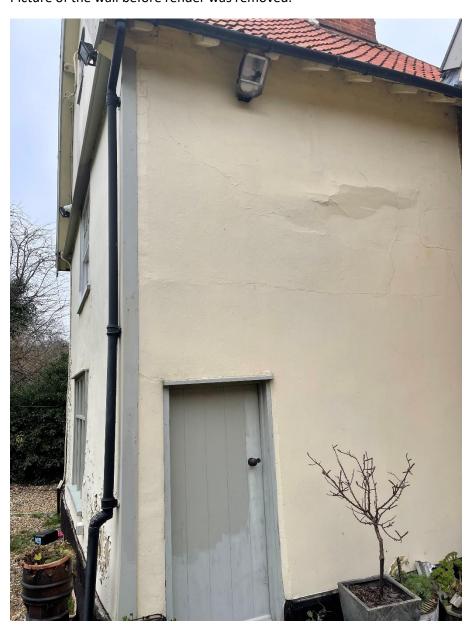
Picture of the wall before render was removed.
