## Phase I Geo-Environmental Desk Study

**Land at St John's Road**  
Kings Lynn  
Norfolk  
PE34 4QL

EPS Project Reference: UK22.5769

## LAND AT ST JOHN'S ROAD, KINGS LYNN

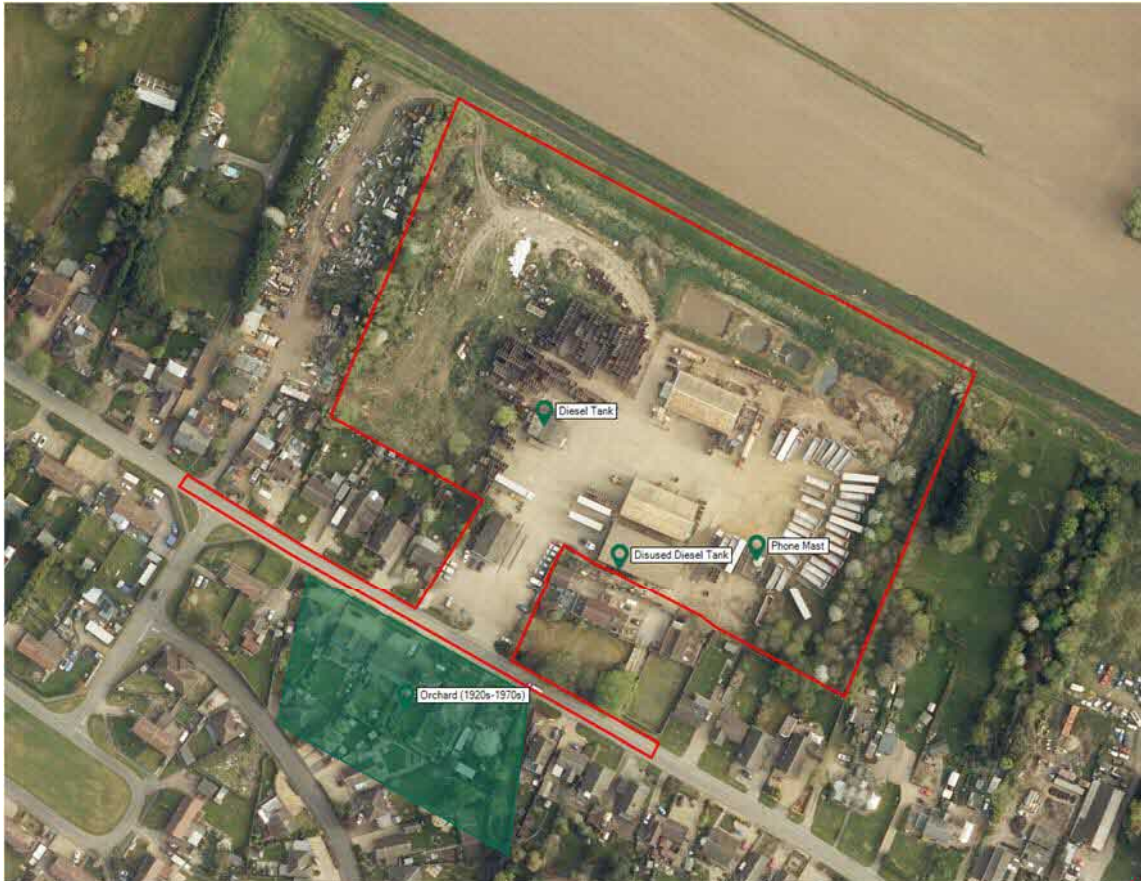
A summary of historical map data from 1886 to 2021 is summarised below. Key points are highlighted and copies of relevant historic maps and any others examined during the investigation are included in this report as Appendix E.

- The earliest available mapping shows that the site had been undeveloped prior to the 1970's, when two small structures were built in the approximate entrance to the modern depot. The weighbridge was added in the 1980's and the current site layout has existed since ~1995.
- Many of the structures in the surrounding area were constructed prior to the structures currently at the site, with many of the nearby residential properties being built 1970s and 1980s.
- Due to the weighbridge being evident on mapping during the 1980's, it is apparent that the site has been used for vehicular activities since that time period.
- Immediately south of site, an orchard existed until the 1970's. In the surrounding area, several small orchards were present, none remain today with the majority being removed by the 1980's.

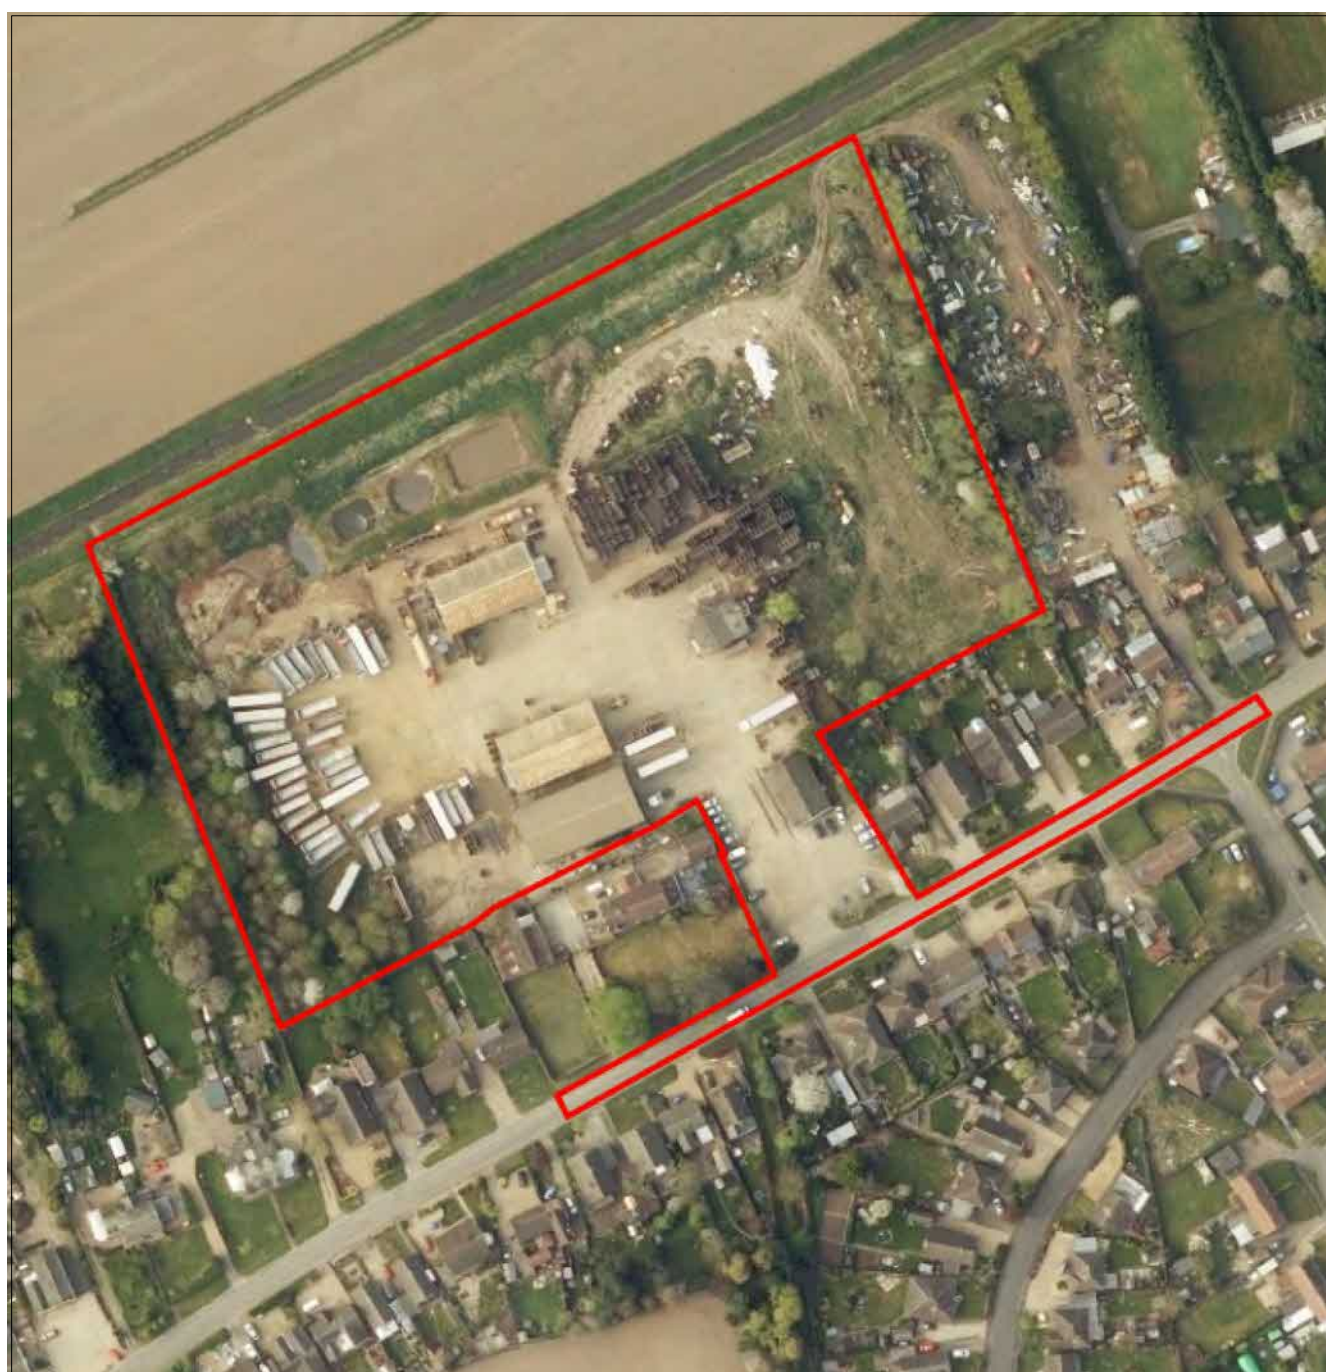
— Approximate Site Boundary

A plan showing the site location is provided as Figure 1 and an aerial photograph is included as Figure 2. Selected Site Photographs are included as Appendix A.

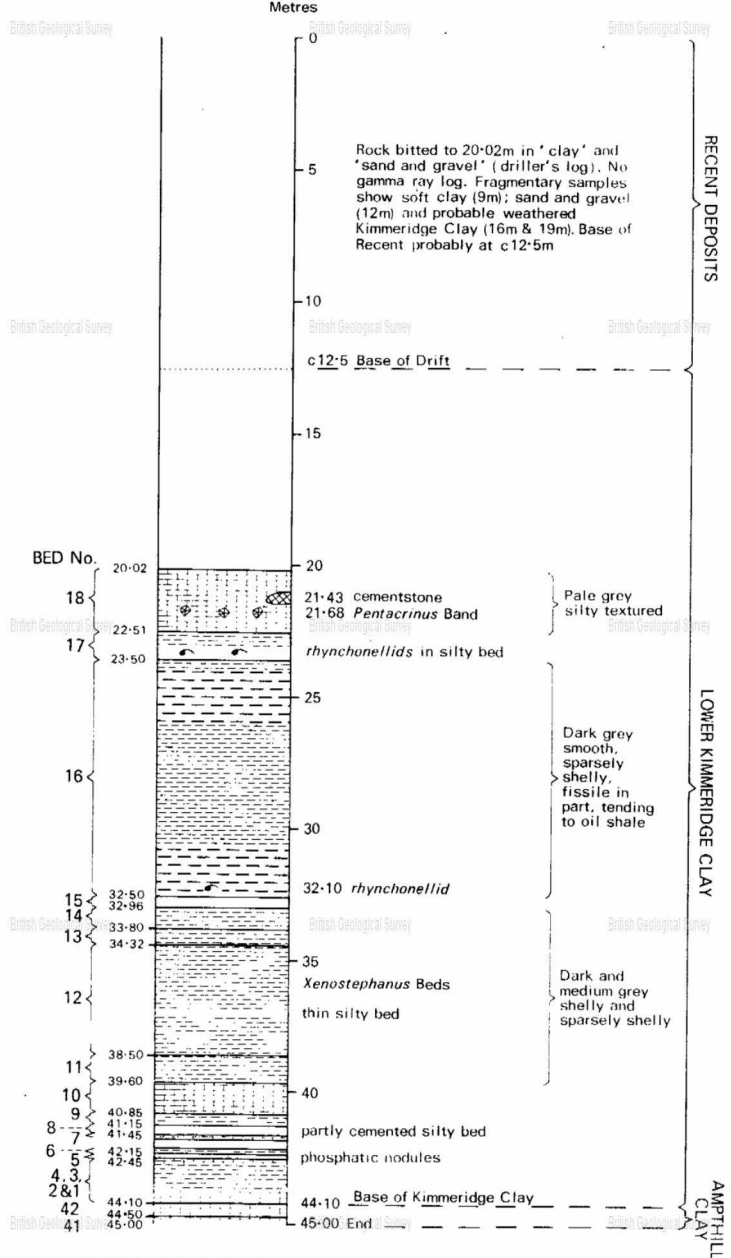
Rig: Failing 314

Ground Level: + 2.21m O.D.N.

Date: 5.9.72 to 12.9.72
