**Barn at Lower Hengoed, GLADESTRY, KINGTON,
HR5 3PL**

Bat survey with mitigation plan

17 July 2021

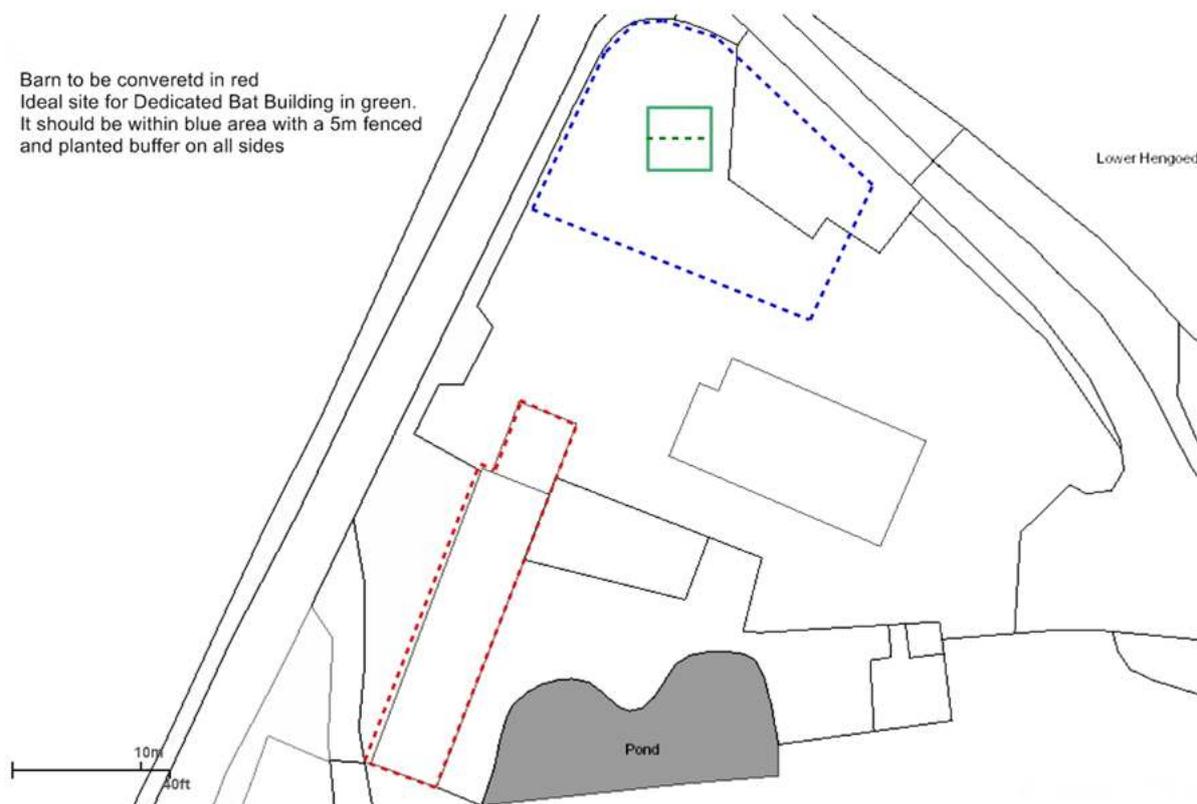
- i) A new dedicated bat building is to be constructed for bats within 40m of the existing building. The design will provide an upper loft with a floor and “cool room” below with a range of temperature regimes within the building, but with a minimum afternoon, mid-summer loft apex temperature of at least 30°C. The loft will be subject to solar gain providing the energy for warm conditions in this part; the ideal roof pitch for this is 52°. The lower room will be much cooler with a floor left as earth for moist conditions and will be dug out below ground level to create a type of cellar of over 1m depth to provide more stable cool temperatures in the winter.

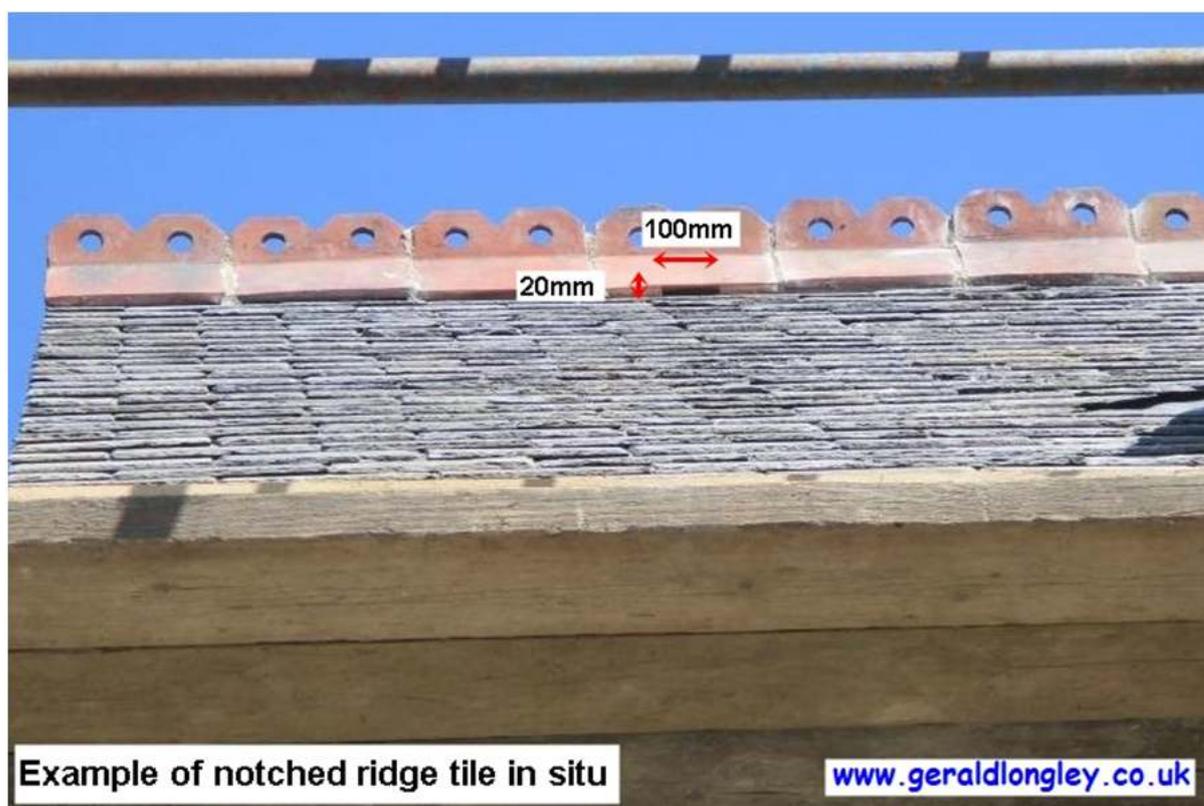
- viii) Five evenly spaced ridge tiles (more on buildings longer than 5m) will be "notched" to their lower edges on both sides to provide a slot 100mm long and an effective depth, when the ridge tile is in situ, of 20mm (and no larger or smaller) to provide access for bats under the ridge tiles, with a cavity left inside at this point. The ridge will be a mortared not "dry system" ridge. See the photograph 'Example of notched ridge tile in situ' below.

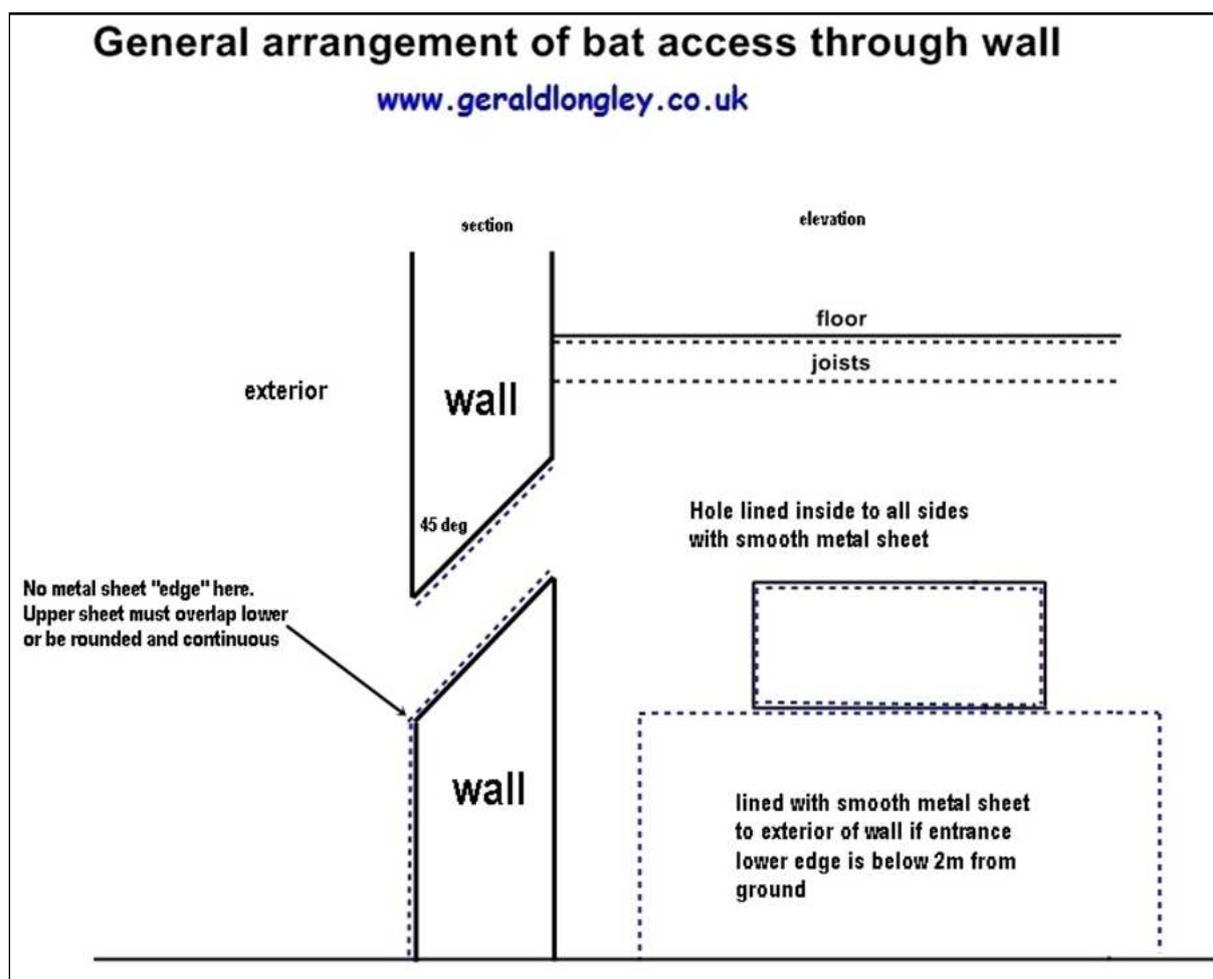
- ix) A rectangular bat entrance/exit will be provided as a hole in the east facing wall. The entrance will be 500mm in width and 200mm in depth. It will be angled up through the wall at 45° in section. It will be installed with its upper edge at about 1.7m from ground level. If the eaves' height is greater than 2m it can be higher. It is to enter the interior in the ground floor room (not into the loft) just below the loft floor. To deter cats jumping/climbing in the entrance, the bat entrance will be lined to all 4 sides in smooth metal sheeting. The area of exterior wall below the bat entrance will also be covered in a smooth metal sheet 1m wide over the timber cladding from ground level bending into the entrance hole with no "edge" there. The sheet will be as smooth as possible with any sheet overlaps being upper sheet over lower sheet. See the diagram 'General arrangement of bat access through wall' below.

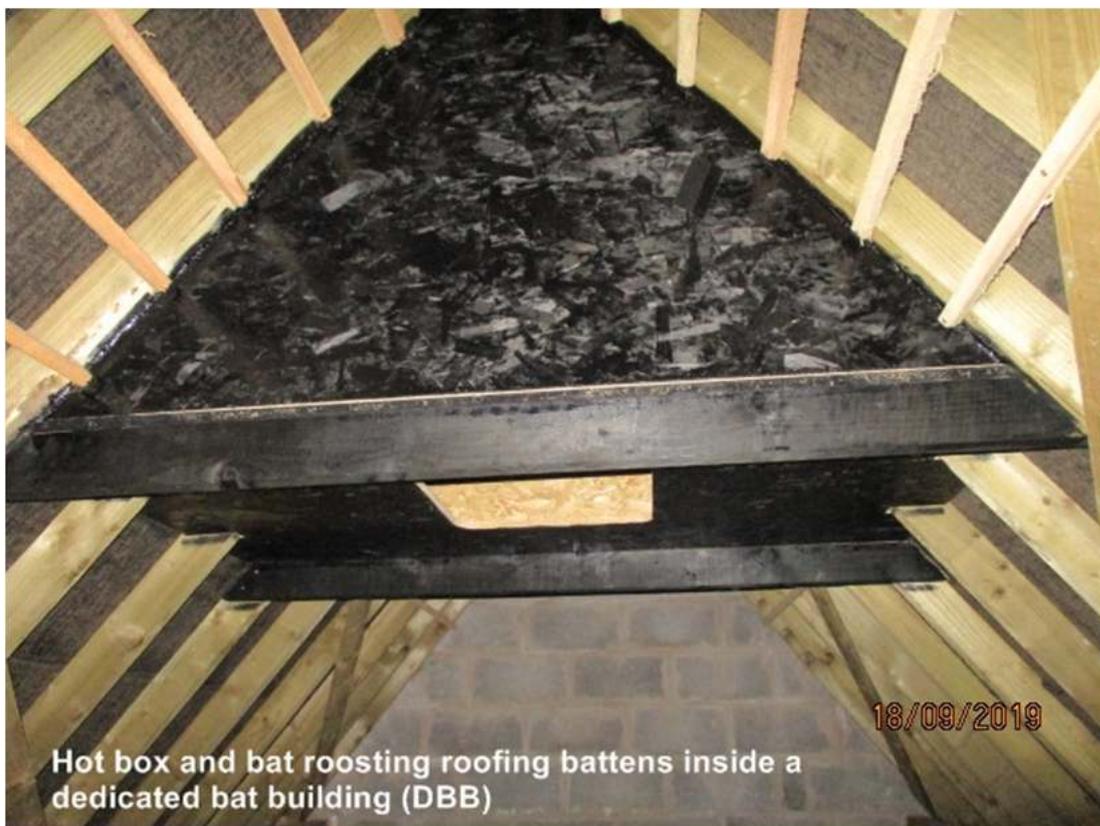
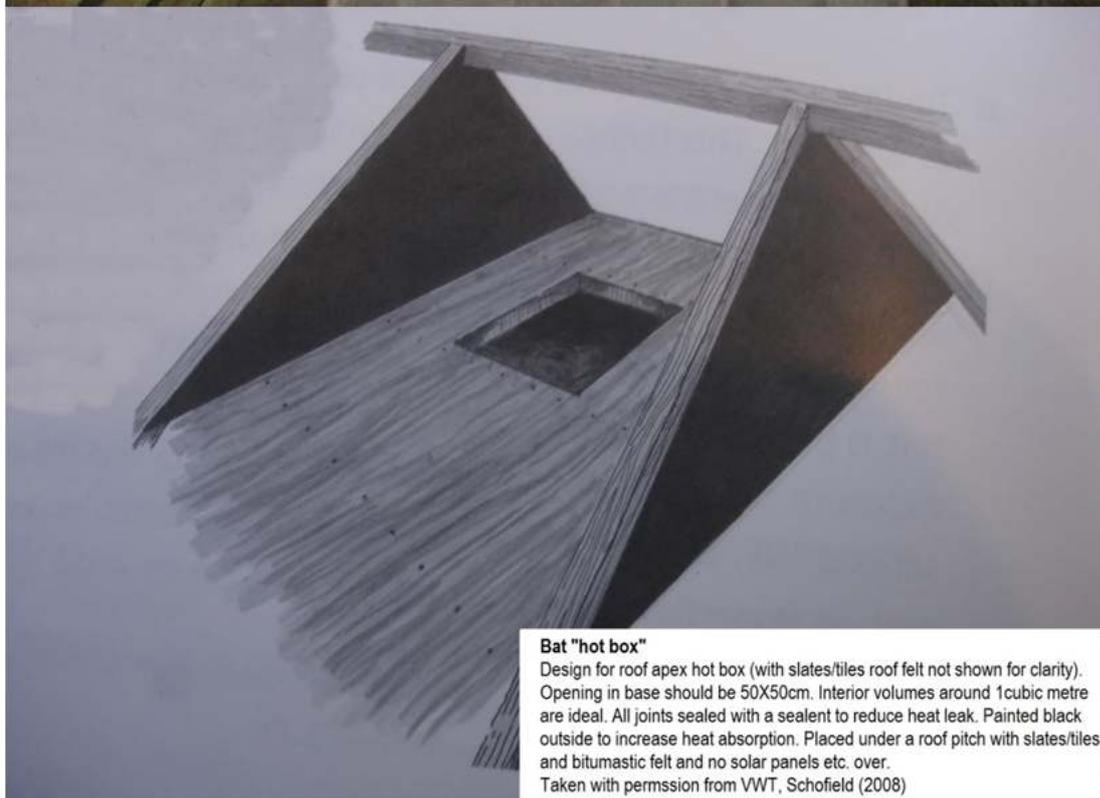
- x) In the centre of the loft, a “hotbox “ will be constructed of sterling/OSB and untreated timber, to be approximately 2m long, and 1m deep, sealed with mastic at its joints, painted black on the outside with a bat access hatch through its “floor” of 45cm by 45cm. See photo of hotbox installed and a drawing with roof and slates removed for clarity (below).

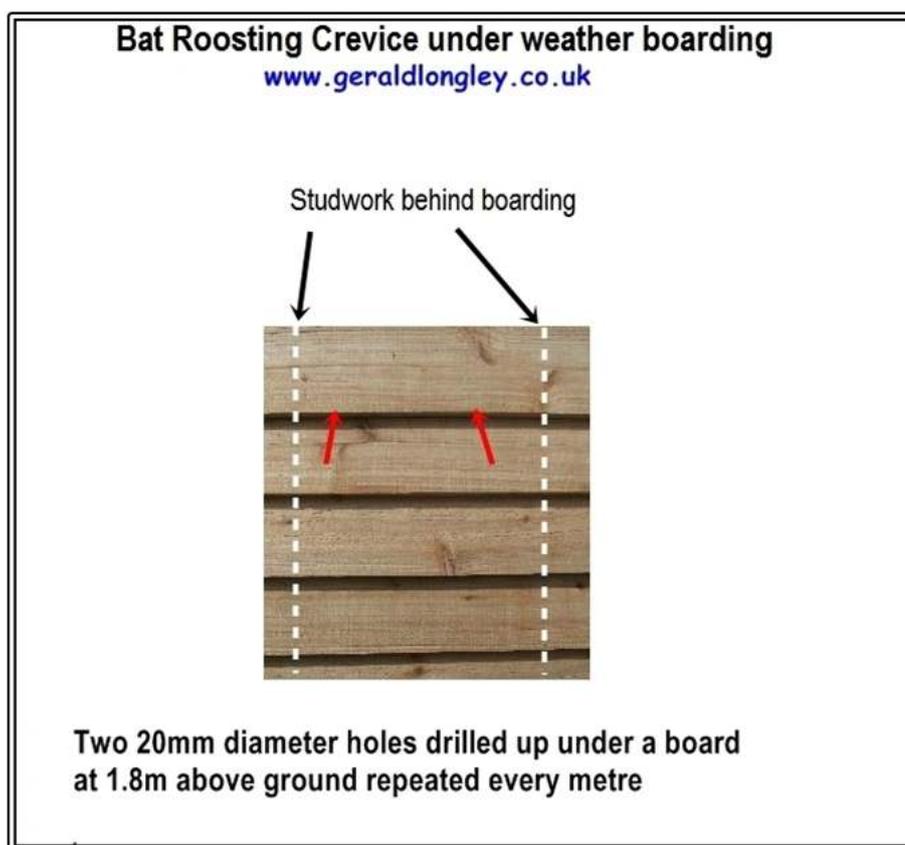
- xiv) The tanalised, horizontal exterior timber cladding will be on timber battens 50mm deep and will have pairs of holes, 20mm in diameter, at approx. 1m spacing, drilled up vertically at the bottom edge of a cladding board, at approx. 1.8m from the ground on each elevation to allow access for bats behind the cladding into the cavities between battens.

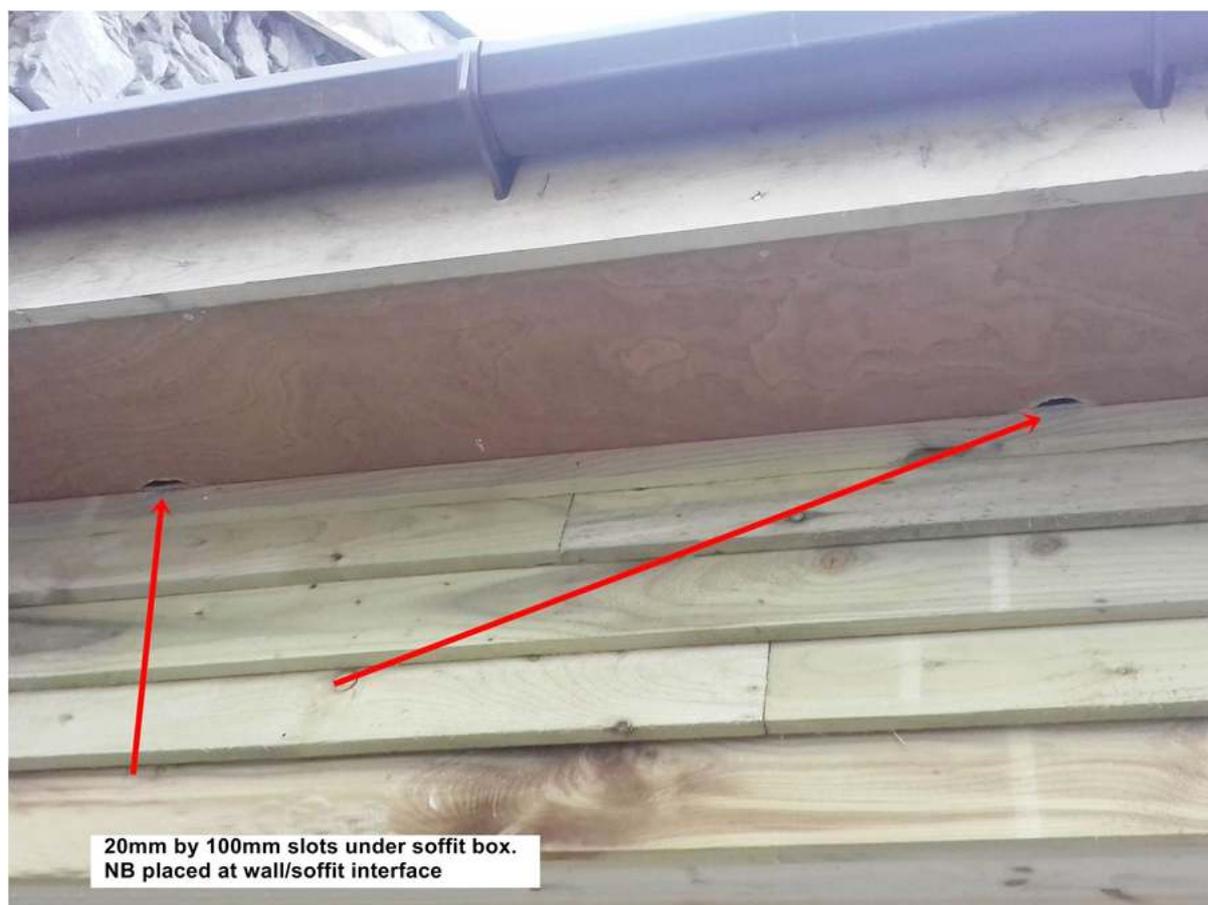
- xv) At the eaves and along the gables soffit boxes will be built with rectangular bat access slots at their wall edge about every metre. Similar slots will be made at the apex of the gables. All slots will be 100mm long and 20mm deep (and no larger) giving access to the soffit boxes and the wall tops. See the photograph 'Example of access slot in soffit box' below.

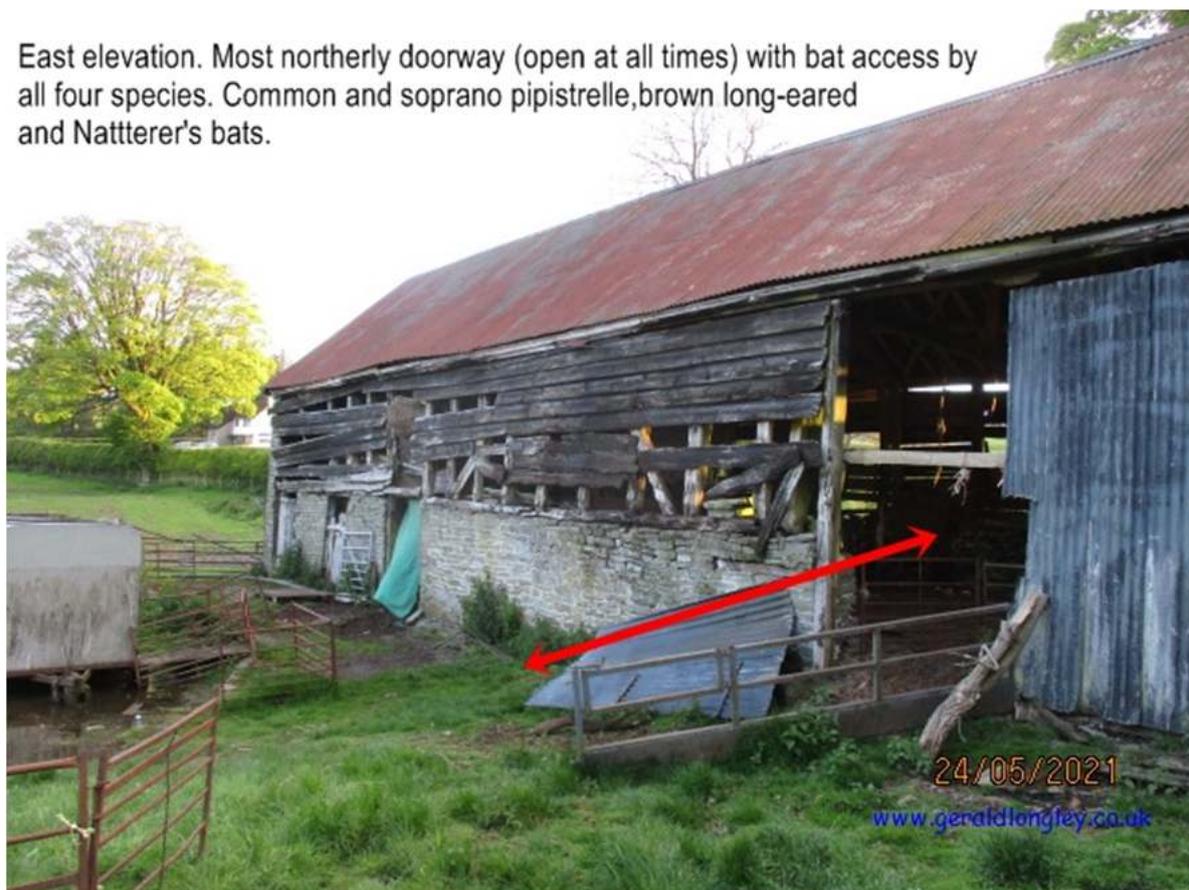
East elevation. Most northerly doorway (open at all times) with bat access by all four species. Common and soprano pipistrelle, brown long-eared and Natterer's bats.

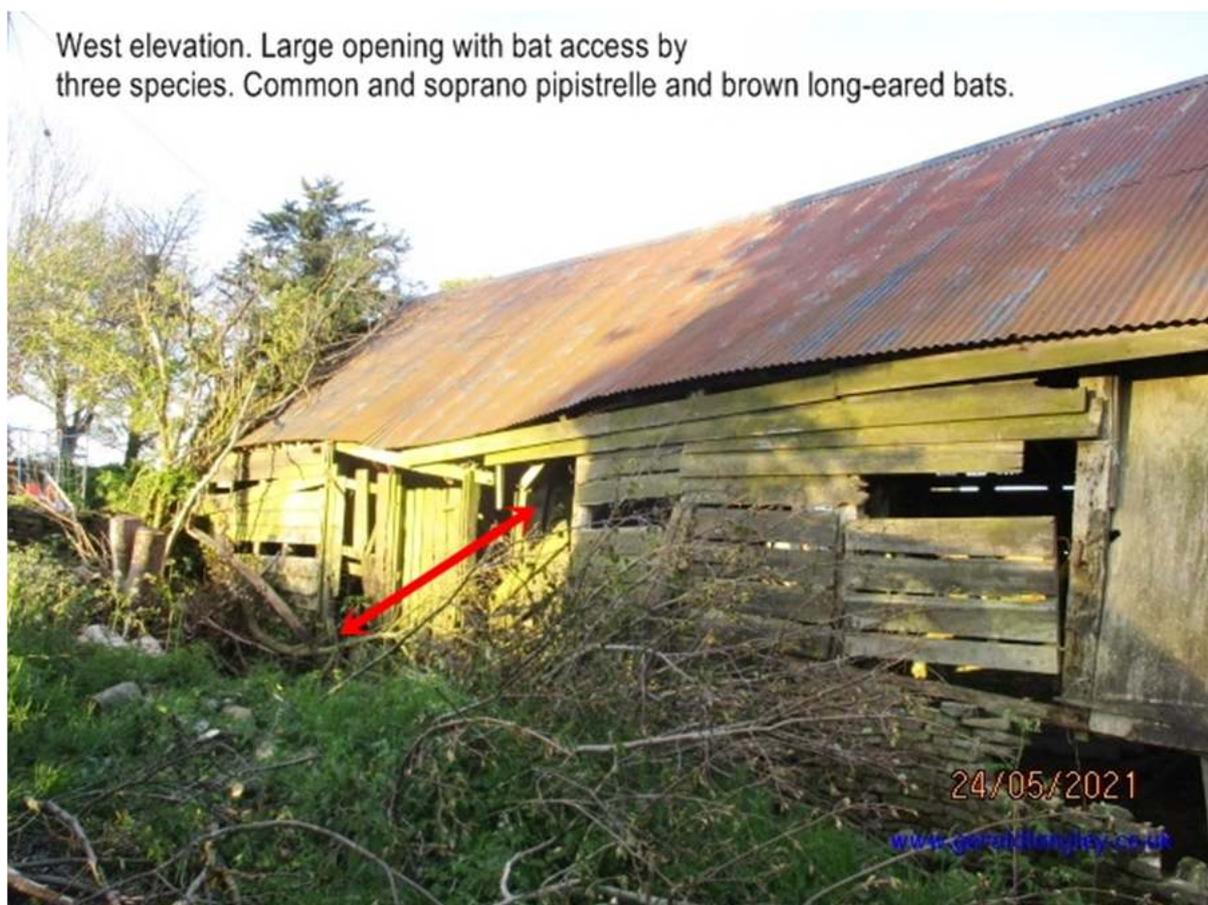
West elevation. Large opening with bat access by three species. Common and soprano pipistrelle and brown long-eared bats.
