# Outbuilding, Holmlea, Nunney

## Bat Survey

June 2022

Client: Lacey Architecture Ltd  
Report Ref: SEB2587\_01  
Author:  
Kate Hayward MCIEEM  
[www.seasonsecology.co.uk](http://www.seasonsecology.co.uk)

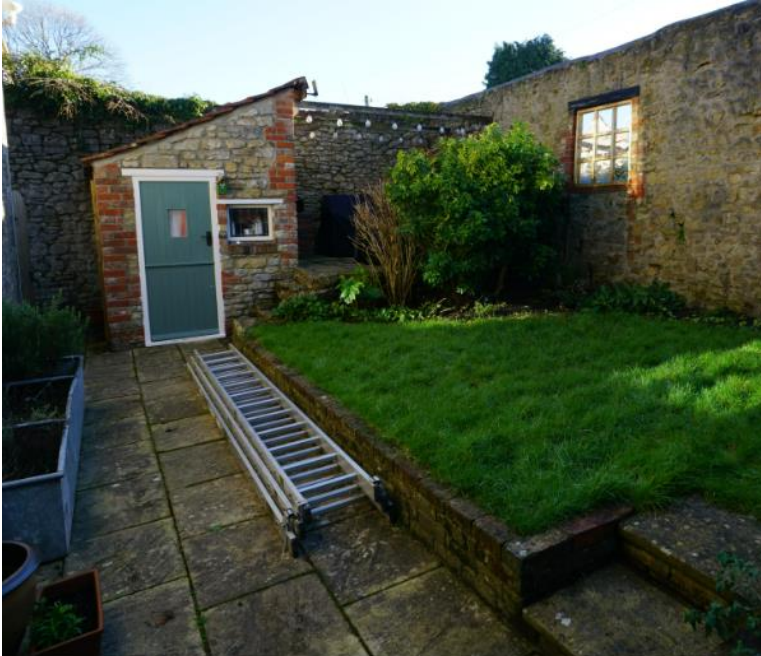
- 5.2.2 The outbuilding is a small, single-storey rubble stone and brick structure with a footprint of approximately 5m<sup>2</sup>. It has a lean-to clay, zig-zag tiled roof. There is a window on the south elevation and a door and window on the west elevation.

Photograph 1. The west elevation of the outbuilding and the high stone walls surrounding the garden.

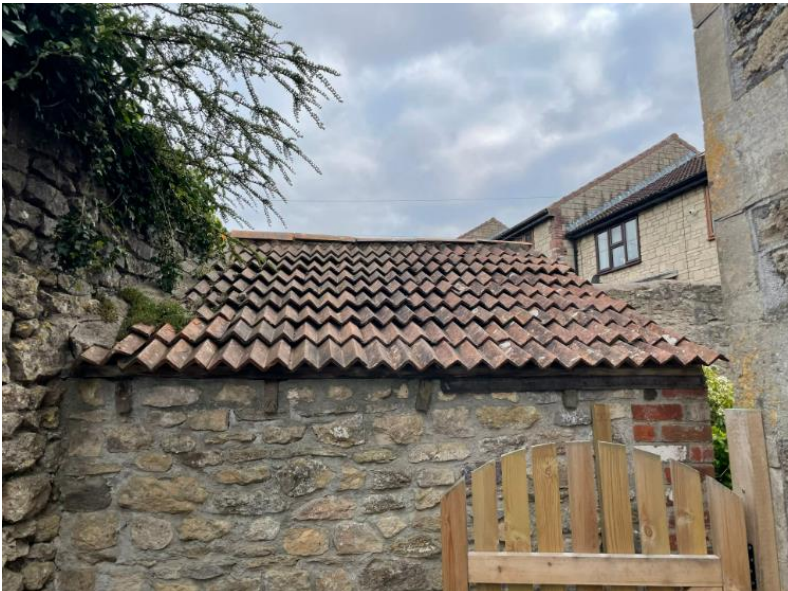
- 5.2.3 Externally, there are gaps under approximately one-third of the roof tiles, but the ridge tiles are well-sealed. There are gaps at the roofline, which lead directly into the interior of the outbuilding. The stone and brick work are in good condition with no cracks or gaps, or cracks in pointing. The door and two windows are well-sealed to the walls with no gaps.

- 5.2.5 The outbuilding is assessed as *Low* suitability to crevice-dwelling species of bats owing to the presence of gaps under roof tiles and access into the interior provided by gaps at the roofline, with the interior of the roof lined with a Bitumen-type liner with several tears and holes.

Photograph 2. The lean-to roof of the outbuilding showing gaps under the clay, zig-zag tiles.

7.2.1 It is recommended that a pre-works check and supervision of the hand removal of the roof structure of the outbuilding is undertaken by a Licensed Bat Ecologist.

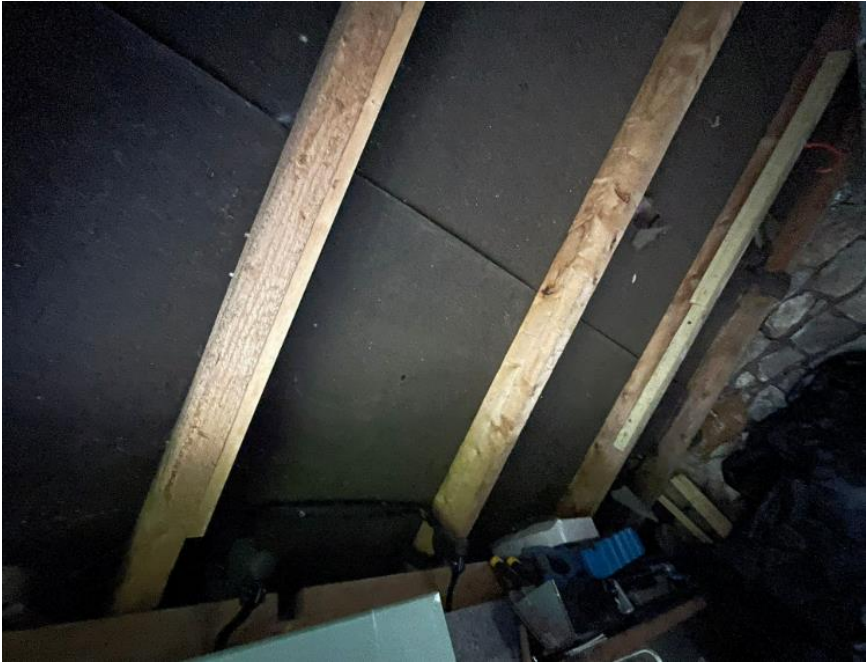
- 5.2.4 Internally, the outbuilding is used for storage and is cluttered. The roof is lined with a traditional Bitumen-type liner with a few tears and holes. No evidence of roosting bats or nesting birds was found inside the outbuilding or externally.

Photograph 3. Internal view of the Bitumen-type liner below the roof tiles with tears and holes.
