Date: 12 May 2022
 Reference: SUF_IP300QE_010422
 Your ref: Roof repair works

Bat Roost at Gedding Grange, Drinkstone Road, Gedding, Suffolk, IP30 0QE

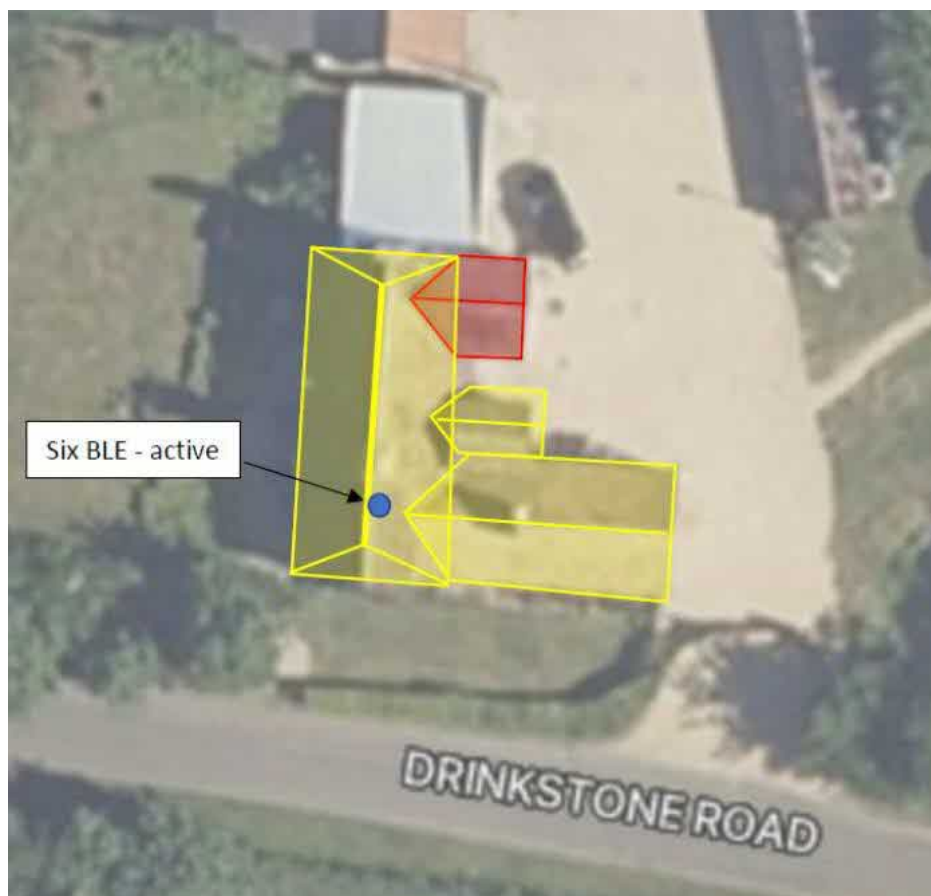
Bats visible at visit	Yes, bats seen during survey.
Bat species and numbers	Six brown long-eared bats seen roosting near the apex at the southern end of the main roof void, with eight dead fully grown bats, estimated to be between 1 and 2 years old found within roof void.
Bat droppings information	No bat droppings in the north-east roof void.
Roost location	Roof tiles largely intact but occasional gaps where tiles are lifted could provide crevice roosting opportunities for species such as pipistrelle bats.
Roost type	Summer maternity roost site definitely present, with potential for hibernation.

Bat access point(s) location	Thousands of long-eared bat droppings scattered throughout the loft void, with accumulations beneath favoured roosting sites.
Additional information	17 th century timber property with 19 th century alterations, rendered with peg tile roof lined with bitumen on main roof and foam insulation fitted to underside of tiles on the north-east section of the property which has a separate loft void to the main building. Loft space boarded throughout with insulation replaced around seven years ago.

Photograph 1, annotated by Volunteer: position of roosting bats. Red area denotes separate roof void, where no evidence of bats was found.

I understand that the foam insulation in the north-east roof void will be removed and replaced with bitumen felt, which will involve the removal of the tiles. We would like to thank you for correctly seeking advice on how these works should be undertaken. Such responsible actions will not only ensure that the law is not broken when undertaking any action to resolve such issues but will also help to conserve the bat colony in the long term by protecting it from harm.

The bats access points to the main roof void are not located on the north-east extension roof and therefore it is not necessary to reinstate any roosting features during the works.

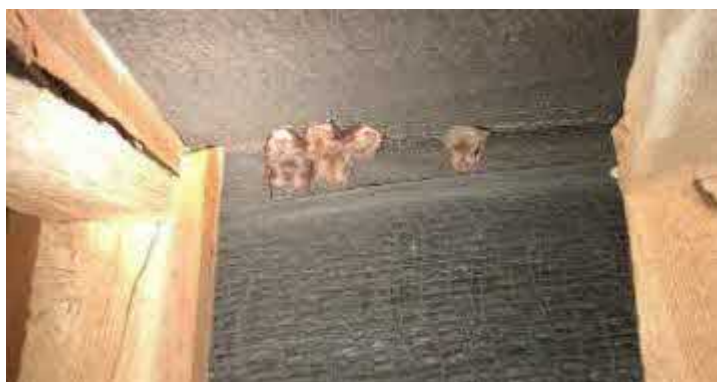
Photograph 2, taken by Volunteer: Cluster of bats seen at south-end of main roof void.
