Bat Survey Report
Brookfield
Ford,
Shropshire
SY5 9LG

Version 2.0 May 2022

1 Purpose and Justification for Survey

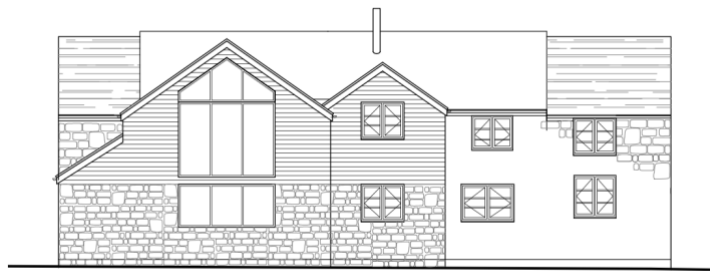
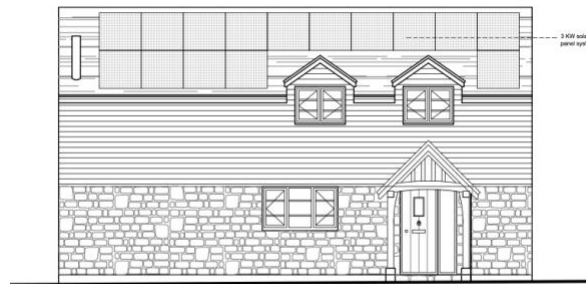
Figure 2 Proposed extension (top) & ancillary accommodation (below)

Rear Elevation

Front Elevation

The construction of an extension to existing house. The construction of ancillary accommodation. Copies of drawings were provided by the architects.

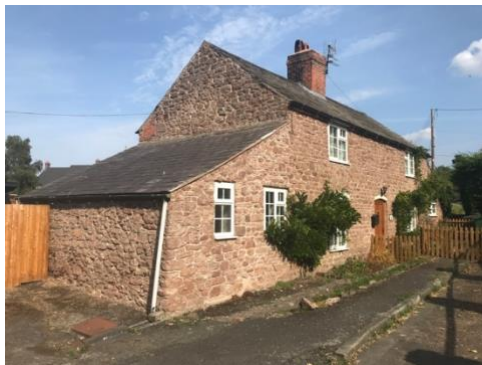
Figure 3 South elevation

A two-storey, stone residential dwelling probably dated to the 19th century. The roofs are part covered in slate and part tiled over a bitmastic felt lining with ceramic ridge tiles. On both gables there is a lean-to section with slate roof. 50% of the roof surface is lit by street lights at night. There are also several security lights around the property. There is one central chimney stack with intact flashings. All the verges are in good condition. The extended part comprises tiles over breathable felt. It could not be accessed and was only viewable from the main roof space through a tear in the felt. There is no insulation in either loft and no light ingress.

There were no bat droppings seen in the loft spaces. The slates and flashings are neat and compact throughout with no defects.

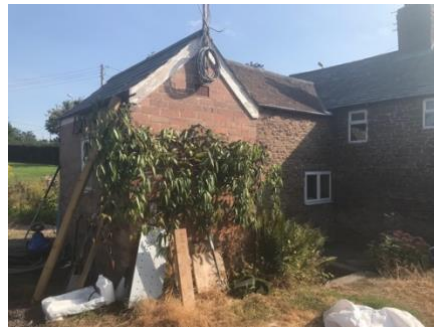
Figure 8 Outside toilet

There is a standalone outside toilet made of brick with an unlined slate roof. There were no droppings evident and the apex was festooned with cobwebs.

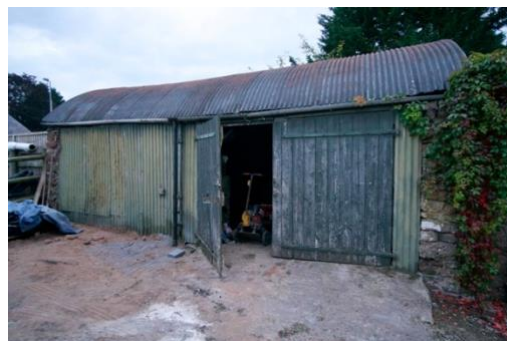
Figure 10 Storage shed N elevation

Two stone gable ends with a curved sheet steel roof. Wooden sides with sliding doors. No sign of droppings and always kept locked for security. Low potential.

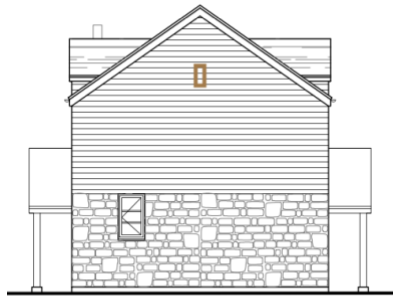
Figure 13 Location of bat tube in ancillary accommodation gable end

Side Elevation

For alternative roosting, capacity, a Schwegler 1FR bat tube or equivalent will be placed on the east gable of the ancillary accommodation. Pipistrelle and myotis bats are known to use these boxes. They should be situated at least 3m high up the walls but not within half a metre of the eaves to avoid predation. The 1FR Bat Tube is designed to be installed on the external walls of buildings, either flush or beneath a rendered or boarded surface. This makes it ideal for situations where you wish the box to be discrete as only the entrance hole need be visible.

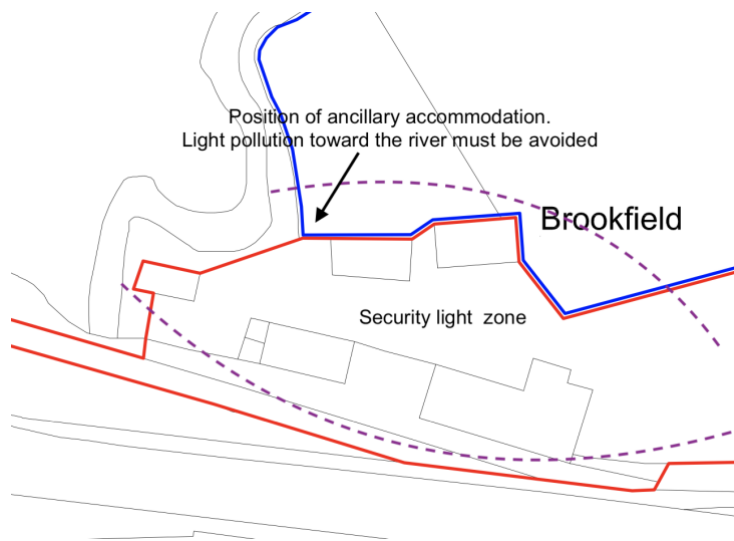
Figure 14 Flight paths over existing

Summary: No bats were seen to emerge. A soprano pipistrelle flew in from the neighbours and common pipistrelles were occasionally active along the road and around the garden during the latter part of the survey. Noctules were foraging around the street lights throughout the survey.

The intention is to extend this building and construct another further north. Pipistrelle bats were seen to use parts of the garden for foraging despite the street, house and security lighting but mostly avoided this area to feed by the brook. Post development changes are unlikely to cause disturbance to bats that already seem to tolerate the lit conditions together with regular traffic noise as long as they have unfettered access to the unlit brook. It would however help other bat species to frequent the site if the security lights on the property were less sensitive to fast moving objects like bats and more downward facing.

The ancillary accommodation is close to the observed bats flight lines and it is important that lighting is minimised to preserve the foraging habitat of the brook for bats and other species. Bankside trees will only provide limited night time shade. This means no large bay windows or patio doors if they were to illuminate the brook.
