HIGH WINDS, TREDUNNOCK, USK

Bat Survey Report

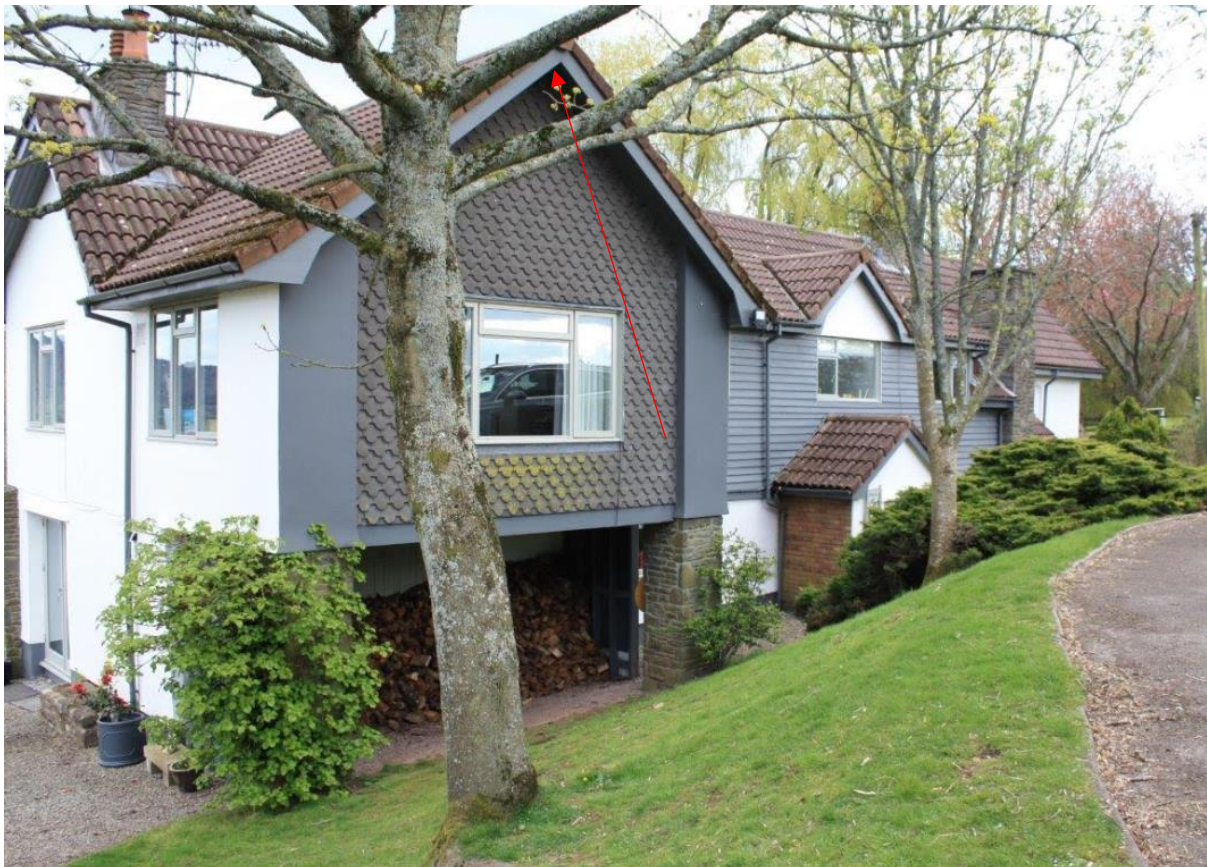
The first bat call heard was a common pipistrelle at 21:15, the bat was seen emerging from the apex of the western gable (figure 5, arrowed red). The bat then commuted north.

Figure 5- common pipistrelle emergence point (arrowed red)

The first common pipistrelle heard was a common pipistrelle at 19:30, the bat was seen emerging from the western gable, the same location it had emerged from during the previous survey (figure 5, arrowed red).

If it is required to remove the barge boards, A no more than 15mm gap will be left beneath the barge board and the wall on the western and southern gable

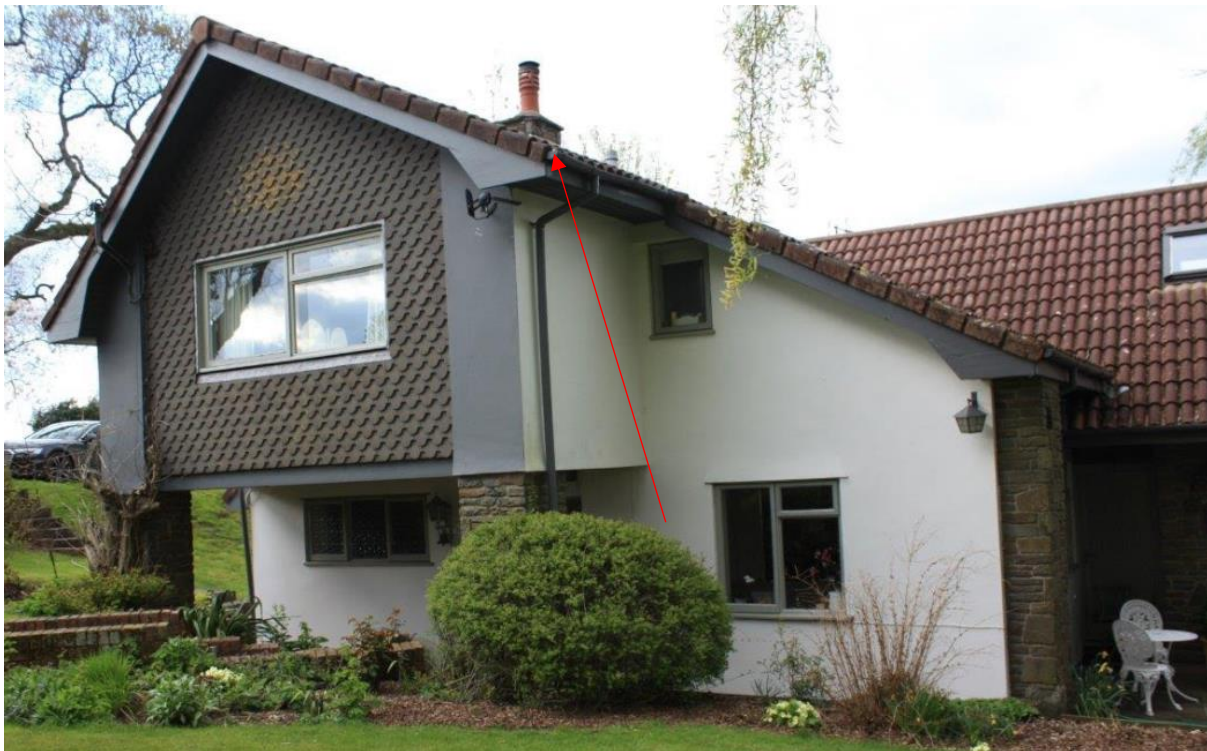
This was shortly followed by a second common pipistrelle emerging from the corner of the southern gable (figure 6, arrowed red). Both bats commuted west.

Figure 6: common pipistrelle emergence point (arrowed red)
