Initial Bat Scoping Report

Barn and Outbuilding at:

Birka Carr Farm

April 2022

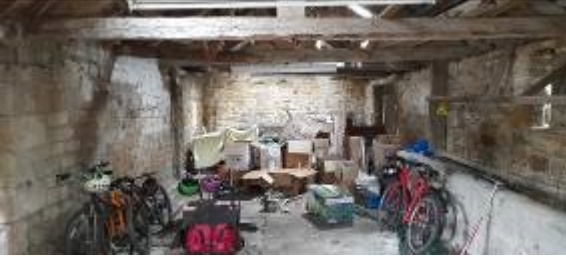
Interior of main barn area	Internal gable of main barn area

A photograph showing the interior of a main barn area. The space is cluttered with various items, including bicycles, boxes, and equipment. The walls are made of brick and the ceiling has exposed wooden beams.

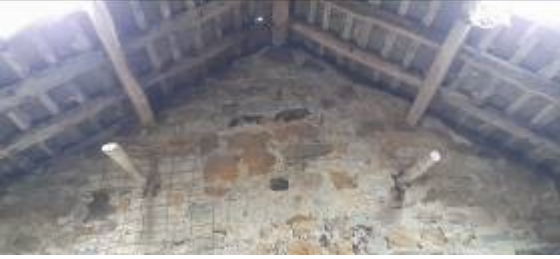
Very few features with the potential to support bats were observed at any location within the barn. Although there was a small gap between the roof tiles and wall at the internal gable ends of the barn on closer inspection, these were shallow and sub-optimal for bats.

A photograph showing the internal gable of the main barn area. The view is looking up at the wooden roof structure, showing the gable end with its rafters and purlins.
Internal roof tiles	Roof frame

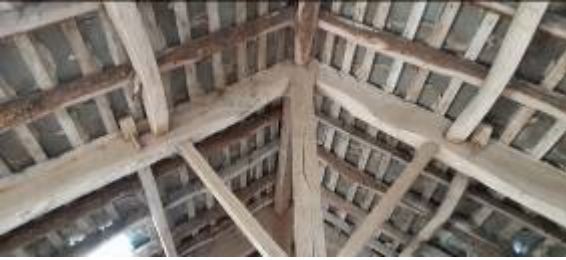
A close-up photograph of the internal roof tiles. The tiles are dark and appear to be made of a heavy material, possibly slate or concrete, and are laid in a regular pattern.	  A photograph showing the roof frame. The view is looking up at the wooden structure, showing the rafters and purlins that support the roof.
