Elevations - As Existing

Elevations - As Proposed

Shed - Existing and Proposed Plans and Elevations

Drav	wing Number	Revision
J	19 06 EG22	В
Sca	le	Date drawing created
1:50	0,1:100 @ A1	24/03/2022

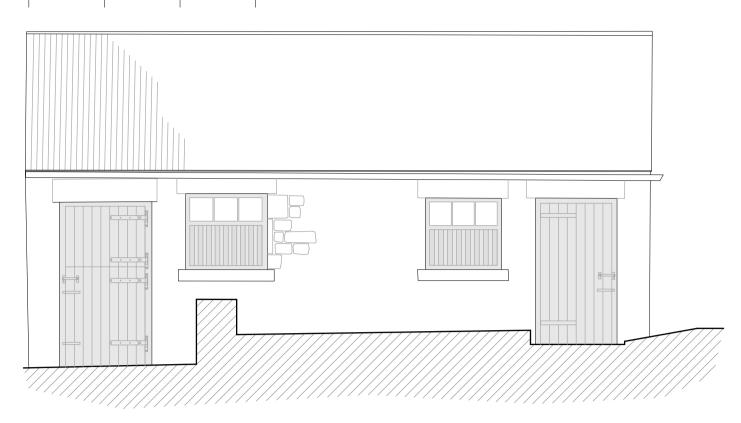
KEY	
	Asbestos sheeting
	Stone
	Black painted timber

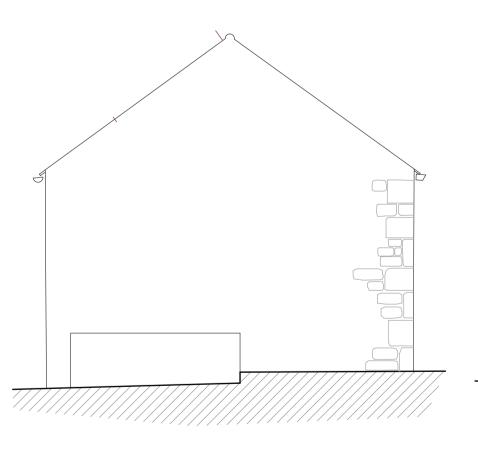
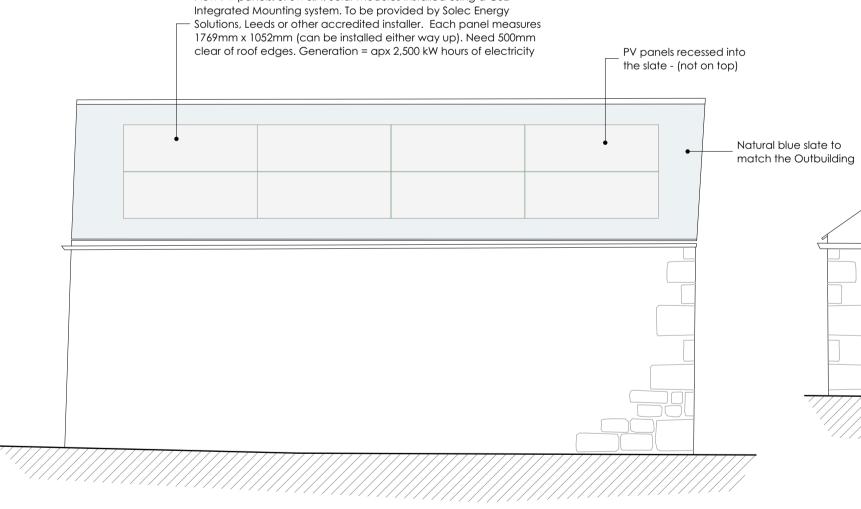
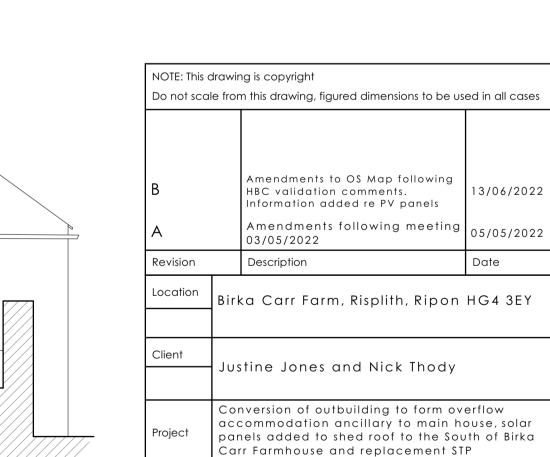
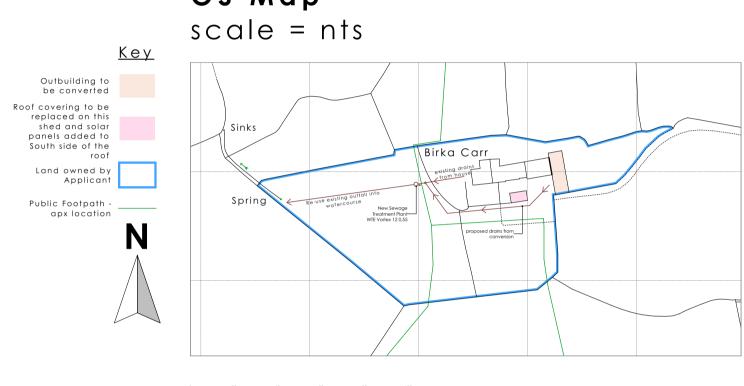
New PV panels: 370w J.A. Solar Modules installed using a GSE

Asbestos replaced with

— natural blue slate to match the Outbuilding Pane of glass removed

Please read the Ecology Report. Access for nesting birds needs to be created into this building by removing a pane of glass from one of the windows. See Ecology Information below.

• Creation of access into the room within Building 2 that is least disturbed during the summer. At least two commoerially available swallow nest cups should be attached inside Building 2 high up on the internal walls (one close to each internal gable apex) out of reach of cats and other predators.
