Fisher House, Rivington Lane, Rivington, Bolton BL6 7SL:

Heritage Statement

Minerva Heritage Project Code: FISR021

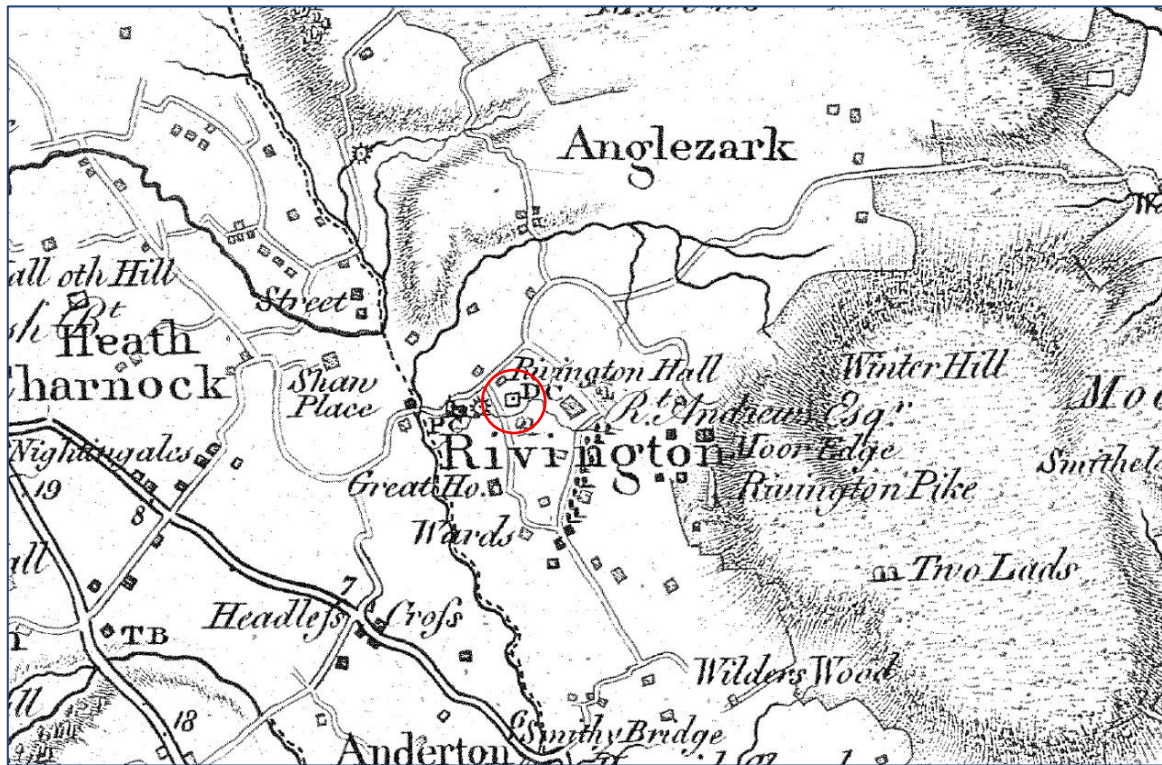
Plate 1: Yates' Map of Lancashire 1786, extract not to scale; approximate location of Application Site in red circle

- 3.8.1 **Yates Map of Lancashire 1786 (Plate 1):** shows a dense spread of farmhouses or otherwise-significant farm buildings. Rivington seems to have been a busy parish at the time. Fisher House is likely to be the square building in the centre of the red circle. A watermill icon is also shown to the west of Fisher House at the edge of the red circle, close to the church.

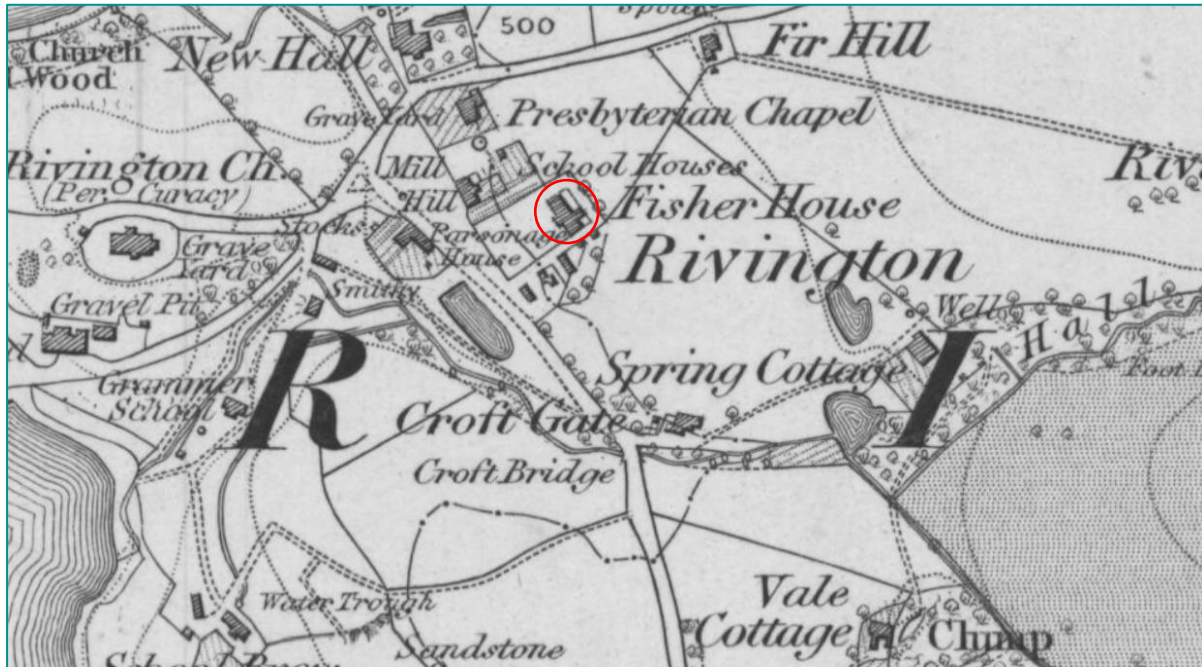
Plate 2: Ordnance Survey 6” Map of Lancashire Sheet LXXXVI, surveyed 1845-47, published 1849, extract not to scale; Application Site highlighted red

3.8.2 **1845-47 Ordnance Survey (Plate 2):** this illustration shows the study area in far more detail. The Application Site is clearly by now a complex building with the porch to the front and extension to the rear. A smithy (LHER PRN9614) and reservoirs that may have powered other mills are still shown in this illustration. The outline of the smithy yard shown on the 25” maps (Plates 4 and 5) may support this.

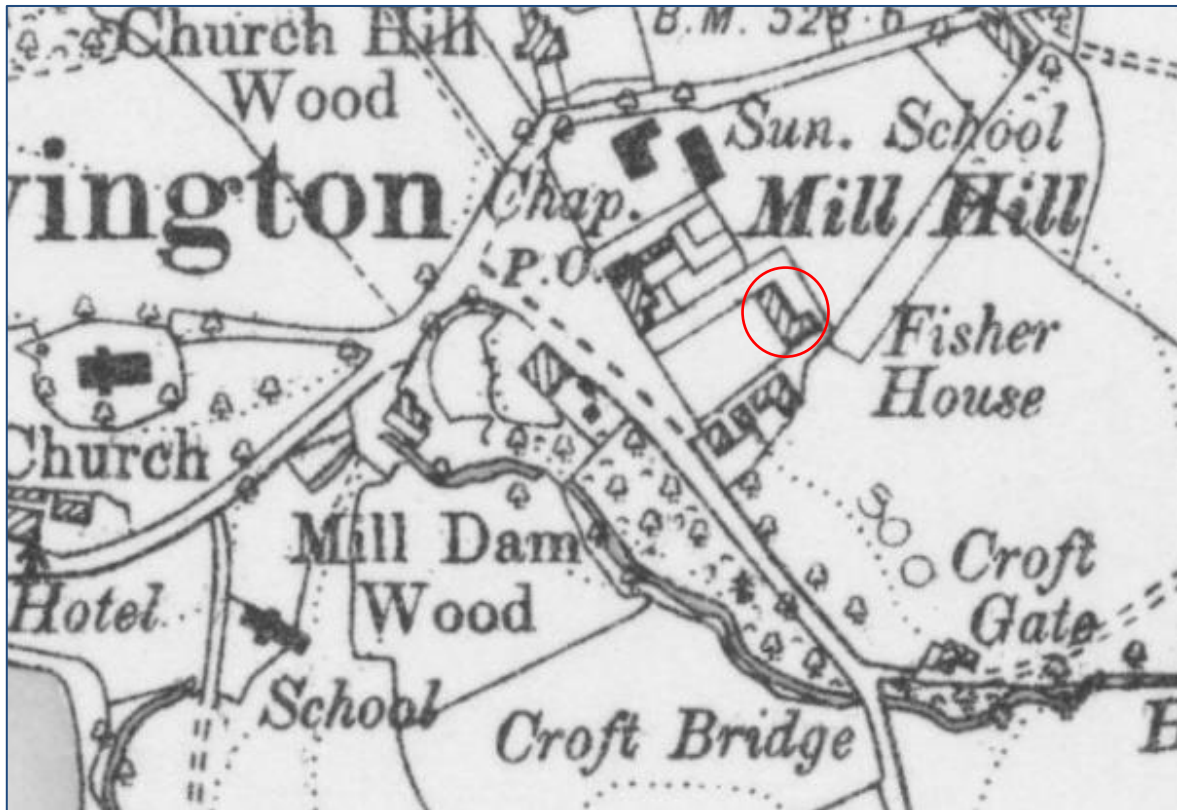
Plate 3: Ordnance Survey 6" Map of Lancashire Sheet LXXXVI.NW, surveyed 1892, published 1894, extract not to scale

3.8.3 **1892 Ordnance Survey (Plates 3 and 4):** this illustration shows a similar situation although the 6" map (Plate 3) is far less informative than the 25" map (Plate 4).

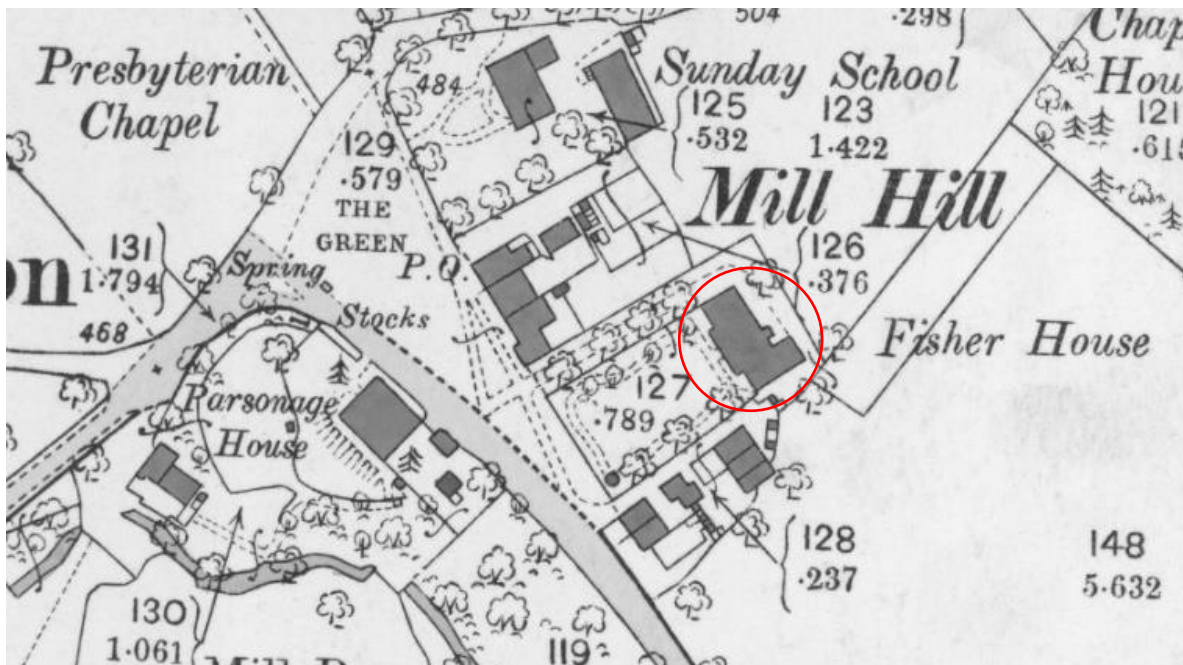
Plate 4: Ordnance Survey 25" Map of Lancashire Sheet LXXXVI.1, surveyed 1892, published 1894; extract not to scale

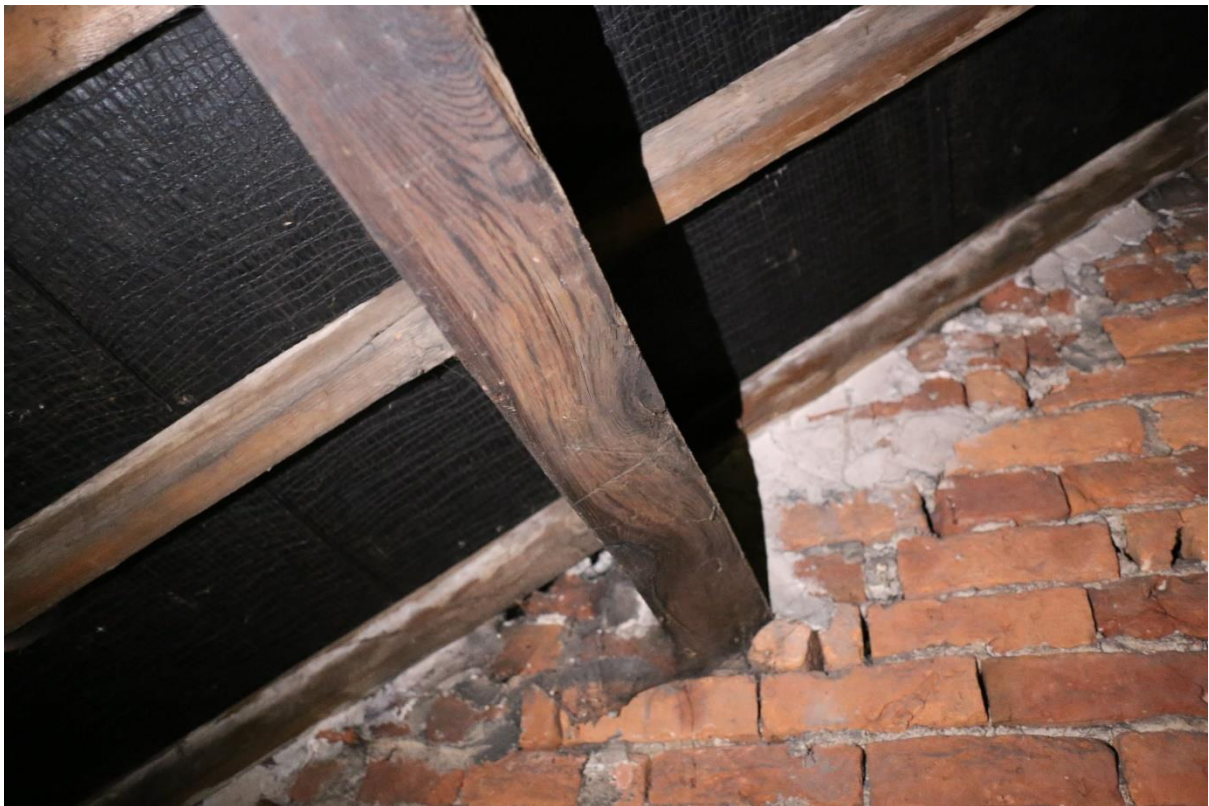
- 4.2.5 The stone slate and slate roof described in the 1967 listing was either entirely replaced or at least extensively repaired in the early 20th century, as shown by the appearance of the frame and roof felt in the loft space (Plates 10-11). The wooden eaves gutter to the front of the property (described in the listing description) is still extant on its timber brackets, although suffering from age; presumably it is still lead-lined. There is no such guttering on the rear of the property (Plate 12).

Plate 10: Modern roof frame over Fisher House

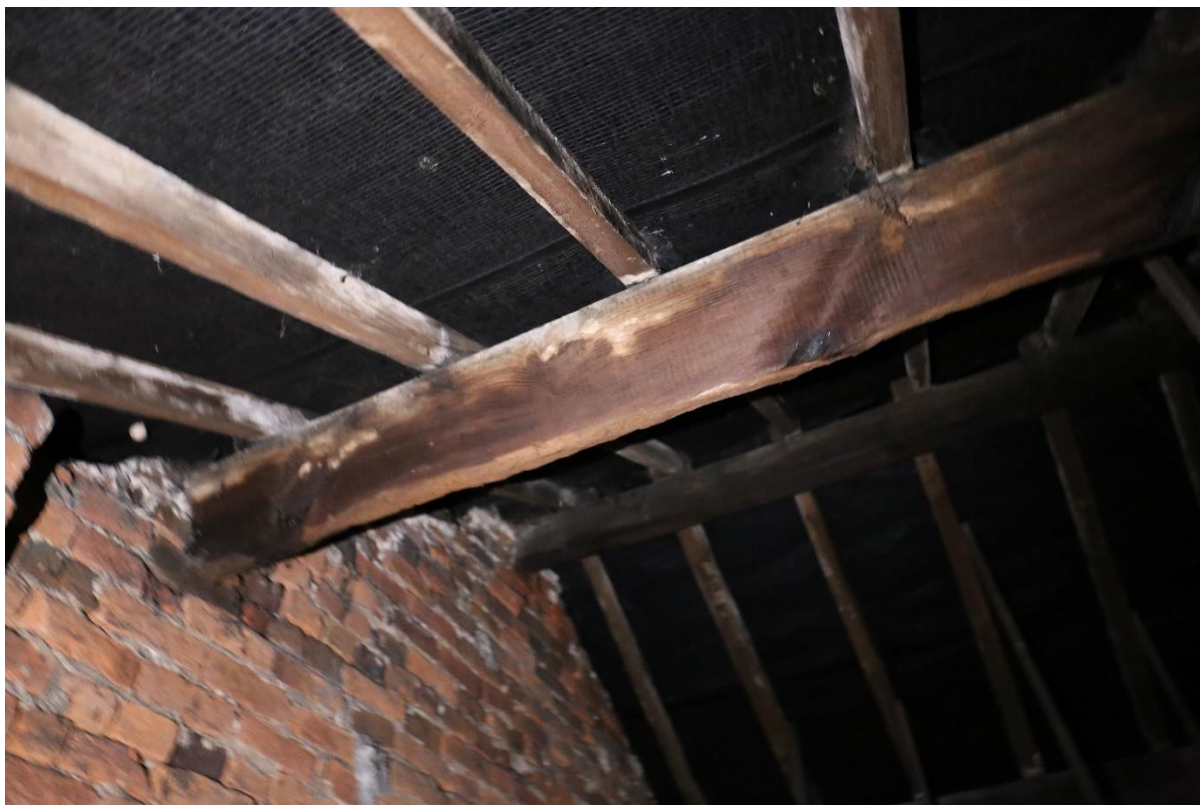
Plate 11: Modern roof frame over Fisher House

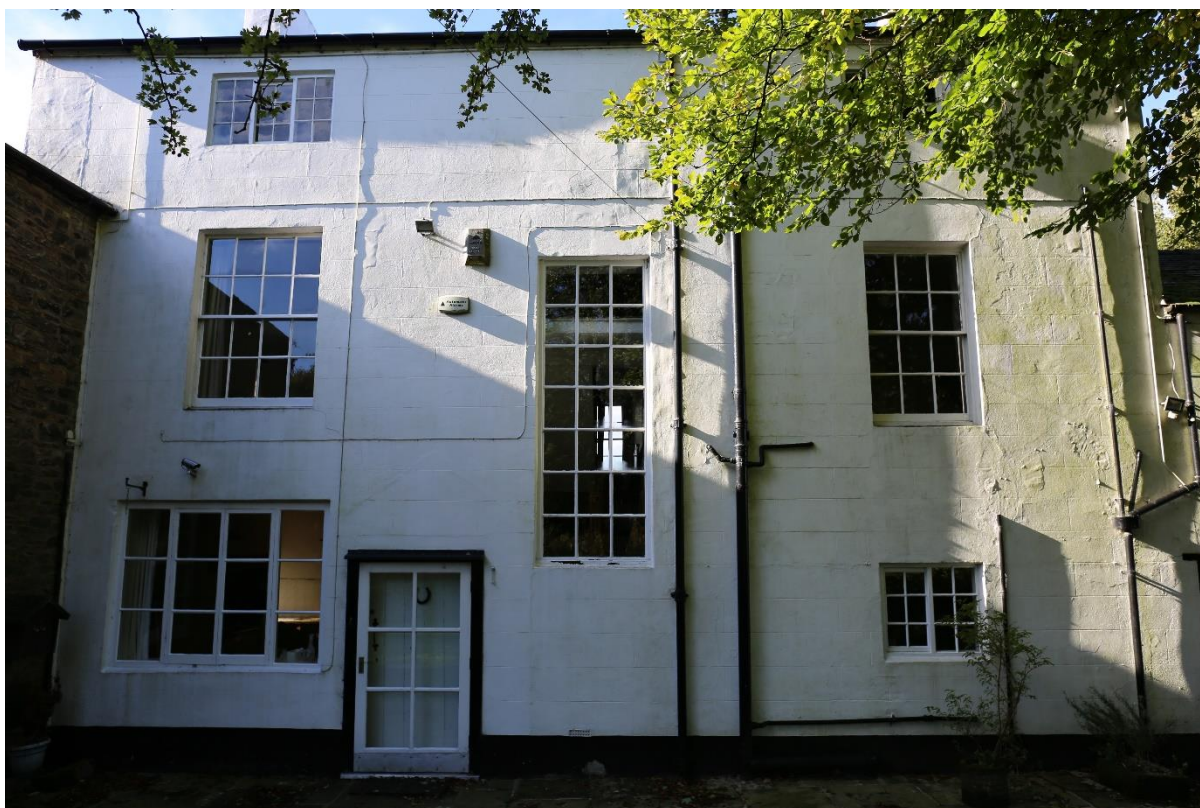
Plate 12: Rear elevation, Fisher House

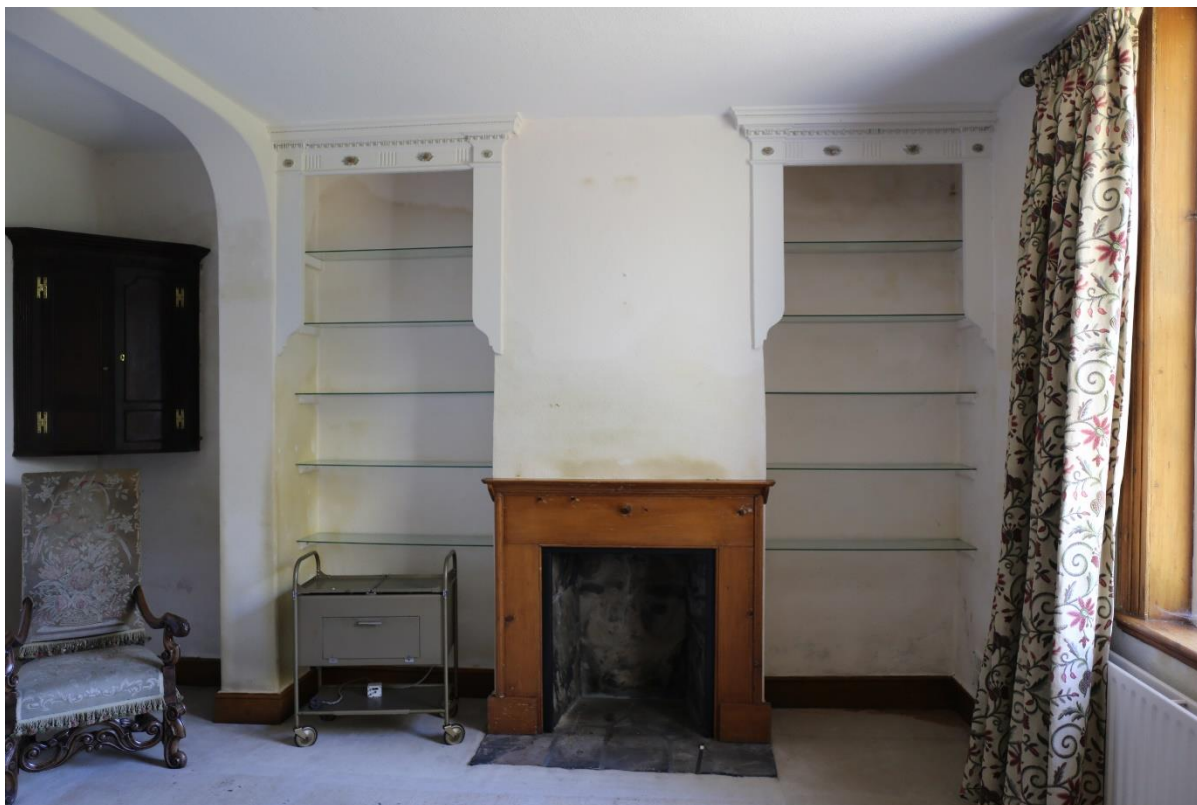
Plate 13: Chimney breast, fireplace, cupboard and window frame in ground floor dining room

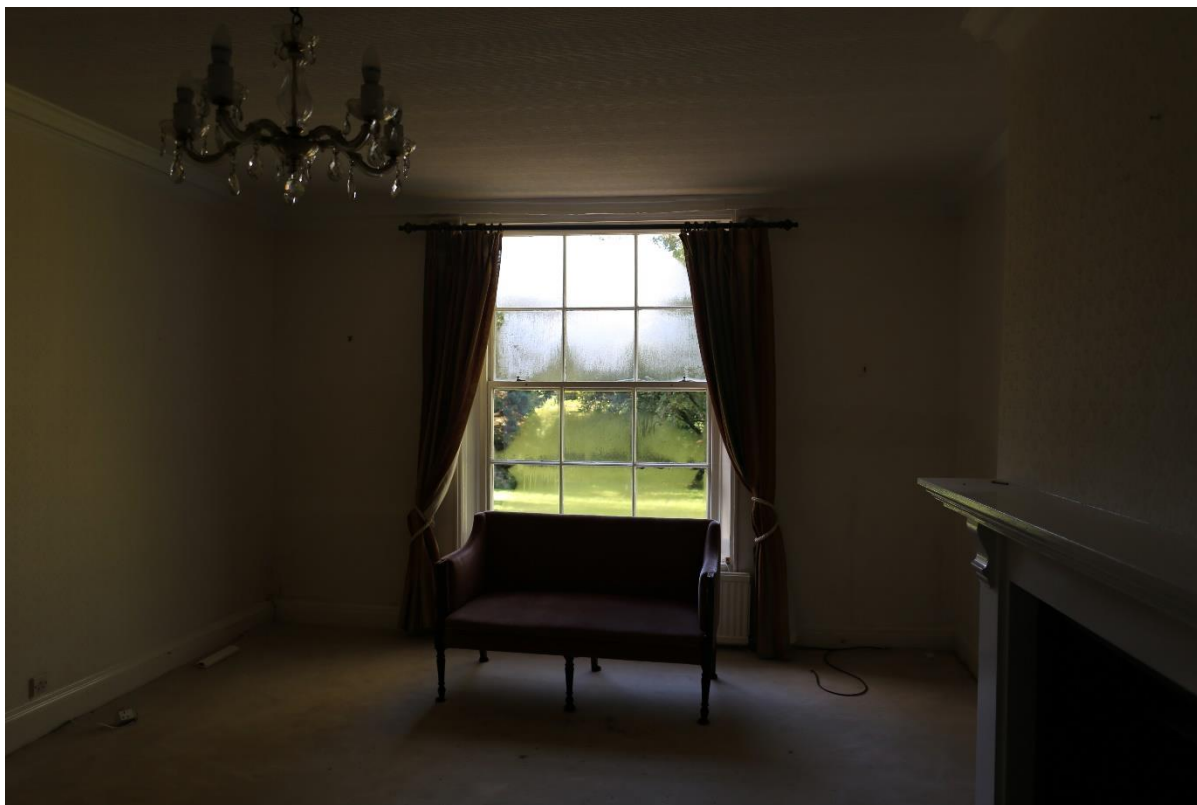
Plate 14: Window frame in ground floor parlour

- 6.3.6 Proposal (kk) is for replacement of the original sash windows to double-glazed framed windows. The asset clearly has a lot of windows across its three floors, but it does not seem proportionate to allocate a greater level of harm to this proposal or to the group. ‘Moderate’ would be the greater level, described as *‘Change to many key historic building elements, such that the resource is significantly modified’*, and significantly modified does not seem to be a sensible conclusion.

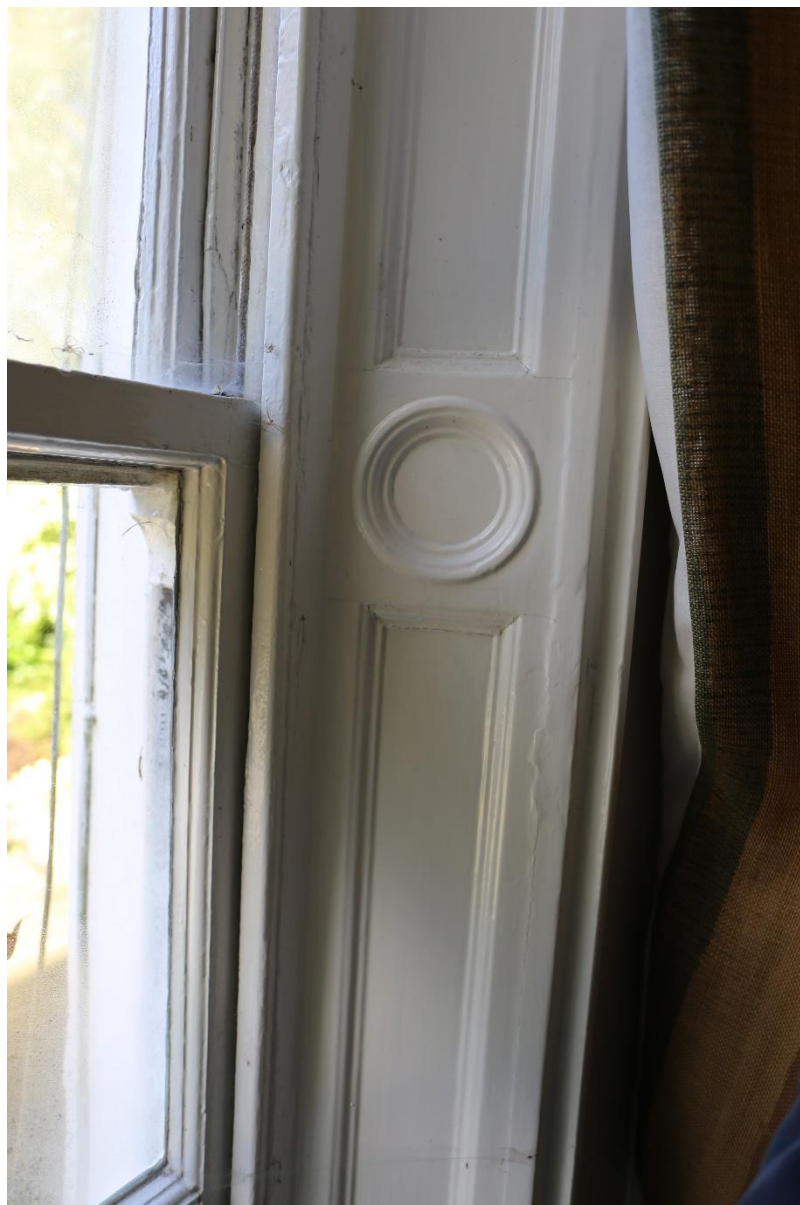
Plate 15: Detail of window frame in ground floor parlour

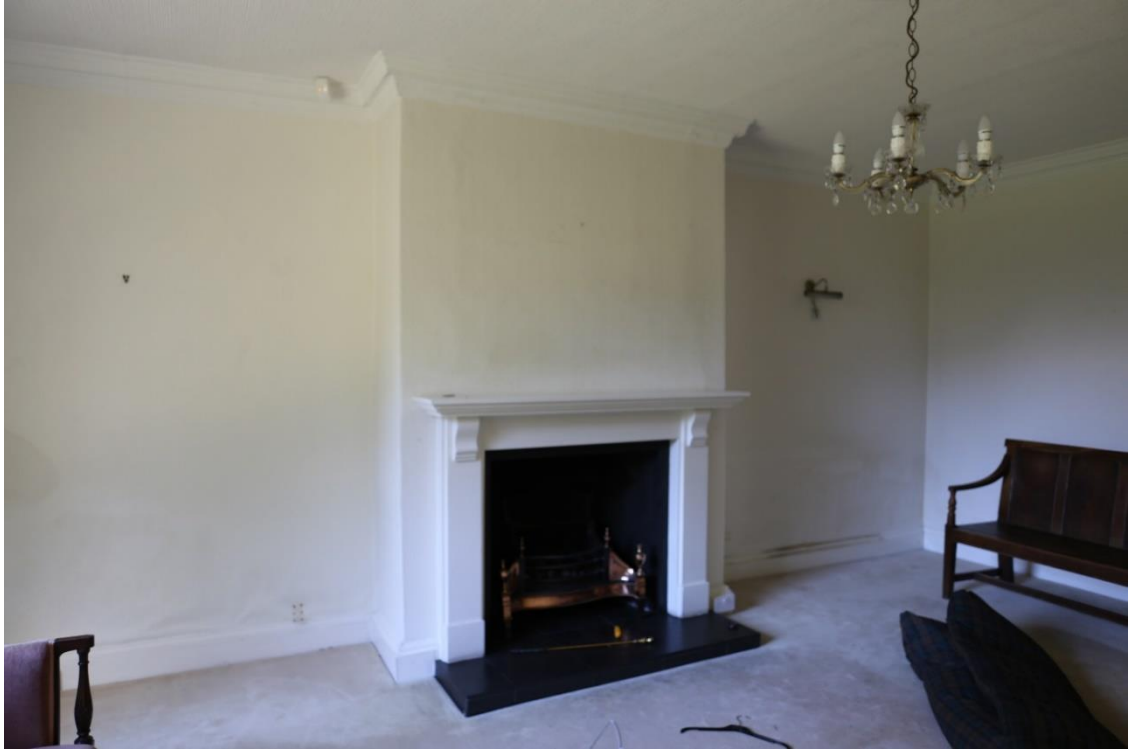
- 4.2.6 On the front elevation's central section, the entrance doorway with its moulded surround, imposts, and ornamental door do appear to be original. There are two 12-pane sashes on the ground floor level, three sash windows at the first-floor level, and three sash windows at the second-floor level. One of the ground floor sash windows – or at least its frame – seems to have been replaced: the right-hand-side example (easternmost, in the dining room; Plate 13) is quite different to that on the left-hand side (in the parlour, Plates 14-15), which matches closely the style of the fireplace in the same room (Plate 16).

Plate 16: Chimney breast and fireplace in ground floor parlour

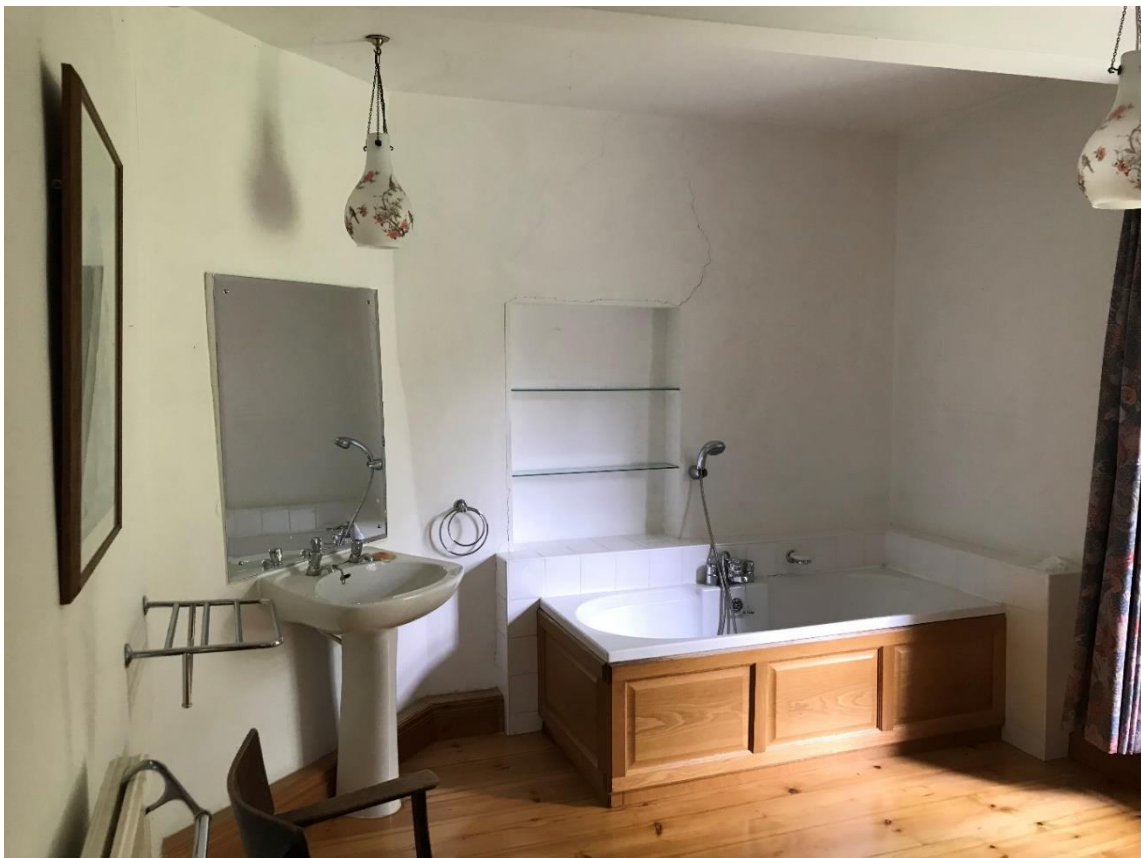
Plate 17: Blocked window reused as alcove, first floor bathroom

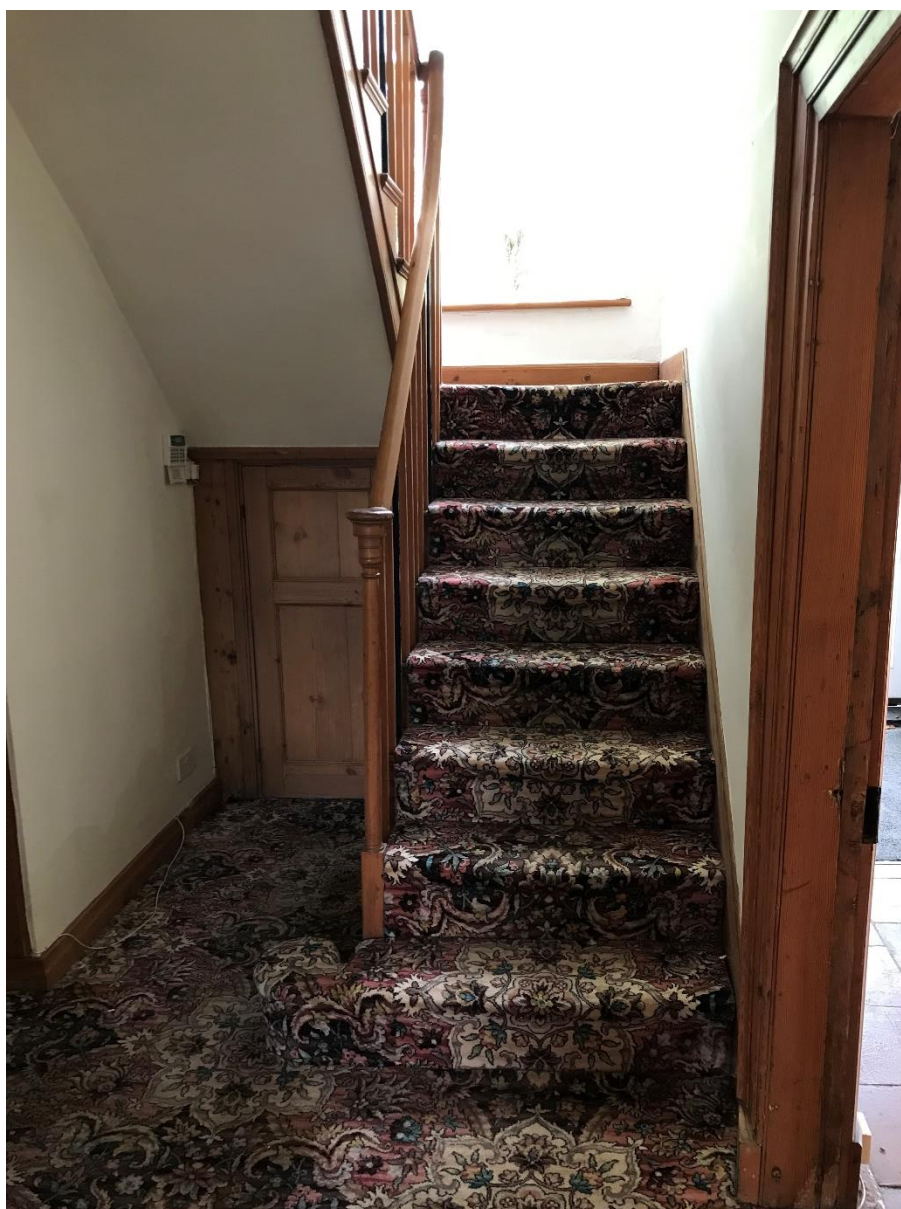
Plate 18: Central staircase, probably original

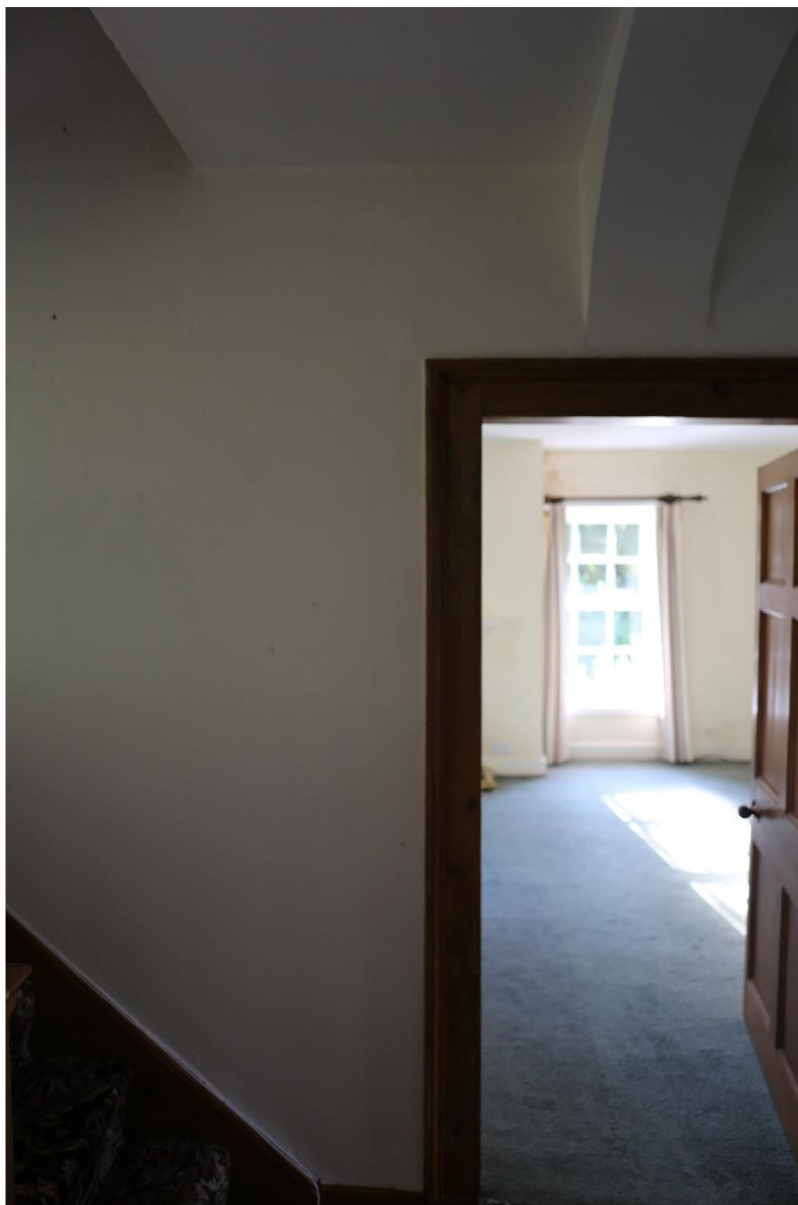
Plate 19: Doorway into Sitting Room at first floor level, located immediately beneath the archway, possibly redesigned from the original

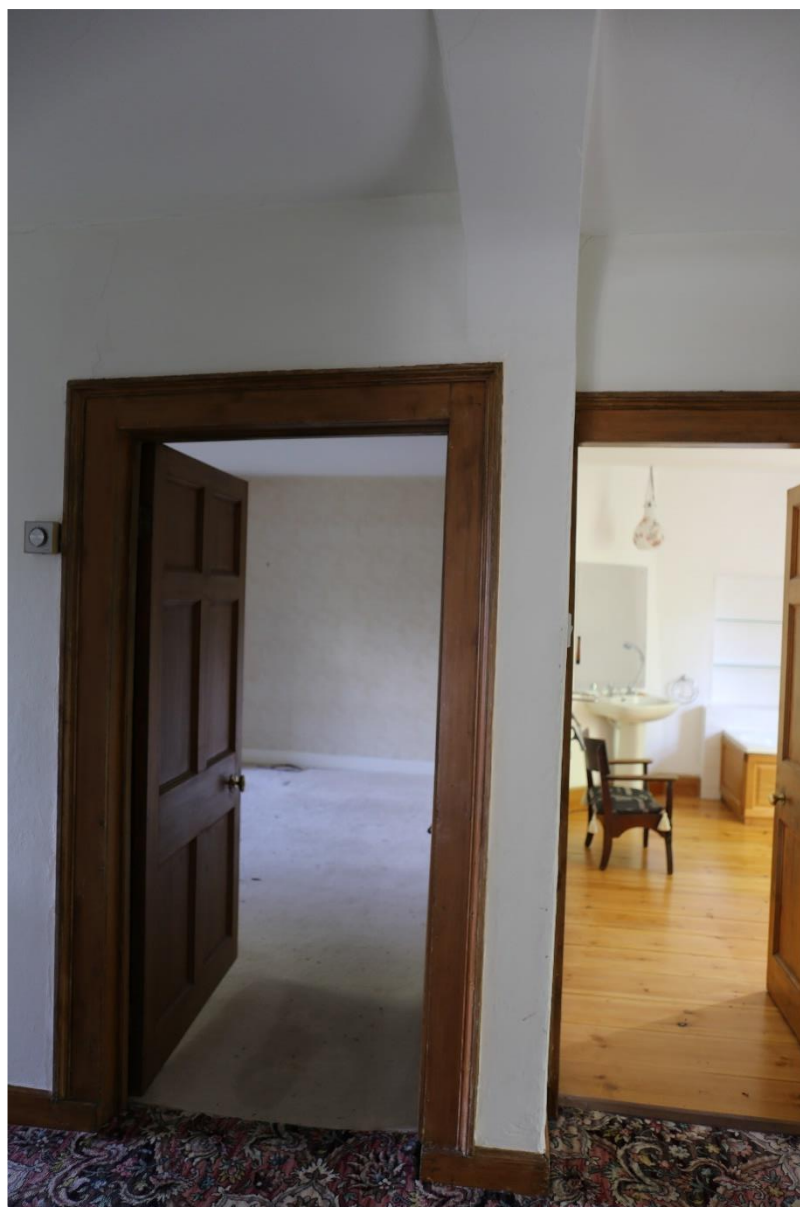
Plate 20: First floor bedroom doorway at first floor level, cutting into the archway above, possibly redesigned from the original

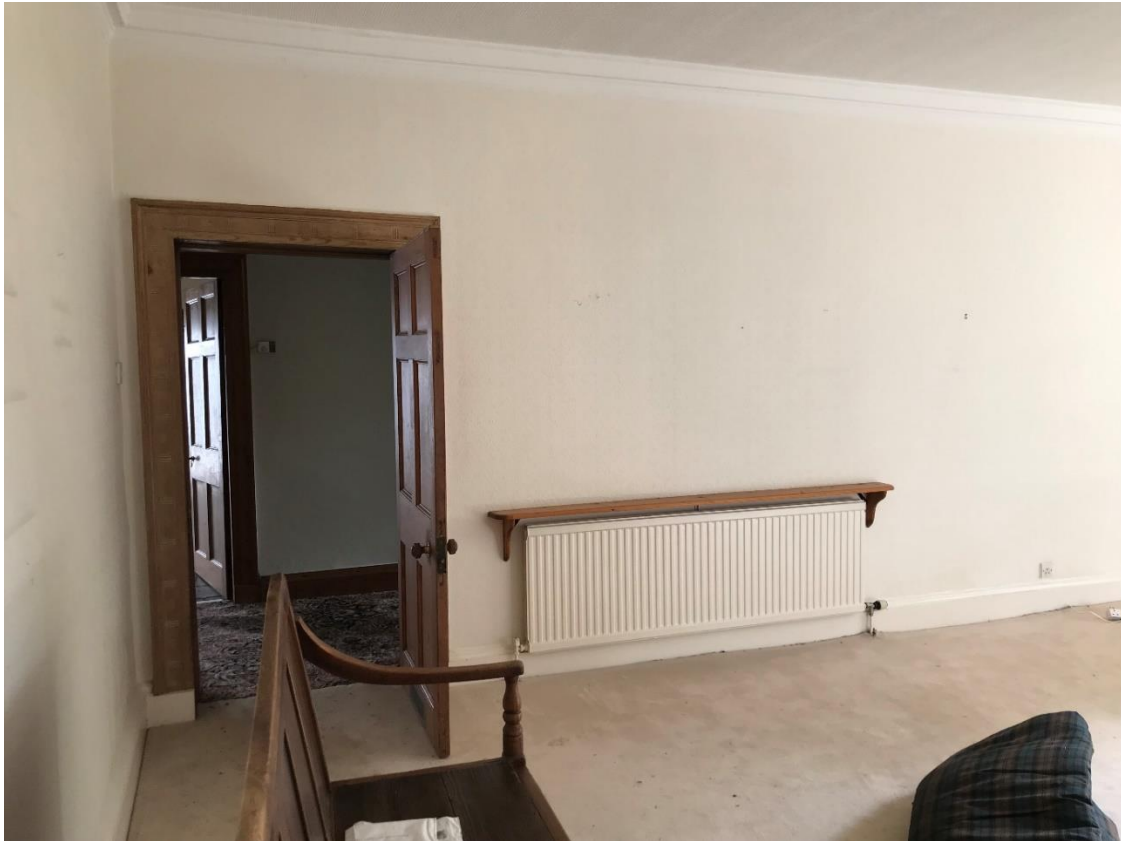
Plate 21: First floor bedroom showing disconnect between door frame and skirts, suggesting some redesign.

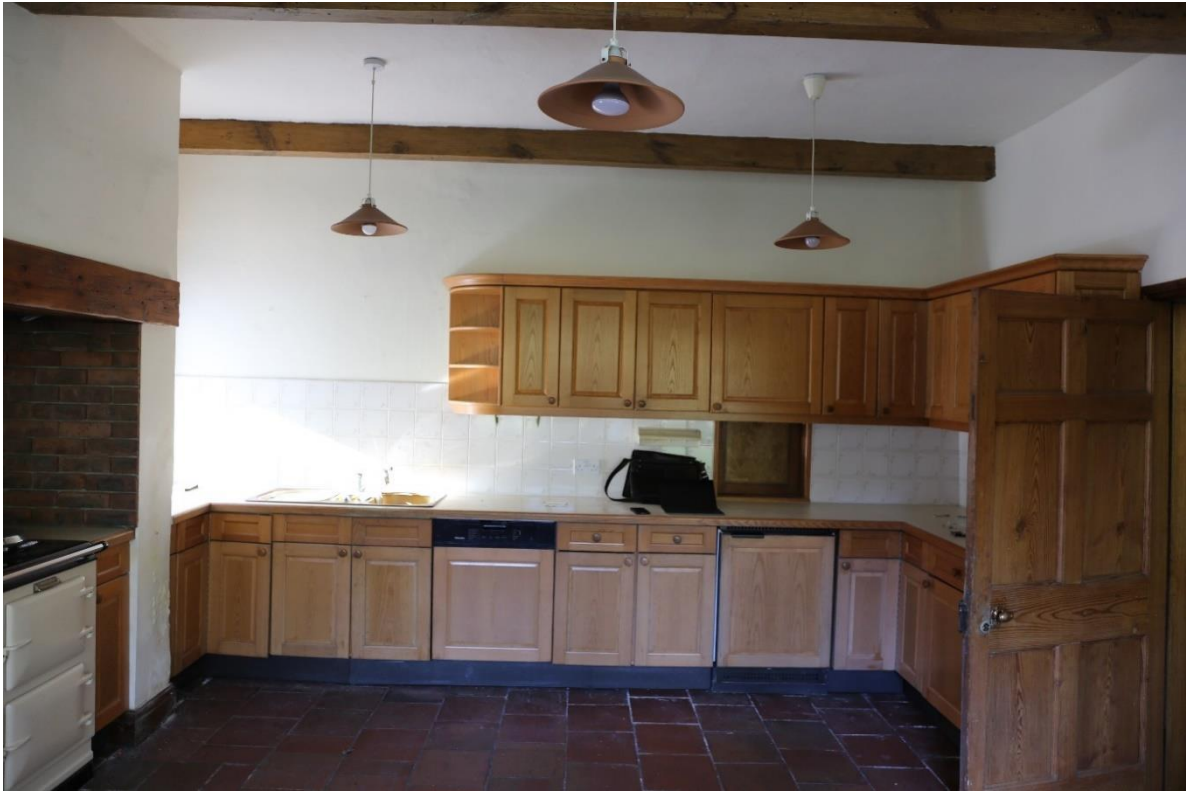
Plate 23: The kitchen, facing towards the hatch into the dining room. Note the modern units.

- a) Creation of archway from kitchen to dining room by removal of party wall and hatch between kitchen and dining room to create single space through
- b) Replacement of existing dilapidated glass house by new family room and formal dining room

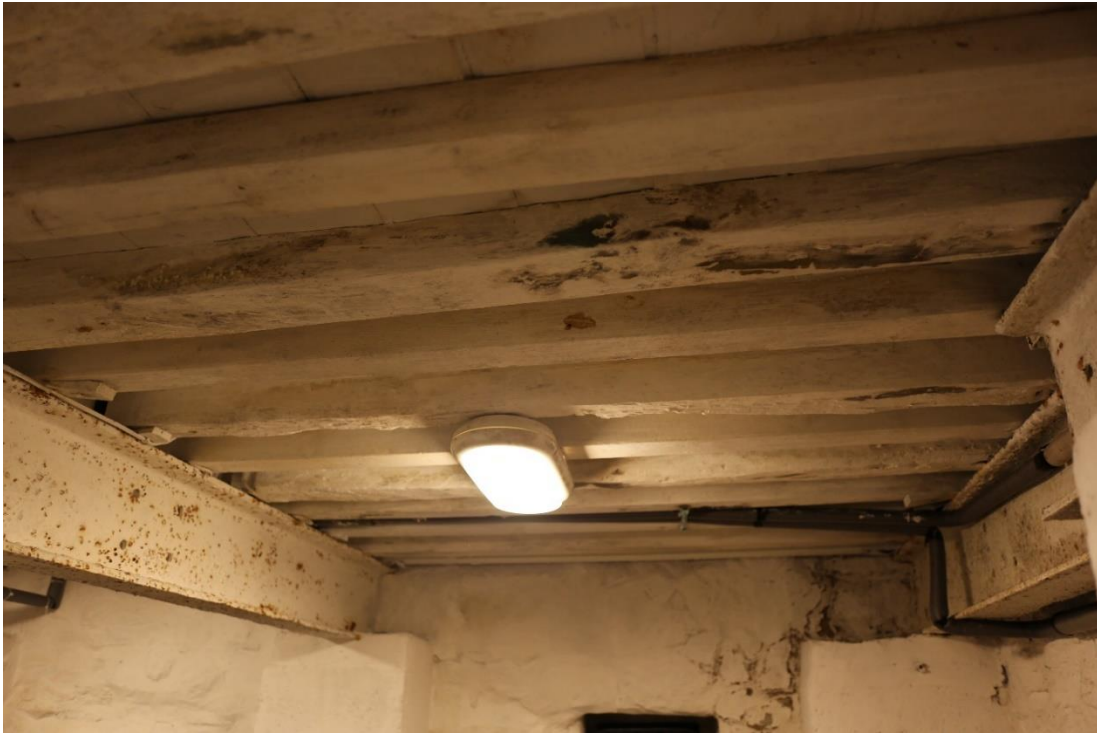
- 4.2.14 There is a brick-built cellar beneath the property. The ground floor joists above are carried over modern ash-block piers and sections of reinforced steel joist (Plate 25). The steps down are brick with the uppermost faces rendered in concrete. Original features include arched openings (Plate 26), cubby holes in the walls (Plate 27) and substantial stone flag shelving (Plate 28). Presumably the timber wine racking and shelving units replaced other stone flag shelves during the 20th century. A window or hatch entrance with a central mullion (Plate 29) is positioned on the west side next to a drain sump; the window is thought to be original, but not the drain.

Plate 25: Ground floor joists above the basement, carried over modern piers and sections of reinforced steel joist

- ee) replacement of rotten cellar ceiling
- ff) all walls to be appropriately treated for damp ingress and appropriate damp proof render.

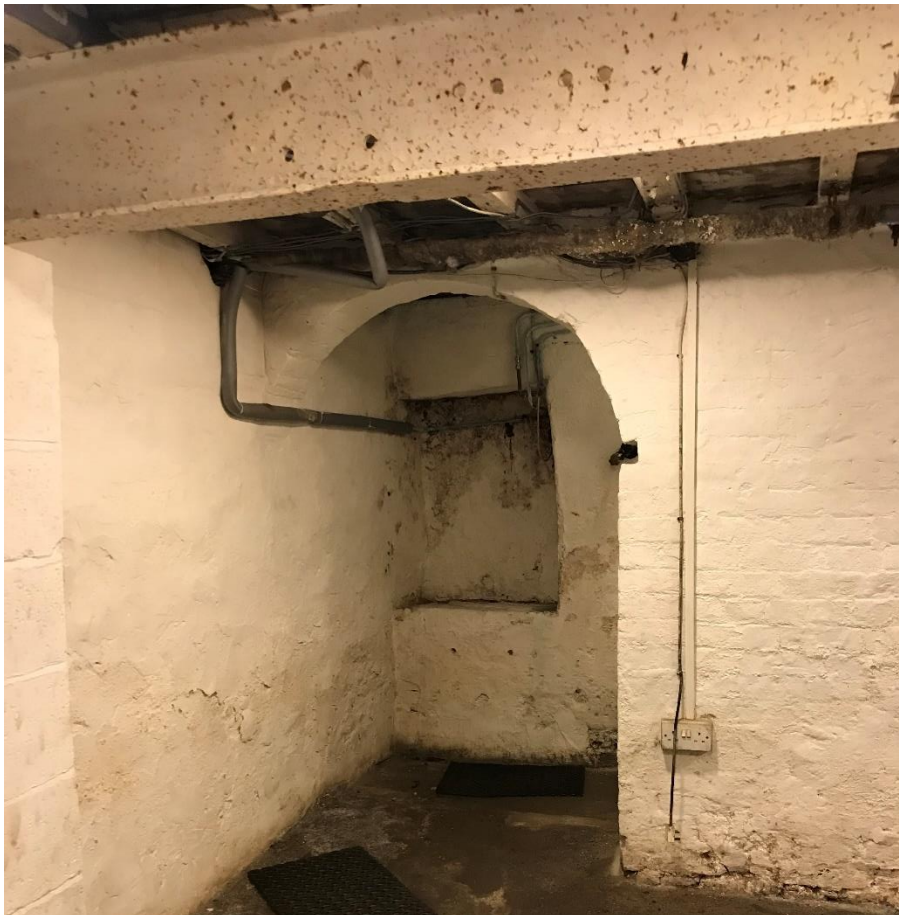
Plate 26: Original features in the basement include arched openings

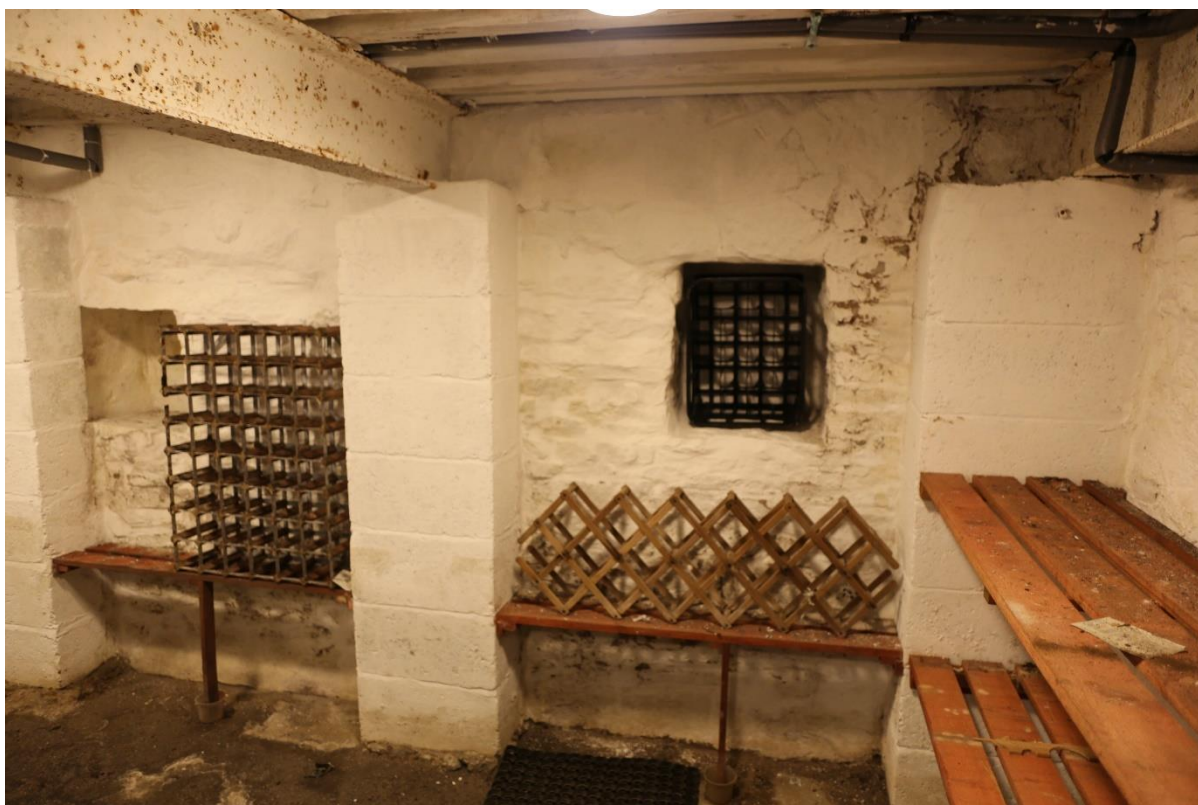
Plate 27: Cubby holes in the basement walls

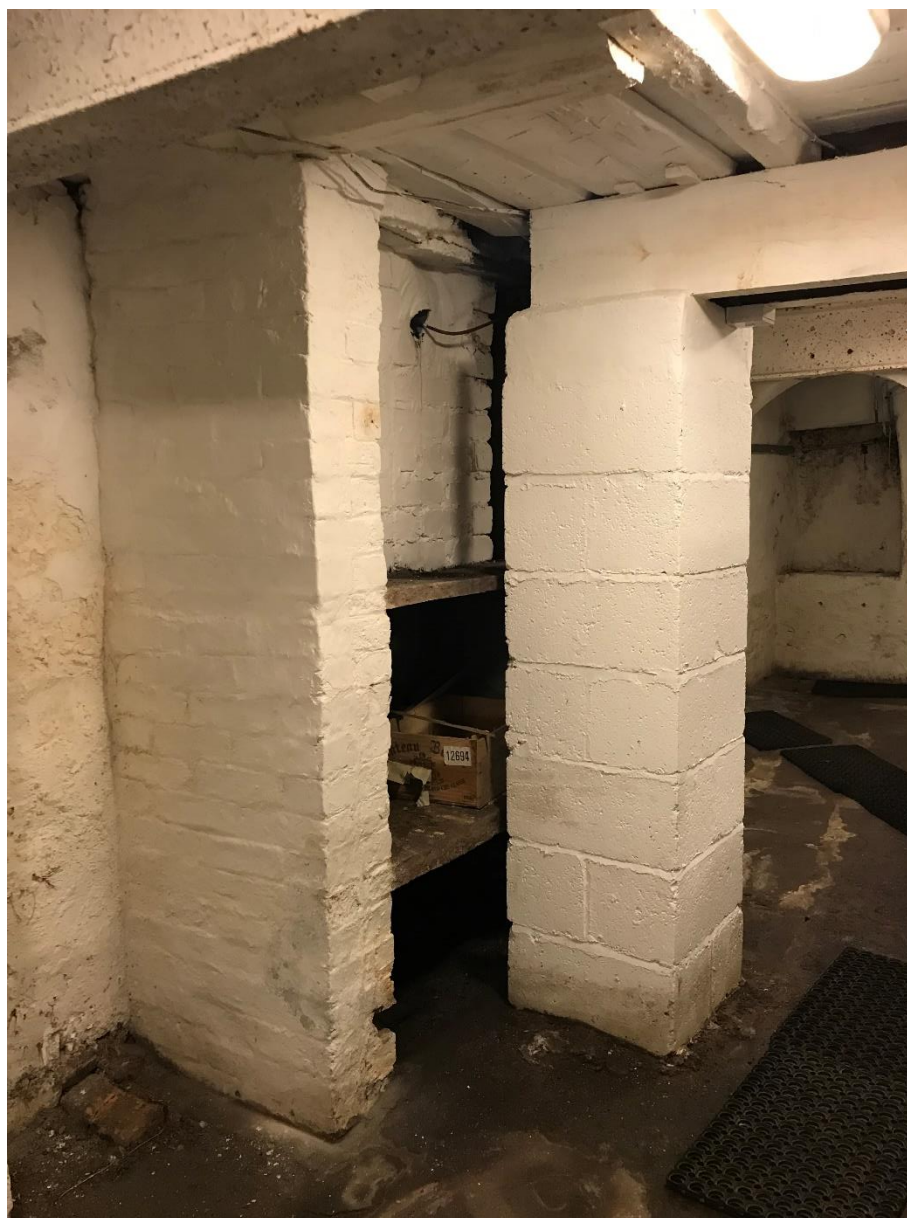
Plate 28: Substantial stone flag shelving in the basement, courtesy of Studio SDA Architecture.

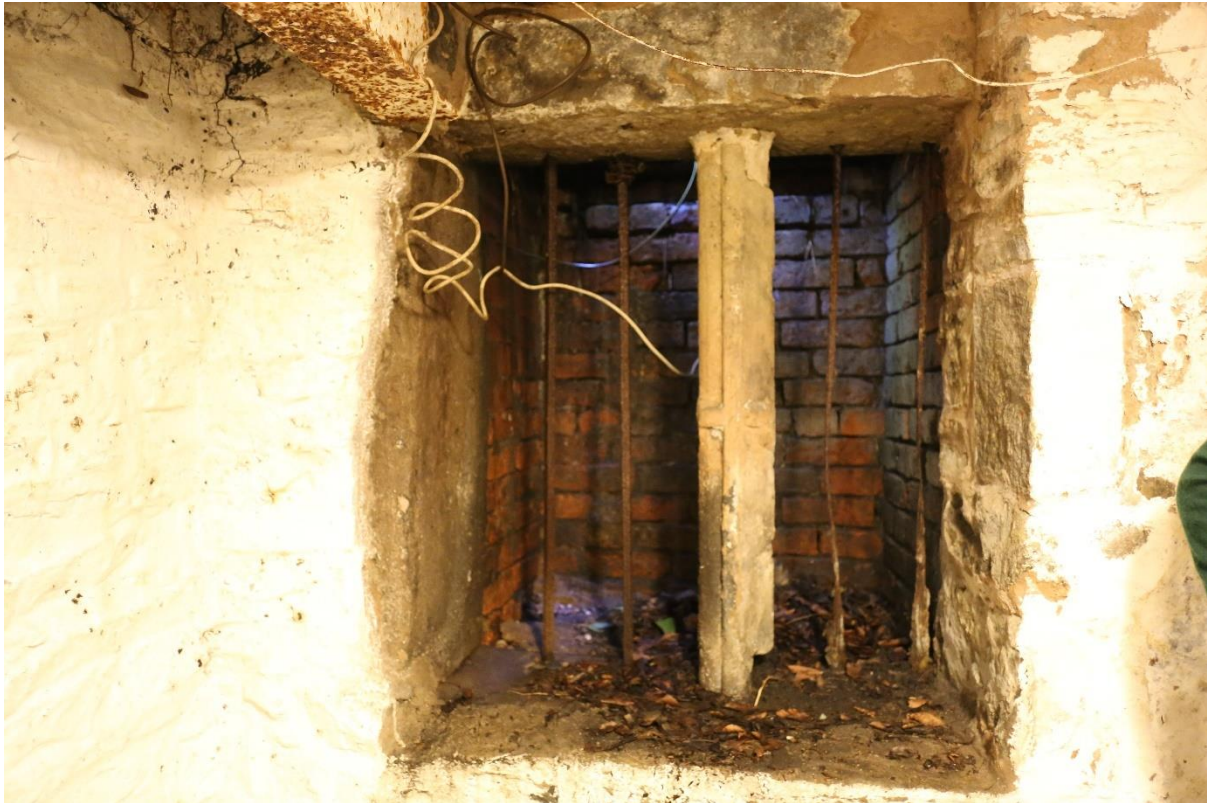
Plate 29: Window or hatch entrance with central mullion on the west side of the basement next to a drain sump.

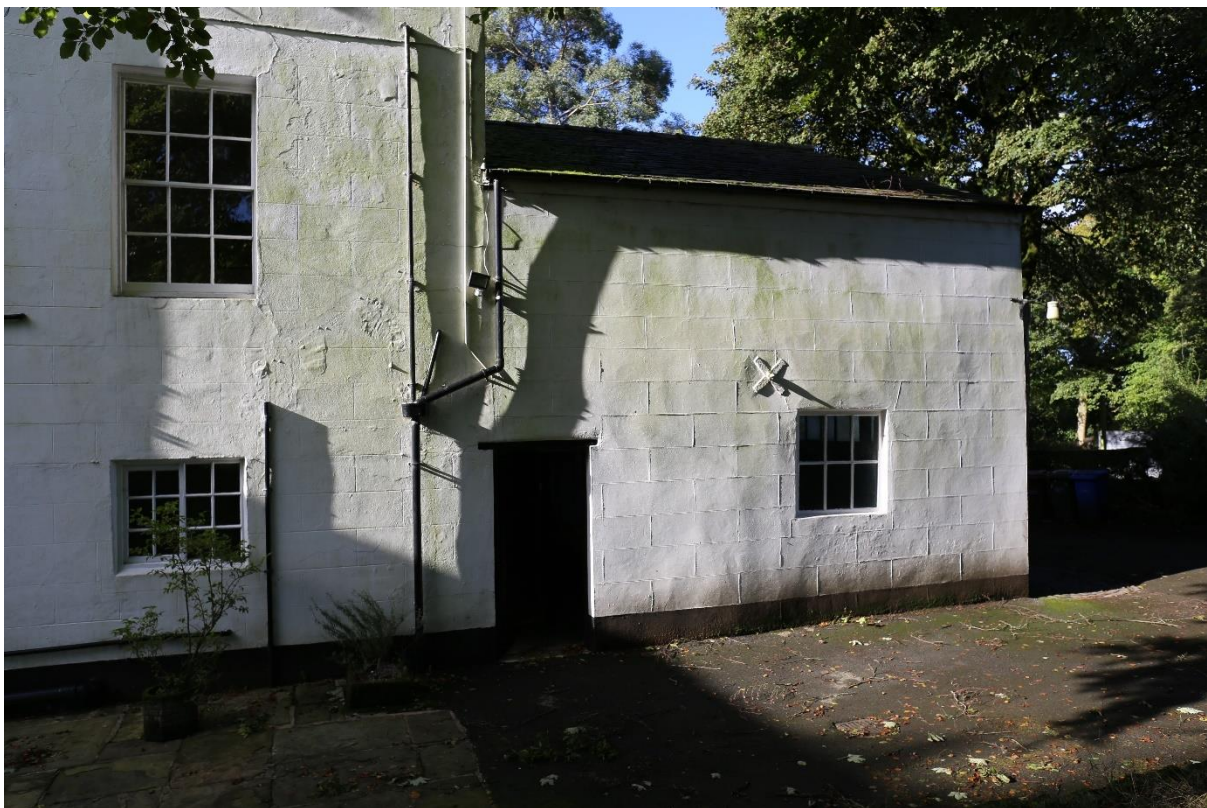
Plate 30: Western wing, now garage and utility room. Note stone block effect render over brick and tie bolt.
