Fisher House, Rivington Lane, Rivington, Bolton BL6 7SL:

Heritage Statement

Minerva Heritage Project Code: FISR021

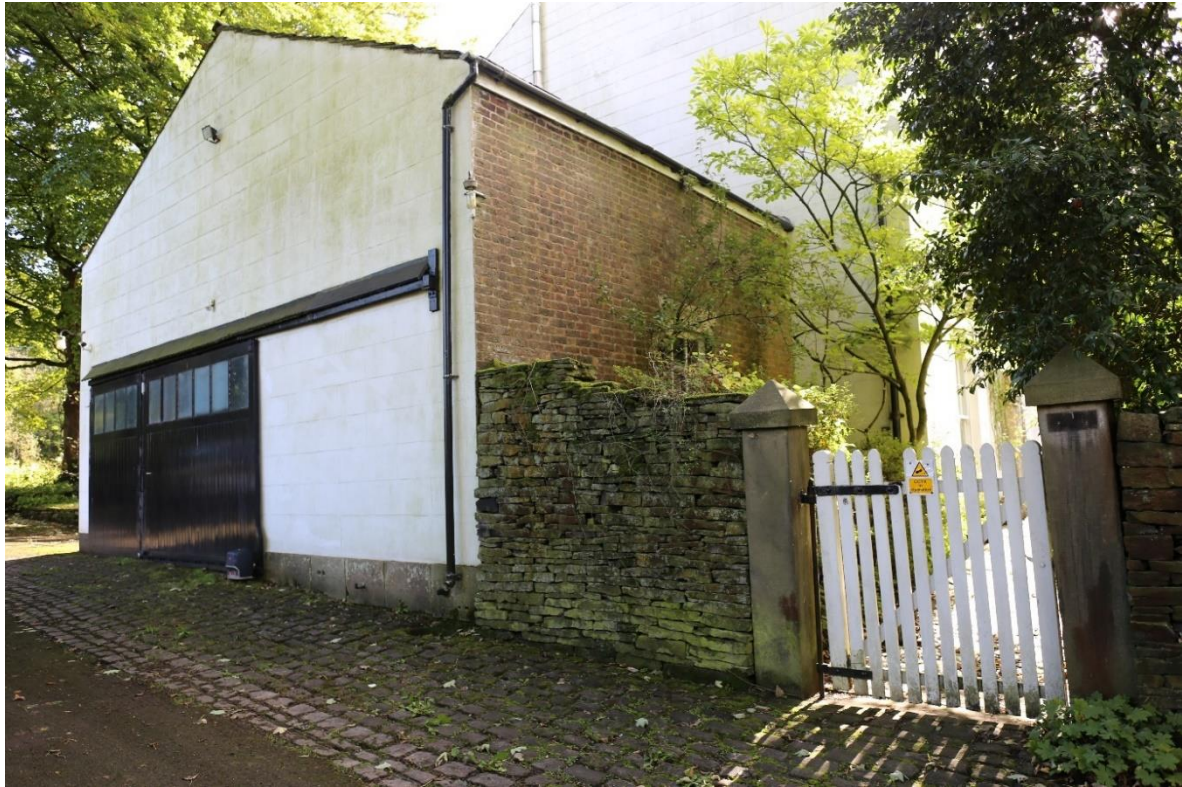
Plate 31: Western wing external elevations, facing east. Note unrendered brick, section of stone wall and sliding garage door.

- g) Replacement of sliding garage doors with new louvre doors and a fixed panel.
- h) Creation of entrance lobby double door.
- i) Existing utility area reconfigured.

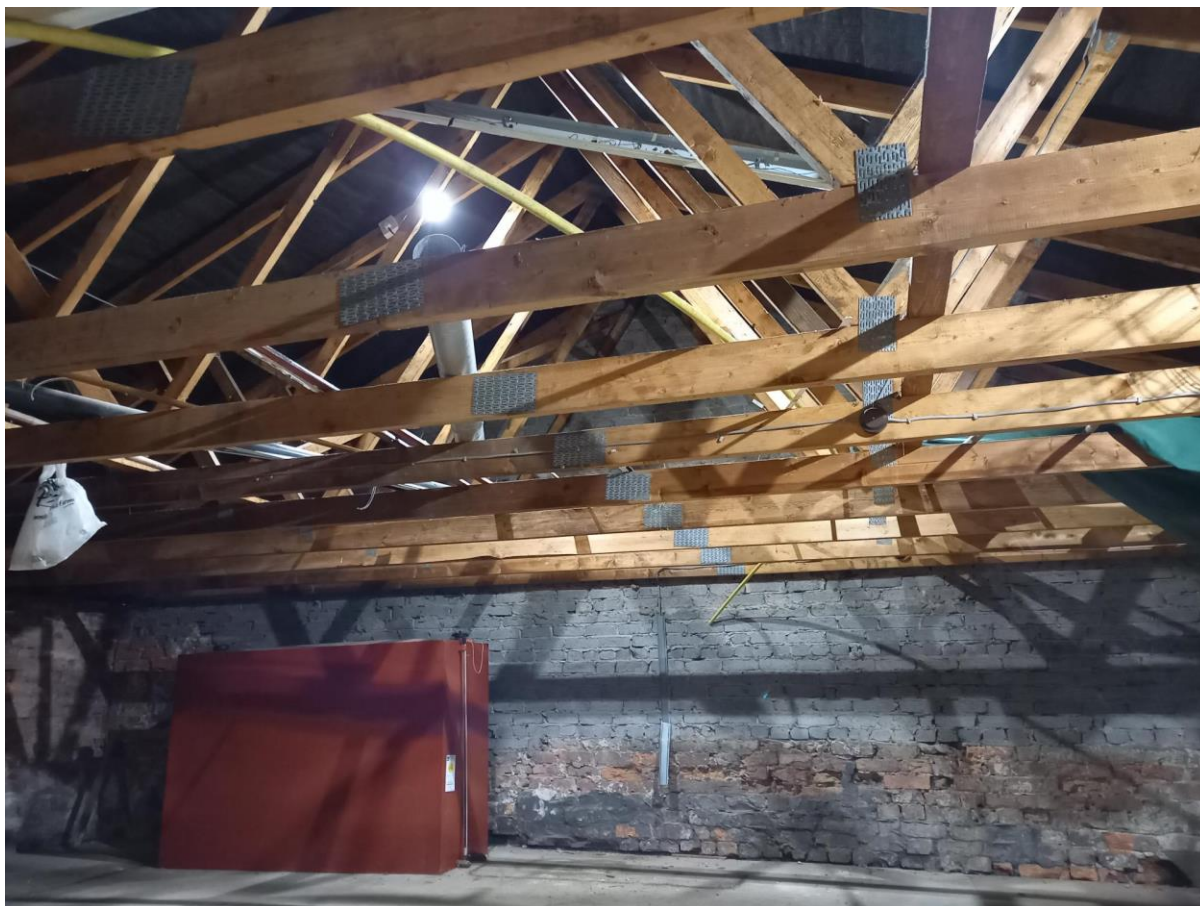
Plate 33: The roof frame is clearly very recent, courtesy of Studio SDA Architecture

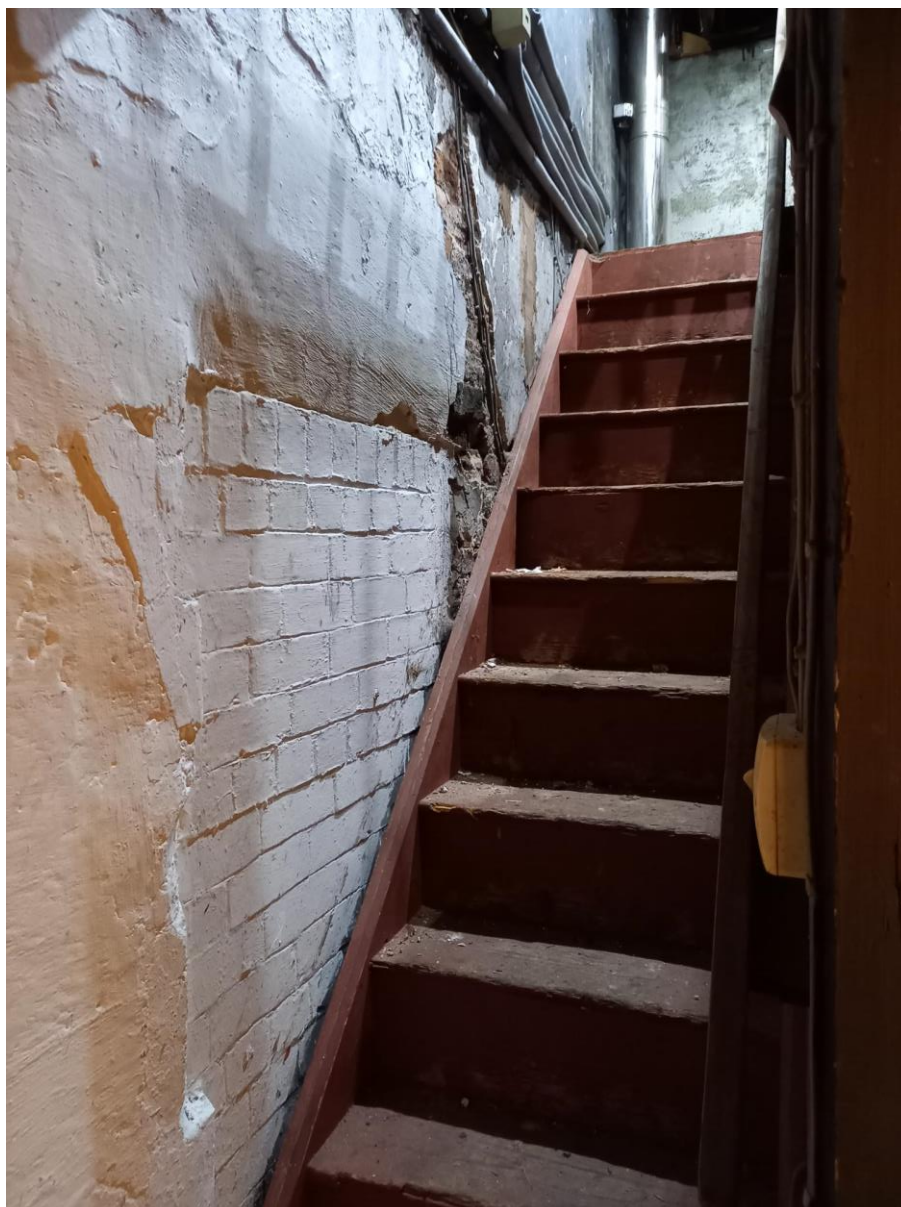
Plate 34: Steps up to the first floor reveal the location of a blocked doorway, courtesy of Studio SDA Architecture

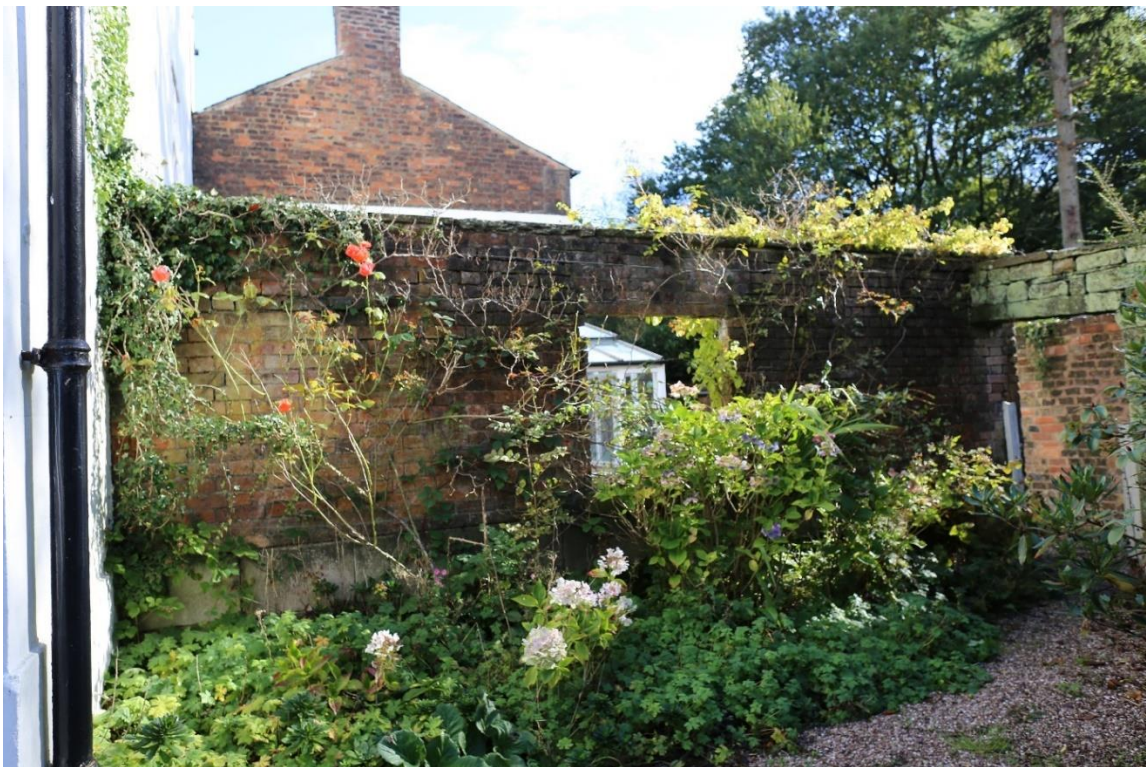
- 4.2.17 Another section of the eastern wing survives only as a dilapidated standing wall with a window opening (Plate 40). The footprint of this part of the wing was replaced by a UPVC conservatory or sunroom in the late 20th century (Plates 41-42), although some of the original floor surfaces seem to have survived (Plate 43).

Plate 40: A section of the eastern wing which survives only as a standing wall with window opening

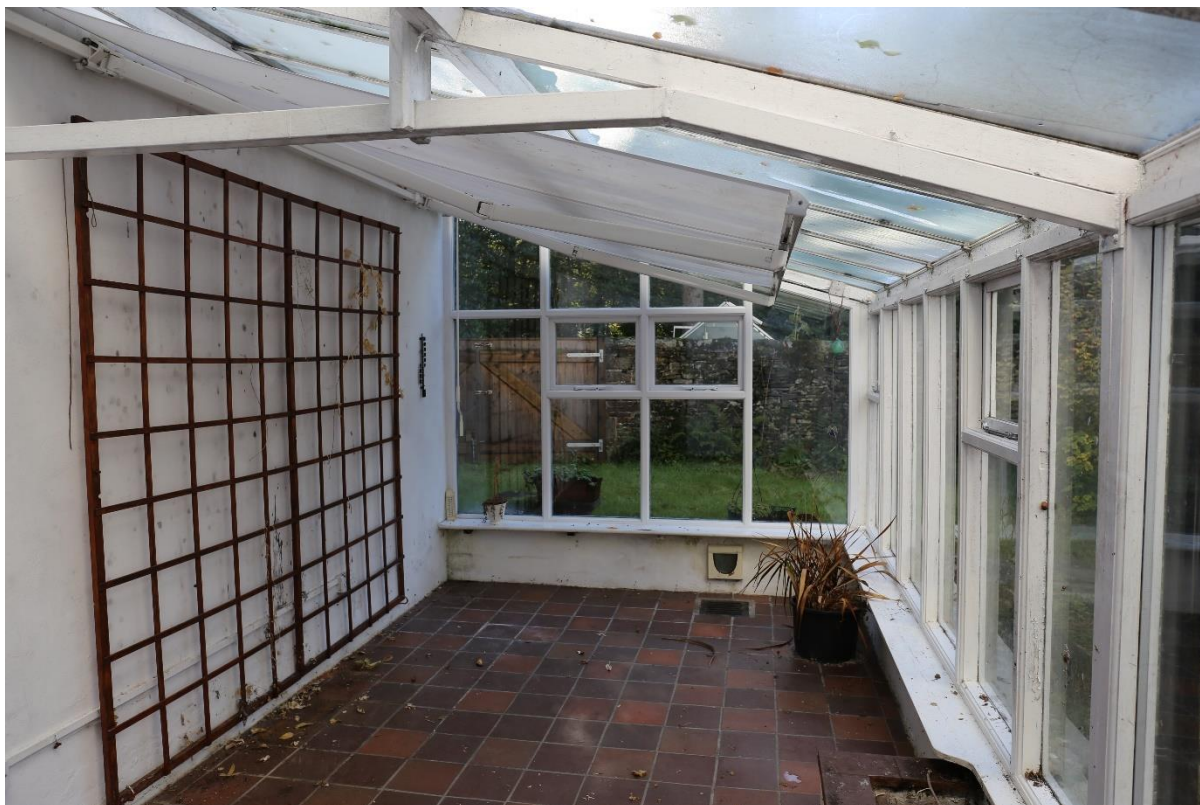
Plate 41: UPVC conservatory / sunroom

- a) Creation of archway from kitchen to dining room by removal of party wall and hatch between kitchen and dining room to create single space through
- b) Replacement of existing dilapidated glass house by new family room and formal dining room

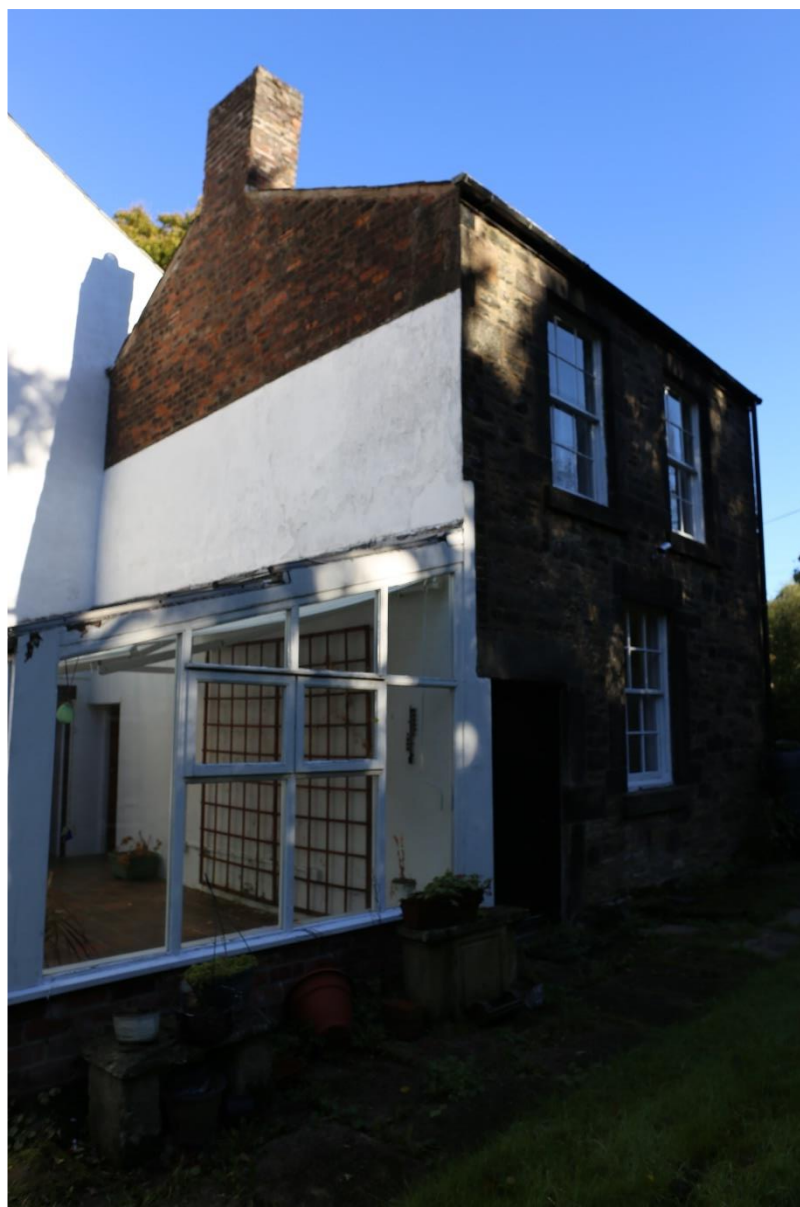
Plate 42: UPVC conservatory / sunroom as built against the servants' wing

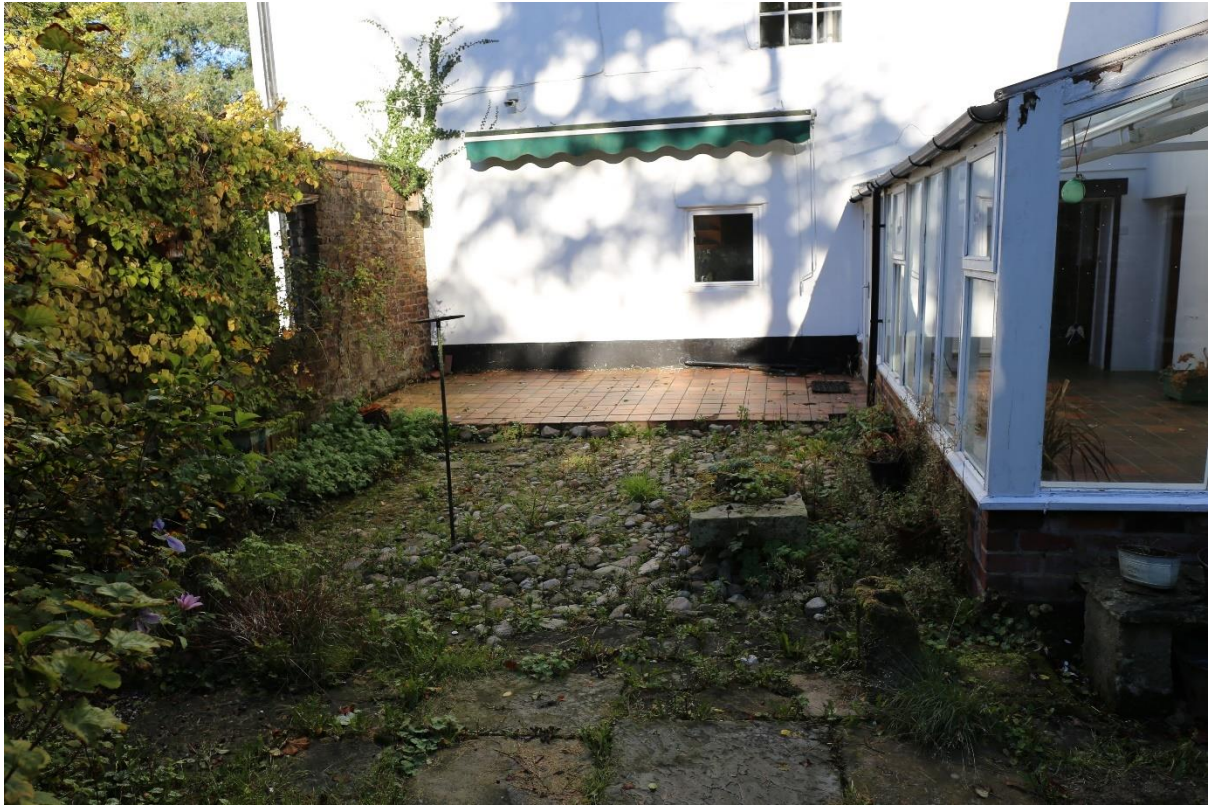
Plate 43: Cobbled and flagged surfaces in footprint of former outbuilding

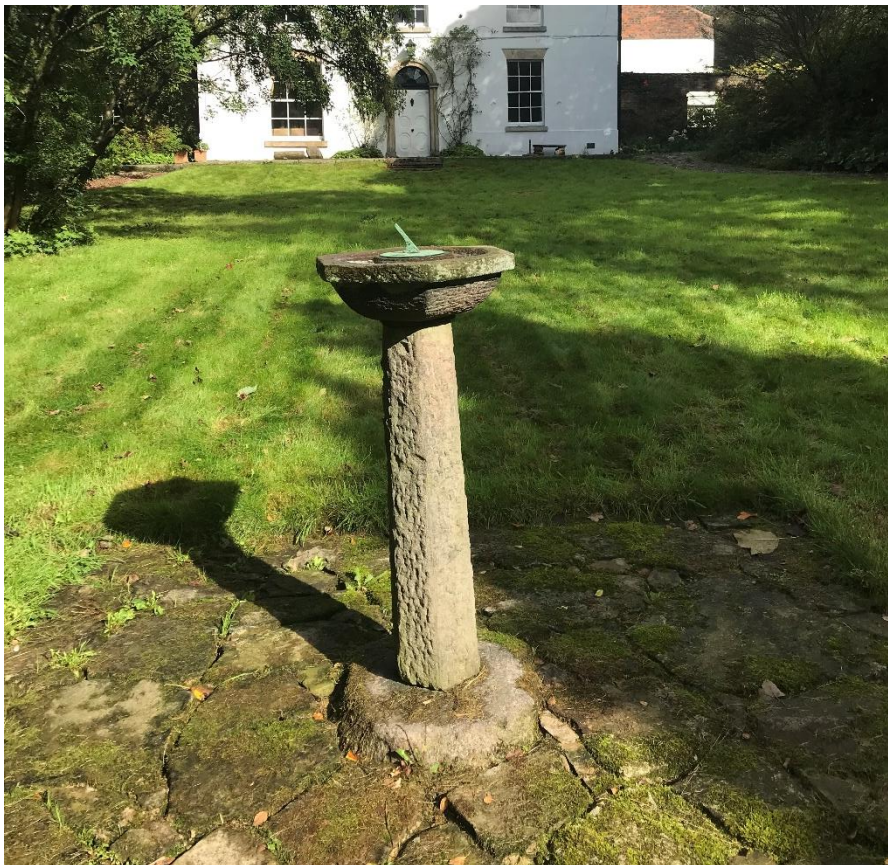
- 4.2.18 At the foot of the lawn there is a sundial (Plate 44), a bench, steps and paving that surrounds a circular pond (Plate 45). It is possible that these are original, but they are perhaps more likely to be 19th century additions.

Plate 44: Sundial at lower end of the lawn, courtesy of Studio SDA Architecture

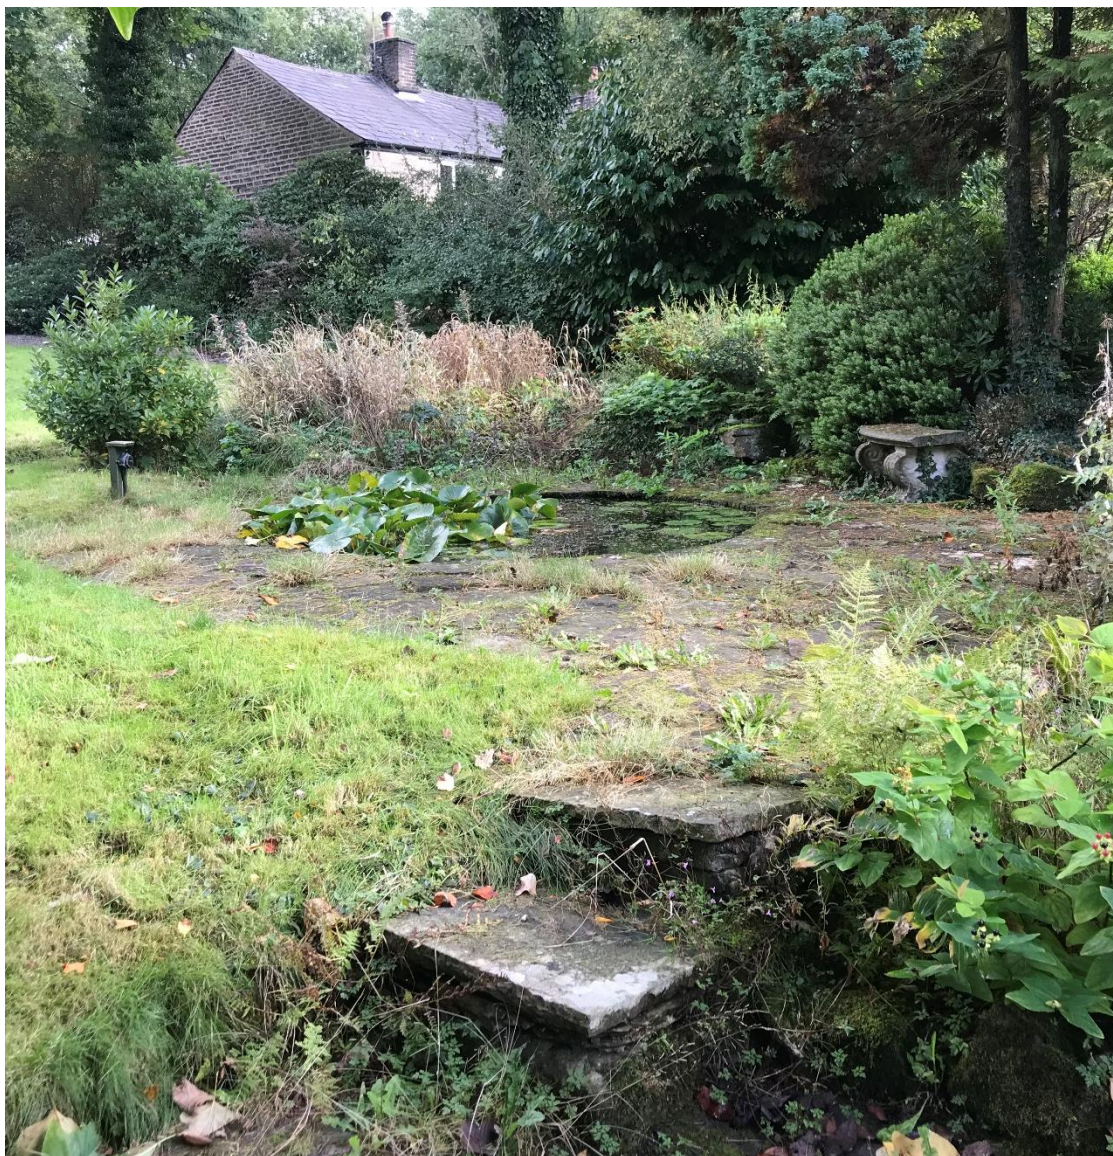
Plate 45: Pond, paving, steps and bench at lower end of the lawn, courtesy of Studio SDA Architecture. Note Wilkinson's and adjoining cottage to right beyond the property boundary
