**ARBORICULTURAL REPORT**

**Background:** LSDP were appointed to prepare an Arboricultural Survey & Report to satisfy Local Authority requirements in respect to the proposed erection of 2no. detached dwellings on land to the south-east of Warren Mill House, Wetherden. The report is based on survey information collected in May 2022.

SITE : Land to South-east of Warren Mill House, Wetherden  
 DRG : Tree Survey, AIA & Protection Plan  
 DRN BY : GH  
 SCALE : 1:250 @ A1  
 DATE : May 2022  
 No : LSDP 1882.01

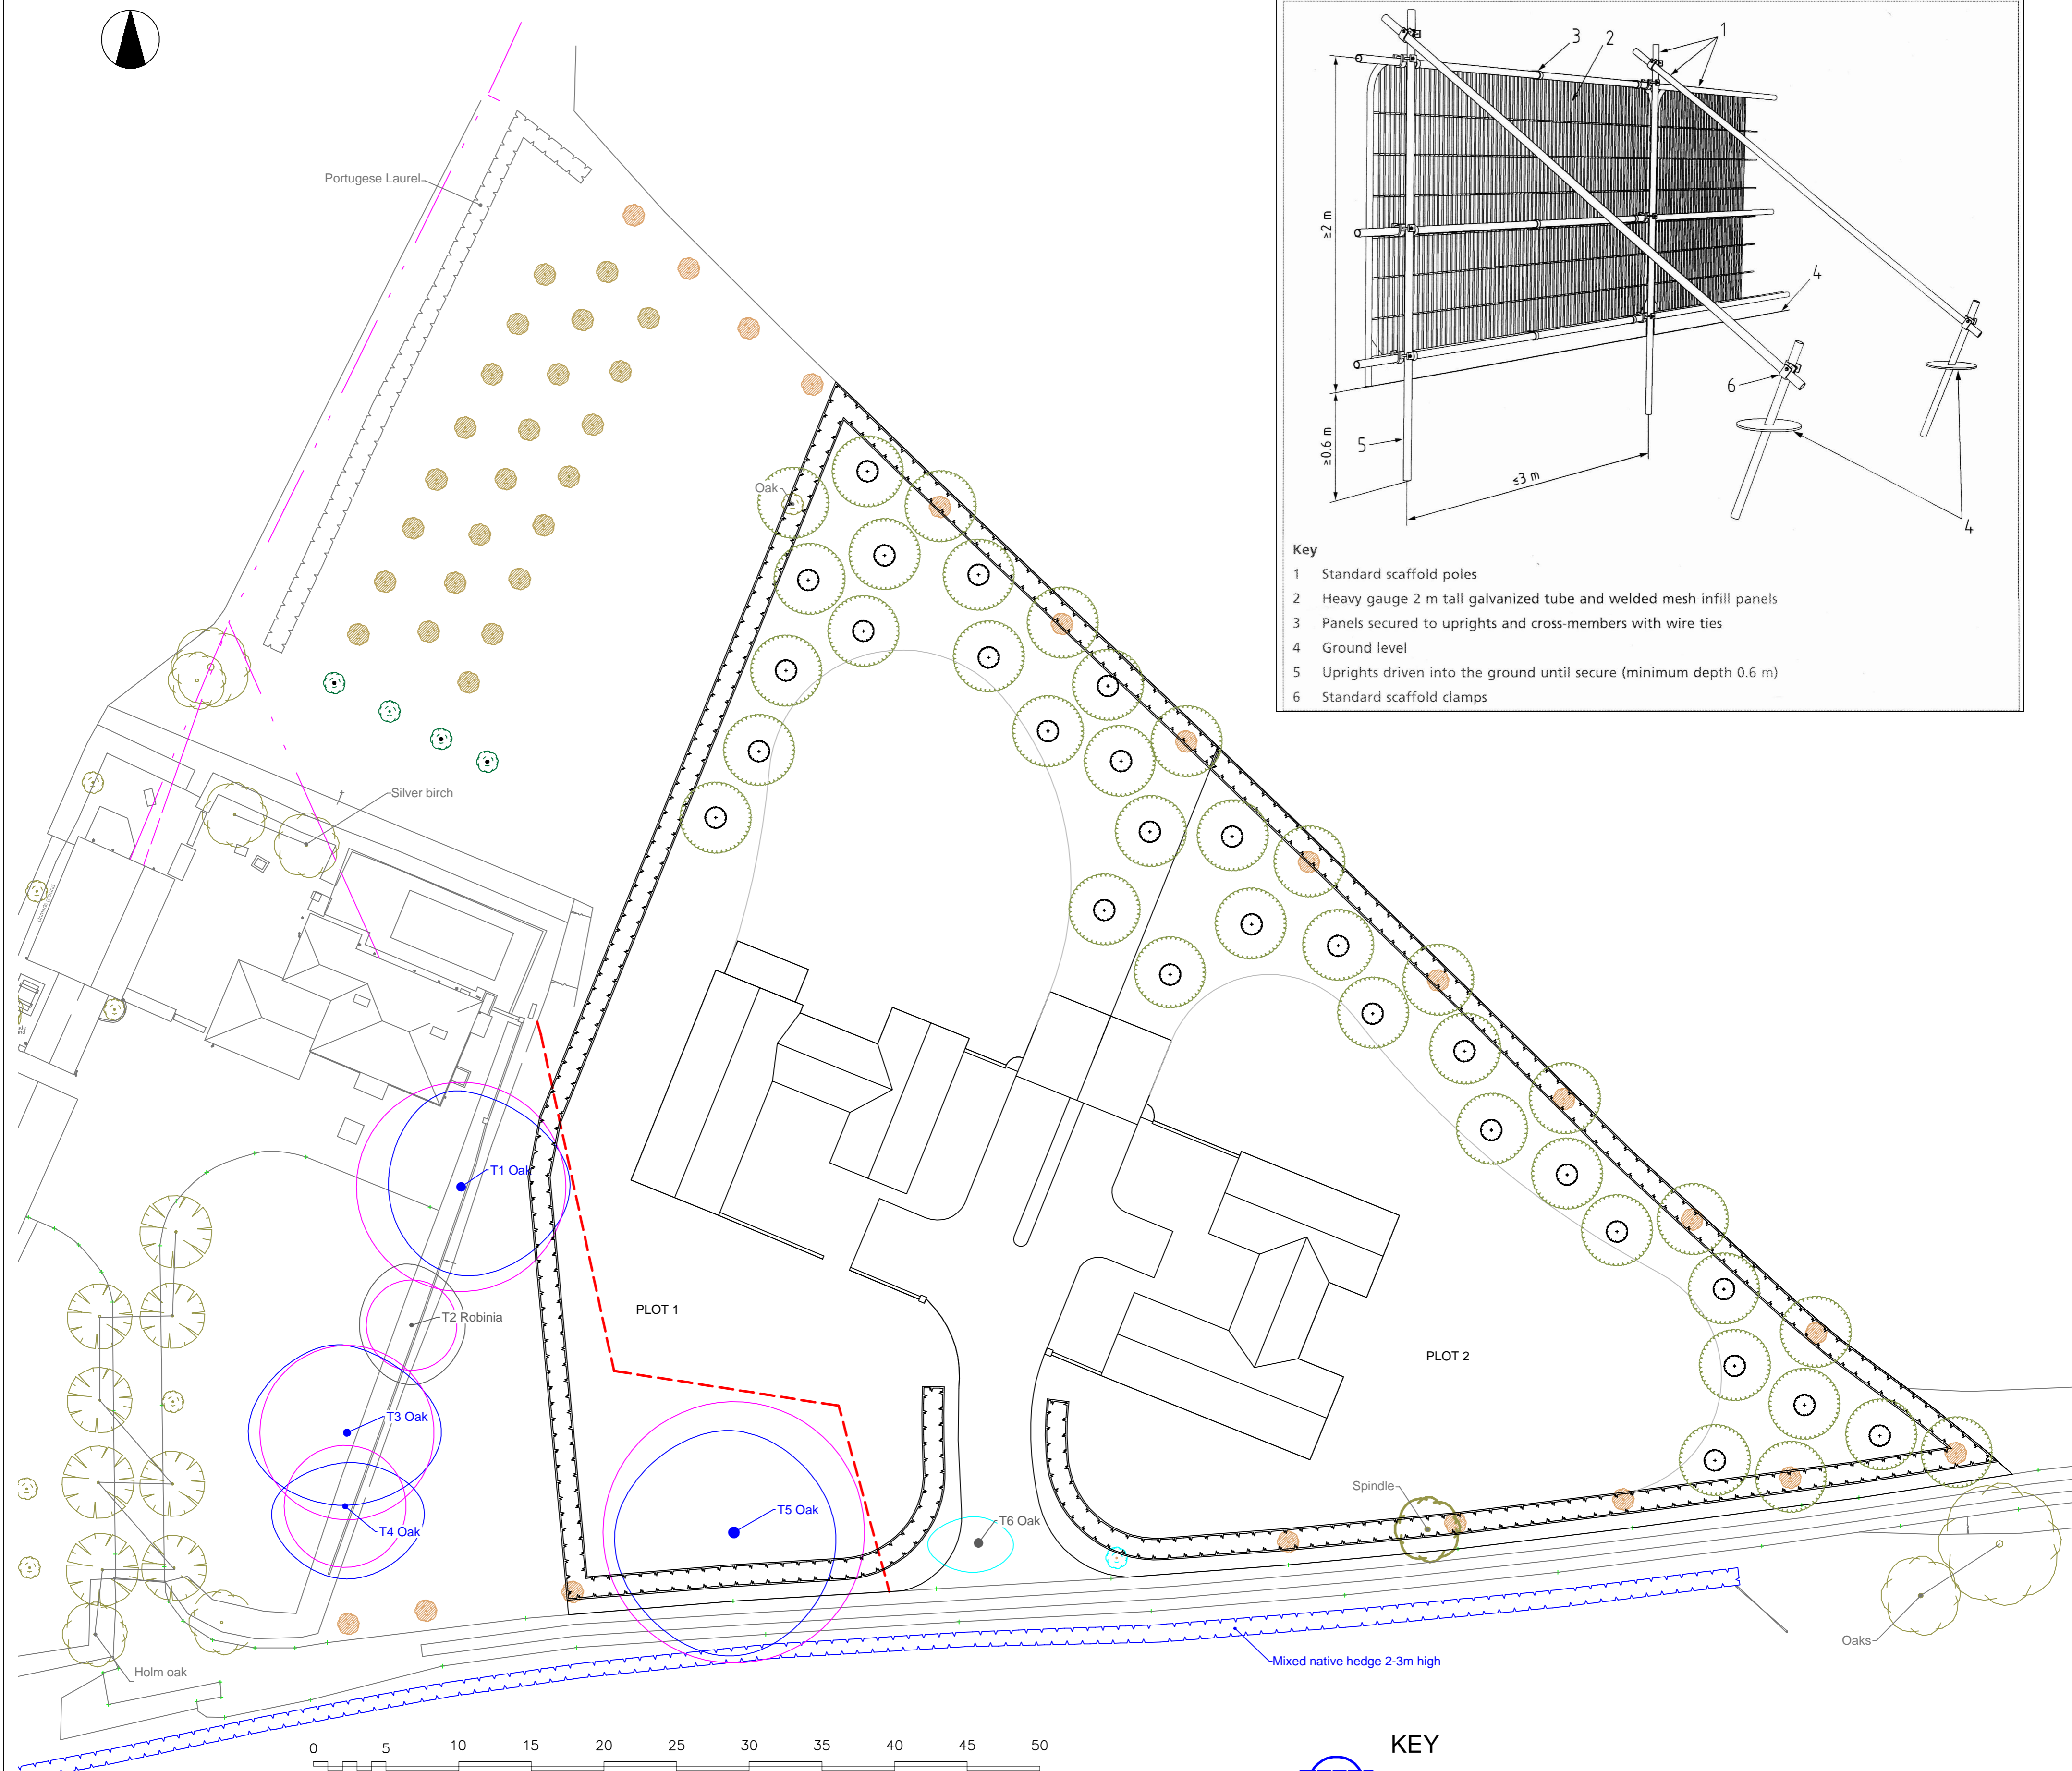
**Generally**  
Before any machinery or materials are brought onto site and before any demolition, development or stripping of soil commences, The Root Protection Area (RPA) indicated on the drawing shall be set out and Protective Barriers installed as shown on the drawing.  
The Protective Barriers shall not be removed or altered without prior recommendation by an arboriculturist and approval of the local planning authority.

**Removal of Trees:** The proposal will require the removal of T6 Oak and a hornbeam sapling to accommodate the layout. T6 is a stump with recent regrowth and its removal will have no impact on the surroundings.

**Proximity of development to trees identified for retention:** The proposed layout does not affect Root Protection Areas and allows adequate space around trees indicated for retention, to accommodate future growth and minimise potential issues with shading / perception of hazard in relation to dwellings and amenity space.

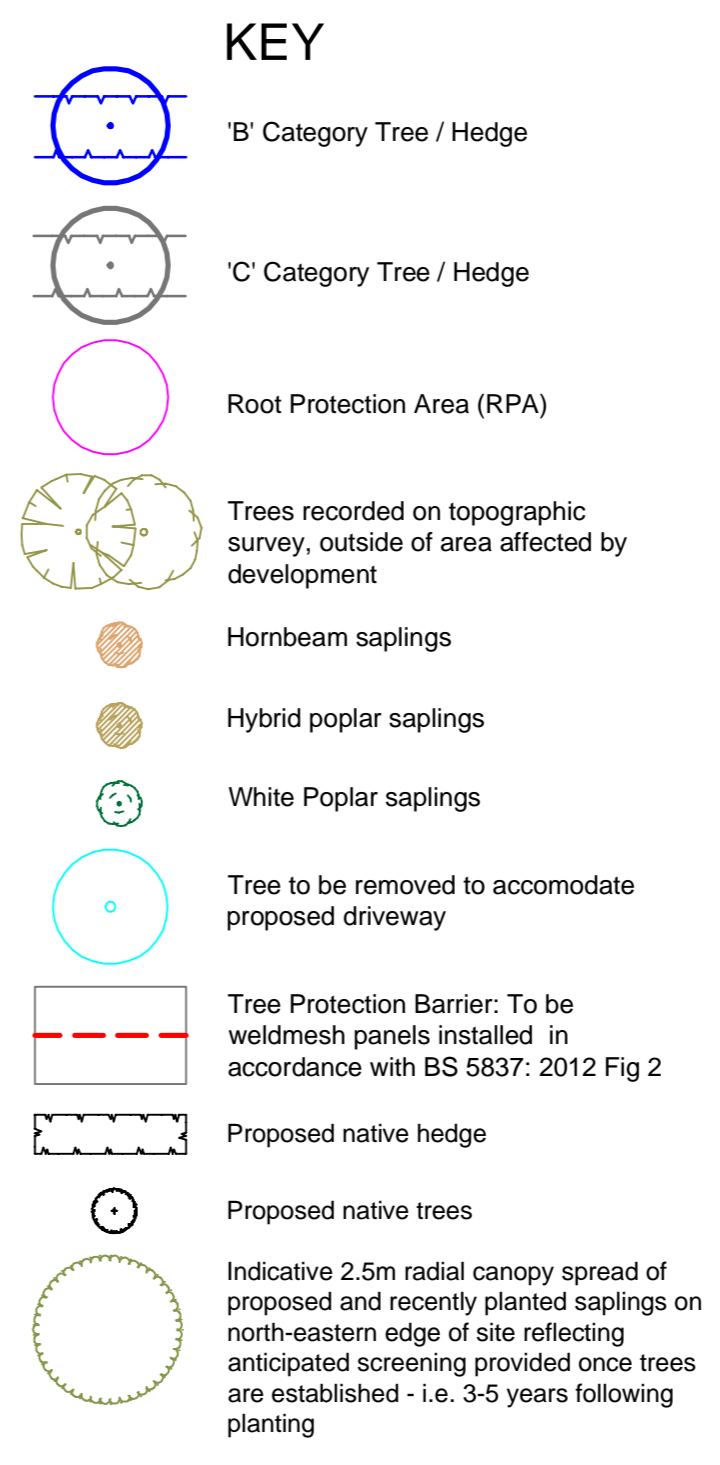
**Protective Barriers**  
Protective Barriers shall be erected to prevent access into designated areas around retained trees. Once installed, all weather notices shall be attached to each barrier with words such as: "Construction Exclusion Zone - No Access". Protective Barriers shall be erected in accordance with BS5837: 2012 Fig 2
