KINGSCLERE VILLAGE CLUB, 35-37 GEORGE STREET KINGSCLERE, HAMPSHIRE

HERITAGE STATEMENT

PROJECT: Kingsclere Village Club, 35-37 George Street, Kingsclere, Hampshire

DOCUMENT TITLE: Heritage Statement

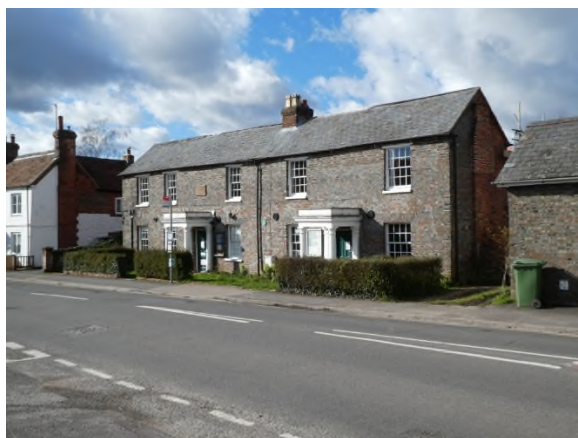
Figure 1: Front elevation of 35-37 George Street

Tablet incised TB 1832. A short terrace of 2 storeys, 5 windows. Slate roof. Blue brick walling in header bond, Dutch flat arches to the ground-floor, stone cills. Sashes (of 16 lights) in reveals. The entrance to each is a Tuscan porch, with smooth columns and pilasters, and half glazed doors.

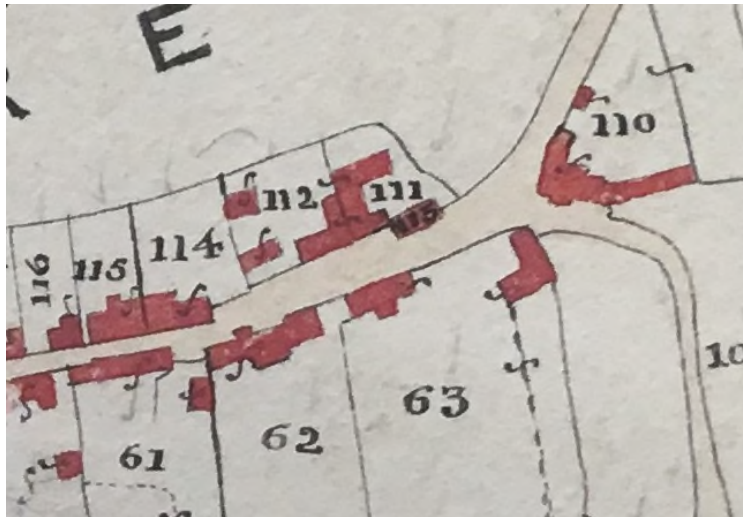
- 3.1.1 The Kingsclere tithe map (1841) shows the footprints and layouts of 35-37 George Street (marked as 111 and 112). No. 35 is shown with an L-plan and positioned within a more spacious and roughly square plot than is currently the case. The western boundary is shown further to the west and included two outbuildings which were probably of brick construction. No. 37 is shown with a roughly U-plan footprint. The rear element has a wider footprint than the main frontage building (possibly a Malthouse). A structure is also shown attached to the south-east corner of No. 37 (numbered 115). This structure projects into the road and is shown parallel to it. It is unclear if the projecting element immediately to the rear of Nos. 35 and 37 represent the parallel element to the rear of the building today. The map shows that the projecting element to the rear of No. 35 is narrower than the existing structure. This may, however, be a draughting error.

Figure 2: Extract from the Kingsclere tithe map (1841)

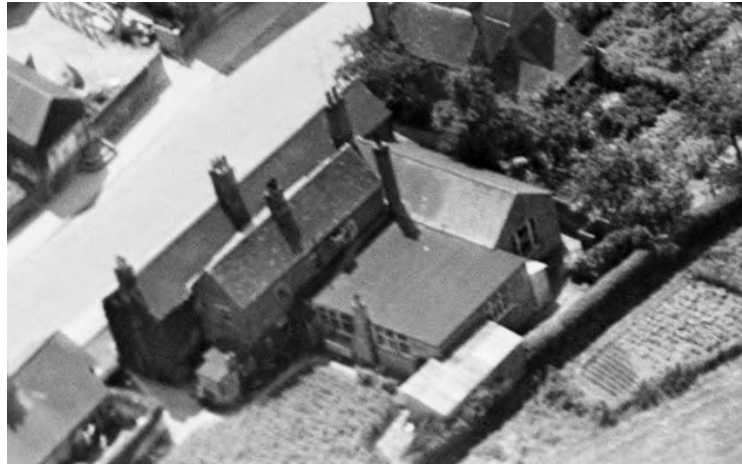
- 3.1.5 An aerial photograph dating from 1930 shows the main part of Nos. 35-37 George Street fronting onto the street, a rear 2-storey extension parallel to the main part of the house, the side extension on the western side of No. 35, the single storey rear extension (No. 35) and a c. 1920s infill extension to the rear of both Nos. 35 and 37.

Figure 6: Extract from an aerial photograph of Kingsclere showing 35-37 George Street in 1930

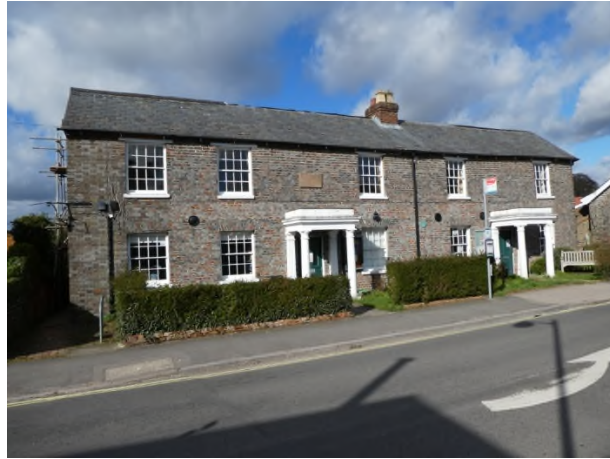
Figure 9: 19th century 8-over-8 sash windows on the front elevation

4.2.1 It is proposed to repair/refurbish all of the windows, including draught-proofing. Where internal shutters exist, they are to be made good/functional. The details of the window refurbishment includes adding concealed brush beading, perfectly balanced weights, new sash cords, removal of excess paint from channels and redecorating channels.

- 4.2.3 It is also proposed to install CozyGlazing secondary glazing which is made of a modern, lightweight equivalent of glass which is fixed using magnetic strips so that it is easy to remove and virtually invisible. The Mitchell and Dickinson website provides examples which appear unobtrusive and have been used for listed buildings. Their web address is as follows:

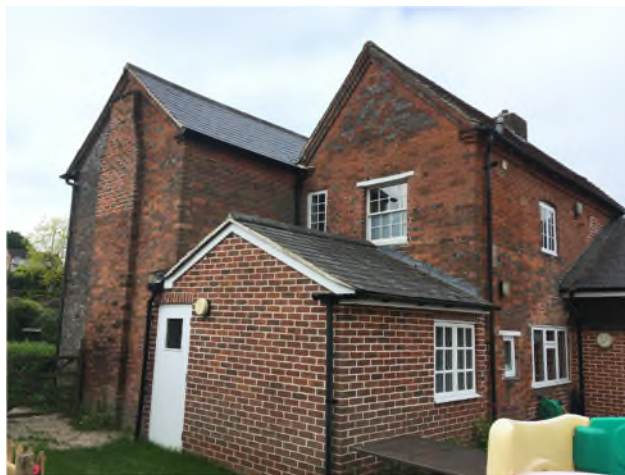
Figure 10: 20th century sash and fixed light on the east elevation

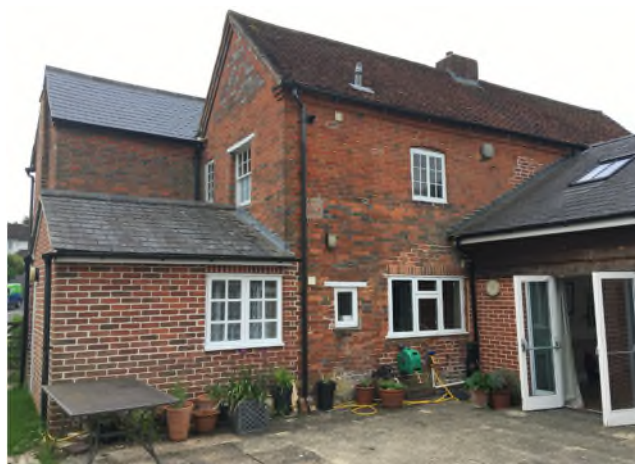
Figure 11: Mix of late 19th-early 20th century casements and modern casements on the rear elevation (north)

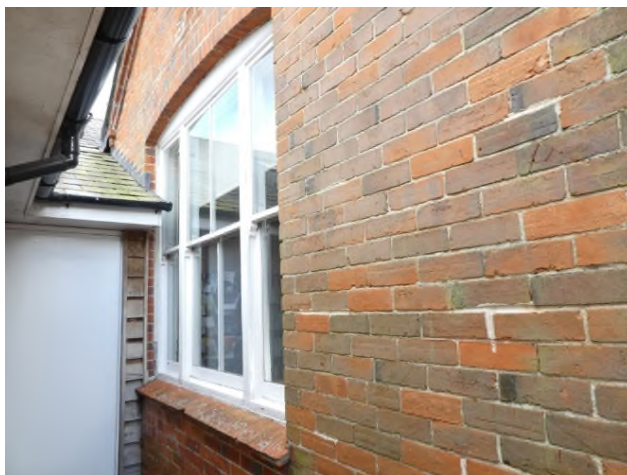
Figure 12: Late 19th to early 20th century tripartite sash window on the north elevation of the rear library wing

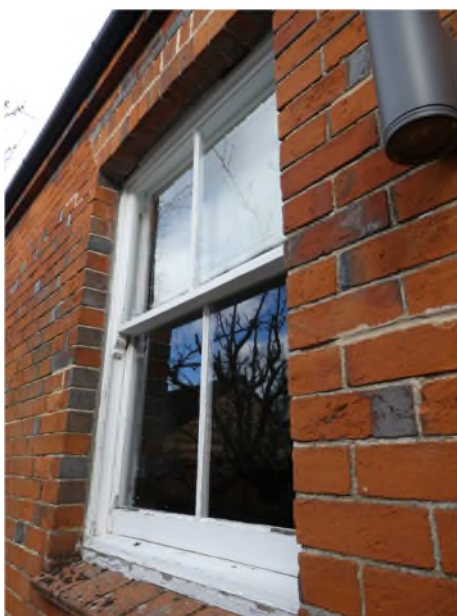
Figure 13: Late 19th to early 20th century sash window on the west elevation (library rear wing)

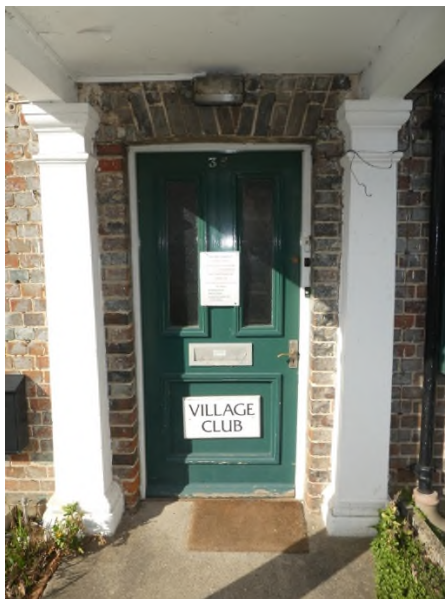
- 4.3.1 The front door to No. 35 providing access to G2 is a modern replacement and is of no heritage value. Its replacement with an appropriately designed replacement that references the design

Figure 14: Modern replacement door at No. 35

of the older door at No. 37 and includes appropriate period door furniture would enhance the character of the front elevation of the listed building.

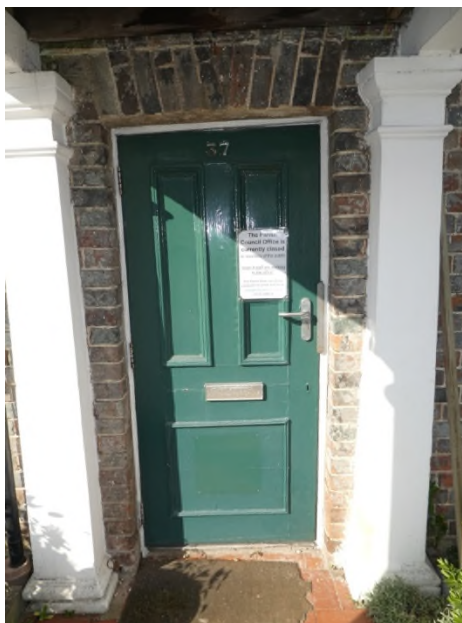
- 4.3.2 The front door to No. 37 includes two upper panels and a single lower panel. The style of the panel mouldings is consistent with 19th century style. The door furniture is modern but there is evidence for original/earlier door furniture on the internal face of the door. Due to the condition and poor fitting of the door it is proposed to replace it on a like for like basis to include appropriate period door furniture. It is proposed to retain the existing door and re-use or display it elsewhere in the building. In this manner historic fabric would not be lost. The replica door would preserve the character of the front elevation.

Figure 15: Front door at No. 37

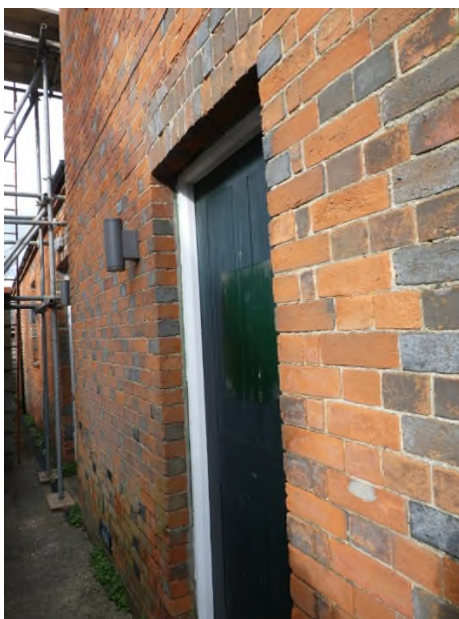
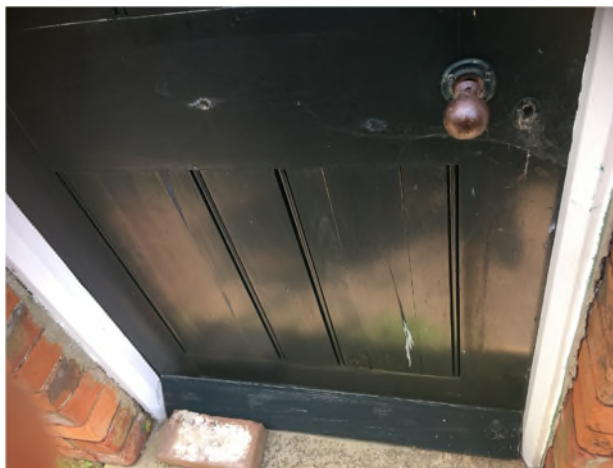
- 4.3.3 The panelled door on the west elevation of Phase 3 is a modern replacement and is of no heritage value. This door replicates the style of the original door on the left hand side of the

Figure 16: Panelled door on the west elevation of Phase 3

Figure 17: Detail showing the crisp finish of the panels of the door on the west elevation of Phase 3

west elevation of the Phase 4 extension. The proposed like for like replacement door would preserve the character of the west elevation.

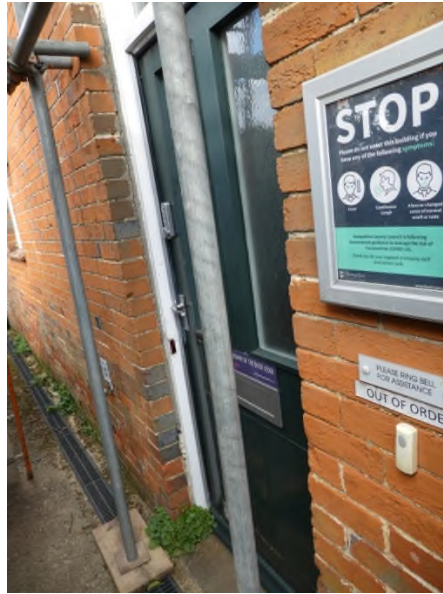
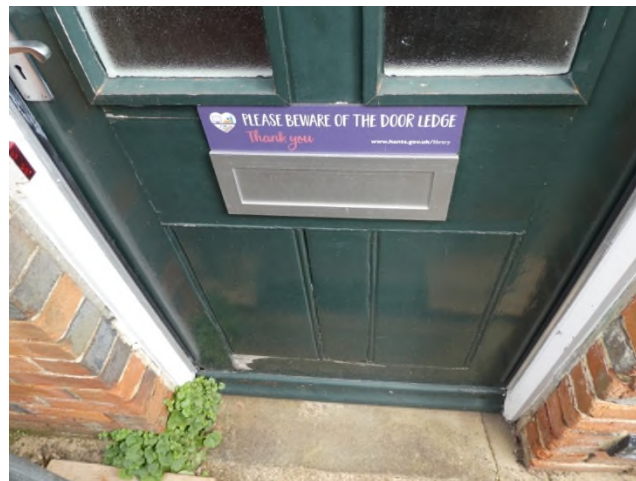
- 4.3.4 The door on the right hand side of the west elevation of Phase 4 was originally a solid door of the same design as the door on the left hand side of the west elevation. This door has been modified with the insertion of glazing in the upper panels. The lower section of the door appears to be original to the Phase 4 extension. This door has been substantially altered and is of relatively late date. This door is considered to be of low significance. The proposed replacement would be like for like to match the established style of doors on this side of the building. The proposed replacement would preserve the character of the listed building.

Figure 18: Existing door on the right hand side of the west elevation of Phase 4

Figure 19: Detail showing the original lower panels and the modern glazed panels

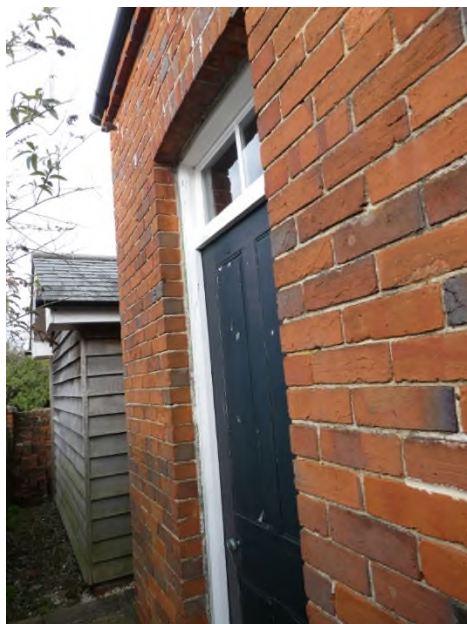
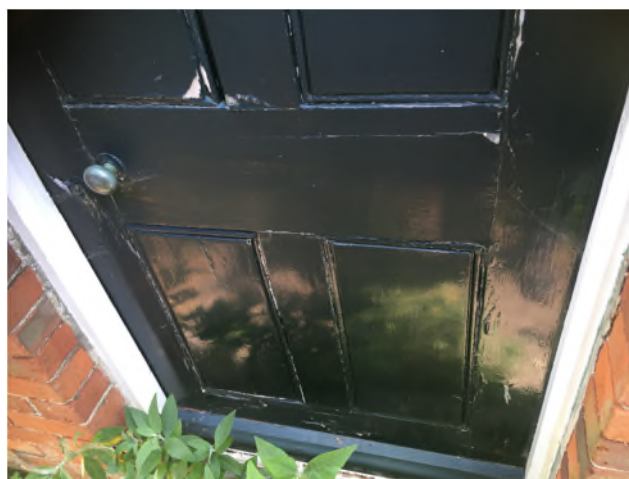
- 4.3.5 The panelled door on the left hand side of the west elevation of Phase 4 is an original early 20th century door. It is proposed to retain and refurbish this door, thereby preserving the evidential value of Phase 4 as well as the established character of this elevation.

Figure 20: Original door on the left hand side of the west elevation of Phase 4

Figure 21: Detail of the panels of the original door on the west elevation of Phase 4

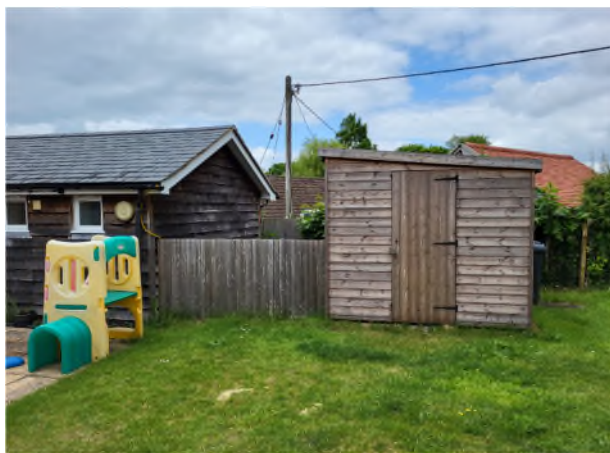
Figure 22: Proposed position of the external heat pumps behind a fence

- 4.4.2 The heat pumps are to be placed on a concrete base behind a modern fence between the modern toilet block and a wooden shed. The proposed heat pumps would not therefore be attached to the listed building or visible within the setting. Pipe work for the main hall would run through the roof space of the toilet block, so not be visible. Pipework for the library will run along the back of the main hall outside, enter the building through the chair store, go through the roof space in the fire porch, and enter the library from that internal wall. The plan is to locate 2 coil heaters in the library high up on the wall. The proposed heating system will be highly discreet and would not adversely impact on the character or historic fabric of the building. The appearance of the external and internal units is shown on the Midea Product

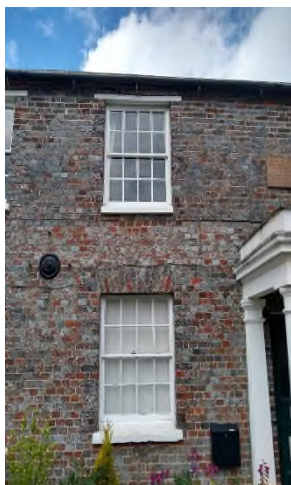
1. Main Building Original Sash Windows

Heritage Consultant's view: These 8-over-8 sash windows are mostly original and include some replacement sashes that reference the original design.

PLANNED WORKS: repair,/refurbish, draught exclude and install cosyglaze secondary glazing. Reinststate the internal shutters in both library windows (front of the building).

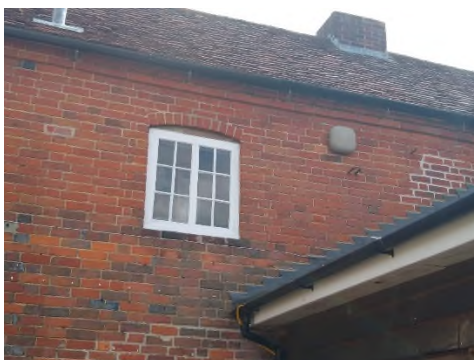
2. Main Building North Elevation 1st Floor

Heritage Consultant's view: This is a historic 2-light casement.

PLANNED WORKS: Repair/refurbish, draught exclude and install cosyglaze secondary glazing.

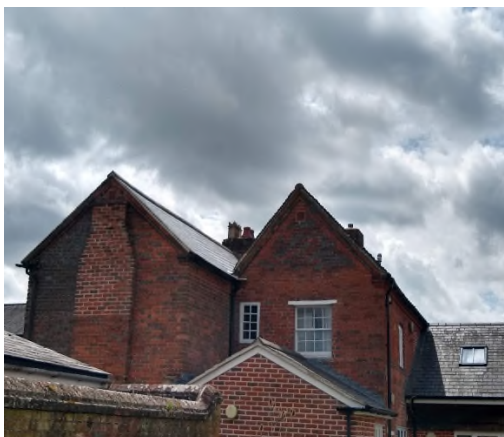
3. Main Building, East Elevation 1st Floor (2 windows - 1 sash)

Heritage Consultant's view: Two 20th century windows within later openings cut into the brickwork.

PLANNED WORKS: Repair,/refurbish, draught exclude and install cosyglaze secondary glazing.

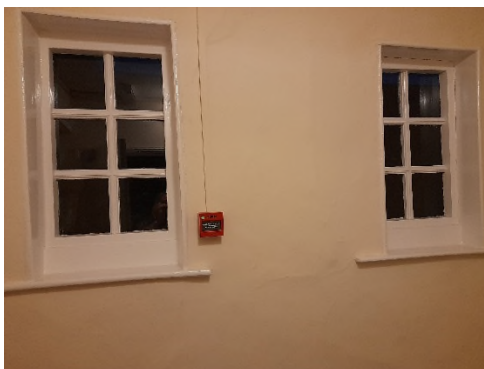
6. Main Building, West Elevation 1st Floor (2 Windows)

Heritage Consultant's view: Two 20th century windows within later openings cut into the brickwork.

PLANNED WORKS: Repair,/refurbish, draught exclude and install cosyglaze secondary glazing.

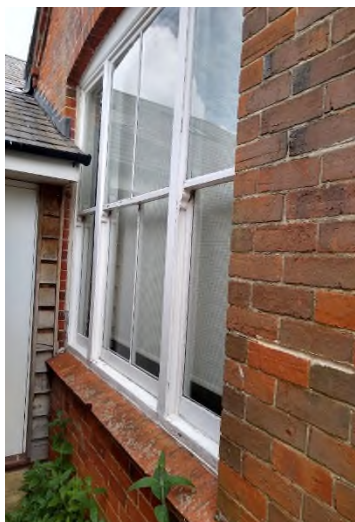
7. Library South Elevation Window

Heritage Consultant's view: This is an original early 20th century window.

PLANNED WORKS: Restore this window, new brushes and beads where needed. Draught proof and secondary glazing

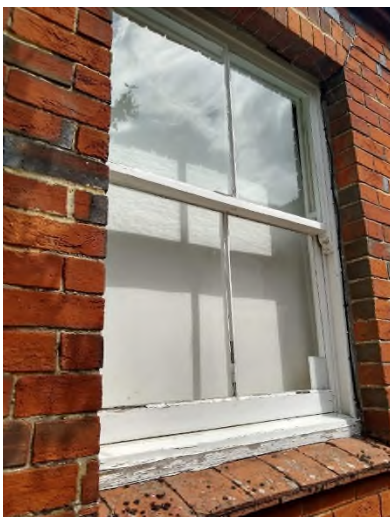
8. Library West Elevation (Sash)

Heritage Consultant's view: This is an original early 20th century window.

PLANNED WORKS: To be repaired/refurbished/brushes, discreet secondary glazing.
