## PRELIMINARY ROOST ASSESSMENT

**Close House, Whalton, NE61 3XD**

**April 2022**

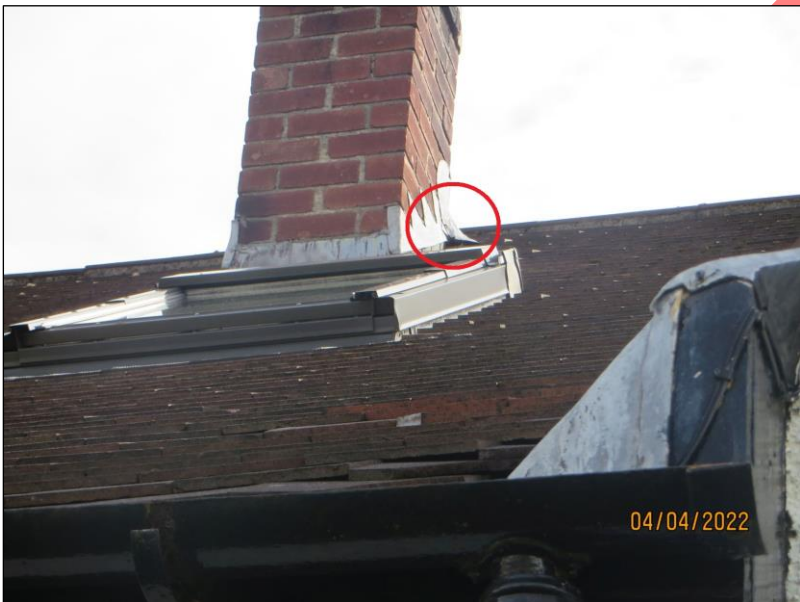
Figure 12. Raised roof flashing.

The property is a brick-built bungalow with dormer windows. The tiled roof is in a good state of repair. Skylights are present allowing light into the bedrooms. Some of the roof flashing is raised, creating a gap beneath (**figure 12**). The mortar on the ends of the tiles is in place and capped off.

**No roof work, including tiles, soffits/wall work should be carried out prior to these surveys being undertaken. This is to reduce any impacts on any bat roosts, if present, which could constitute a legal offence.**

- Roofing features including soffits and tiles to be removed by hand, carefully checking for bats.
- If bats or signs of bats are found, then work must stop, and the project ecologist contacted for advice.
