Arboricultural Method Statement

For Trees On

Land Adjacent To Tollgate House,

Bedlington

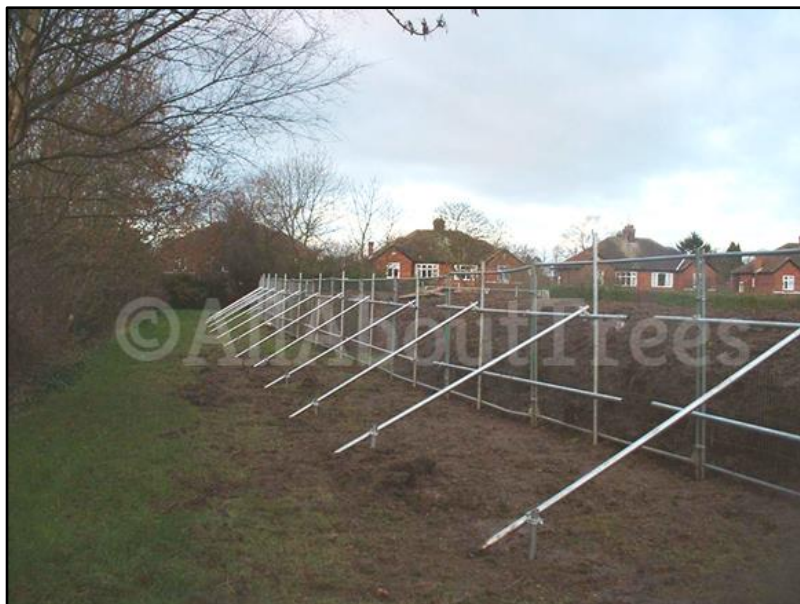
Figure 2 - Actual barrier erected on site

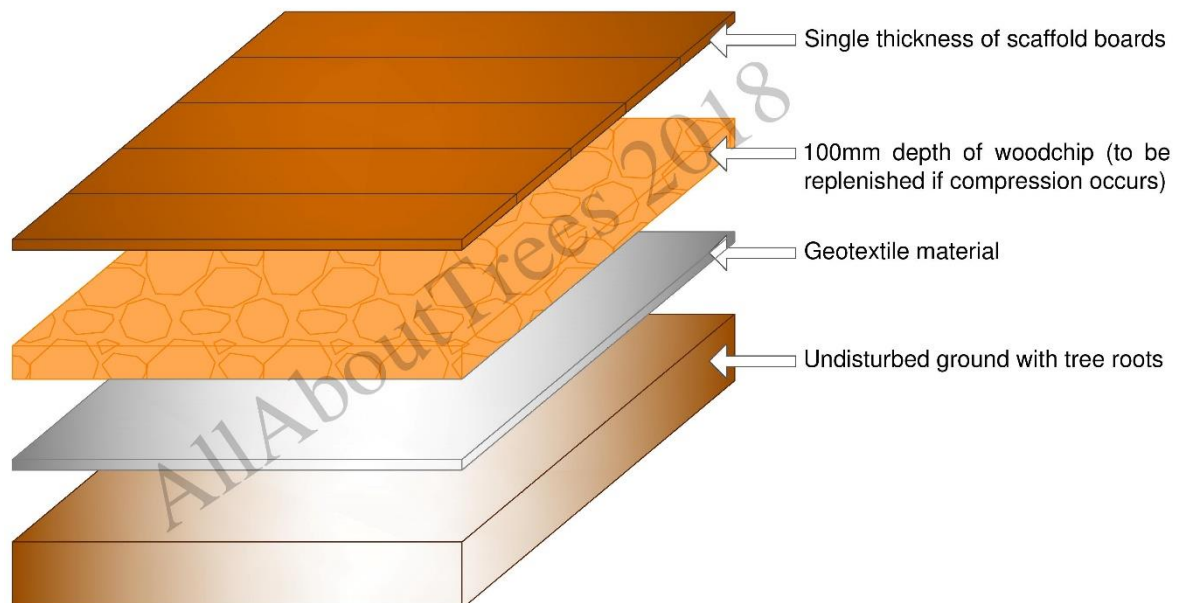
Figure 3

Ground Protection Suitable For Pedestrian Movement Only

3.4.3 Temporary ground protection should be tailored to the likely load it will be subjected to. The following diagrams indicate the acceptable techniques for:

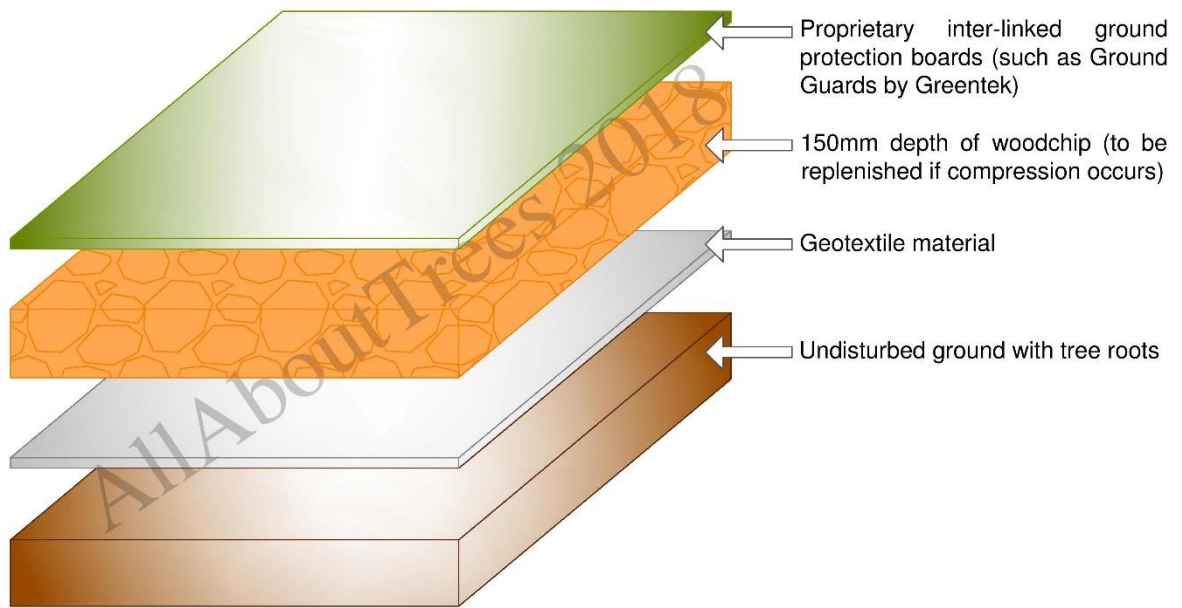
Figure 4

Ground Protection Suitable For Pedestrian Operated Plant Up To A Gross Weight of 2t

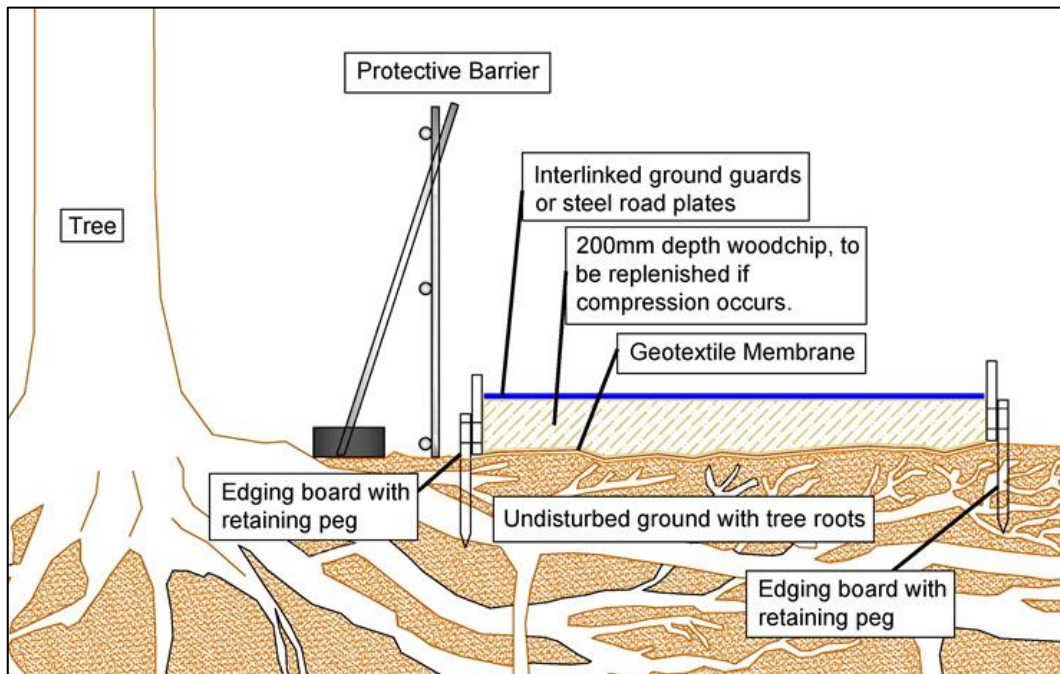
Figure 5

3.4.4 If the likely loading is to exceed 2t gross weight it will be necessary to produce an engineered solution with arboricultural advice to accommodate the likely load safely. One such example is shown below. In some cases it may be necessary to install a temporary road using a 3D cellular confinement system (such as Cellweb by Geosynthetics Ltd).
