1 ROSE COTTAGE, FAWLER
OX7 3AJ

HERITAGE STATEMENT

MAY 2021

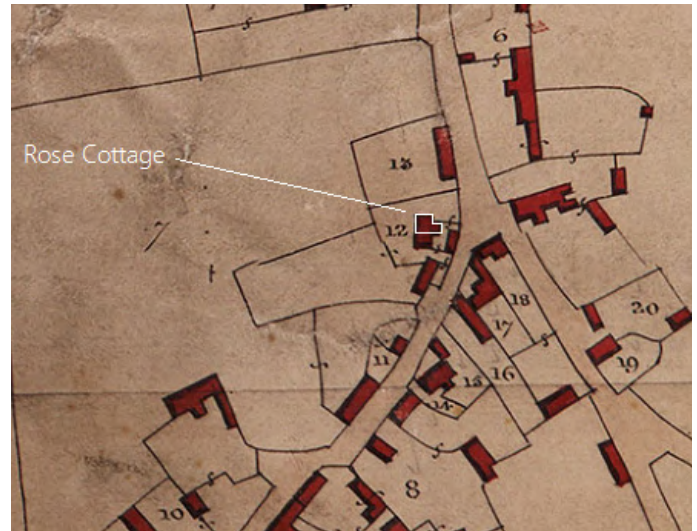
Tithe Map 1847

The earliest documentary evidence available directly related to Rose Cottage is the 1847 Tithe Map and Register. The Tithe Map shows the site formed part of two connected plots of land, collectively labelled "12". On the north edge of the combined plots close to the roadside, three buildings are shown. According to the associated register entry, this plot belonged to His Grace the Duke of Marlborough and comprised "Cottages and Gardens", which at the time were occupied by Thomas Harris and Samuel Couling. [IR29 Tithe Commission and successors: Tithe Apportionments, IR 29/27/30, National Archives]. It is not possible to tell from the detail provided in the Tithe Register, whether Rose Cottage was already being occupied by two families. A second rectangular shaped building is shown on the adjoining plot and whilst this may have been a second and separate dwelling its principal elevation is facing away from the road which would suggest that it was in agricultural use. A third smaller building immediately adjacent to the road partially screens the site. This is thought to be a washhouse as extant material within the building shows the remnants of a heated copper but it could have had other supplementary uses. Although agricultural buildings are usually distinguished from dwellings on tithe maps by colouring them grey, this is not always the case and does not seem to be the case here as all the buildings on the 1847 Tithe Map are shaded red regardless of their use. It therefore seems likely that the two ancillary buildings shown on the plot are not dwellings.

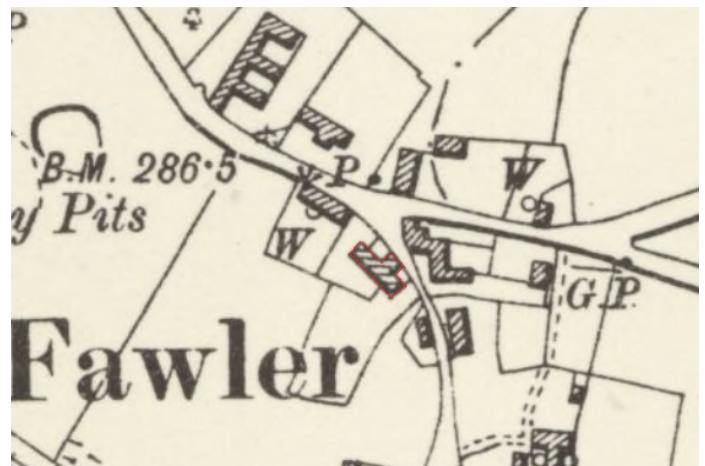
Oxfordshire XXVI.NW (includes: Combe; Fawler; Finstock; North Leigh Revised: 1898, Published: 1900 'Reproduced with the permission of the National Library of Scotland')

The simplified form of the building shown on the 1898 OS Map is somewhat misleading. By the 1919 edition the porch is shown, perhaps shortened, with a detached structure at the front and the entire plot sub-divided either defined by different uses or because the house is in use as three separate household units. According to the building outline shown on the 1919 edition the east side of Rose Cottage steps forward of the building line. Close examination of the stonework on the front elevation reveals slight differences in the stonework and pointing but not sufficient to say with any degree of certainty how much of the outer walls have been altered and rebuilt.

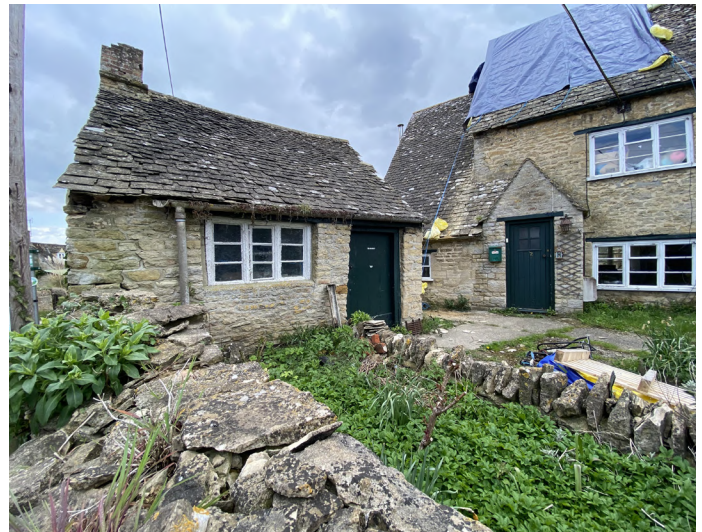
Small detached building to the front of 2 Rose Cottage, thought to be a washhouse but could also have operated as a shop late 19th century.

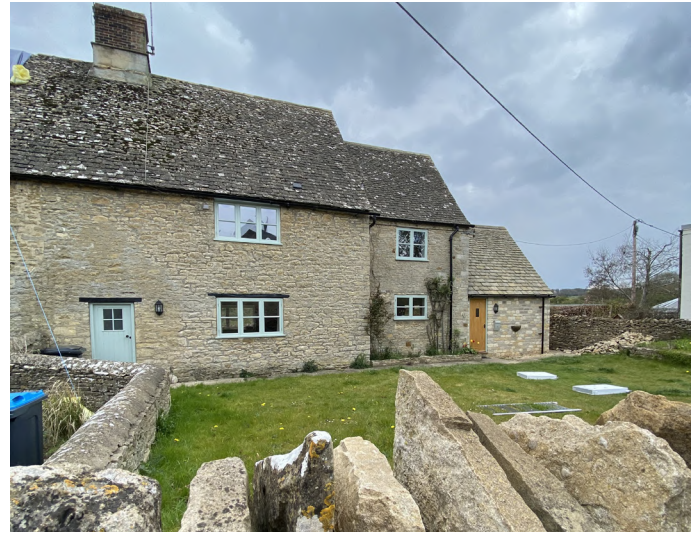
Front Elevation as seen from Main Street.

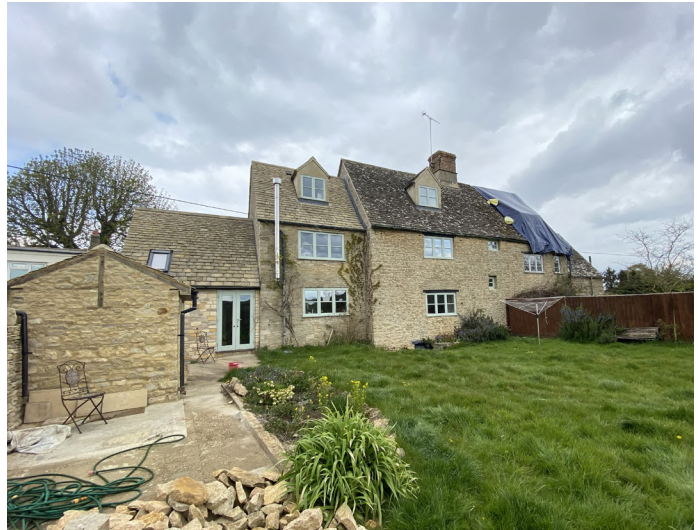
Rear elevation with small modern outbuilding on the left. This elevation has been heavily altered with dormers added and larger glazed windows and doors in the extension.

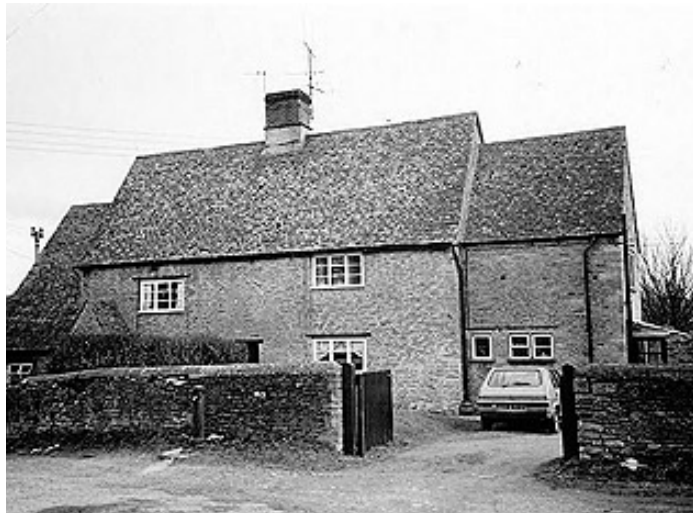
*Nos 1 and 2 Rose Cottage, Main Street 1987-1989
©POX0419308 www.pictureoxon.org.uk*

The site is bounded by traditional stone walling but the cranked capped stone wall dividing the two properties is a recent and unconventional division that may have replaced hedging visible on a photograph from the late 1980s. The original basement area was internally accessed from the other side of the building, now number 2. The stairs have been blocked internally and access remains only from the rear garden of number 1 through a small opening with a timber lintel over. The cellar basement consists of a single chamber with a flagged floor, whitewashed stone walls, and a small chute for coal to the side now blocked by the kitchen extension. Unusually the basement area is a good height and once access is re-arranged the space could be put to beneficial use.

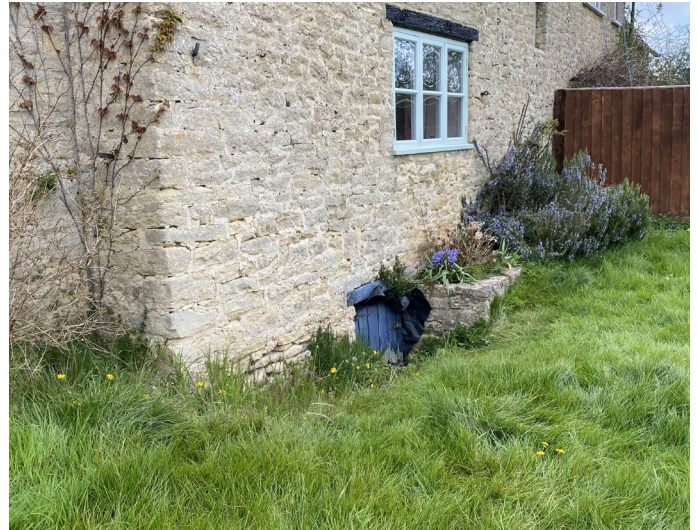
Access to the basement is through the blue shuttered opening at ground level, currently without stepped access. Approval was given in 2010 to amend this situation but the works have not been implemented.

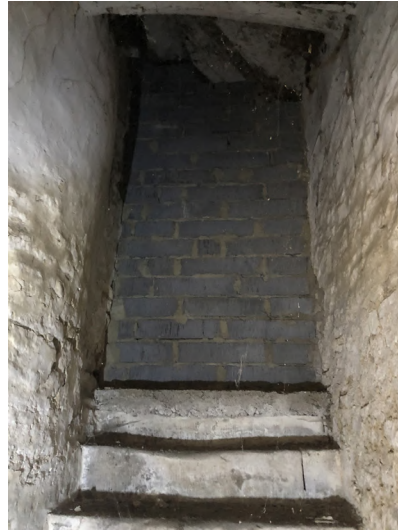
Well-used stone steps now redundant are abruptly sealed with modern blockwork where they would have entered next door.

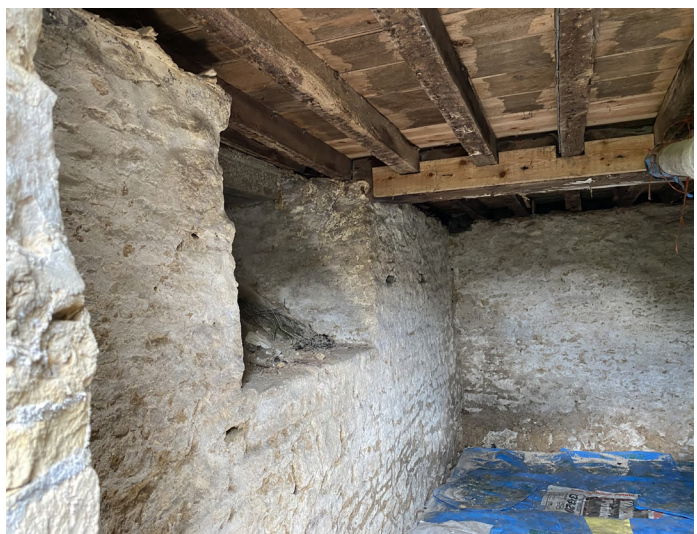
Coal chute to the side, intrusive soil pipe just visible on the right of the image.

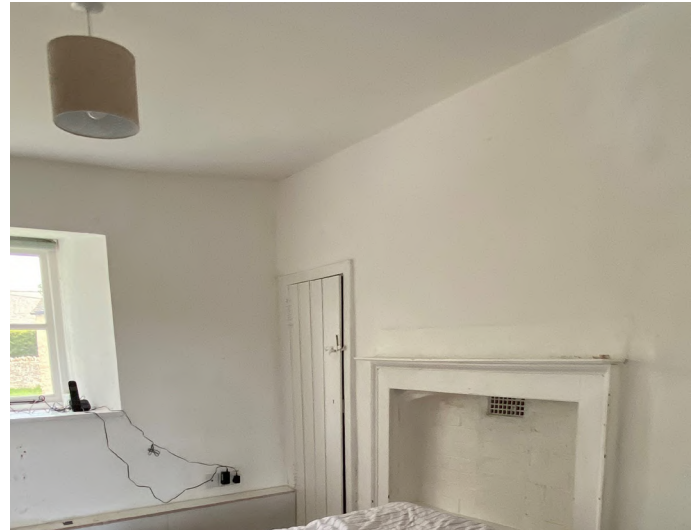
A small section of stone moulding is discernible just below the later fire surround. The fireplace is very shallow here having been infilled and an intrusive air vent added.

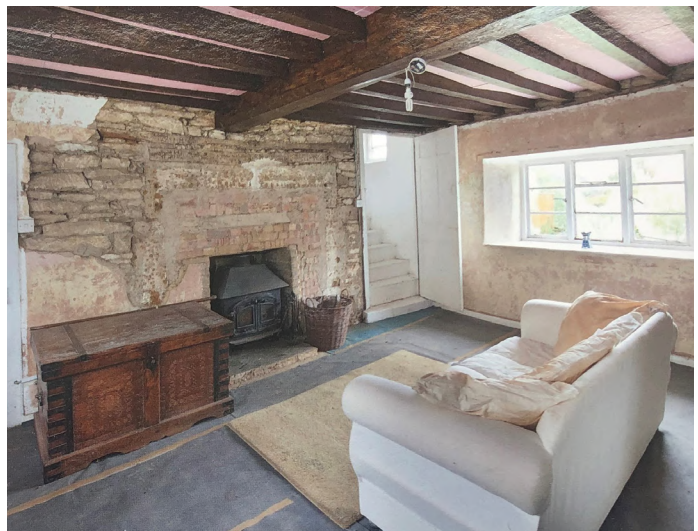
Exposed walls 2014 show the progressive infilling of the fireplace with a mix of brick and stone blockwork.

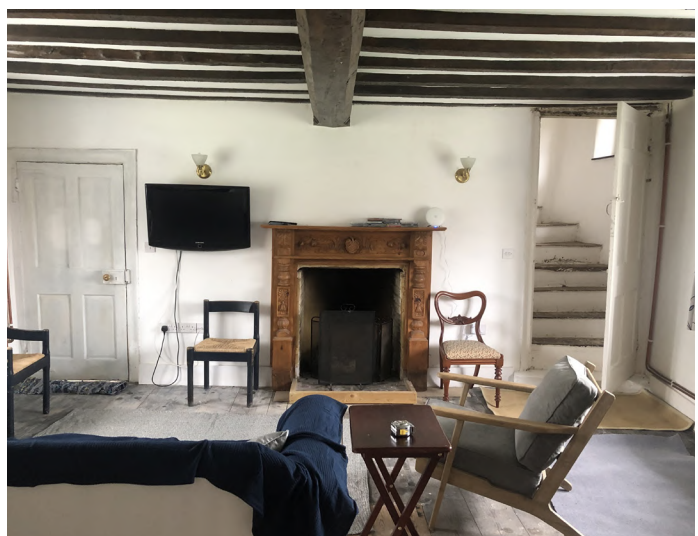
Proportions of the fireplace opening, over-elaborate and crudely carved fire surround and its off-centre position clearly indicate its later date. Winder stairs to the right lead to the first floor and attic level.

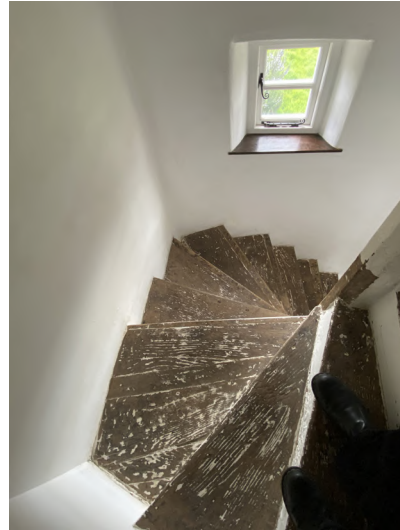
Newel post on the right of the image usually found in more prosperous houses and often as here rises through more than one storey to serve the attic as well.

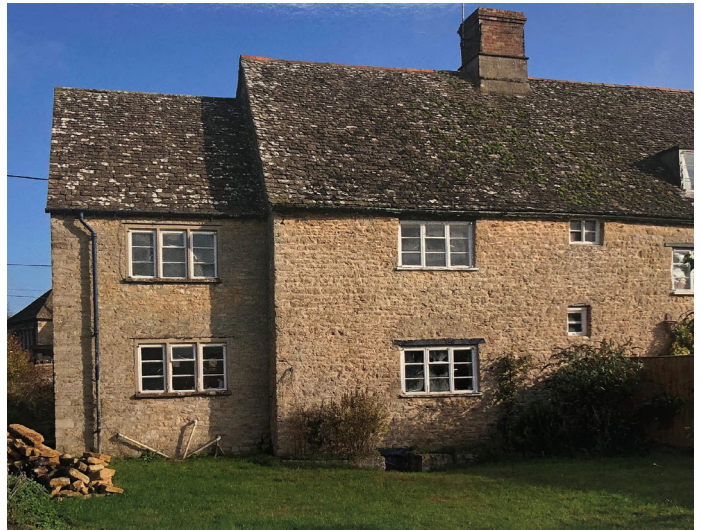
Rear of Rose Cottage taken in November 2014 prior to the partial implementation of the 2010 scheme which included a single storey extension and the insertion of two dormers, one in the older section of the building and the other on the later subservient range. All the windows have subsequently been replaced.

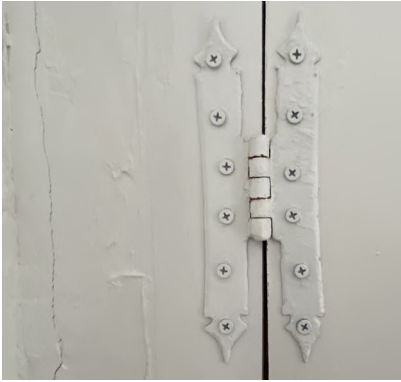
H-hinge very common in the late 17th century and the early 18th century and usually used for lighter internal doors and cupboard doors. During the course of the 18th century the decorative ends are often lost and the plain H-hinge becomes the ubiquitous form in use.

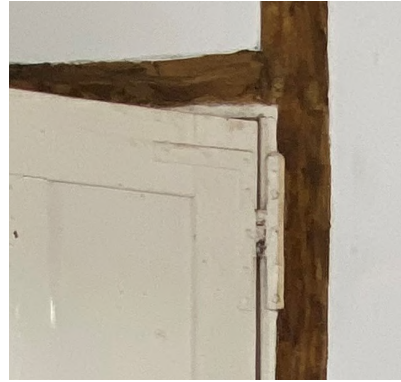
L-h-hinge came into use in the late 17th century, plain ones as here are the norm throughout the 18th century and into the early 19th century.

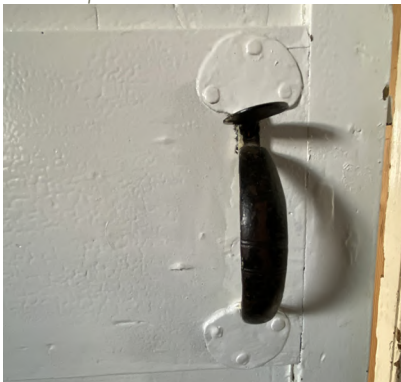
Round ended upright door handles are the simplest form of latch operated handles and mostly date from the 18th century when the ends can be quite large as here. Earlier versions from the 17th century are slightly smaller and often have leaf shaped decorated ends.

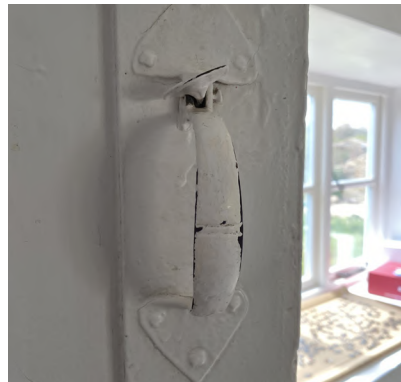
Late 18th century leaf-shaped door ends (larger than a 17th century version) and handle with incised lines across the centre of the handle. Considered by some to be apotropaic 'evil-averting' marks barring the way to any evil spirits that may wish to enter.

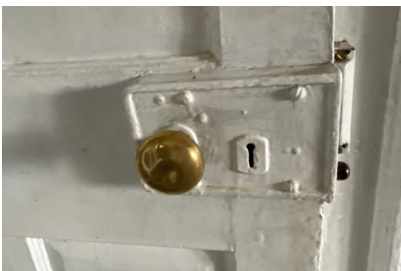
Brass lock cases became popular in the 18th century incorporating lock, latch, and handle in one unit. Its' use on an internal door indicates increased interest in security perhaps as a result of several families sharing an interconnected space.

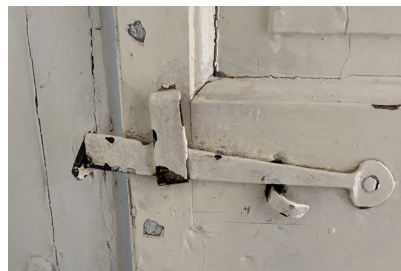
Mid-18th century iron latch

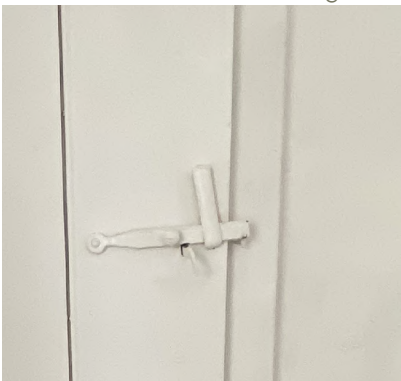
The small round knob on the latch reveals that this is a much later fixing from the mid-19th century.

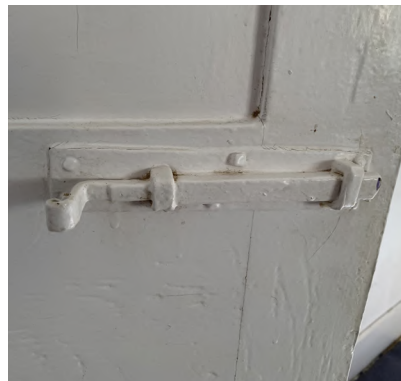
Late 19th century bolt.

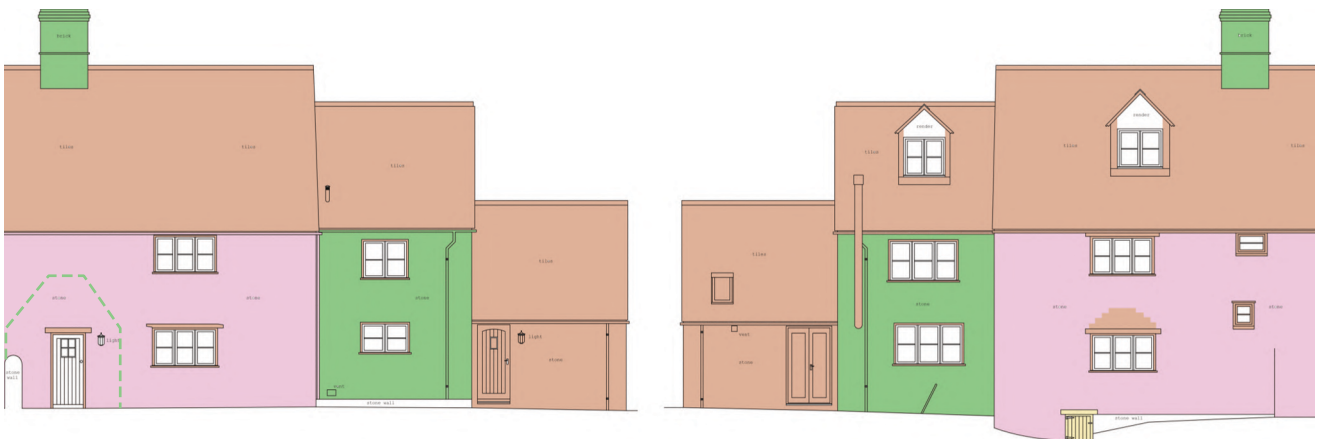
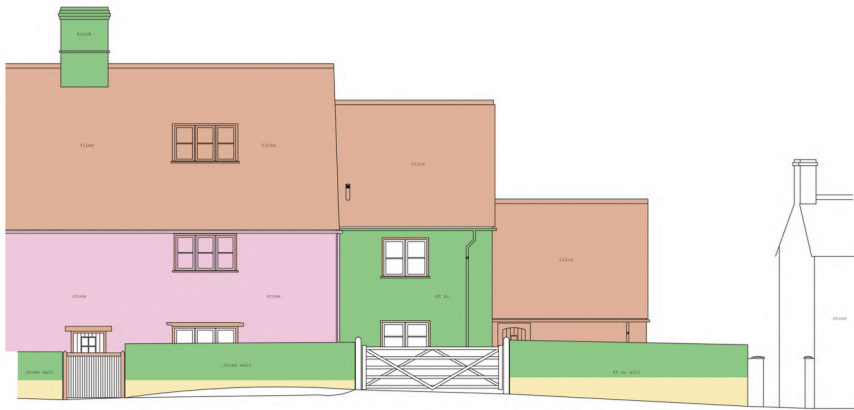
4.5 DEVELOPMENT PLANS

21st Century 20th Century 19th Century 18th Century
