PRELIMINARY ROOST APPRAISAL (PRA) & BAT ACTIVITY REPORT

Southwood, Burley, Hampshire, BH24
4AS

On behalf of: Mark and Jacqui Evans

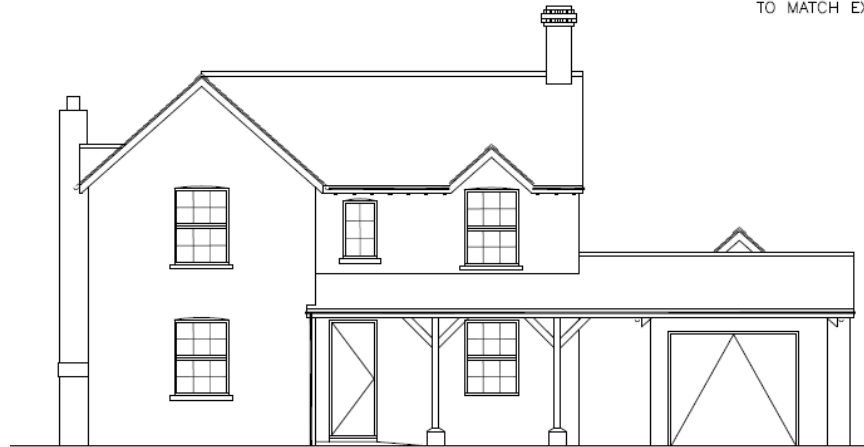
PROPOSED FRONT ELEVATION

NEW WINDOWS TO BE DOUBLE GLAZED (16mm GAP). AND FITTED WITH LOW E GLASS. MIN. U VALUE OF 1.6W/M²C

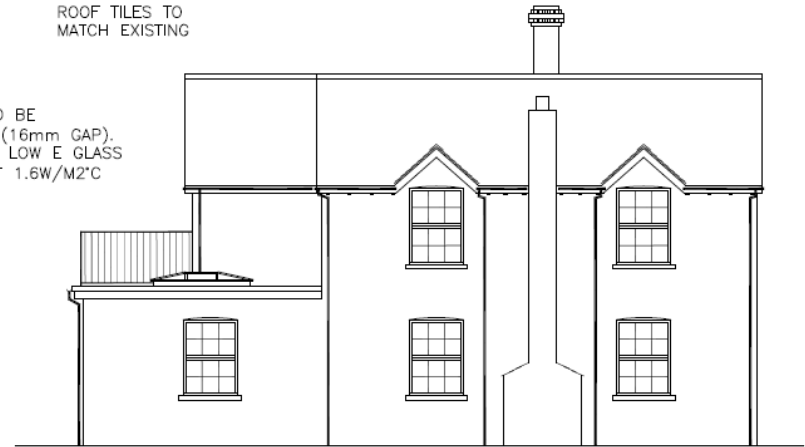
PROPOSED SIDE ELEVATION

VENT STACK IS TO BE TERMINATED A MIN OF 900mm ABOVE ANY OPENING WINDOW

WALLS PAINTED WHITE TO MATCH EXISTING

WHITE BALCONY RAILING OR SIMILAR APPROVED

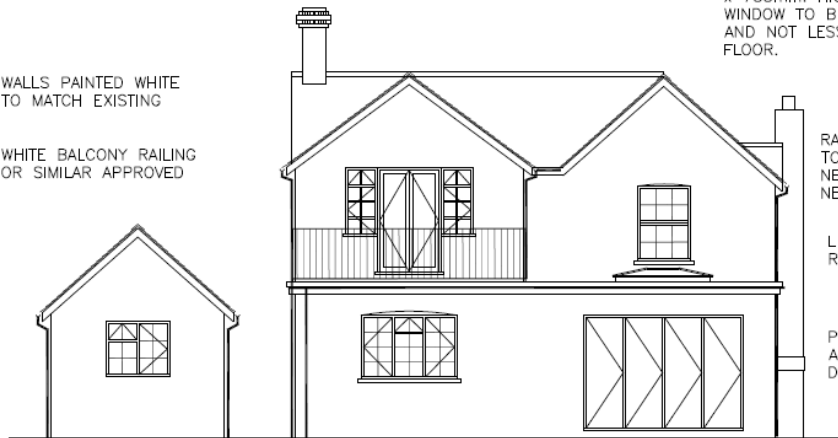
PROPOSED REAR ELEVATION

RAINWATER TO RUN IN TO NEW GUTTER IN TO NEW DOWNPIPE ON TO NEW ROOF

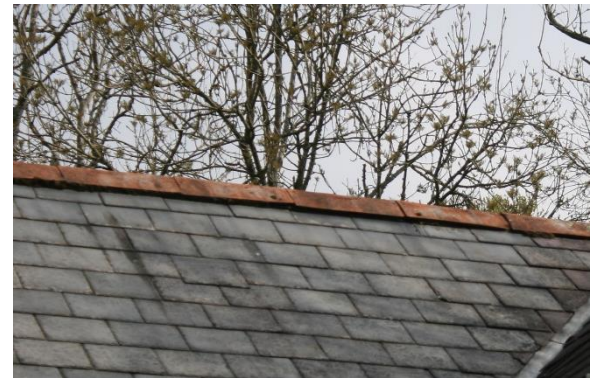
Building name	Potential bat access points	Potential roosting provisions	Potential of the building
Southwood	<ul style="list-style-type: none"> • Gaps under ridge tiles on the southern side of the east to west pitch. • Gap between end ridge tile and barge board on northern gable end. • Roof tiles and barge board on western gable end. • Gaps under dormer fascia's on eastern elevation. 	<ul style="list-style-type: none"> • Space between ridge and roof tiles. • Space between roof tiles and barge boards. • Crevices under fascia's on eastern elevation. 	'Moderate potential' for roosting bats

Photo 6: Raised ridge tiles

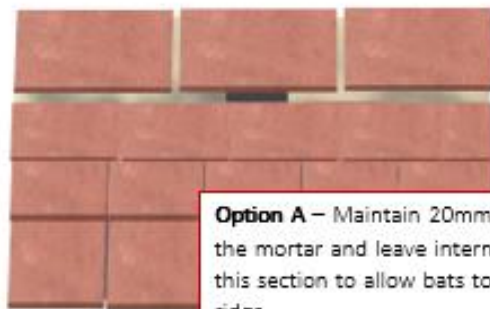
Option A – Maintain 20mm x 50mm gap in the mortar and leave internal mortar under this section to allow bats to roost along the ridge.

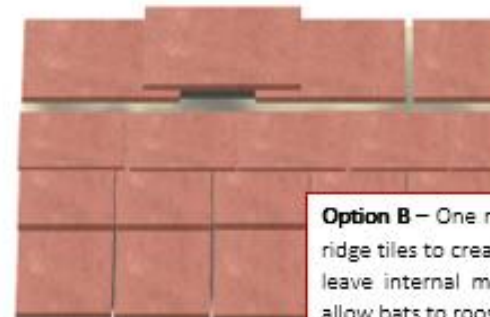
Option B – One ridge tile set on top of other ridge tiles to create a 20mm x 50mm gap and leave internal mortar under this section to allow bats to roost along the ridge.
