**An archaeological desk-based assessment
for land at Yew House, Old Hall Drive,
Elford, Staffordshire B79 9BZ**

ULAS Report No 2022-049
©2022

Site Name: Yew House, Old Hall Drive, Elford, Staffordshire B79 9BZ

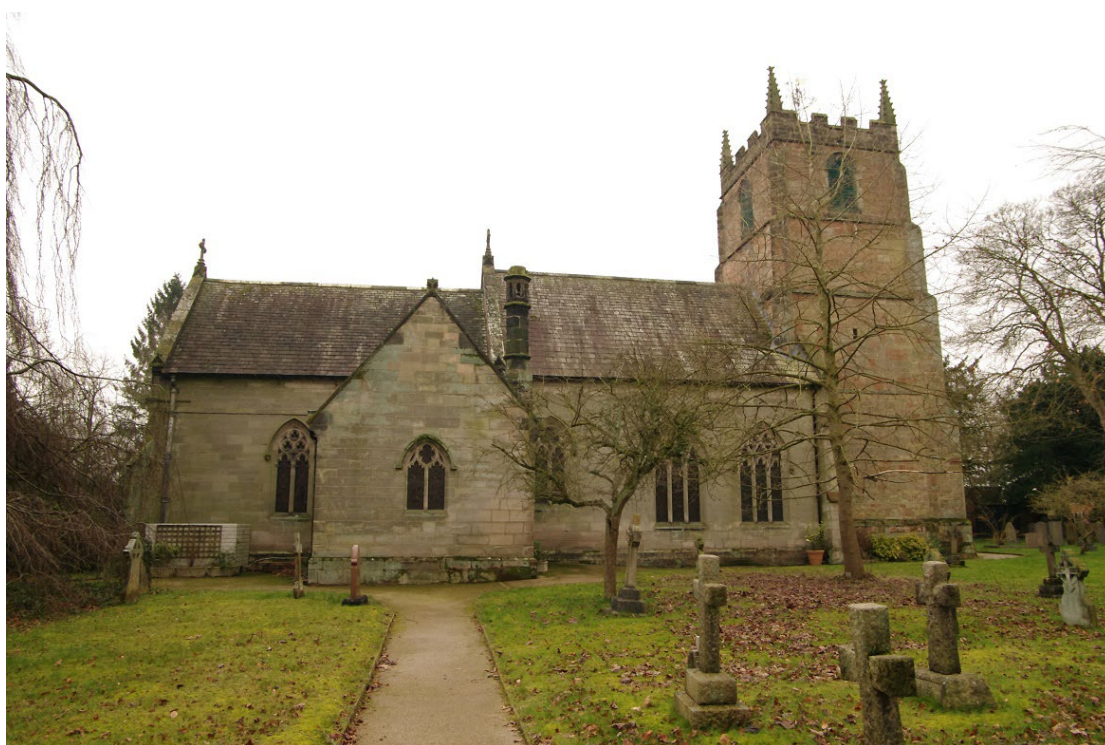
Figure 7: Church of St. Peter, looking south

The nearest listed building to the site, and the most significant, is the Grade II* listed church of St. Peter that lies 50m to the north-west of the assessment area. The church is of medieval foundation, with a tower built in 1598, but the building was mostly rebuilt in 1848- 9 by Anthony Salvin, in a style of circa 1290, with additions of 1869-70 by G.E. Street. It is ashlar built with slate and lead covered roofs with coped verges (**MST5262; LB 1038899**) (Figure 7).

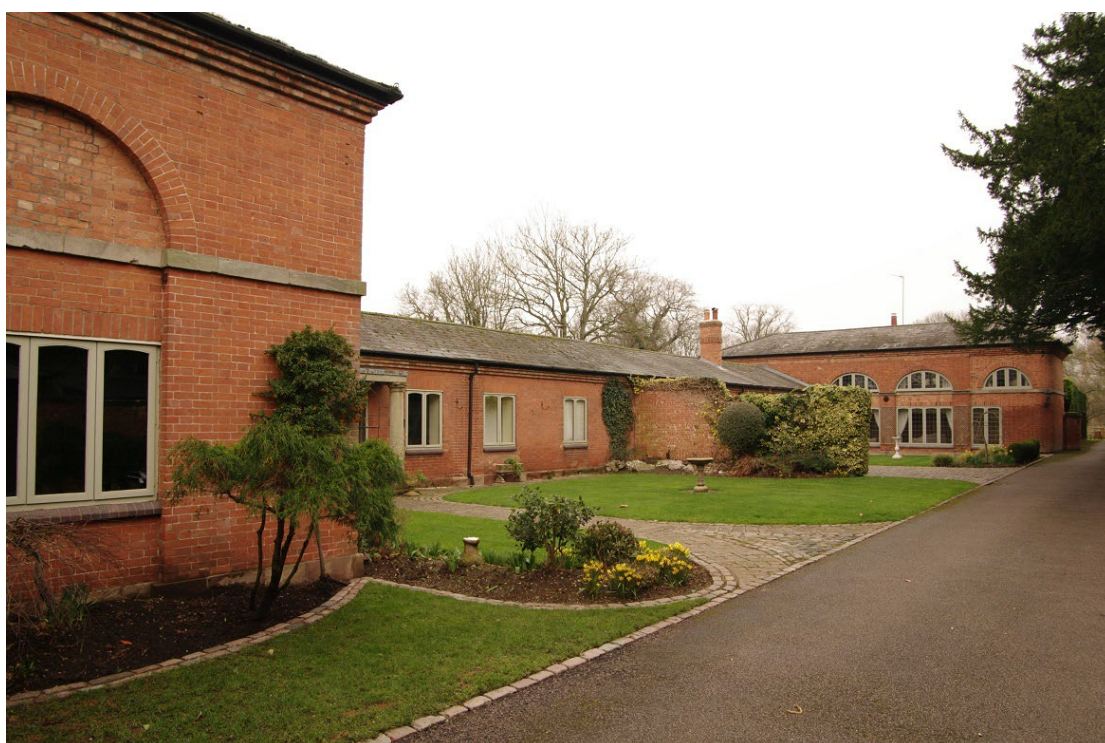
Figure 8: Former coach houses, now residences, looking north

Around 80m to the north-west of the assessment area and 50m west of the church are the Grade II listed coach houses formerly associated with Elford Hall. They are of red brick construction with a hipped slate roof. The buildings are of early 19th century date, but were remodelled circa 1980 and are now in use as two houses (**MST9219: LB 1038898**) (Figure 8).

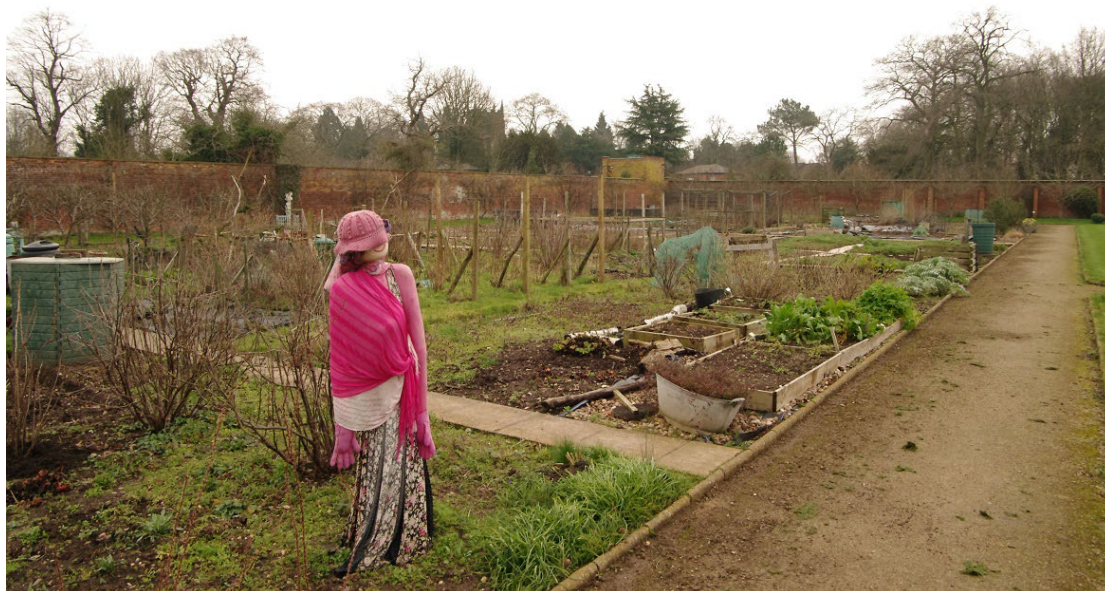
Figure 9: The interior of the walled garden, now a community allotment, looking south-east

The 18th century kitchen garden walls, formerly of Elford Hall, lie 150m to the west of the assessment area. These are of red brick in garden wall bond with plain stone coping ramped up in places, segmental and flat arch doorways and brick lean-to potting sheds. It encloses a large square kitchen garden of the early 18th century. These are also Grade II listed (**MST12460: LB 1380564**) (Figure 9).

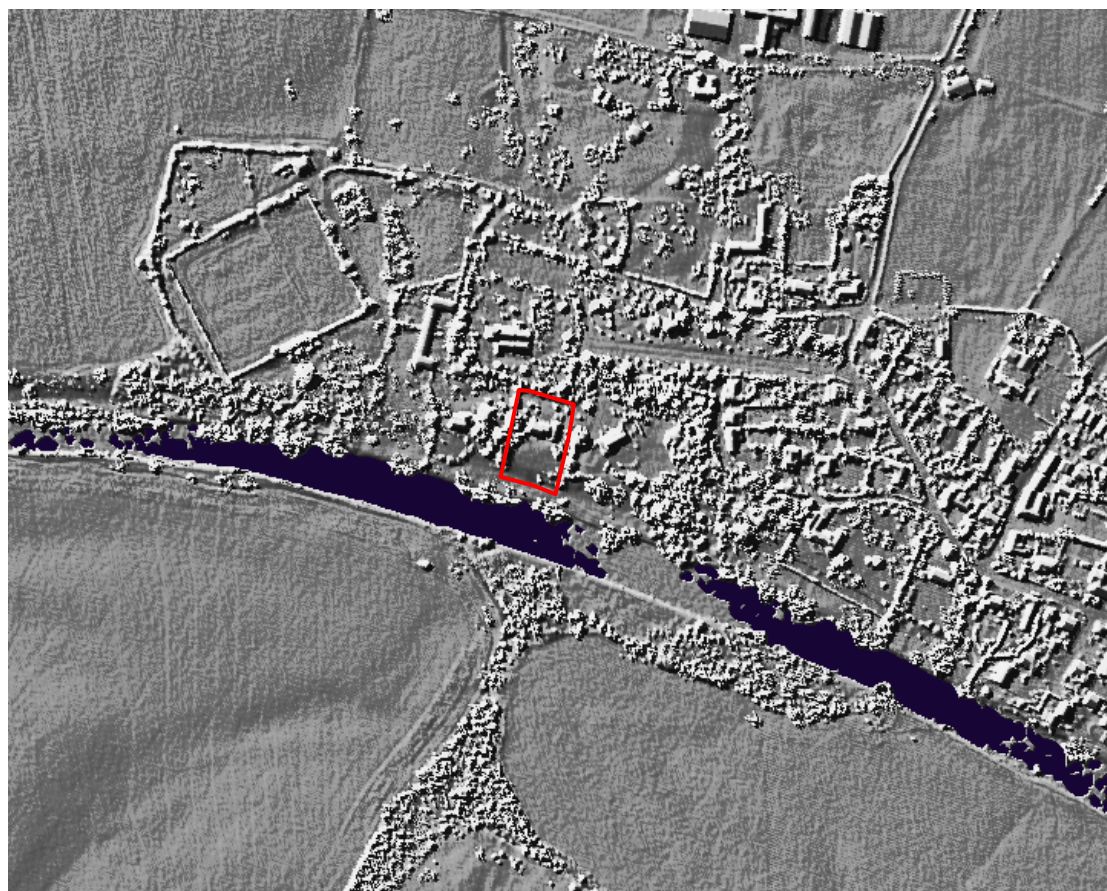
Figure 14: LiDAR data for the assessment area.
Open Government LIDAR data (DSM 1m) from the Environment Agency

There is Light Detection and Ranging Data (LiDAR) for the area available (Figure 14). There is little detail that can be seen from the Lidar survey. However, the dense tree cover is very apparent (Figure 14).

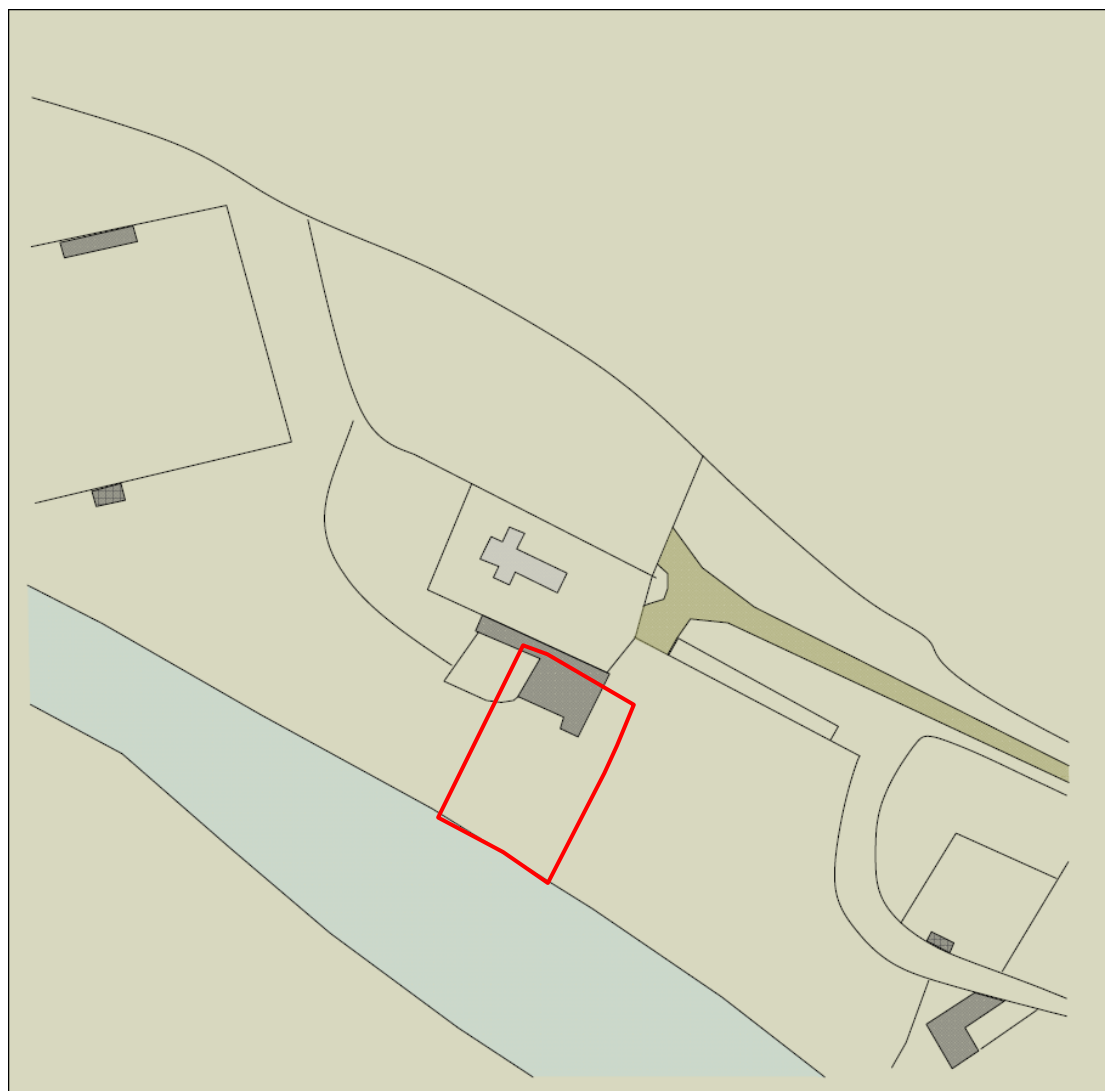
Figure 15: Detail of sketch copy of 1839 tithe map of Elford parish, with assessment area approximately highlighted. Scale Unknown

At this time there is only the church, the Hall (to the south of the church) and the walled garden of the Hall (to the west) are shown. The large rectory and a smaller building lie to the south-east. The coach house is not shown, although the listing describes it as ‘early 19th century’ so it may have been built shortly after this survey.

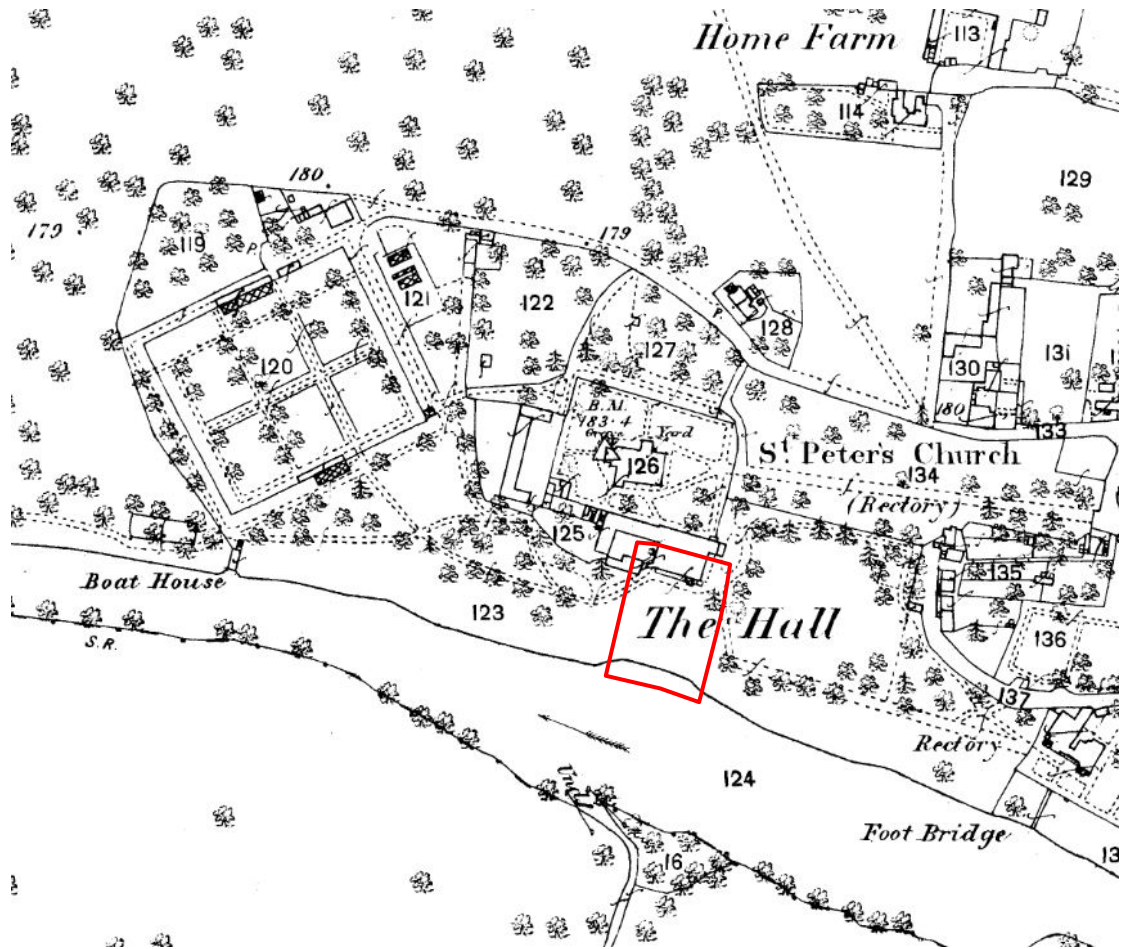
Figure 16: Detail of first edition OS map (1885), sheet Staffs LIII.10, with assessment area highlighted. Scale 25 inch to 1 mile

The next available map of the area is the first edition Ordnance Survey map of 1885. This shows the area in some detail. The church is shown within its churchyard with the hall to the direct south, sharing the perimeter with the church. To the west are the coach houses and the formerly laid-out gardens are to the west of this. Smaller buildings are shown, including a boat house down by the river and greenhouses to the north-east of the gardens as well as attached to the garden. The rectory lies to the east.

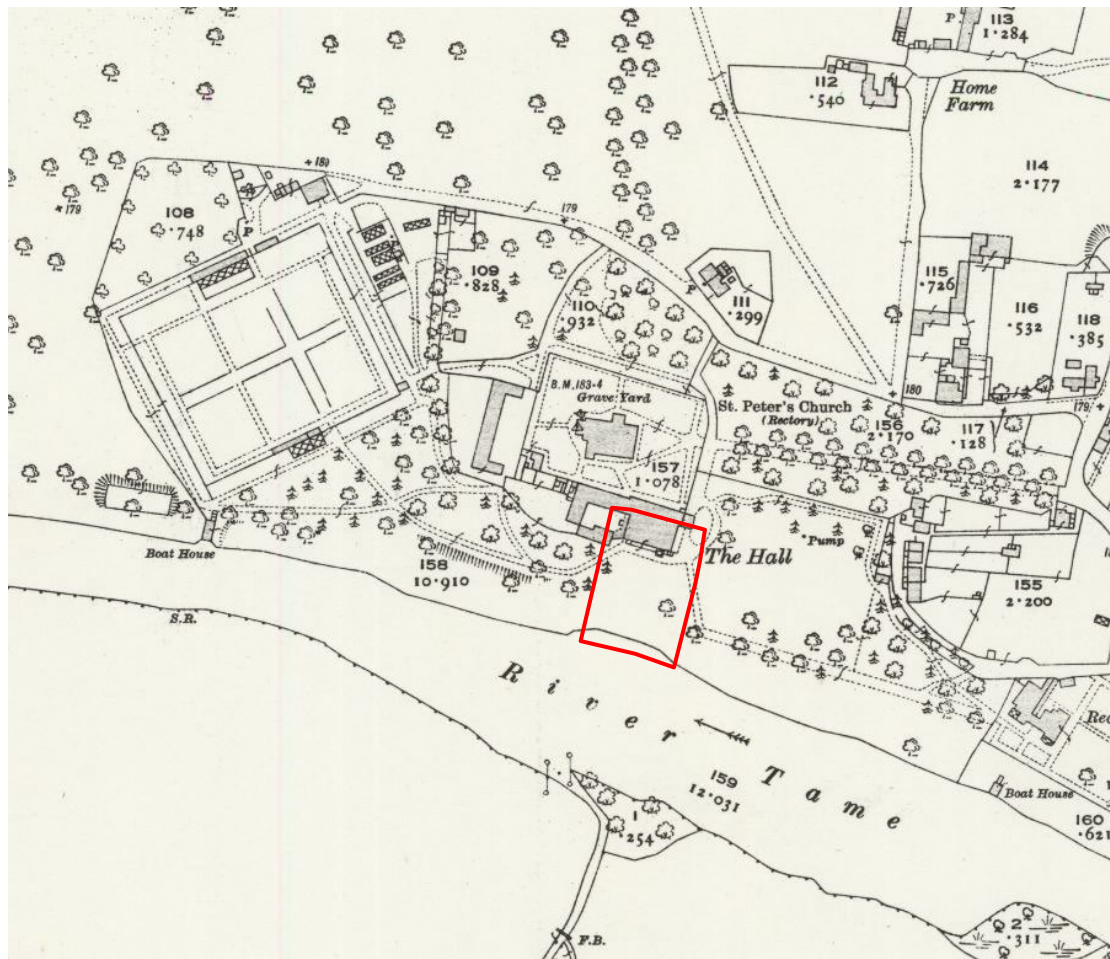
Figure 18: Detail of 1923 edition OS map, sheet Staffs LIII.10, with assessment area highlighted. Scale 25 inch to 1 mile

The 1923 edition of the OS map is also very similar with just a few additions to the gardens (Figure 18).

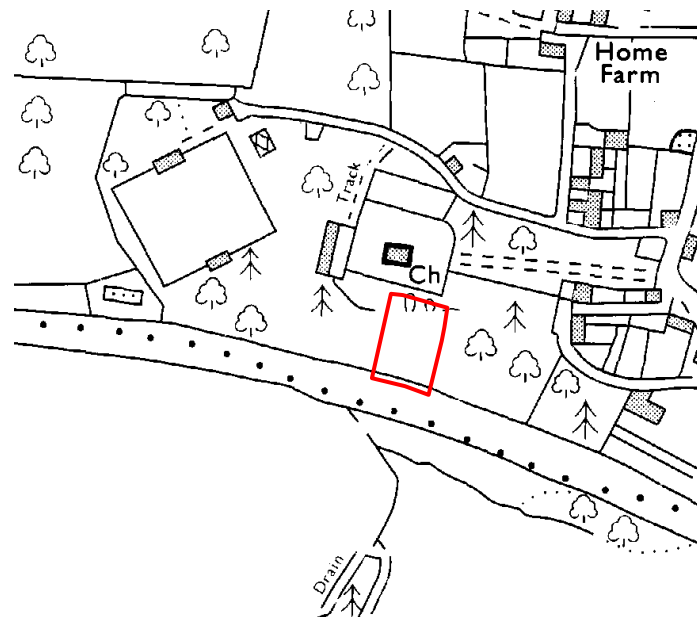
Figure 20: Detail of 1989 edition OS map, sheet SK 11SE, with assessment area highlighted. Scale 1: 10 000

The smaller scale OS map of 1989 also shows an empty plot. However a plaque on Yew House records that it was built in 1983 (Figure 20).

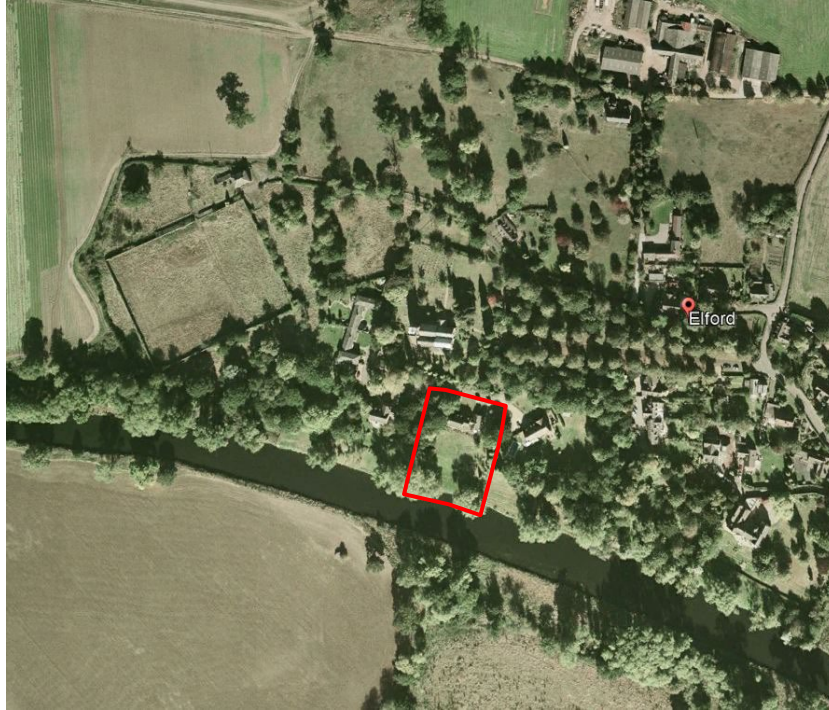
Figure 21: 2003 Google Earth image of current state of the assessment area.
Imagery ©2020 Bluesky, CNES/Airbus Getmapping plc, Infoterra Ltd & Bluesky, Maxar technologies, Map data ©2022

There are several versions of Google Earth images available. Two are shown illustrating the recent changes to the area. The image from 2003 shows the assessment area now occupied by the house and gardens. There are also new properties to the east and west of the site. The walled garden is shown as disused. The heavy tree cover of the area is immediately apparent (Figure 21).

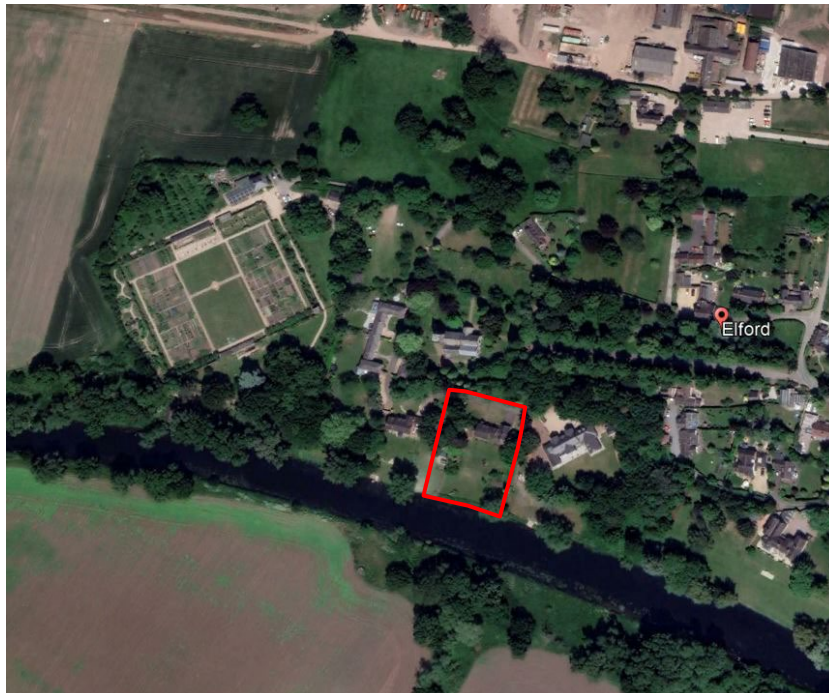
Figure 22: Modern Google Earth image of current state of the assessment area.
Imagery ©2020 Bluesky, CNES/Airbus Getmapping plc, Infoterra Ltd & Bluesky, Maxar technologies, Map data ©2022

The more recent image from 2021 is very similar, although it illustrates the restoration of the walled garden, with its new allotments within (Figure 22).

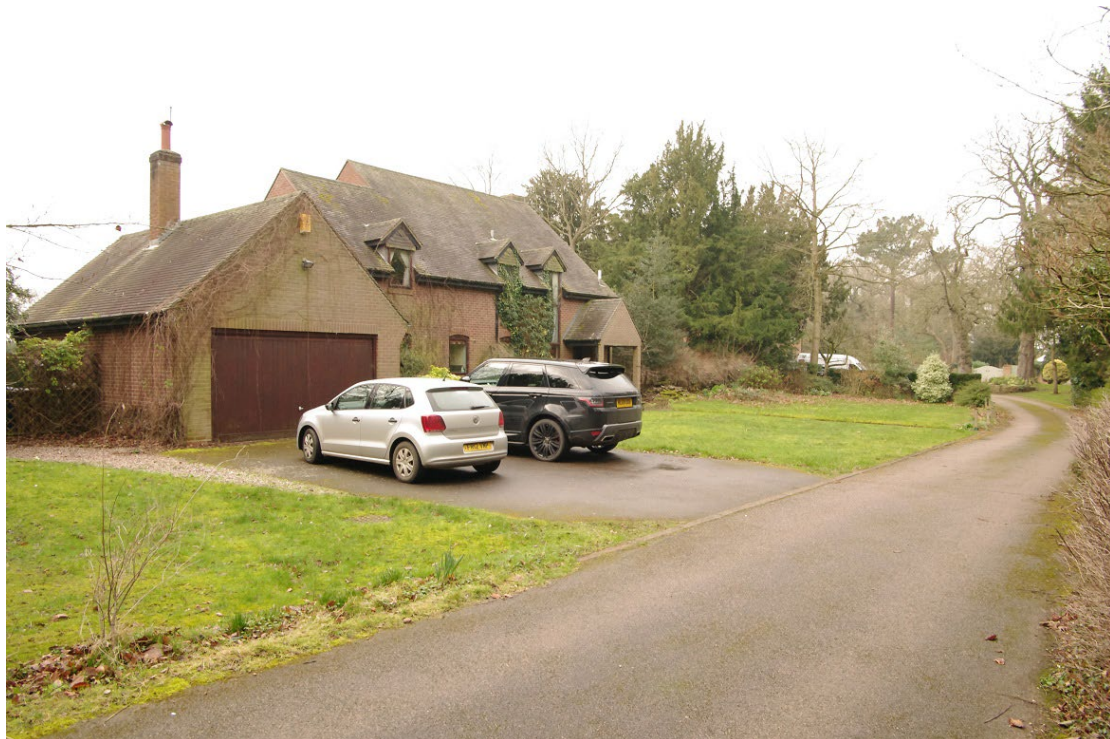
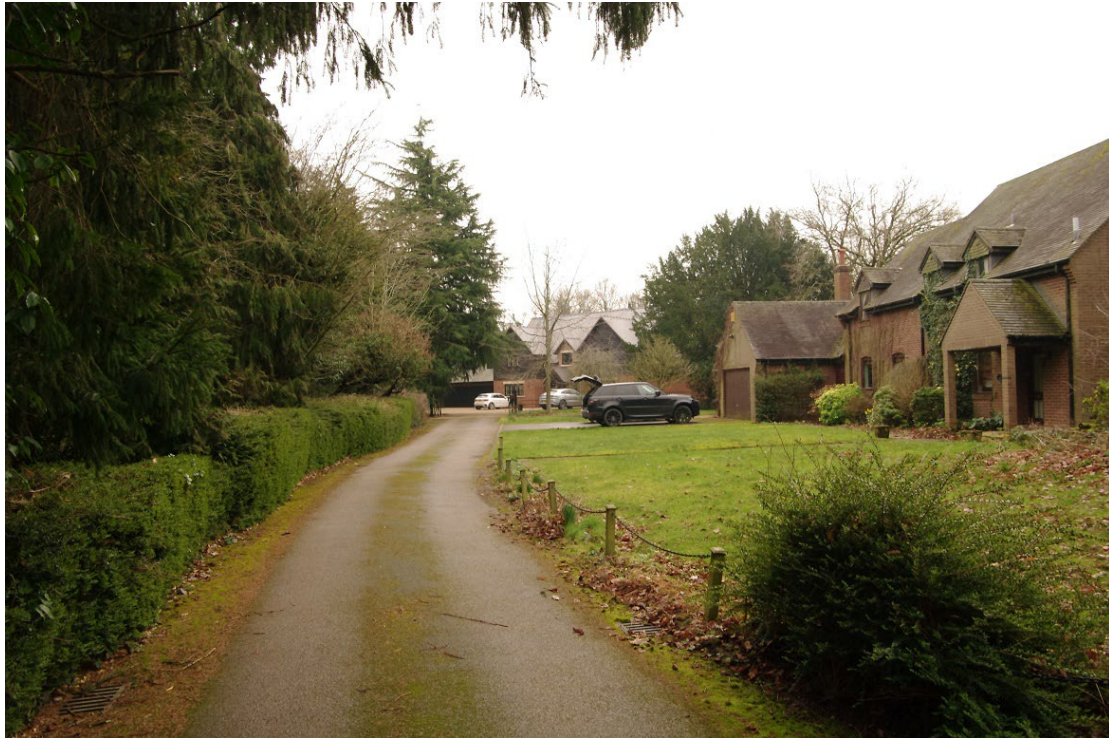
Figure 23: Yew House and Old Hall Drive, looking south-west

The Yew House site consists of a roughly rectangular plot of land located on the south side of Old Hall Drive which leads southwards from Church Road in the north-west. Old Hall Drive is a private and gated road. The driveway leads past the former stable block and continues past three late 20th century houses one of which is Yew House (Figure 23 & Figure 24).

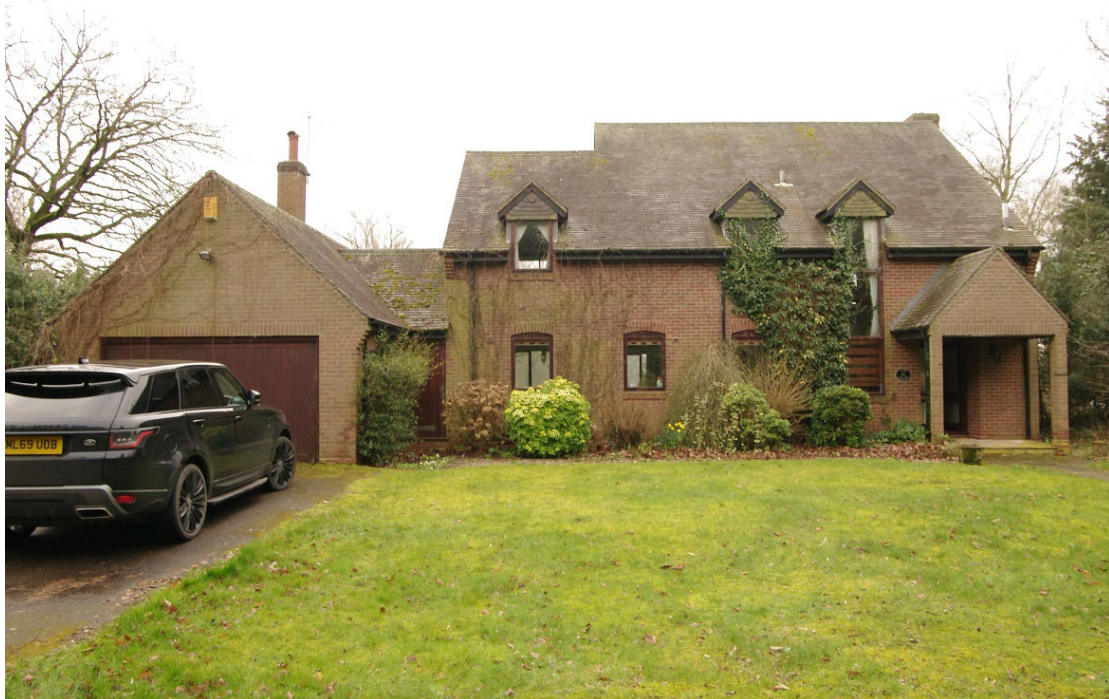
Figure 25: Yew House and front garden, looking south

Yew House is a modern two storey detached house with a garage and was built in 1983 as a dated brick in the pillar next to the front door shows. All three houses on this part of Old Hall Drive were built around the same time. The house is built of brown bricks with wooden window frames. The roof has red-brown ceramic tiles similar in style and colour to a number of other properties to be seen around the village. Overall the house, although well-built and in good repair, is a typical 1980s building with little imagination and does little to improve the locality (Figure 25).

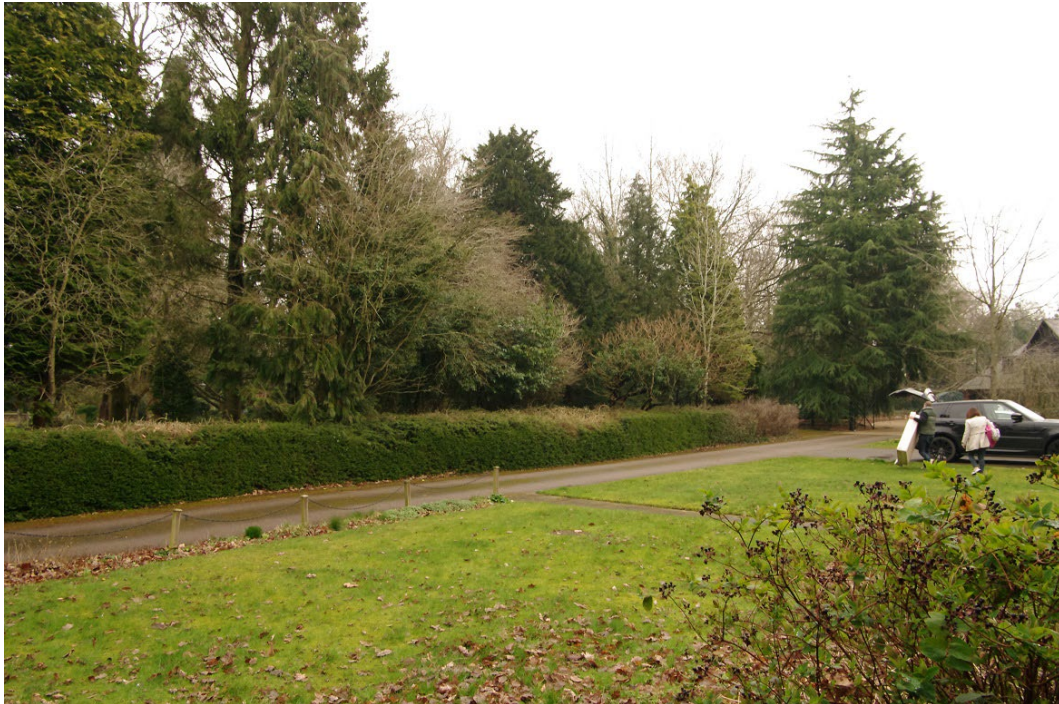
Figure 26: The front garden and Old Hall Drive, looking north-east

The house has a lawn at the front (north) which opens directly onto Old Hall Drive. Neither of the other two adjacent properties have front hedges or fences (Figure 26).

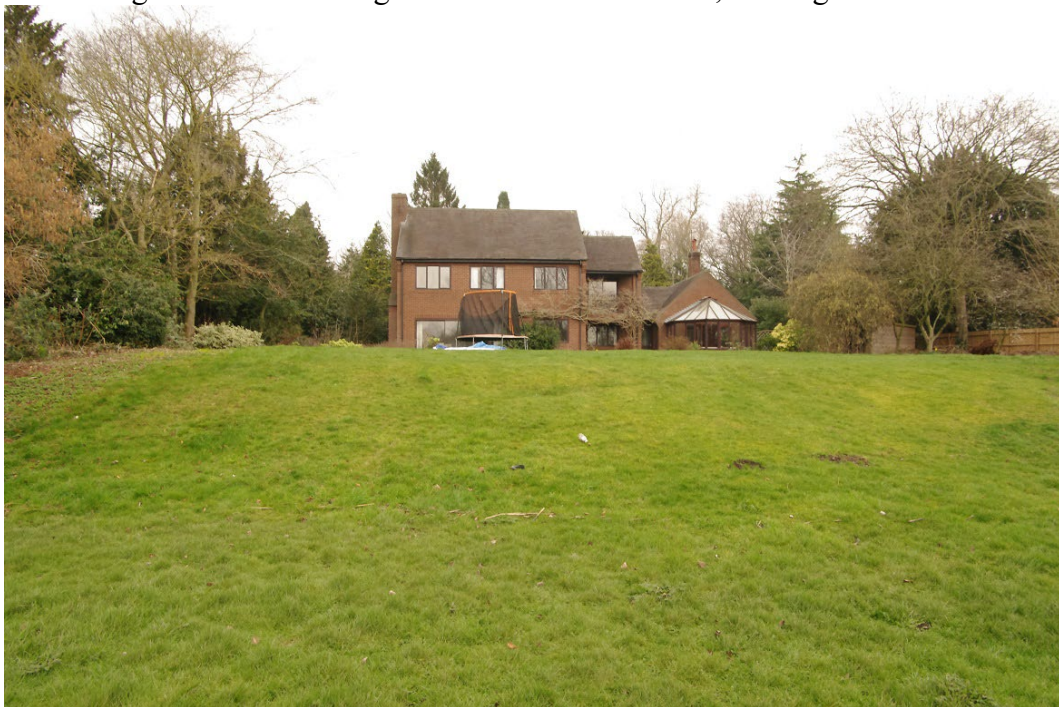
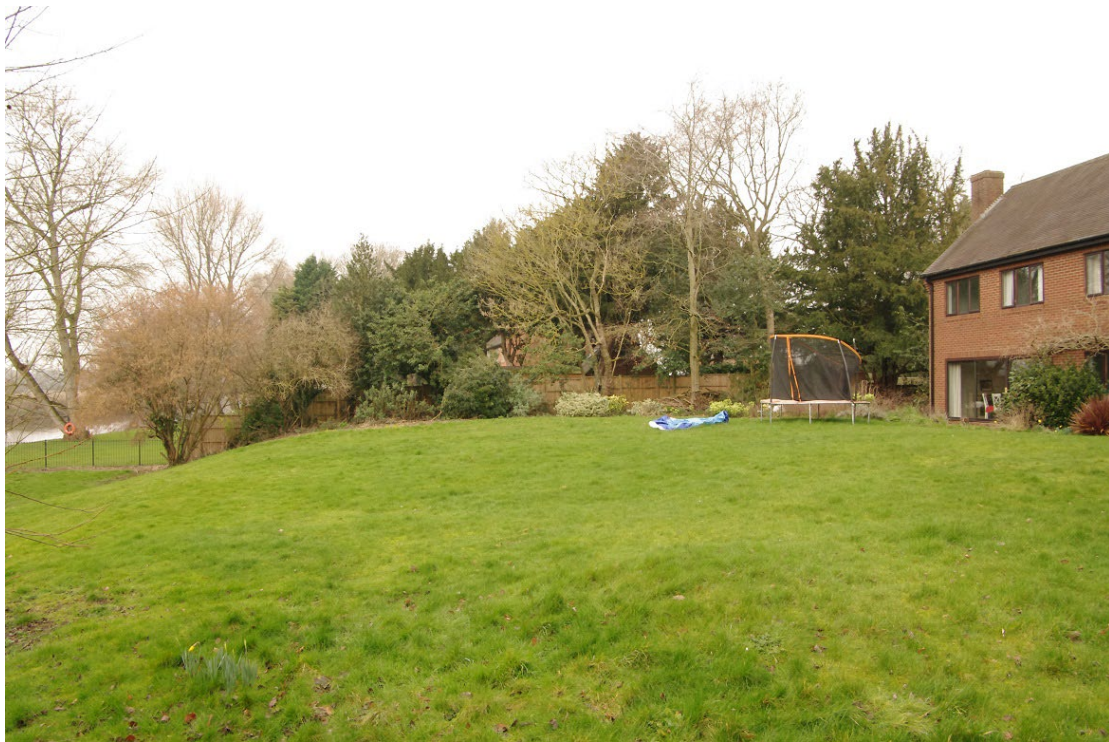
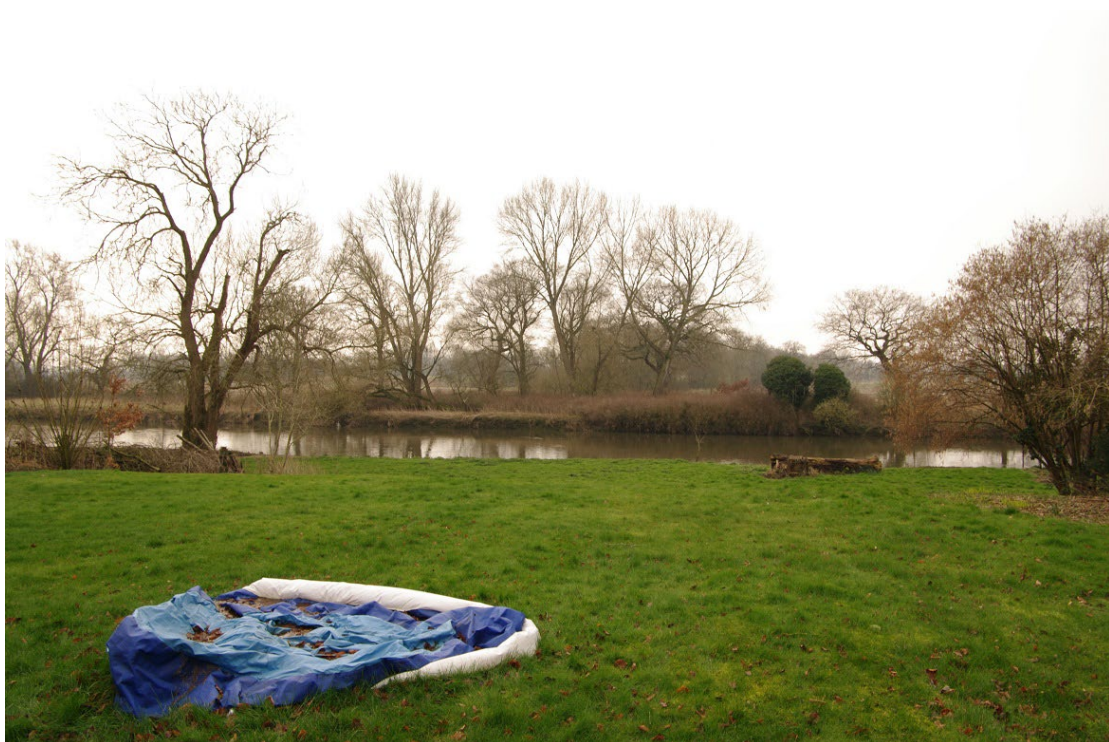
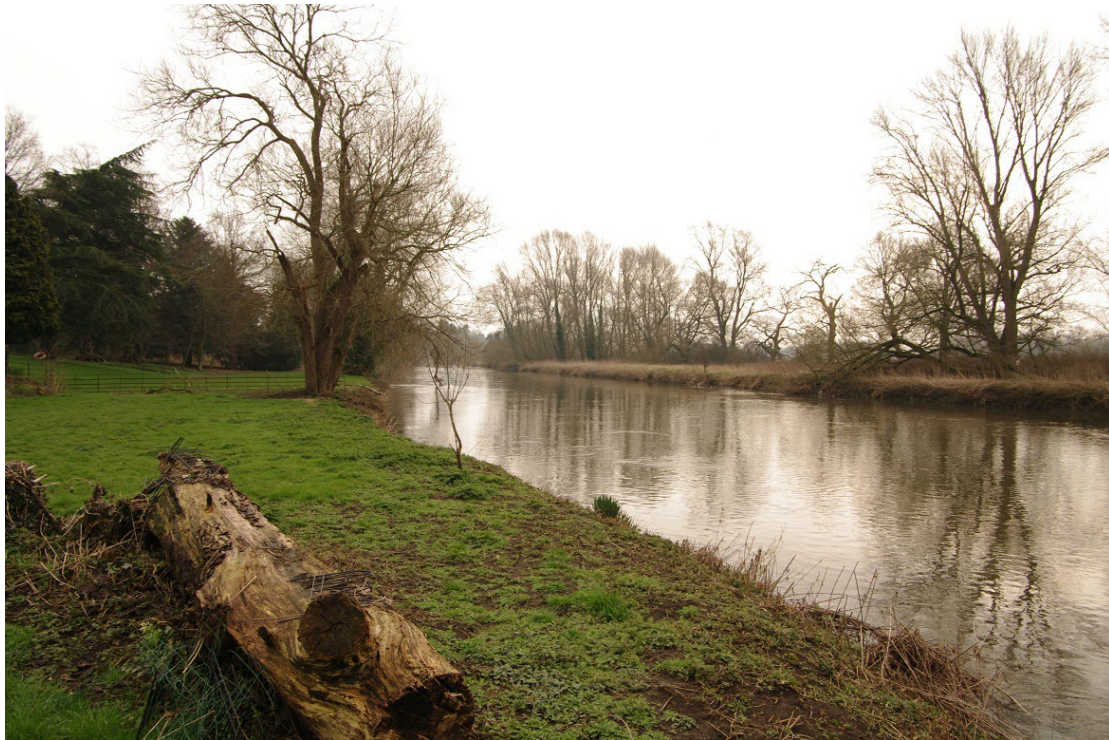
On the south side of the house the garden drops down to the River Tame. The house sits on a terrace which is at a similar level to the driveway and there is a step down of just over 1.5m down to a lower terrace next to the river. Trees and shrubs form the east and west boundaries to the adjacent properties (Figures 27-30).

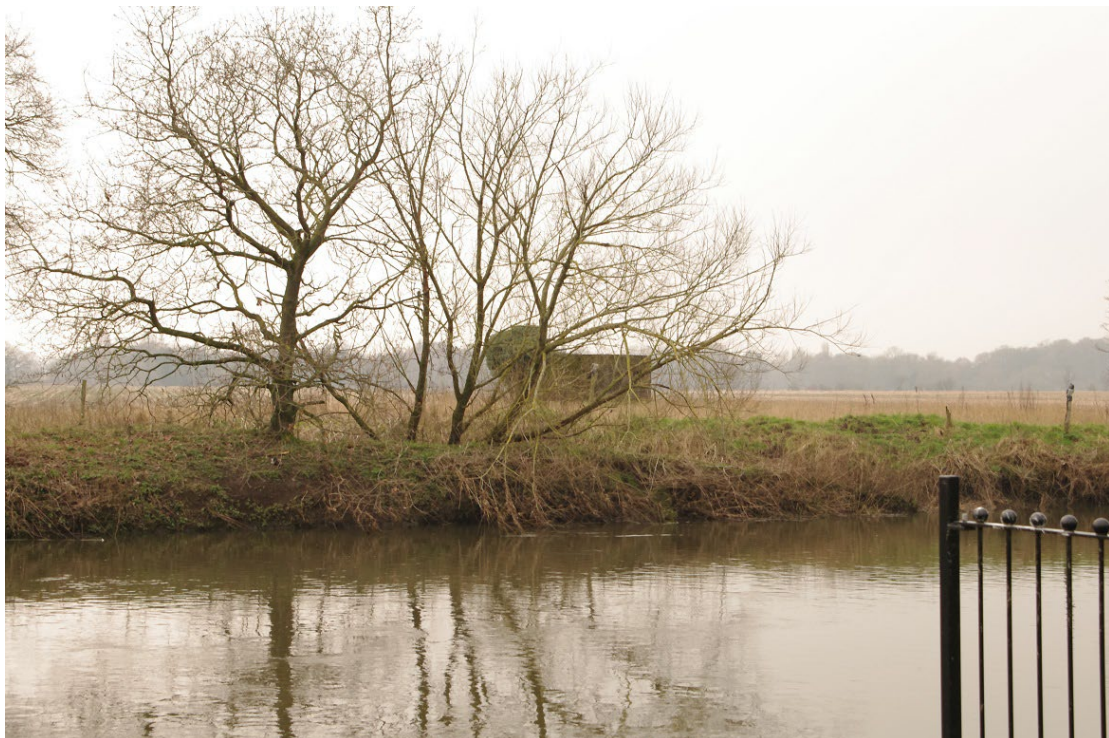
Figure 31: The WWII pillbox on the south bank, looking south

Across the river the ground is fairly level and appears to form a large flood plain. Trees can be seen forming hedge lines and also around former gravel workings. There is also a small WWII pillbox on the opposite bank (Figure 31).

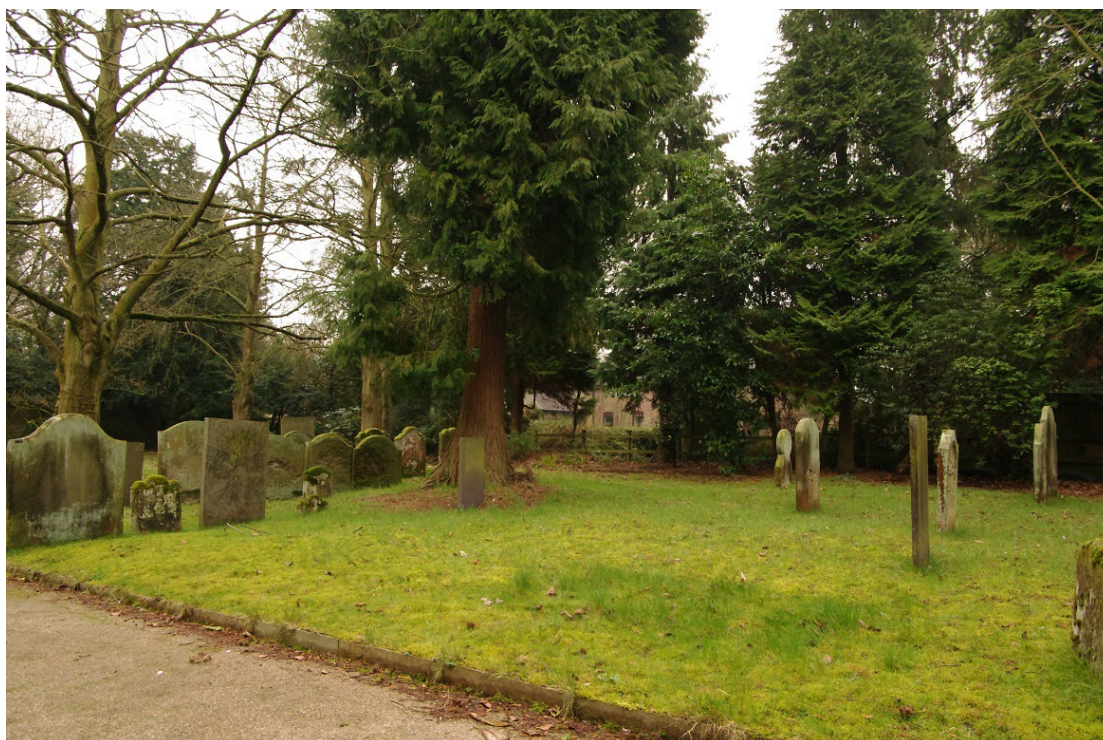
Figure 34: Yew House glimpsed from the churchyard, looking south-east

The 1980s house to the east of Yew House has recently been refurbished (pers. comm. the owners) and has had new external treatments and extensions. Part of this building has been timber-clad. This house faces towards the north-west towards St. Peter's Church. The house to the west of Yew House, also of the same period, is built using pale red bricks. Tall mature trees form the boundary between the churchyard to the north making the church building all but invisible from Yew House or indeed from any of the other houses here (Figure 32 & Figure 33). Gaps in the hedge and between the trees give very limited views of Yew House from within the churchyard (Figure 34). The churchyard is more open to the north and faces across open fields.

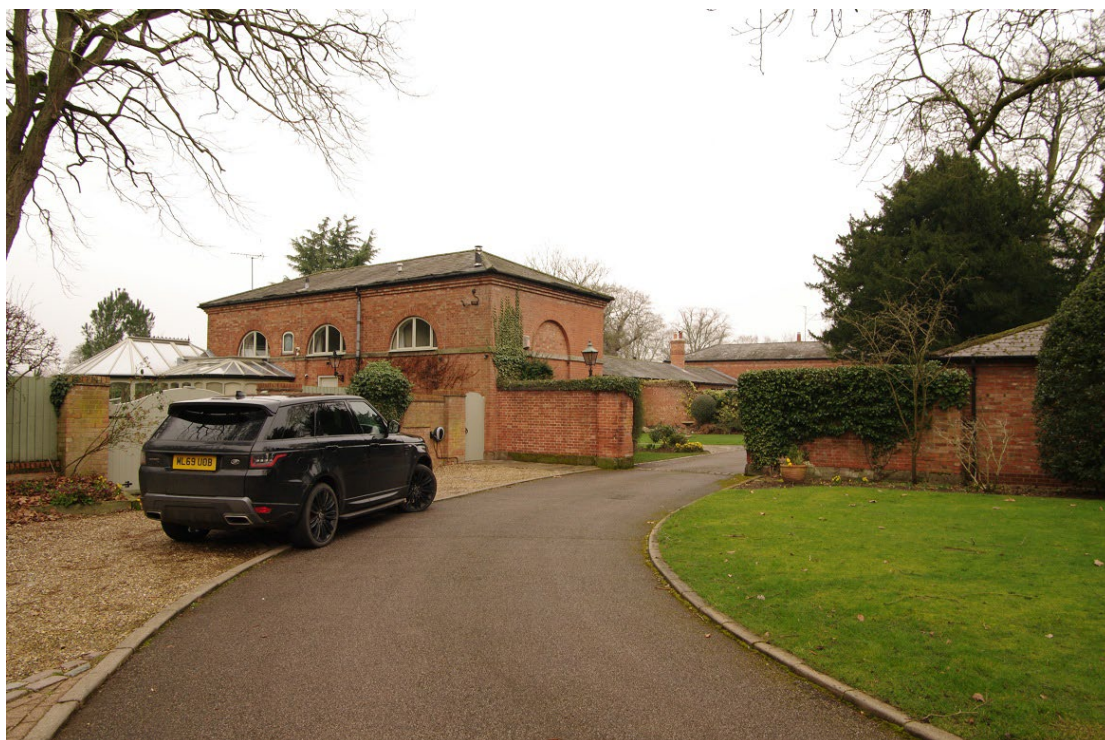
Figure 35: The coach house from the south, looking north up Old Hall Drive

On the western side of Old Hall Drive are the former stable buildings which have been converted into a domestic dwelling (Figure 35). It is possible to see the roof and end of the southern wing of the stables from the northern edge of the Yew House site. None of the stable windows have a view of Yew House. Old Hall Drive passes to the east of the stables and heads northwards to join Church Road.

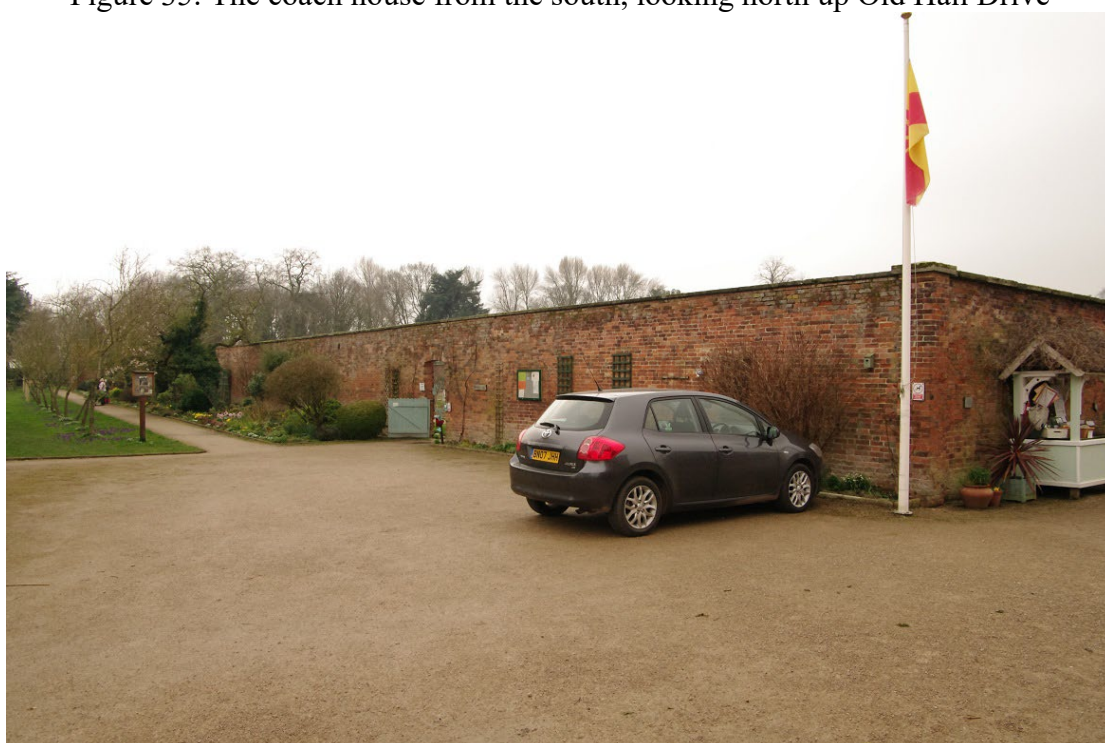
Figure 36: The walled garden from the north, looking south

To the west of the stables is the former walled garden belonging to the hall (Figure 36). This is now a large community garden with an active volunteer membership. Part of the area within the walls is used for allotments. The walled garden cannot be seen from Yew House nor can the house be seen from the garden.

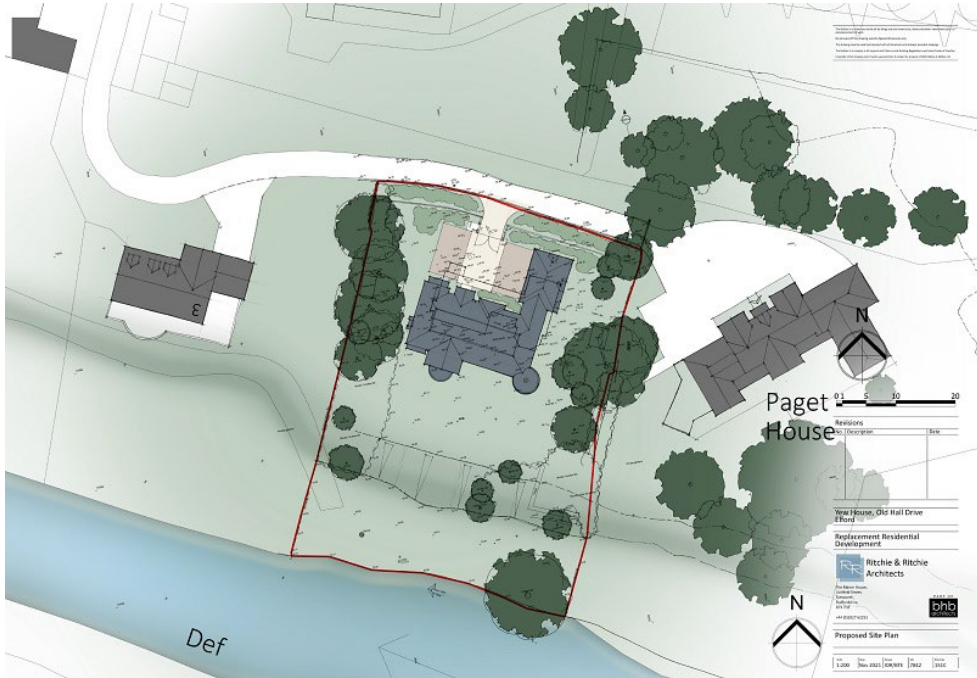
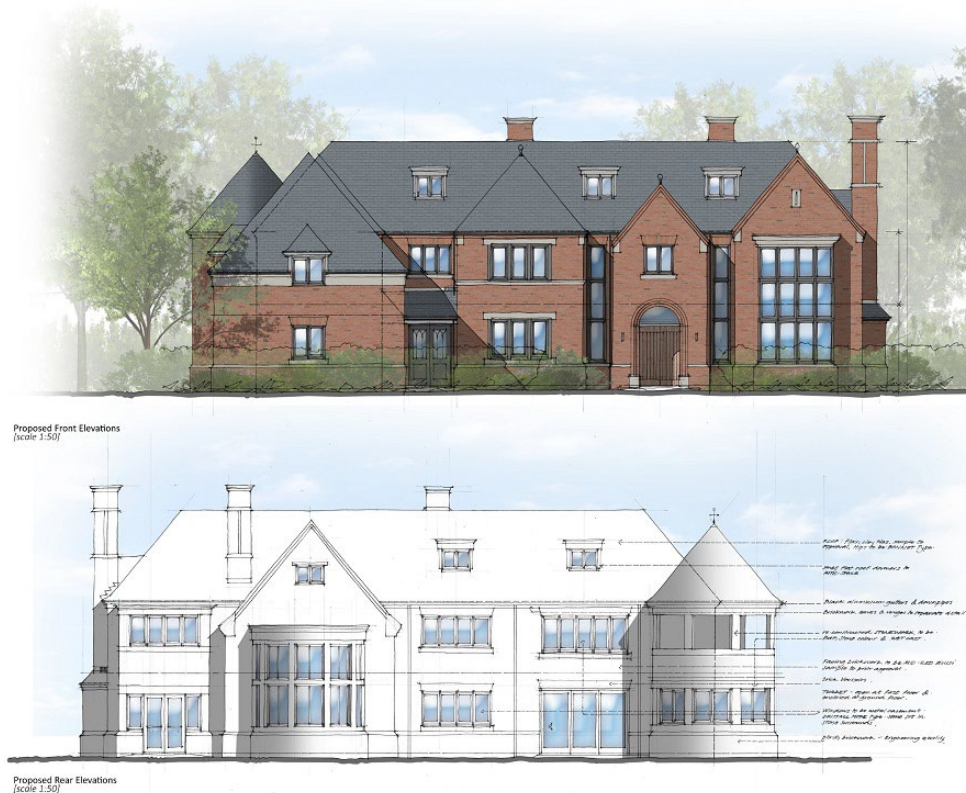
Figure 37: Plan of proposed development. Provided by client

The new proposal is for a new large detached dwelling covering the footprint of the old existing house, which will be demolished. There will also be an extended attached garage and new drive leading from the road (Figure 37 & Figure 38).

The foundation trenches for any new dwellings are likely to be at least 1m deep and will therefore have a detrimental effect on any underlying archaeological remains that might be present on the site. Trenches for new services and landscaping can also have a negative effect on buried archaeological remains.

The development proposal is for the existing dwelling to be replaced by a larger detached dwelling, broadly within the same footprint, although slightly larger.
