Arboricultural Implications Assessment and Method Statement for

Land to the north of 'The Hollies', Hill Street, Calmore

Report Ref: **211369 - AIA 2**

Report Date: **14 June 2022**

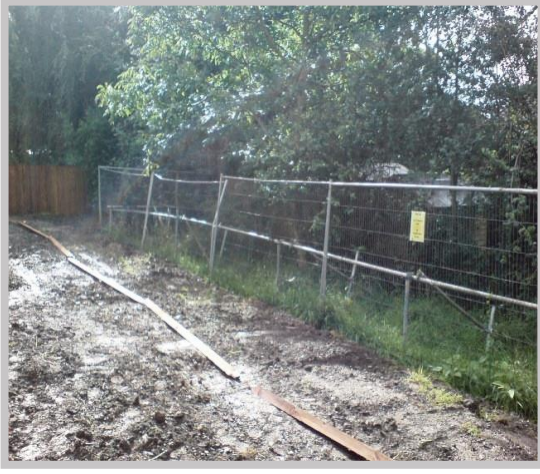
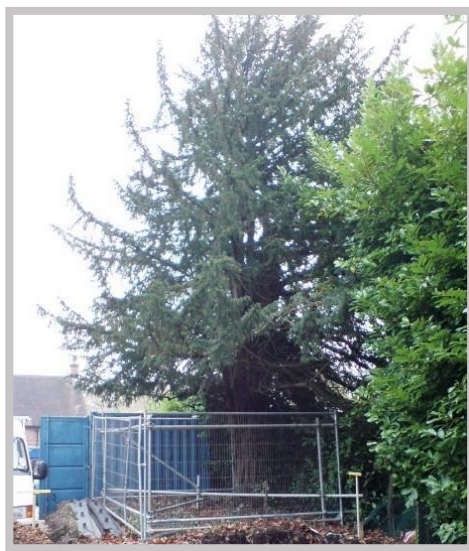
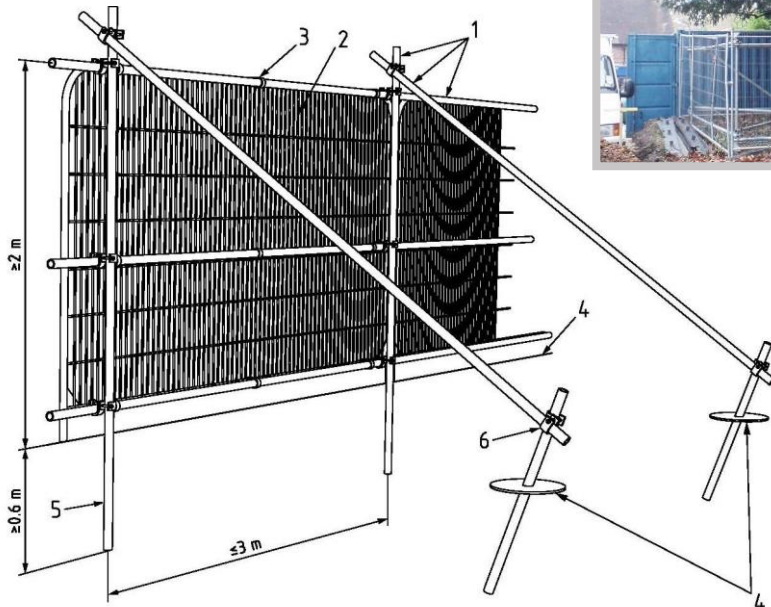
Ref: Tree Protection Barriers (Type 1)	Drawing No. TPB1
Scale: N/A

- 1 Standard scaffold poles
- 2 Heavy gauge 2 m tall galvanized tube and welded mesh infill panels
- 3 Panels secured to uprights and cross-members with wire ties
- 4 Ground level
- 5 Uprights driven into the ground until secure (minimum depth 0.6 m)
- 6 Standard scaffold clamps

The default specification should consist of a vertical and horizontal scaffold framework, well braced to resist impacts. The vertical tubes should be spaced at a maximum interval of 3 m and driven securely into the ground. Onto this framework, welded mesh panels should be securely fixed.

5.1.2 **Protective barriers:** The approximate location of the barriers is illustrated on the plan in Appendix 1 and information on barrier design based on BS 5837:2012 guidance is included in Appendix 3. The protective barriers will be erected before any materials or machinery are brought onto the site, and before any clearance or construction activities occur. With the exception of the barrier positions around trees/groups T6, T20 and G22 (see below), once the protective barriers have been positioned, these will stay in situ for the duration of the construction, unless previously agreed with the arboricultural consultant or council's tree officer. There will be no access into the protected areas and the storage of excavated debris and building materials will be prohibited, unless authorised by the arboricultural consultant, after discussion with the council's tree officer. No fires or fuel storage will be allowed within (or near to) protected areas under any circumstances.

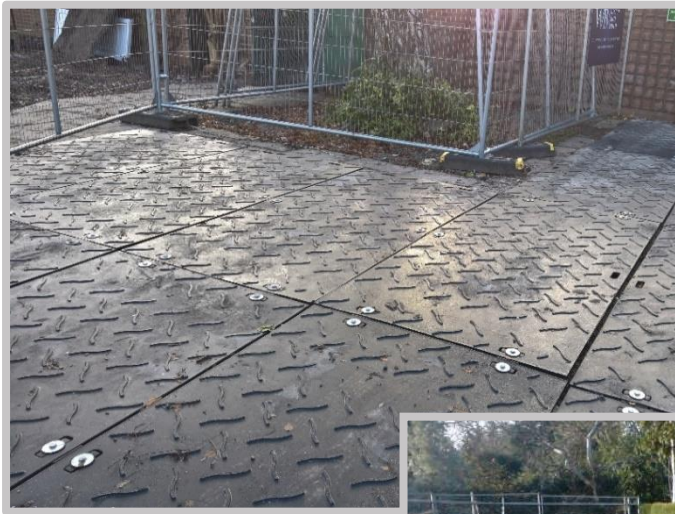
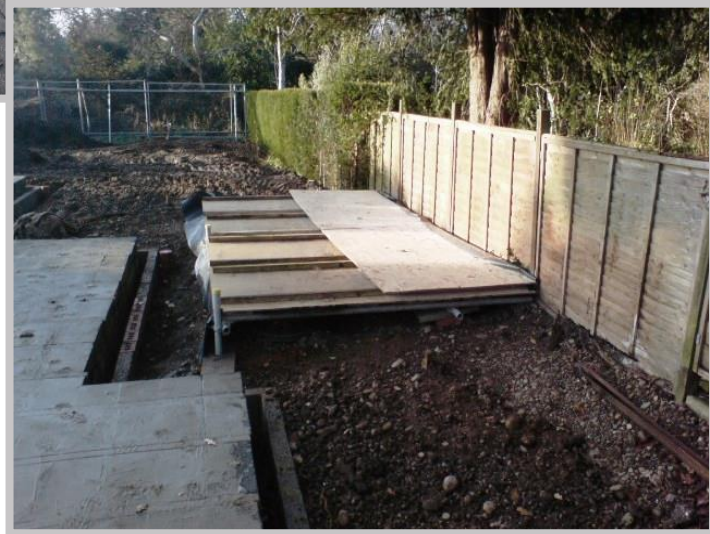
Ref: Ground Protection	Drawing No. GP1
Scale: N/A

New temporary ground protection should be capable of supporting any traffic entering or using the site without being distorted or causing compaction of underlying soil.

a) for pedestrian movements only, a single thickness of scaffold boards placed either on top of a driven scaffold frame, so as to form a suspended walkway, or on top of a compression-resistant layer (e.g. 100 mm depth of woodchip), laid onto a geotextile membrane;

b) for pedestrian-operated plant up to a gross weight of 2 t, proprietary, inter-linked ground protection boards, placed on top of a compression-resistant layer (e.g. 150 mm depth of woodchip), laid onto a geotextile membrane;

c) for wheeled or tracked construction traffic exceeding 2 t gross weight, an alternative system (e.g. proprietary systems or pre-cast reinforced concrete slabs) to an engineering specification designed in conjunction with arboricultural advice, to accommodate the likely loading to which it will be subjected.

-
- 5.1.4 **Ground protection measures:** Where the positioning of tree protection barriers is not feasible due to the need for construction access, then ground protection measures will be needed to safeguard RPAs. The position of ground protection is shown on the plan included in Appendix 1, with guidance for ground protection design included in Appendix 4 and an helpful installation video for proprietary ground protection is available to view at <https://www.youtube.com/watch?v=QiaRgNUackY>. The ground protection will also be installed before any materials or machinery are brought onto the site and prior to any clearance or construction activities occurring. Again, once the ground protection has been positioned, it will stay in situ for the duration of the construction phase, unless previously agreed with the project arboricultural consultant or council's tree officer.
