ECOLOGICAL IMPACT ASSESSMENT
and Bat Activity Survey

6 Appletree Meadow,
Presteigne,
Powys

A Report for
Mr & Mrs Vaughan

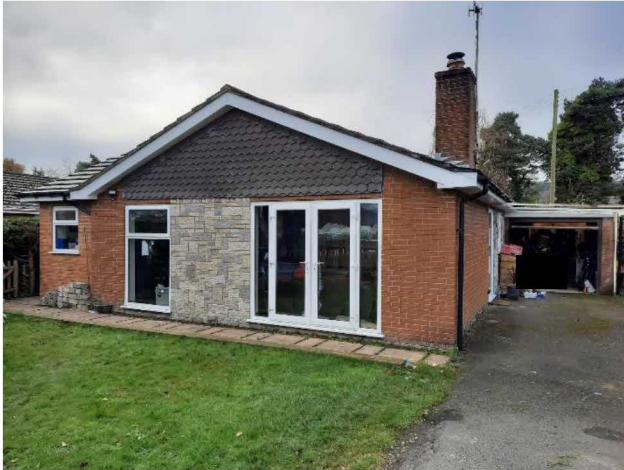
Plate 1: Northeast gable, patio and lawn.

The Site is a detached bungalow in an estate of similar dwellings. The Site is set within a managed garden with lawn off the northeast and southwest elevation (Plate 1 and 2). There is patio slab running around the building with a tarmac driveway off the northwest elevation.

The patio slab has grasses growing in crevices, the ground is compact.

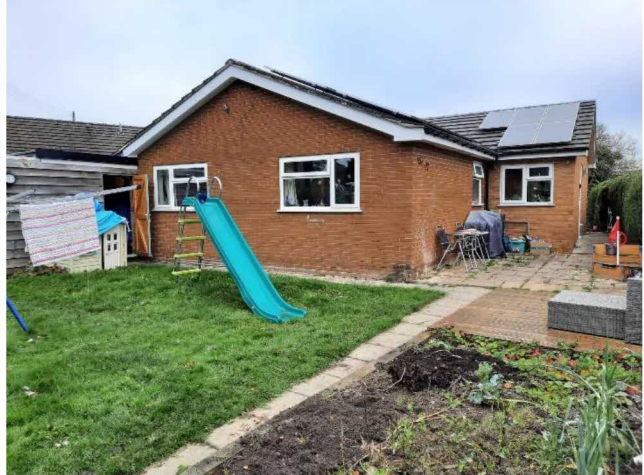
Plate 2: Southwest gable looking across the garden.

The remains of a single house martin nest was recorded on the southwest gable.

There is a collapsed house martin nest at the southwest gable.

The proposed works will result in short-term loss of the location previously used by house martin. The proposed southwest gable will be rendered as existing which has potential for use as a house martin nest location post construction.

Avoidance measures may be required prior to the start of works to prevent use of the southwest gable by house martin.

Avoidance: Monitor use of the southwest gable as a house martin nest site. Avoid works during the bird nesting season (April-September) to prevent disturbance or damage of an active nest, if the site is in use.

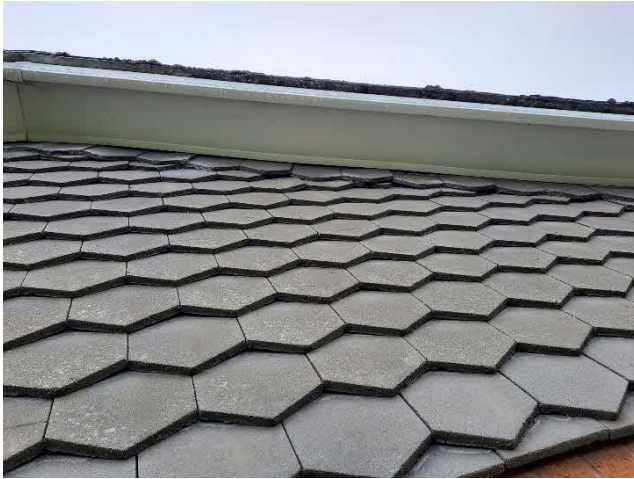
Plate 3: Hanging tiles on northeast gable.

At the northeast elevation there are gaps between the soffit boarding and hanging tiles. The gaps lead up under the soffit/fascia boards.

The northeast gable has hanging tiles over the upper section. The hanging tiles are in place. However, the tiles against the soffit boards have lifted edges and gaps leading under the tiles to larger cavities behind (Plate 3).

There are gaps leading under the hanging tiles of the northeast gable, most gaps are covered in spider webs and there is evidence of spider activity within the crevices. No other features offering bat roost suitability were identified.

The building inspection identified the presence of crevices created by the hanging tiles fitted to the northeast gable. Due to the rural setting with high value habitat, orientation, size and depth, the crevices are considered to provide 'Low' suitability as a bat roost. No evidence of bat use was found by inspection of these features, including by endoscope.

The dusk bat activity survey identified the likely absence of a roost within the hanging tiles.

The building inspection and additional survey effort has identified likely absence of a bat roost within the hanging tiles. The proposed removal of the hanging tiles is assessed as having a negligible impact on bats. Due to the likely absence of a bat roost, no avoidance work methods or timing of works are recommended.

The building inspection and bat activity survey have found the likely absence of a bat roost within the hanging tiles of the Site. No further surveys are recommended. No avoidance measures are considered necessary for the proposed works. A Natural Resources Wales development licence is not recommended for these works.

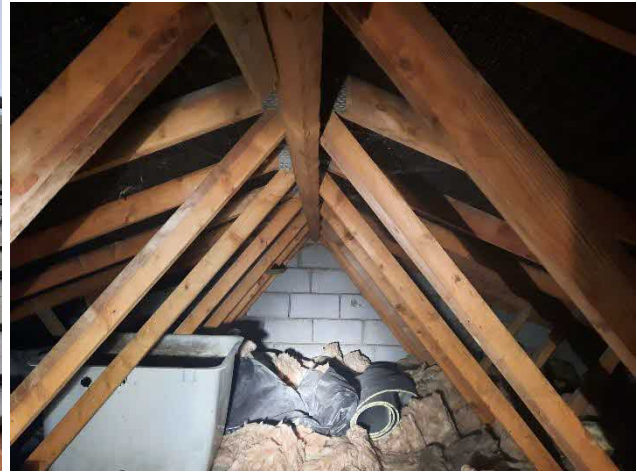
Plate 4: Loft space, looking to northeast gable.

The Site has a single loft space over the main house and extension. The roof is supported by a 'W' truss frame.

The loft is insulated throughout and boarded over some sections for use as storage. The loft is clad with bitumen felt which is intact throughout.

No bat droppings or field signs of bat use were found internally or externally by the building inspection. The second external inspection of the northeast gable found no evidence of bat use.
