JPC Environmental Services (A Division of JP Chick & Partners Ltd)

Red House Farm, Otley Road, Framsden, IP14 6HU

STAGE I – Contaminated Land Assessment

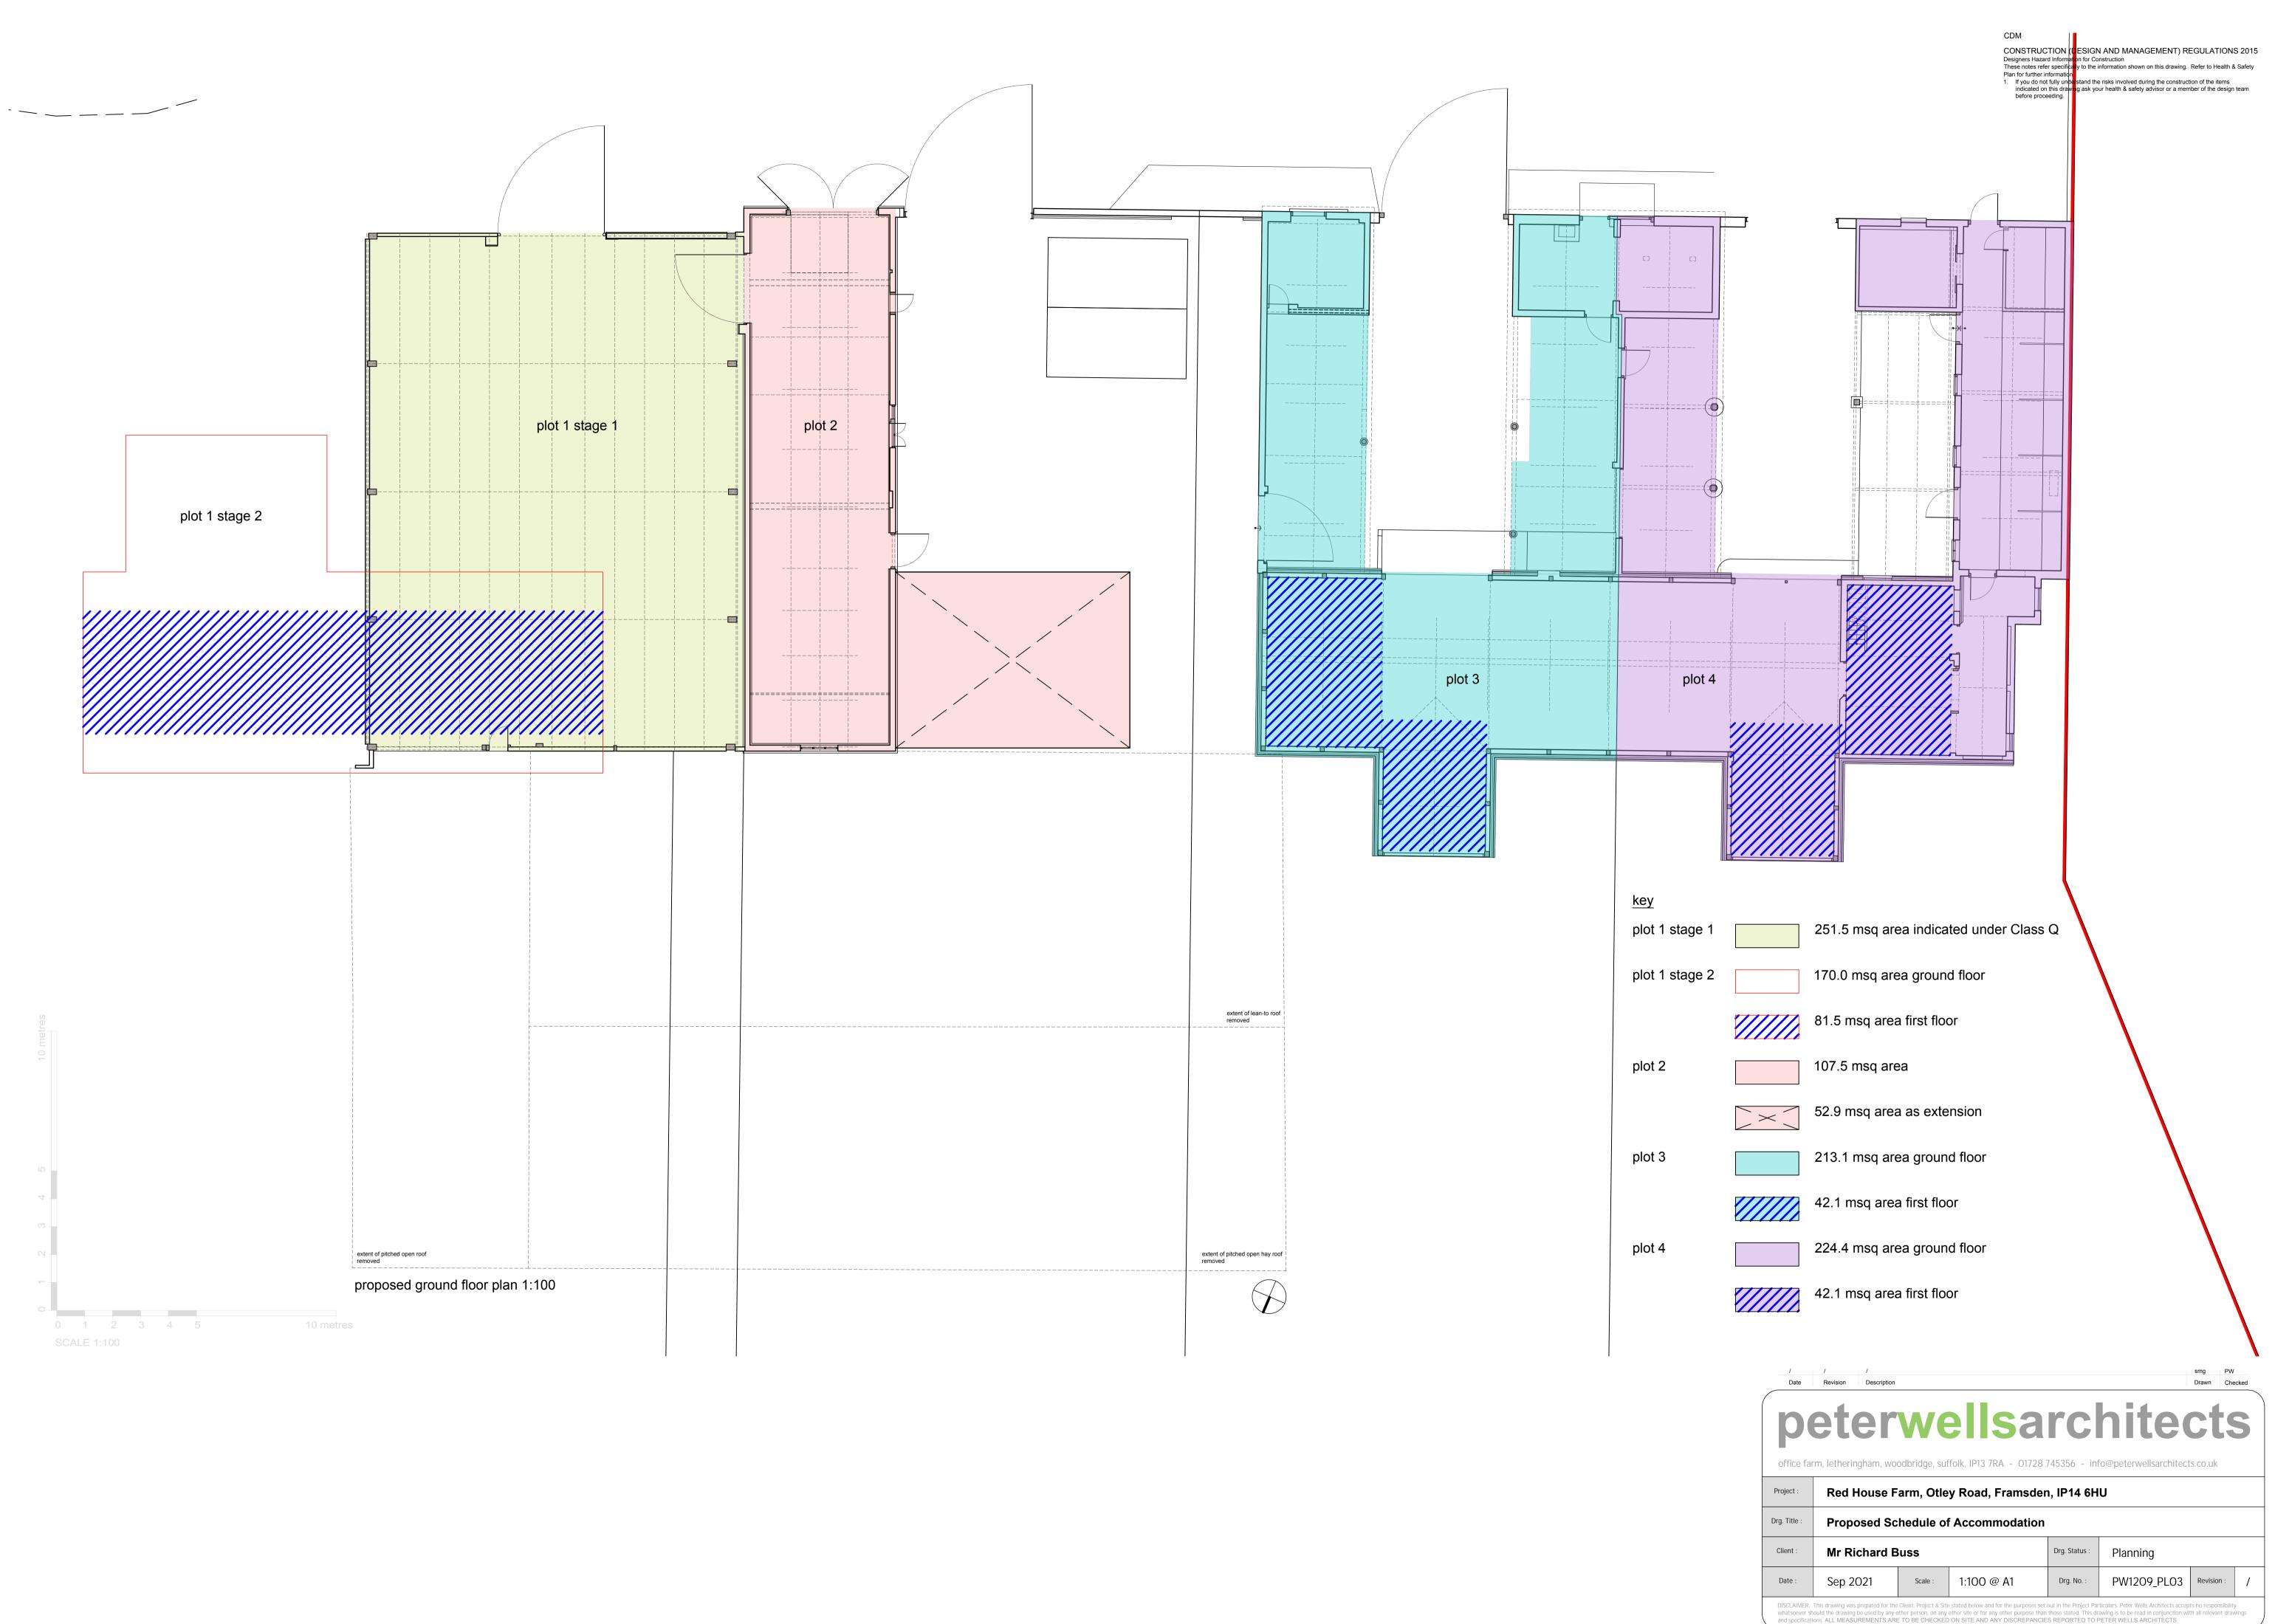
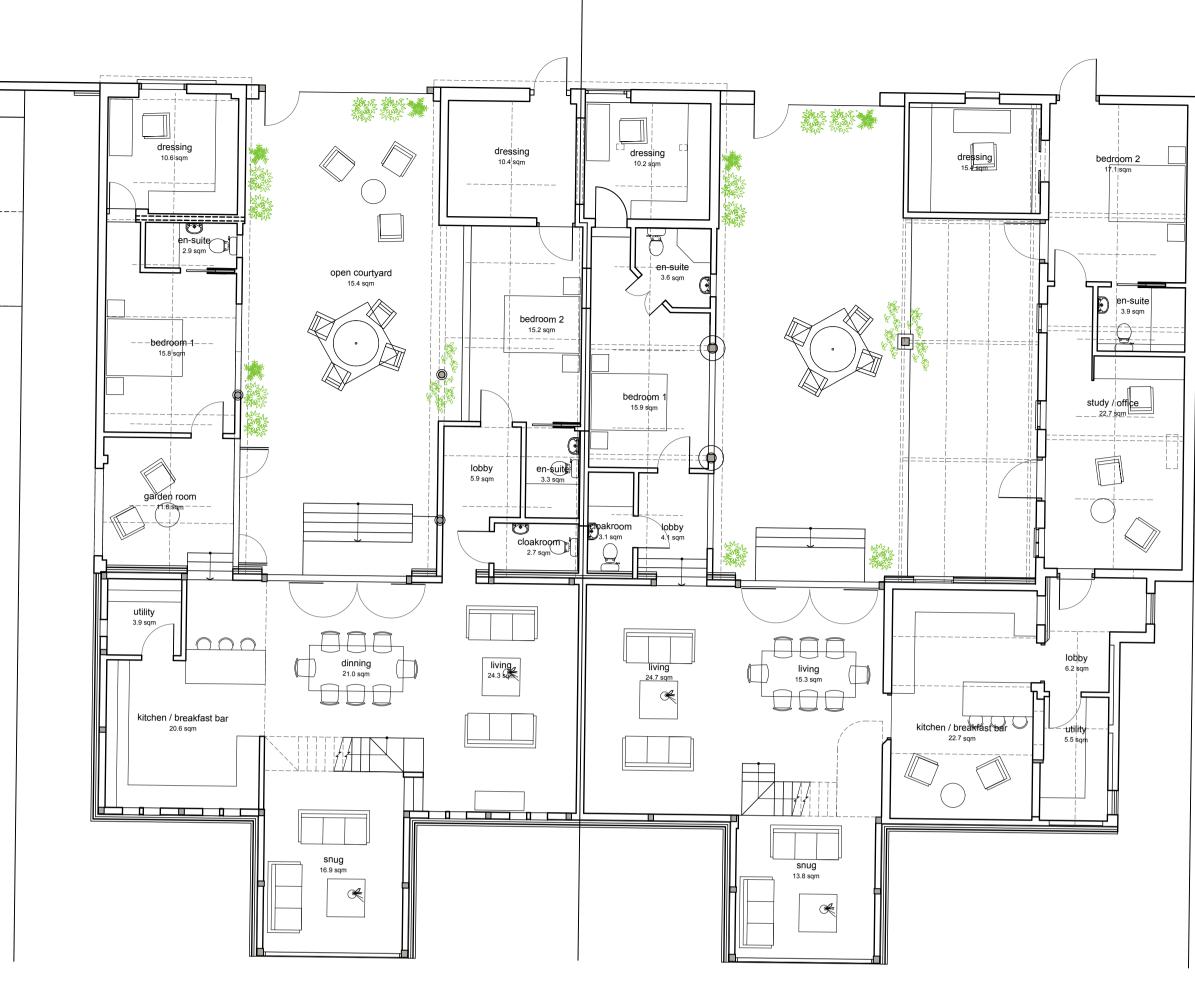
Appendix B – Architect's Plans

plot 1 proposed ground floor plan 1:100 Total Ground Floor Gross Internal Area = 244.6 m² [2632 sqft] plot 2 proposed ground floor plan 1:100 Total Ground Floor Gross Internal Area = 140.2 m² [1509 sqft]

plot 3 proposed ground floor plan 1:100 Total Ground Floor Gross Internal Area = 170.5 m² [1835 sqft] Total Gross Internal Area = 213.1 m² [2293 sqft]

plot 4 proposed ground floor plan 1:100 Total Ground Floor Gross Internal Area = 196.8 m² [2118 sqft] Total Gross Internal Area = 239.0 m² [2572 sqft]

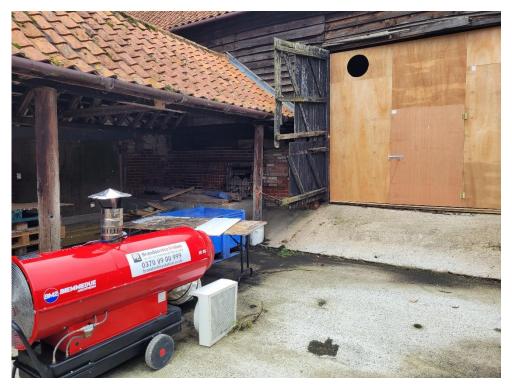
Building 7 – Is a concrete block-built barn with asbestos sheet roofing.

Photograph 3 – Asbestos seen on the front of barn 7.

- A Stage I/ Tier II ground investigation and risk assessment should be undertaken to quantify or dismiss the potential for ground contamination and to refine the human and environmental risk assessment.
- Based on the information obtained to date we would recommend that samples of on-site soils are tested for a routine suite of organic and inorganic contaminants, together with an asbestos screen.
- Although not related to the condition of the on-site soils, we would recommend undertaking a HSG264 Pre-demolition/major refurbishment asbestos survey on the existing buildings. All asbestos containing material (ACMs) should then be removed, by a suitably experienced contractor, prior to the conversion/ of the buildings.
