Location:  
**Howick Hall,  
Northumberland**

Report Type:  
**Arboricultural Method Statement  
inc. Impact Assessment**

Ref:  
**ARB/CP/2642**

Date:  
**June 2022**

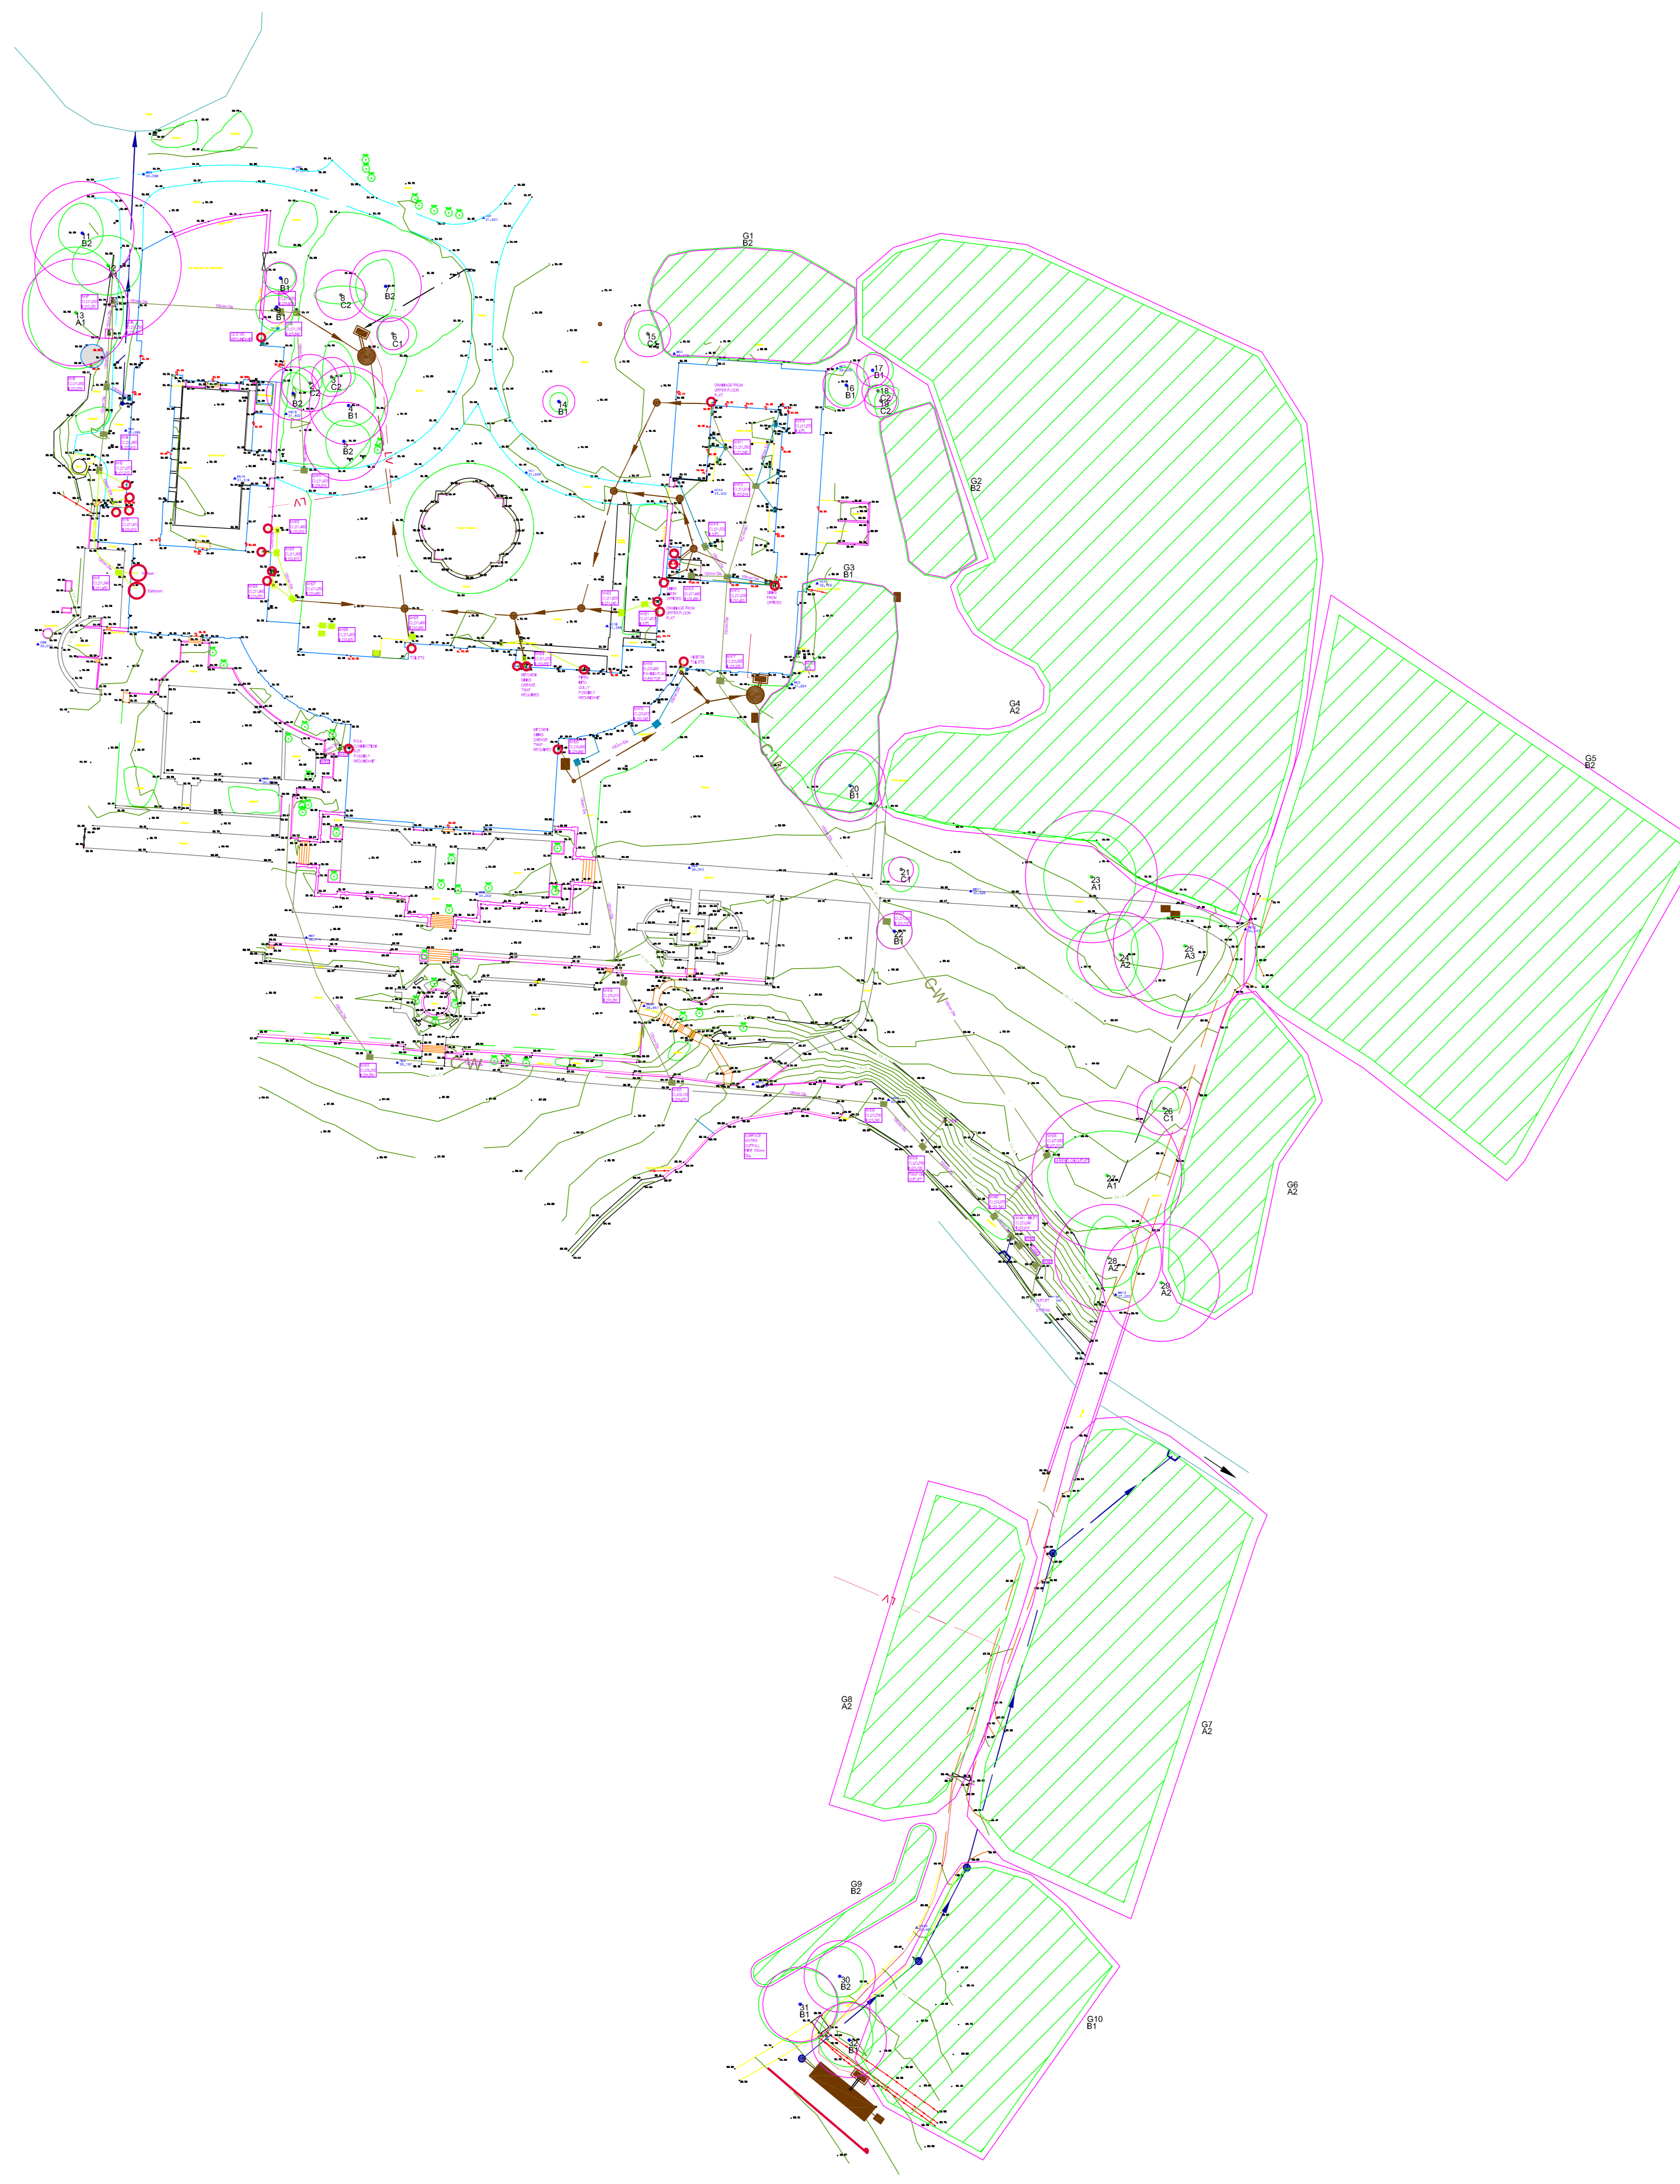
Drawing Title: Tree Constraints Plan  
 Project: Howick Hall, Northumberland  
 Drawing Number: ARB/CP/2642/TCP  
 Date: July 2021  
 Scale: 1:500 @ A0

Tree Position Showing Crown Extents and BS5837 Category A
-

Tree Position Showing Crown Extents and BS5837 Category B
-

Tree Position Showing Crown Extents and BS5837 Category C
-

Root Protection Area - to remain free from disturbance
-

- 3.2.1 **Category A** (coloured green) trees are those of high quality and value, and of a condition whereby they could make a substantial contribution to the site. The retention of Category A trees should be considered during the design phase and afforded adequate physical protection during the construction phase in accordance with BS 5837:2012 where retained. This means keeping proposed features and alterations to ground levels outside of root protection areas and crown spreads so as to ensure that the tree remains in an adequate condition post-development. Root protection areas and crown spreads are displayed upon the Tree Constraints Plan, Appendix 3. eight individual trees and five groups of trees were classified as Category A.

- 3.2.2 **Category B** (coloured blue) trees are those of moderate quality and value, and of a condition that they make a substantial contribution to the site. The retention of Category B trees should be considered during the design phase and afforded adequate physical protection during the construction phase in accordance with BS 5837:2012 where retained. fourteen individual trees and five groups of trees were classified as Category B.

- 3.2.3 **Category C** (coloured grey) trees are considered to be of low quality and value, but of an adequate condition to remain in the short-term. Trees with a stem diameter of less than 150mm (measured at 1.5m above ground level) are classified as Category C; these trees should also be retained where possible but where they form a significant constraint to development their removal should be permitted. Where they are to be retained they should be afforded adequate consideration during the design phase and physical protection during the construction phase in accordance with BS 5837:2012. Nine trees were classified as Category C.

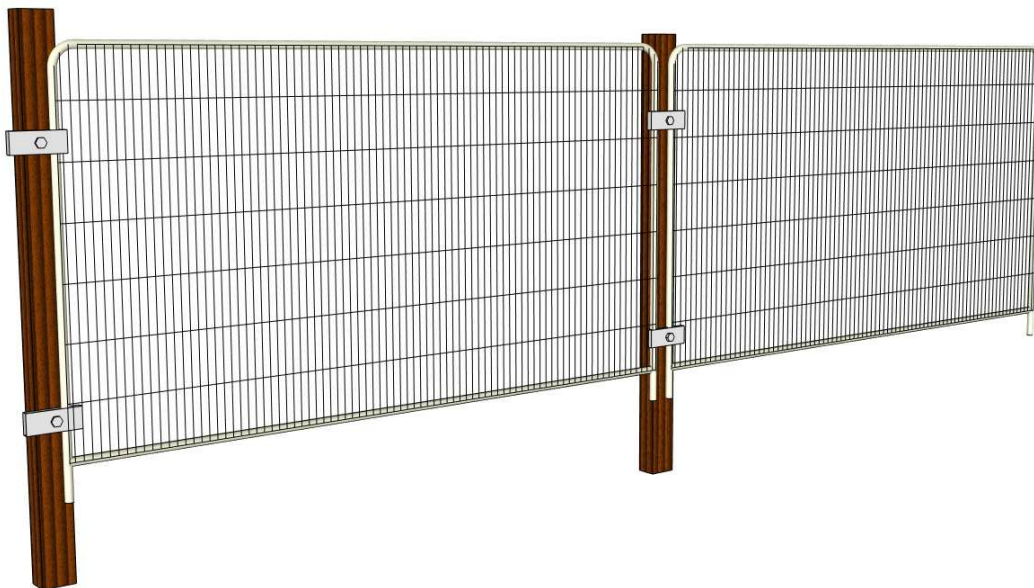
## B:- Alternative Fencing Detail: Adequate protection - provided LPA approve its use

Weldmesh fence panels attached together using fence couplers bolted to 100mmx100mmx2400mm treated timber fence posts driven 500mm into the ground. Use of plant to assist with erection only from outside of root protection area.

- 5.3.1 The barriers needs to be installed according to the locations found on the Tree Protection Plan, Appendix 4 and conform to the specification within Appendix 5, Type B, if approved by the Local Planning Authority. All weather notices should be attached to the fencing marked with the following: '*Construction Exclusion Zone - Keep Out*' (a notice is provided within Appendix 8).

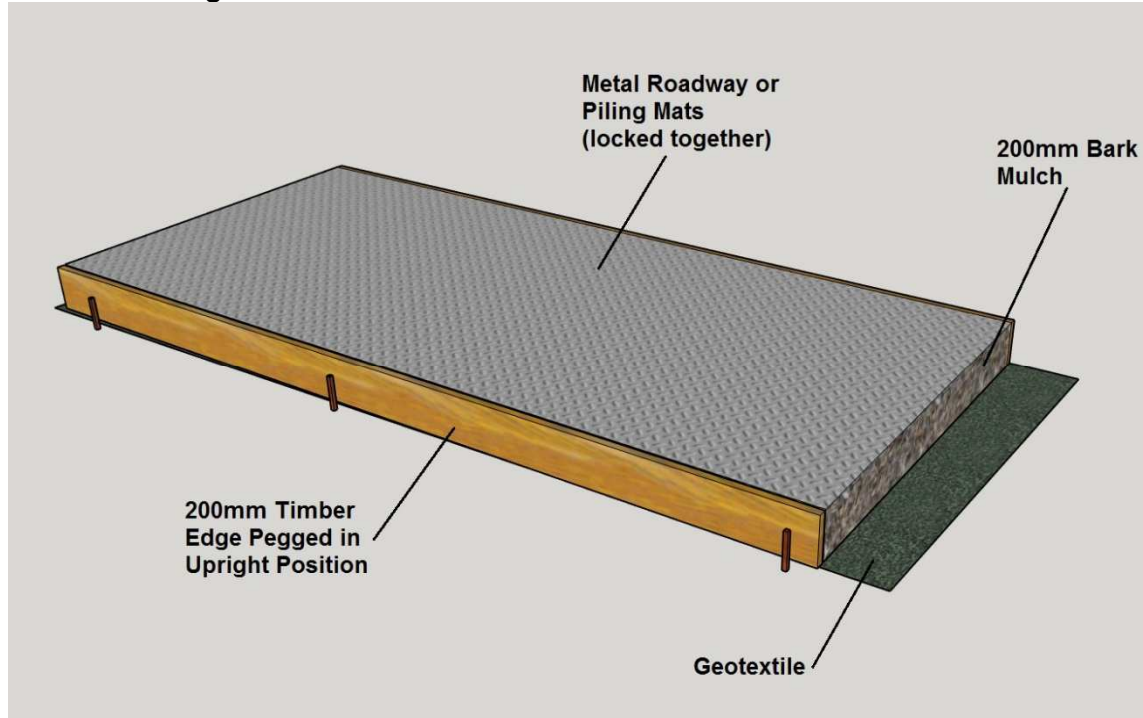
#### Suitable for Light Traffic & Plant

Where erecting scaffolding within areas of protected ground. The geotextile should be laid and then the scaffold footings placed on boards to spread the load. Ground protection as above should then be installed if access beneath the scaffolding is required.
