## BAT SURVEY & STRATEGY 2021

### BROOK COTTAGE OZLEWORTH, GLOUCESTERSHIRE

#### **EXECUTIVE SUMMARY**

To refurbish the cottage including reroofing it.

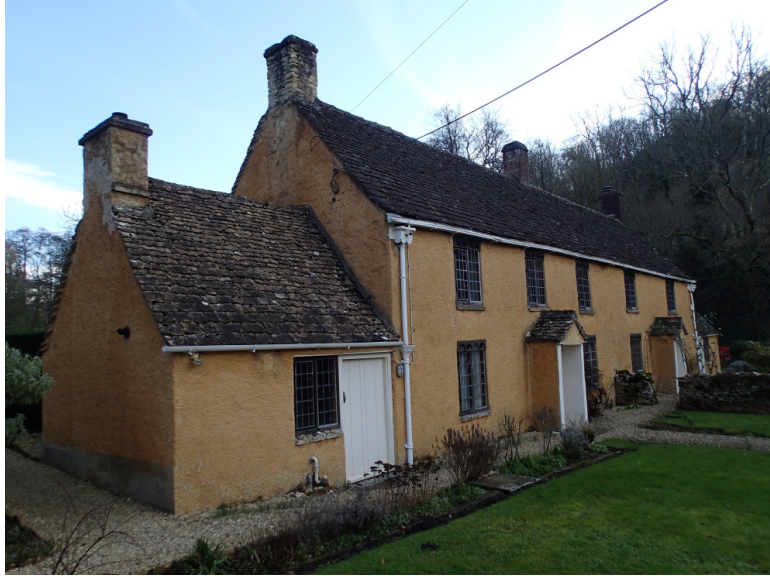
*Photo 1 South-western front*

The walls are painted, rendered stone. The doors and windows are timber and intact. The roof is twin-pitched and capped with Cotswolds stone slates on bitumen felt (and plastic in places). The felt is exposed in the attic rooms. There are four chimneys with a mix of stone, brick and rendering, which are mortared to the roof at their bases.

Overall the building is generally in a good sate of repair, though with gaps at the wall tops and with natural gaps between the stone slates that a bat could access.

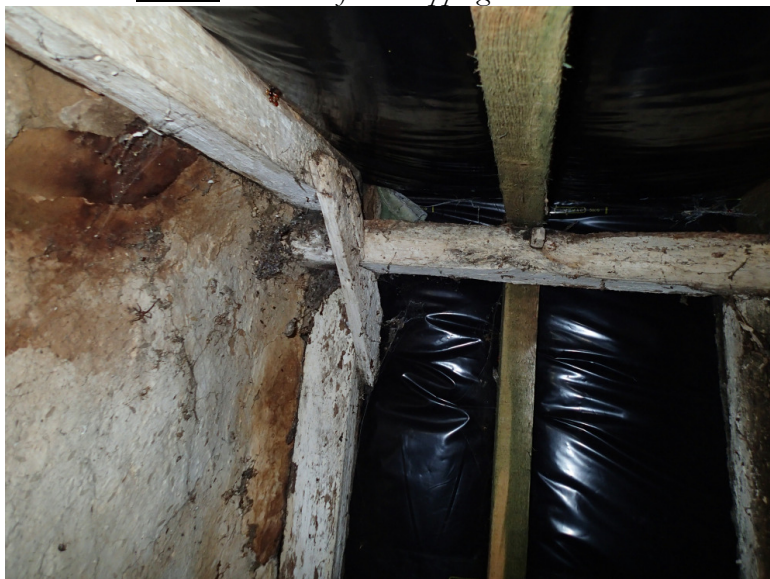
*Photo 3 Location of bat droppings in attic room*

There were several old bat droppings located in the north-most attic room. These were at the gable end, caught in cobwebs underneath the ridge. DNA analysis identified these to be **soprano pipistrelle droppings**. **The bat(s) would have been roosting in the structure of the roof at the ridge close to where there is a chimney.**

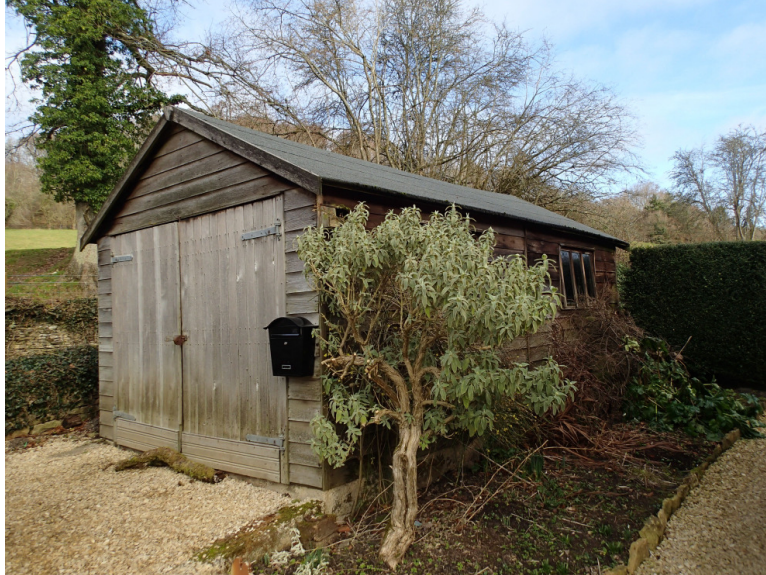
*Photo 4 Garage*

The garage is made from tongue-and-groove timber planks, with roofing felt on a pitched plank roof and closed double doors.. No signs of bats were found in it. The garage has a negligible potential for roosting bats.

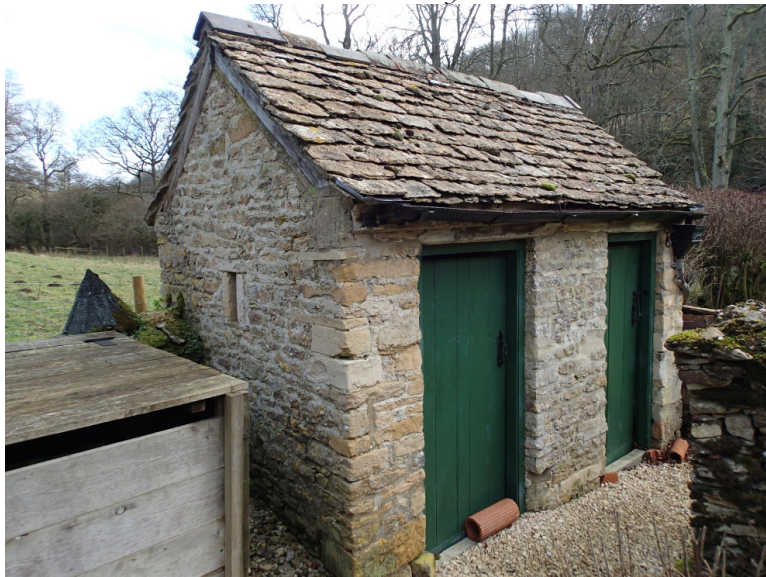
*Photo 5 Privy*

The garden privy is made with mortared Cotswolds stones and has a twin-pitched roof capped with stone slates on bitument felt. There are open venetian lancetts in the end walls and narrow gaps over the closed doors to two stalls. The privy was checked three times over the period of surveys and no signs of bats were found. The roof was cobwebby inside and there were rat droppings on the floor. The privy is assessed to not be used by roosting bats.

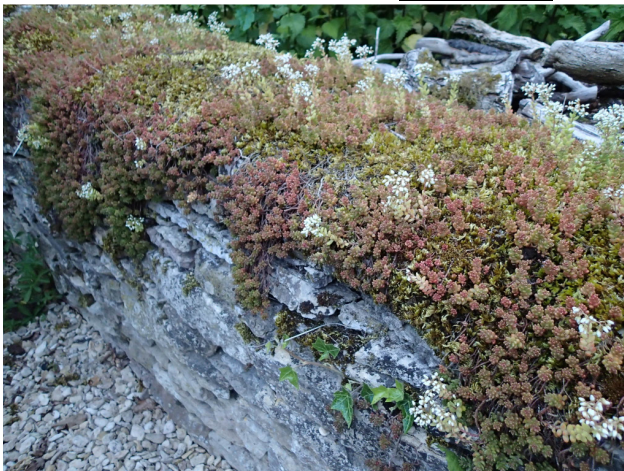
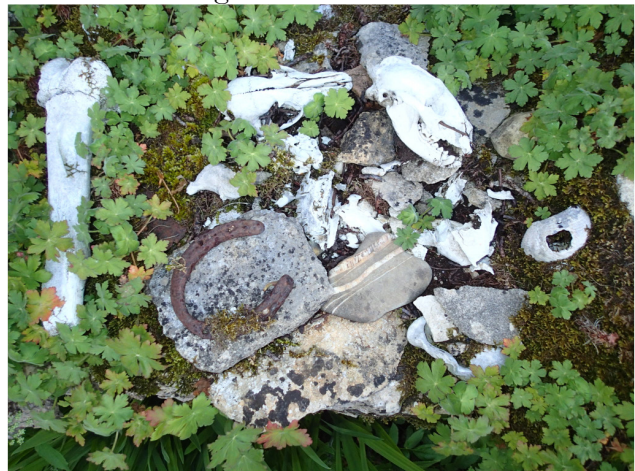
*Photos 6 & 7 Stone walls at Brook Cottage*

The dry-stone walls around and within the garden (in a rural setting) support plant communities and features that are valuable habitat for wildlife. This 'frass' of plants, mosses, *etc.* are an attractive feature of long-established Cotswolds stone walls in the Area of Outstanding Natural Beauty. The previous owners of the cottage (a renowned poet) look to have stashed bones and other objects into the walls.

- **The project is encouraged to actively map, protect and retain the plant communities and features of the stone walls during the refurbishment work.** Ivy to be cleared from them where it occurs.

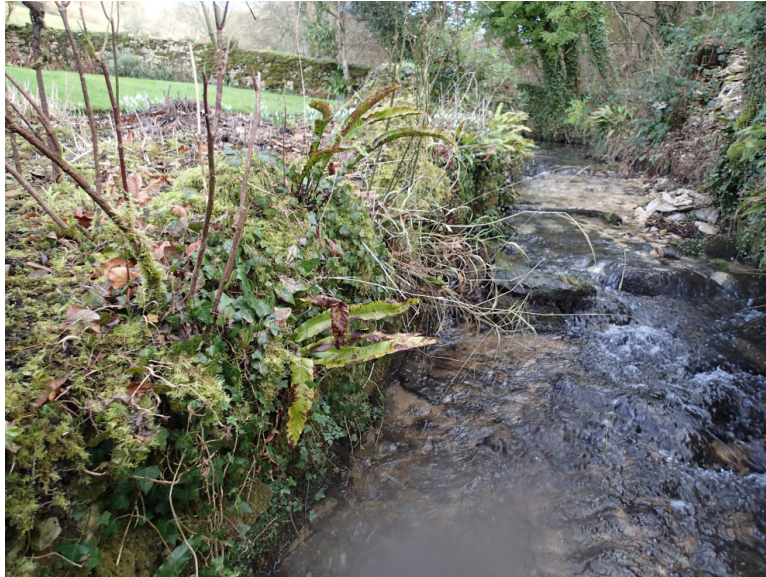
*Photo 8 Marlee Brook*

The Marlees Brook flows along the southern edge of the garden.

- It is recommended that **a procedure is put in place to ensure that no pollutants (including no silt) enters the brook during the works.**
