## **8.4 Results – Inorganics**

## **9 Revised Conceptual Site Model and Risk Assessment**

## 11 Conclusions & Recommendations

**MENV07112 – Land at Brynlllywarch Garden, Kerry, Powys**

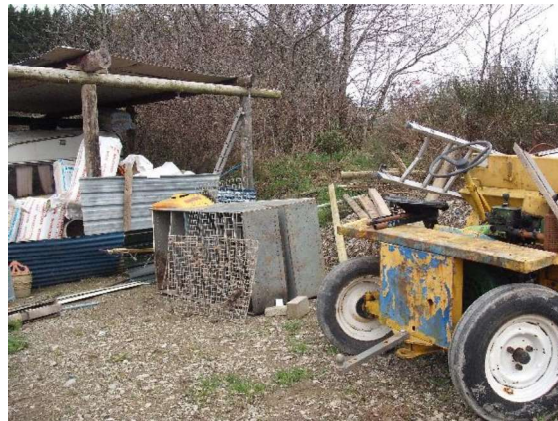
Photo 5: temporary roofed area in front of cutting

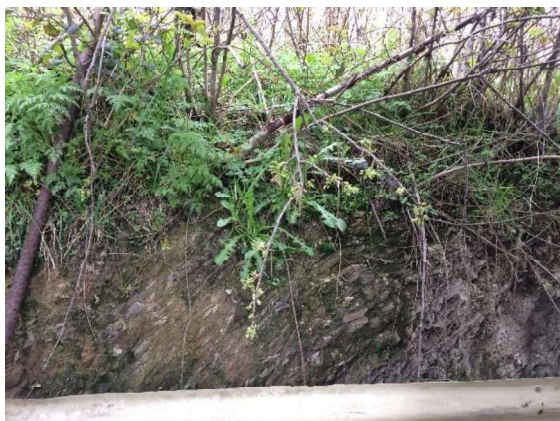
Photo 3: Area of cutting into shale
