# Well Garden Bradley, Alresford, SO24 9RY

Bat Report

**Ecology 7963**

**Issue 01**

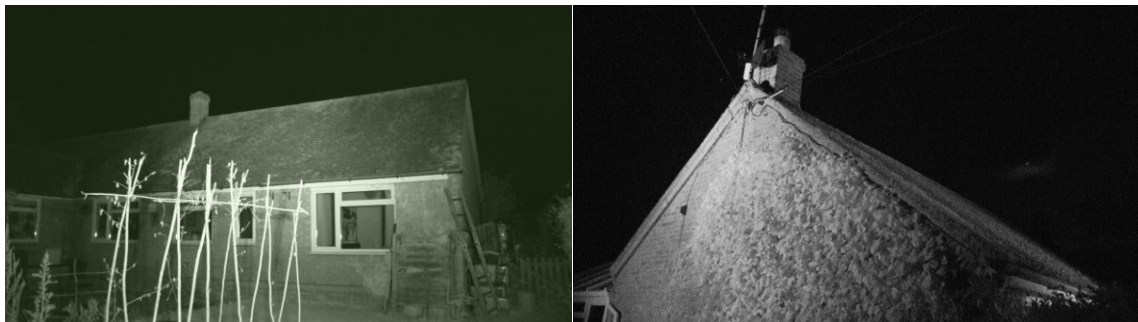
**Figure 1:** Camera coverage from the northwest corner and **Figure 2:** Camera coverage of the northeast corner.

- 3.7 Three dusk surveys were undertaken using NVAs rather than any dawn surveys. This approach follows the *Interim Guidance Note: Use of night vision aids for bat emergence surveys and further comment on dawn surveys* (Bat Conservation Trust 2022). Dusk surveys using NVAs are considered sufficient in this instance as the cameras and IR illuminators provided sufficient coverage of the building to ensure all potential access and egress points were covered. To demonstrate this, screenshots from the camera at the end of each survey have been provided in **Figures 1 and 2 below.**

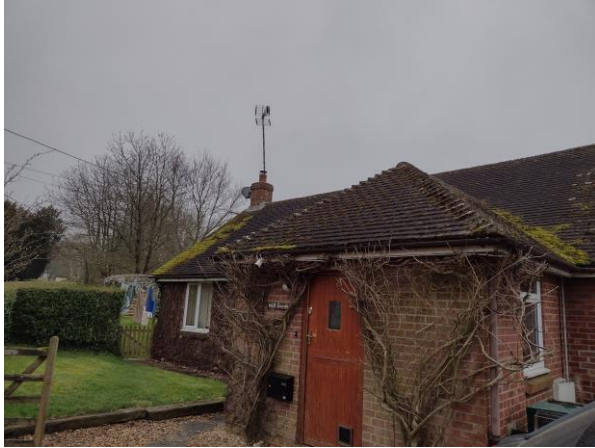
**Figure 3:** Northern elevation of the property

- 4.4 The bungalow recorded on site comprises brick elevations with a pitched roof with clay roof and ridge tiles. A conservatory is present on the western elevation of the property (**Figures 3 and 4**). Wooden soffit and fascias were present and were in good condition. The lead flashing was partially lifted around the central chimney stack providing a potential access/egress point.

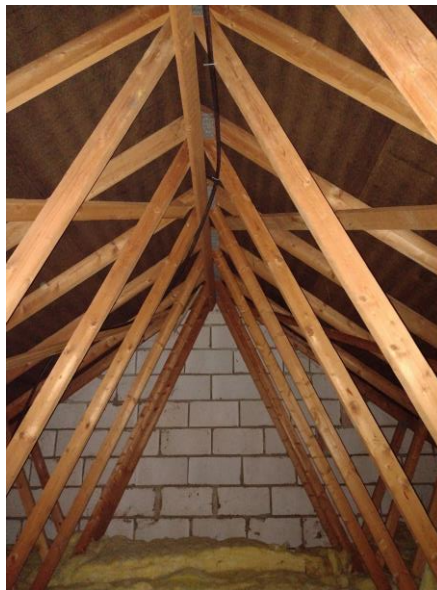
**Figure 5:** Roof void

- 4.5 A roof void was present in the northern section of the bungalow which measured approximately 6 metres in width, 2.25 metres in height and 5 metres in length. The roof was lined with bitumen felt which was in good condition and the roof structure was a typical truss design (**Figure 5**).

- 4.6 Approximately 20 droppings were recorded near the northern gable end with a single bat dropping, recorded in the centre of the void and one dropping recorded at the southern gable end of the roof void.
- 4.7 The bat droppings were sent for DNA analysis and were confirmed as common pipistrelle (**Appendix C**).
- 4.8 Due to the presence of bat droppings the bungalow has been assessed a **confirmed roost**. Further surveys were therefore carried out to characterize the roost.

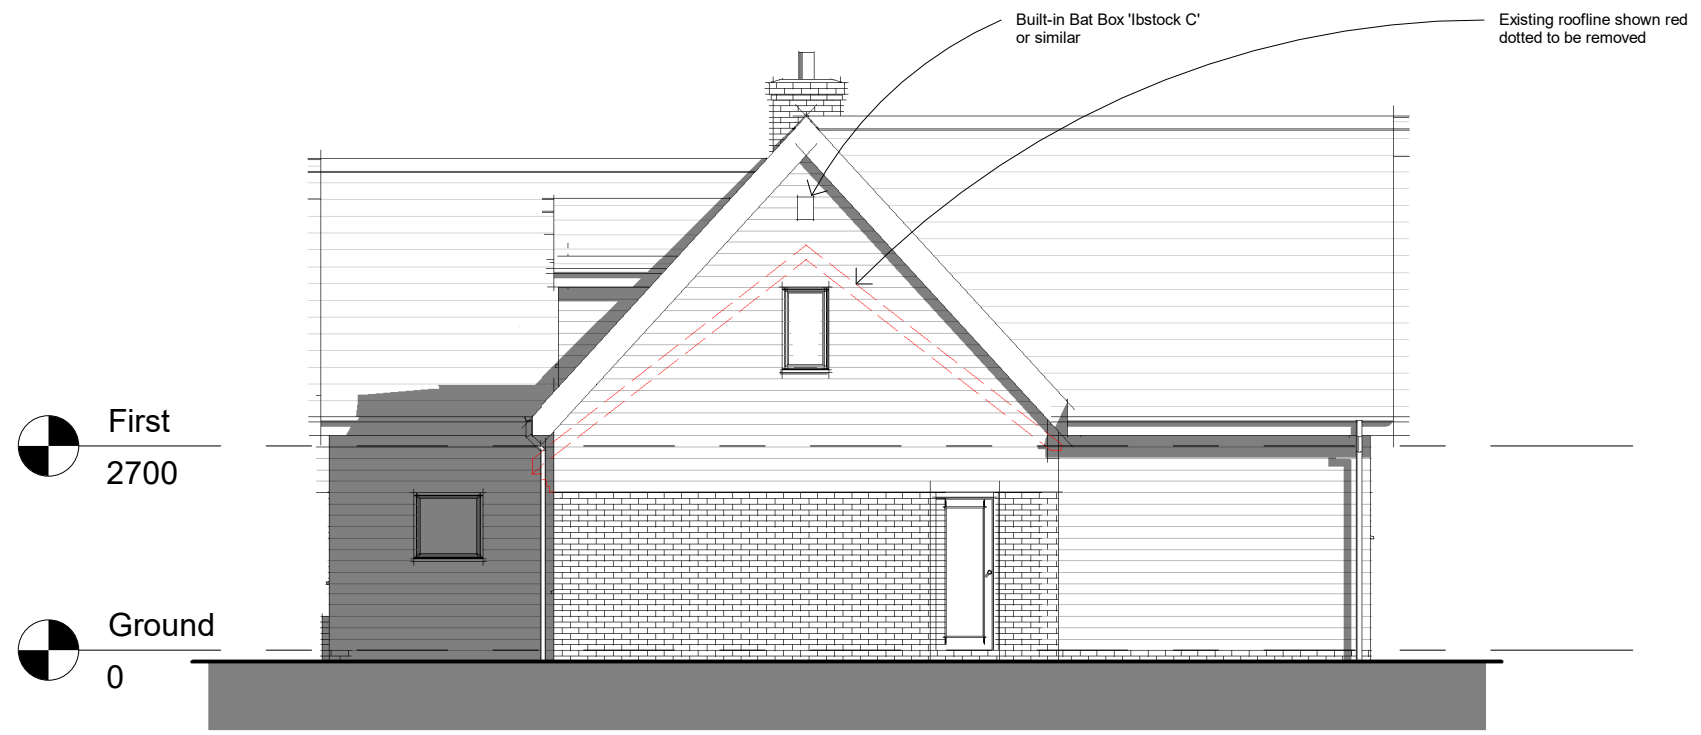
**North-west**  
1 : 100

- 4.10 One common pipistrelle was observed emerging from the apex of the north western gable end. This bat then flew southeast over the building (Target Note 1 for the survey, **Appendix D**).
- 4.11 High levels of foraging activity by common and soprano pipistrelles using the surrounding tree lines were recorded throughout the survey, starting at 20:46. Foraging lasted up to 35 minutes continuously. A single barbastelle pass was recorded at 21:16 but was not seen. A single noctule pass was recorded at 21:21.

- A replacement bat roost will be provided via an integrated bat box on the north western elevation. Roost locations will be provided in the new roof. Ridge access tiles will provide access to the space beneath the tiles and above the bitumen liner with two provided. Any lighting will be positioned away from the access points.

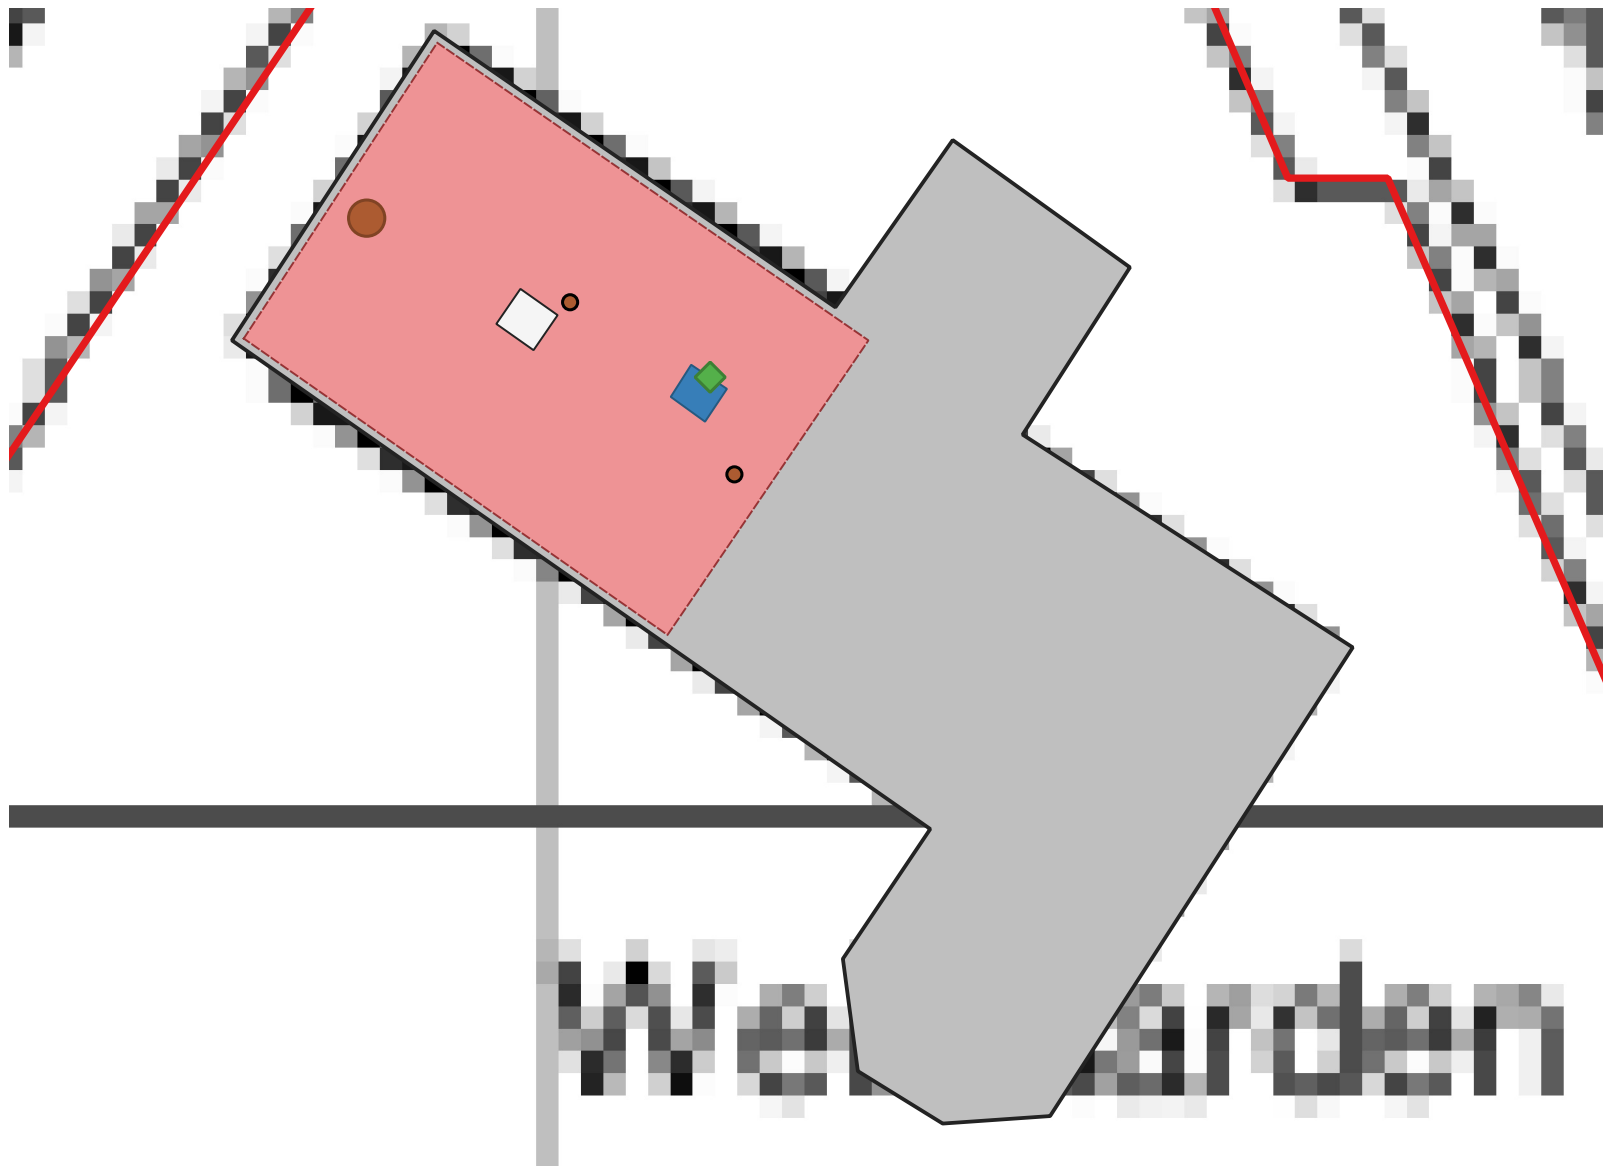
DRAWING:  
Preliminary  
Assessment  
DATE:  
24/03/22

- Approx. 20 Droppings
- Gap in Lead Flashing
- Single Bat Dropping
- Chimney
- Loft Hatch
- Roof Void
- Property Layout
- Site Boundary

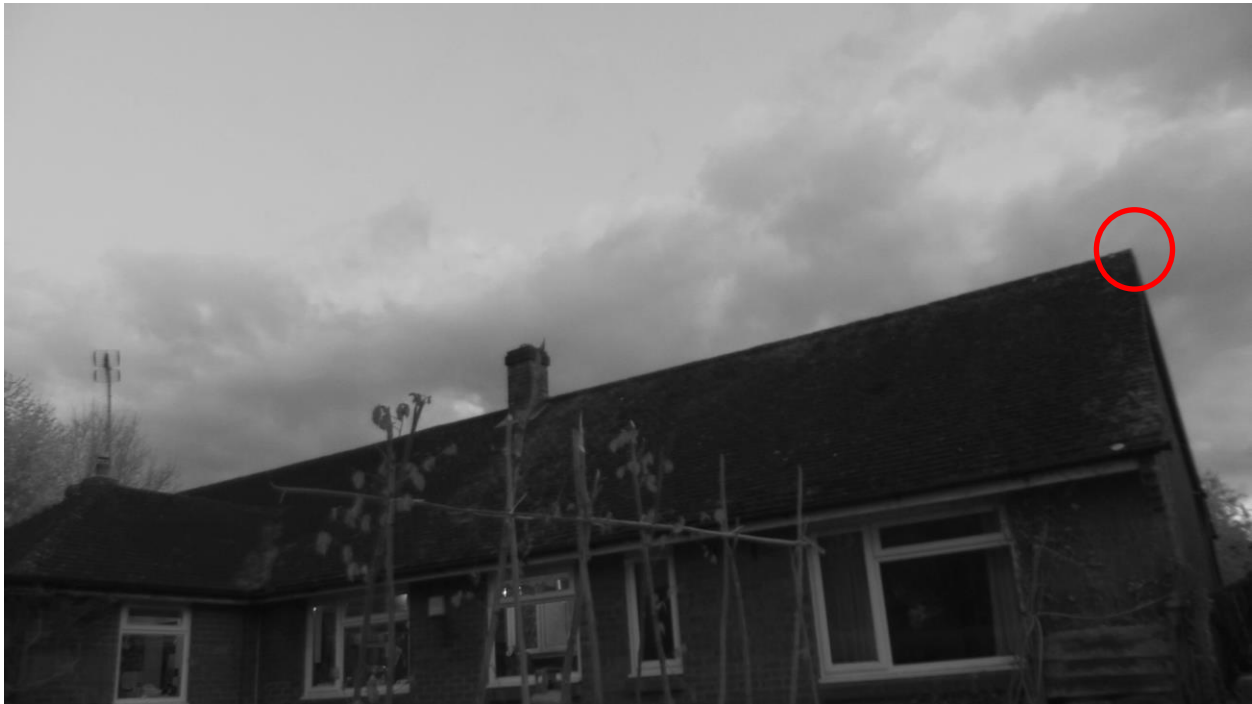
Target Note 1, 4<sup>th</sup> May 2022 – Alex Hannam, Northwest corner of the building – emergence from the apex of the western gable.

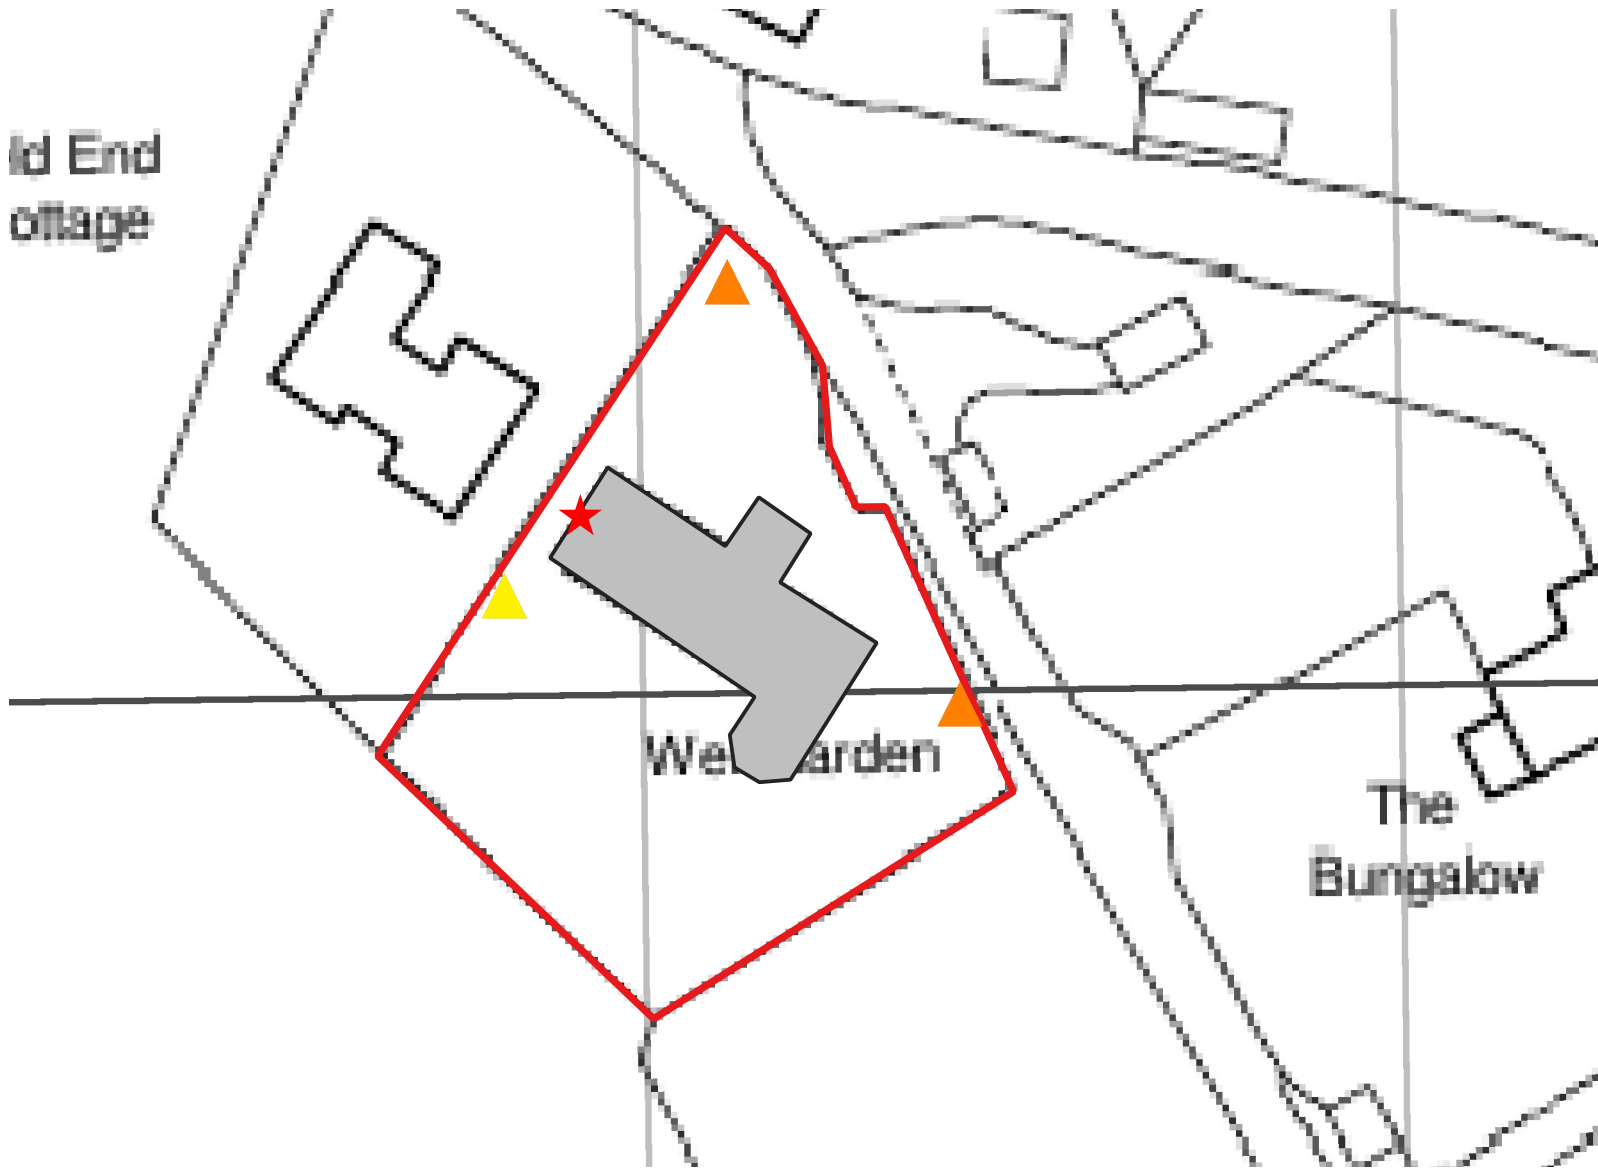
DRAWING:  
Emergence  
results

- 4.14 These surveys have confirmed a common pipistrelle roost location within the structure, with the main access point at apex of the north western gable. Mitigation measures will be required and are described further in **Section 5.0**.

- ★ Common pipistrelle emergence point
- ▲ Surveyor
- ▲ Surveyor and camera
- Building
- Site Boundary

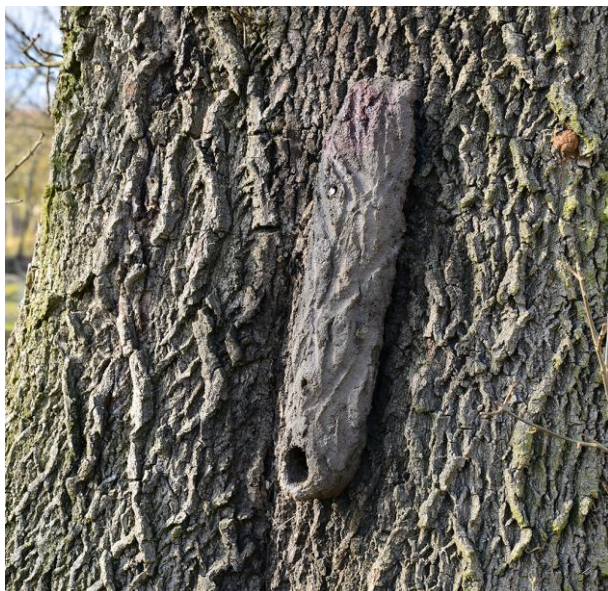
### **Bark Rot Hole – BarkBoxes.co.uk**

Creates a crevice against the bark of the tree, mimicking a natural rot hole, with joint to be sealed by clear silicone. Primarily for use by individual roosting bats but may also be used by small birds as a safe roost site. 'Rot hole' provides an opportunity to gather droppings for DNA analysis.

- 5.1 The following mitigation will be included in the licence application and is shown in **Appendix E**.
- A bat box will be positioned on a suitable tree prior to work commencing. This will allow any bats that are found during works to be safely relocated. The box will be retained as an enhancement feature.

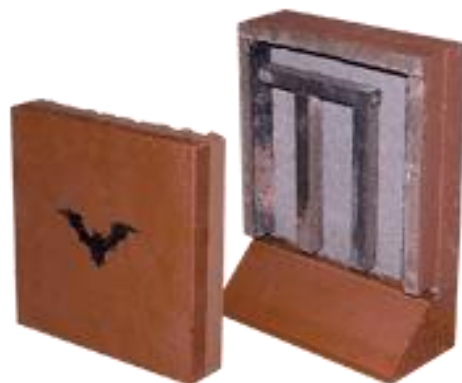
### **Ibstock Enclosed Bat Box 'C'**

Ibstock Enclosed Bat Box 'C' is a solution that can be integrated directly into the brickwork to produce a discrete but attractive home for bats.

- Several roosting zones
- Discrete
- Maintenance-free
- Red or Buff
- Durable and fully frost resistant
- 215 x 215mm / 215 x 290mm
