BUILDINGS AT LONG WHITE COTTAGE -
EDINGLEY, NOTTINGHAMSHIRE
PROTECTED SPECIES APPRAISAL

JULY 2022

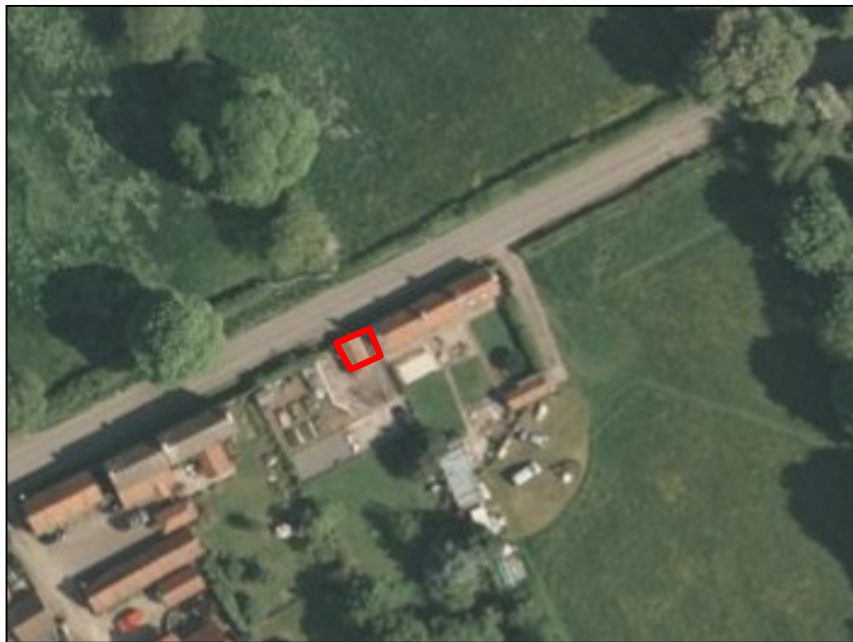
Plate 1 - Aerial view of site with buildings surveyed in red

The site lies off Station Road at OSGR SK 67068 56046 and consists of a lean-to attached to the main dwelling property at its eastern end and a single garage unit attached to the lean-to at its western end (see Plate 1).

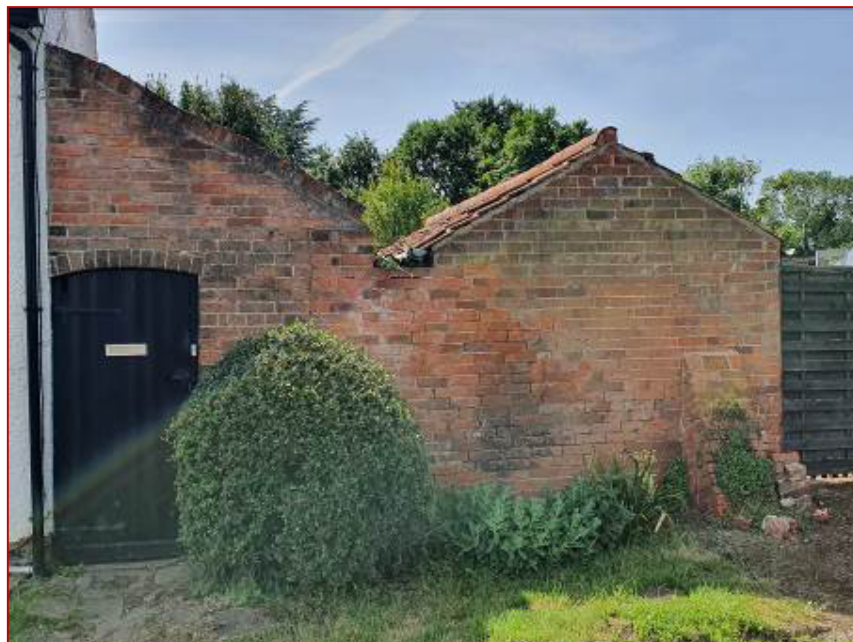
Photograph 1 - Northern aspect of buildings

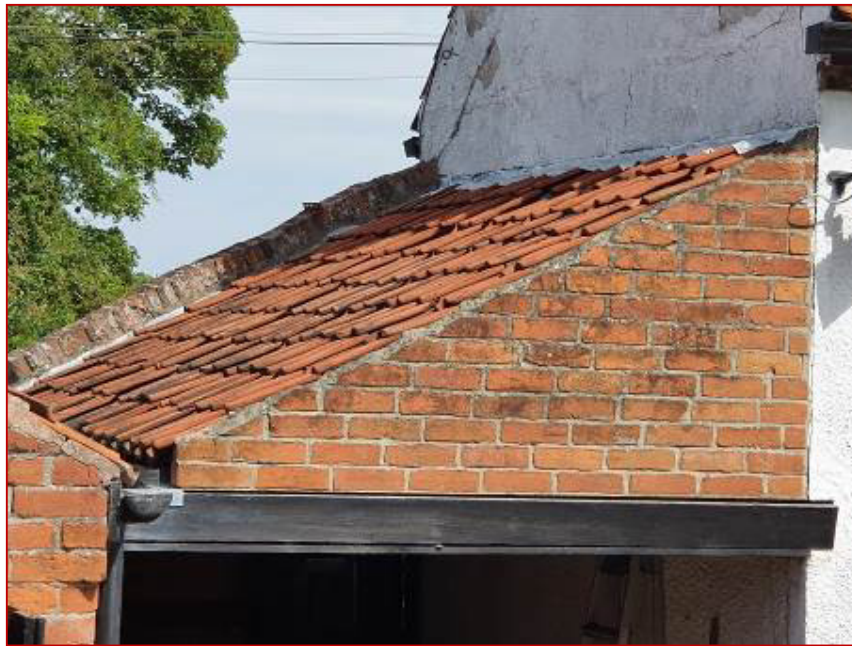
The buildings are in relatively good condition with no gaps, cracks or crevices in the brickwork and mortar. There are a number of tiles on the roofs which have the leading edge raised. This was assessed to be from minor movement in the timbers of the roof and the tiles all still meet properly under the first ridge. The majority of these gaps were found to be blocked with mosses or cobwebs at the time of survey.

Photograph 2 - Roof of lean-to

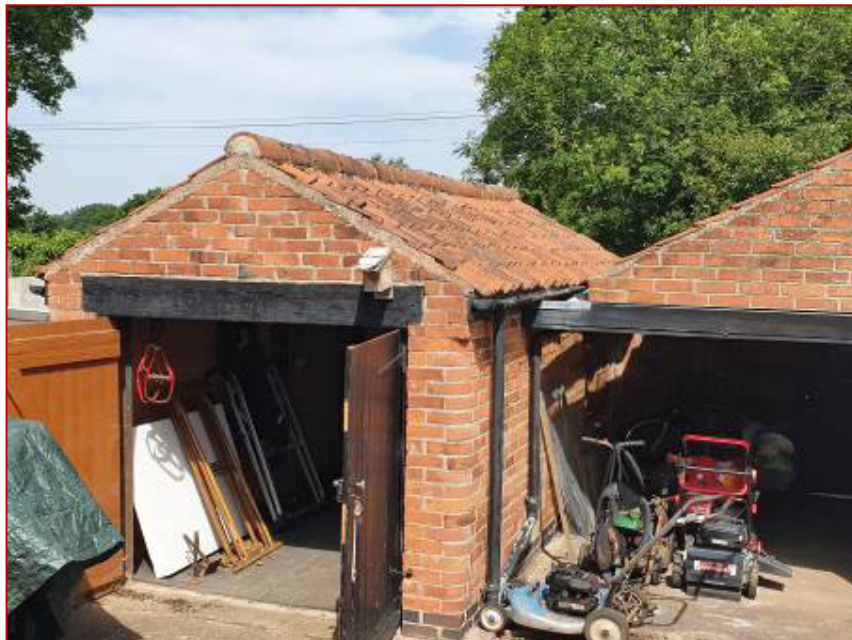
Photograph 3 - Southern aspect of buildings

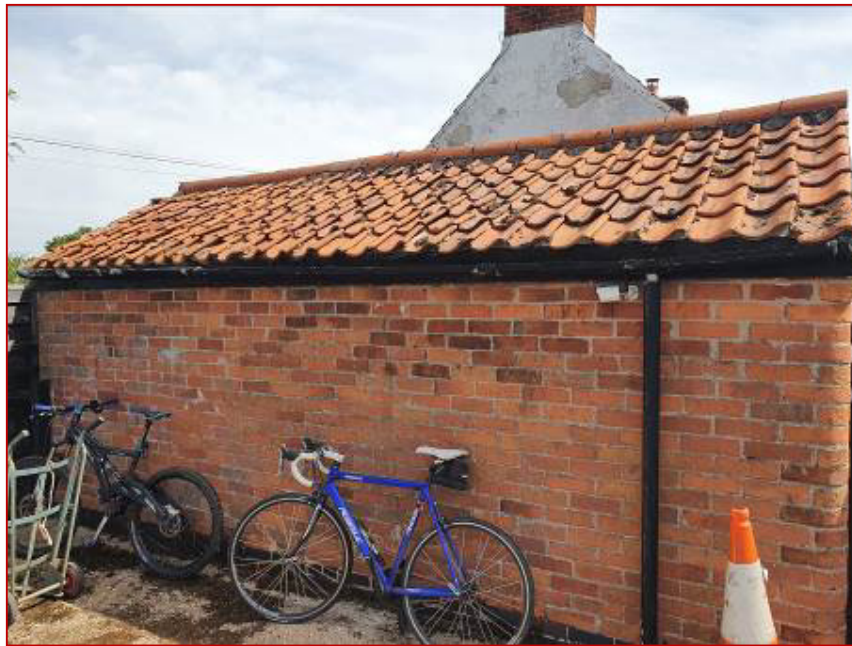
Photograph 4 - Western aspect of garage

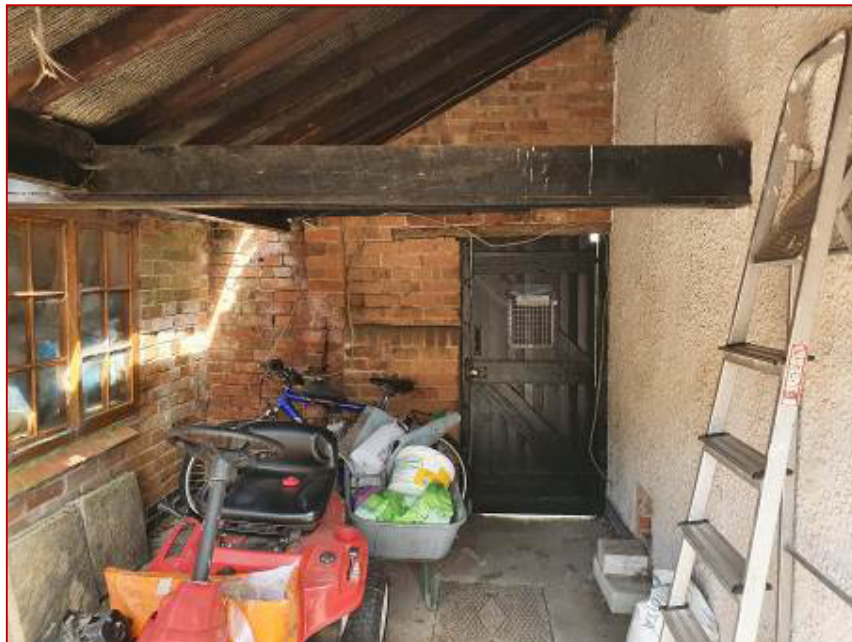
Photograph 5 - Internal view of lean-to

The lean-to is bright, draughty and open to the elements and is assessed to be generally unsuitable for use by roosting or resting bats.

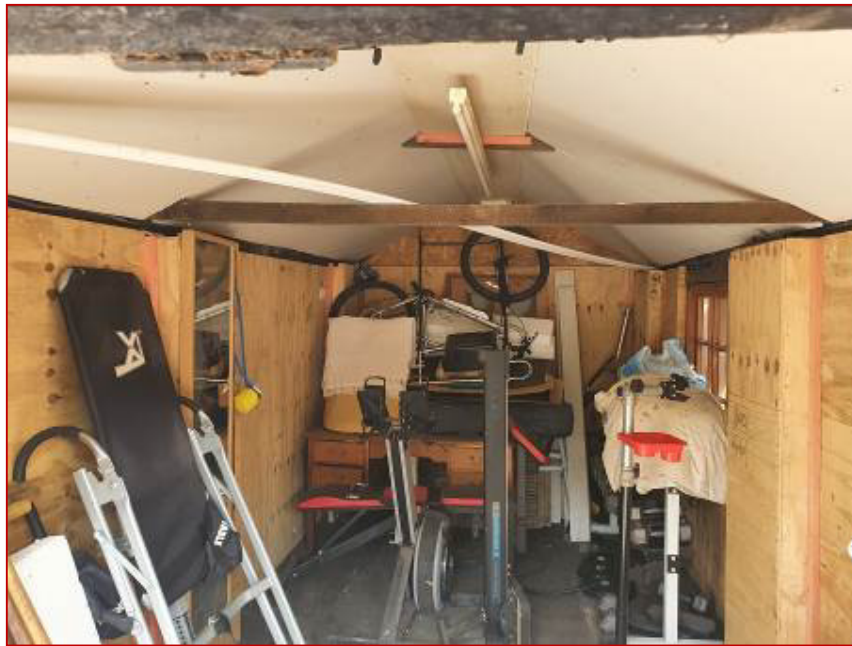
Photograph 6 - Internal view of garage

The tight-fitting door and intact felt lining prevented internal access to the garage unit for roosting bats.
