**Bartonbury Farm, Down Saint Mary, Crediton, Devon, EX17 6EB**

**Bat Survey - Preliminary Roost Assessment**

11<sup>th</sup> November 2020

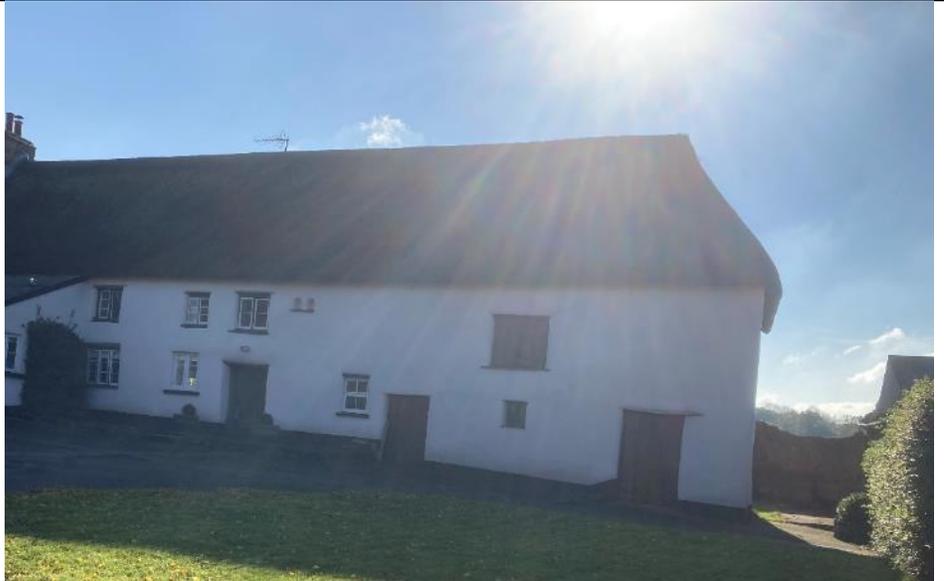
Photo 1: Showing the western half of B1, taken from the north. The area left of the central door is comprised of the main house, whilst the area to the right is the former stable block.

This is a barn annex attached to the western end of the farmhouse (see Appendix 3, photo 1). The building is constructed of a thatched roof over thick cob walls and is currently used for storing household items (see Appendix 3, photo 12).

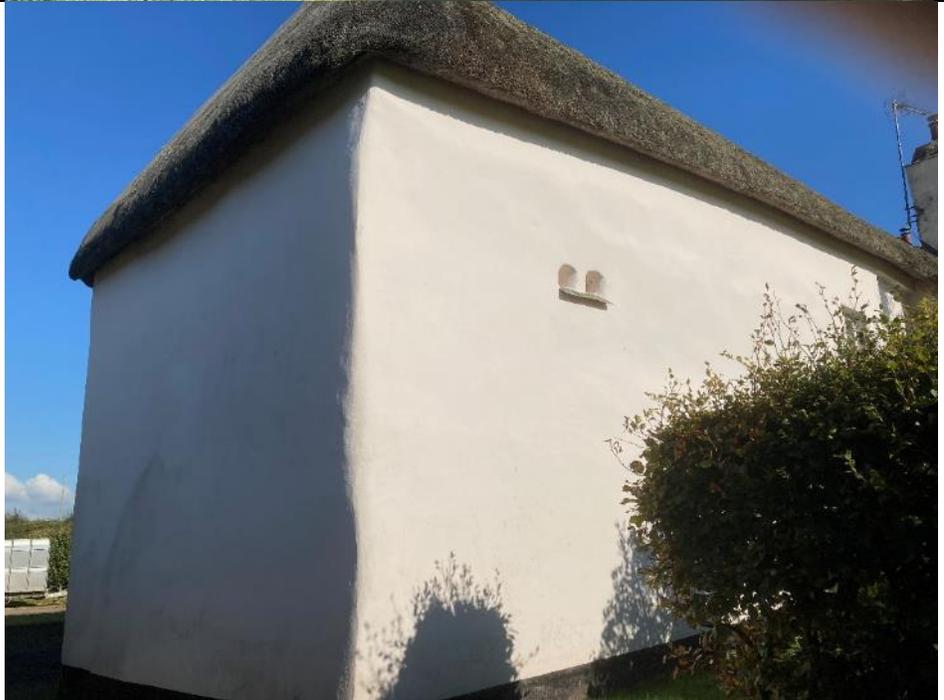
Photo 2: Showing the southwestern corner of B1, taken from the south.

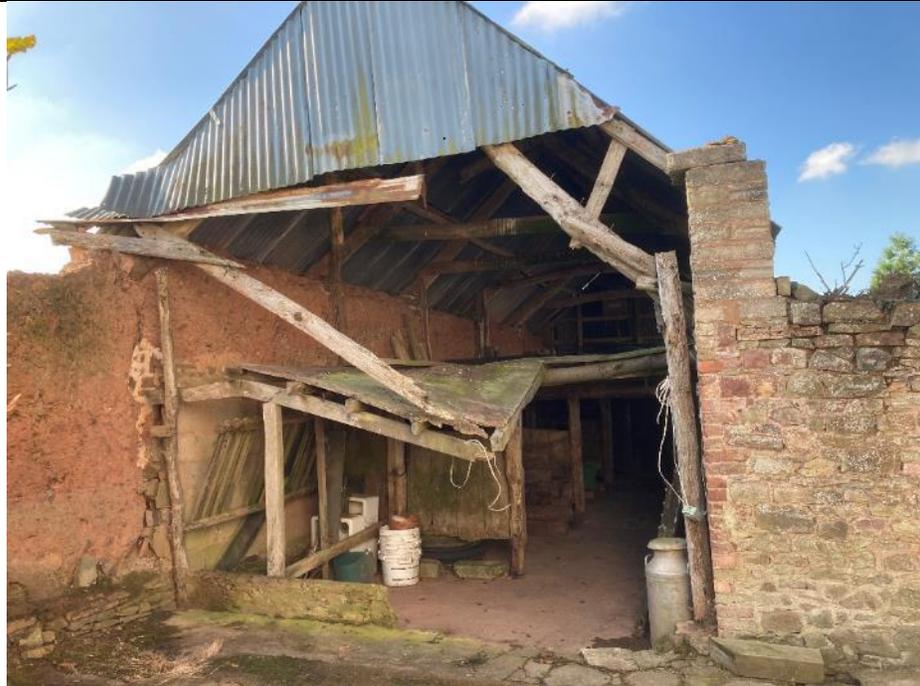
Photo 5: The linhay taken from the east.

This is a detached traditional barn that appears to have undergone extensive repairs during modern times; with both modern and traditional materials used in the construction (see Appendix 3, photos 5-11). The building is light and airy, being open in the west and the north. A traditional mezzanine floor is present, with this in some state of disrepair.

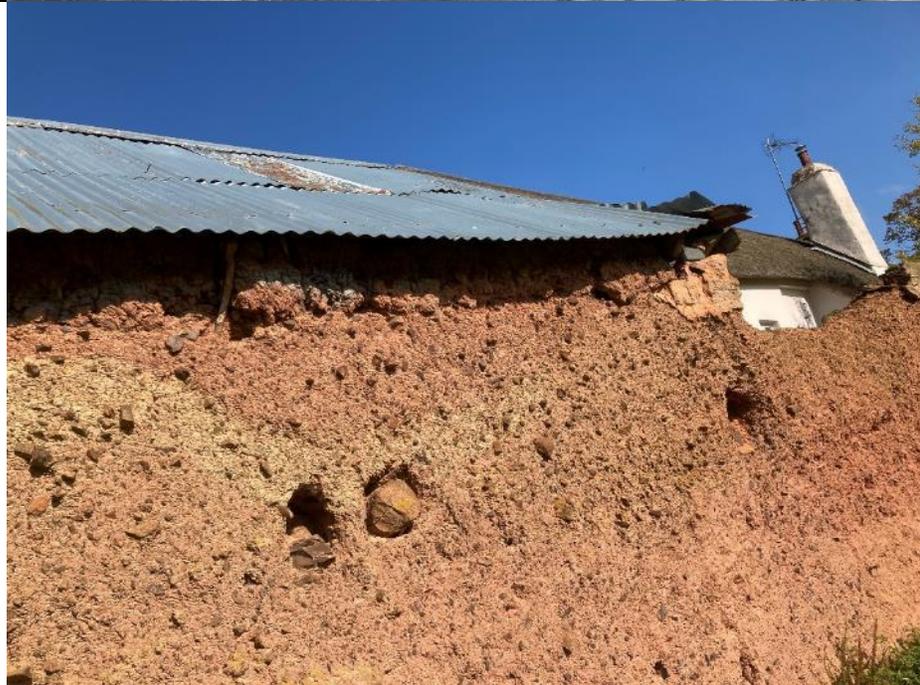
Photo 7: The cob linhay wall taken from the south.

The building has a pitched roof constructed of corrugated metal sheets over a mixture of modern and traditional beams and rafters. Some gaps and spaces are present between and above these (see Appendix 3, photo 7). No underlining is present.

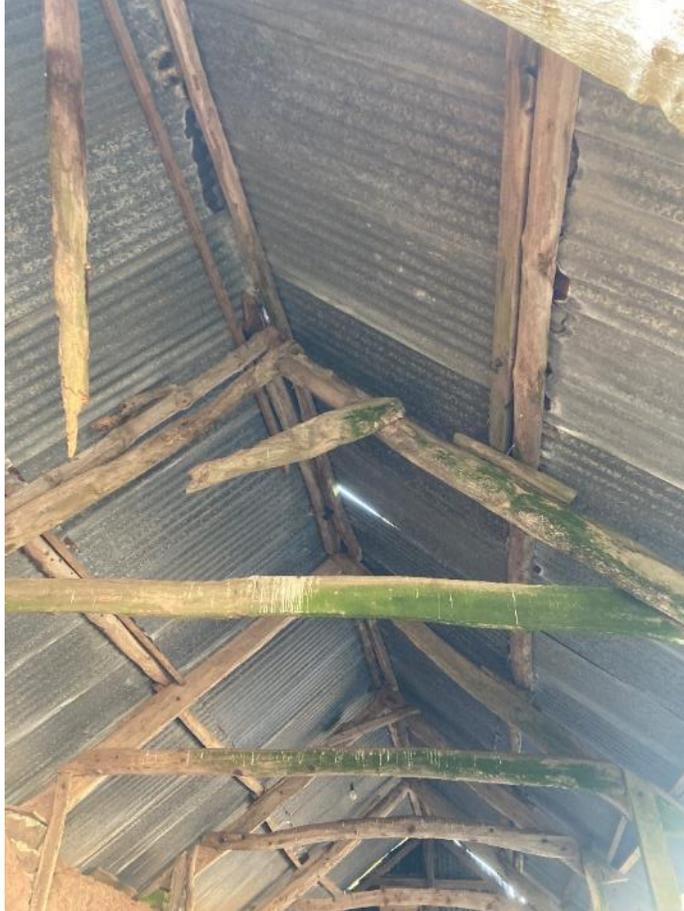
Photo 8: The internal linhay roof structure.

Below this the walls contain sections comprised of both concrete blocks (in the west), and traditional cob (along the south). Some crevice/gap features occur in the latter (see Appendix 3, photo 8,) although many of these relatively large and exposed.

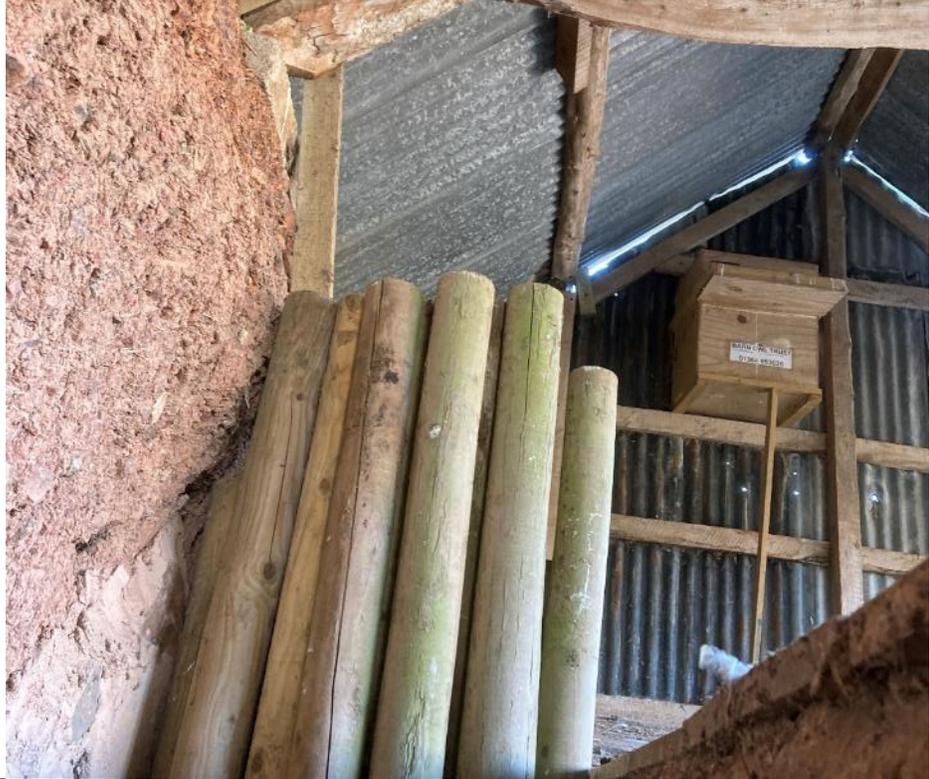
Photo 10: View of the upper level of the linhay, including the barn owl box.

Internally there is a wooden mezzanine floor, in poor condition and sagging in places, below which are a series of wooden stalls. An internal barn owl box is present against the western wall.

A barn owl nest box is located within B2. No obvious signs of barn owls were found within the building (although the mezzanine floor could not be checked up close). No nests were noted within B1, however occasional bird droppings were noted within this and there is also a likelihood of suitable nesting features to be present out of view (e.g. at obscured positions along the western wall tops).

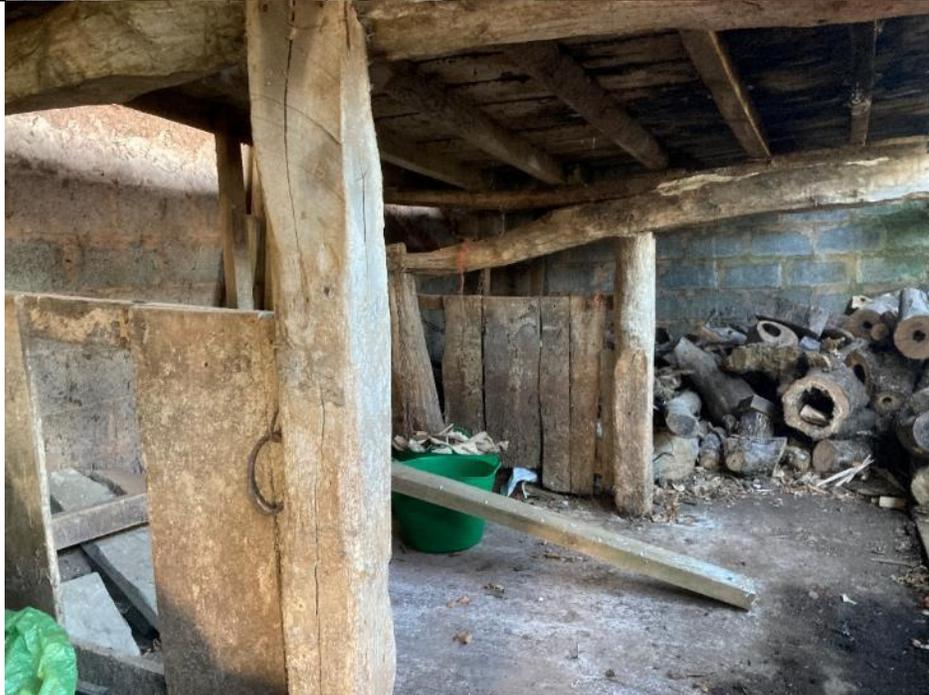
Photo 11: View of the lower level of the linhay, with wooden stalls.

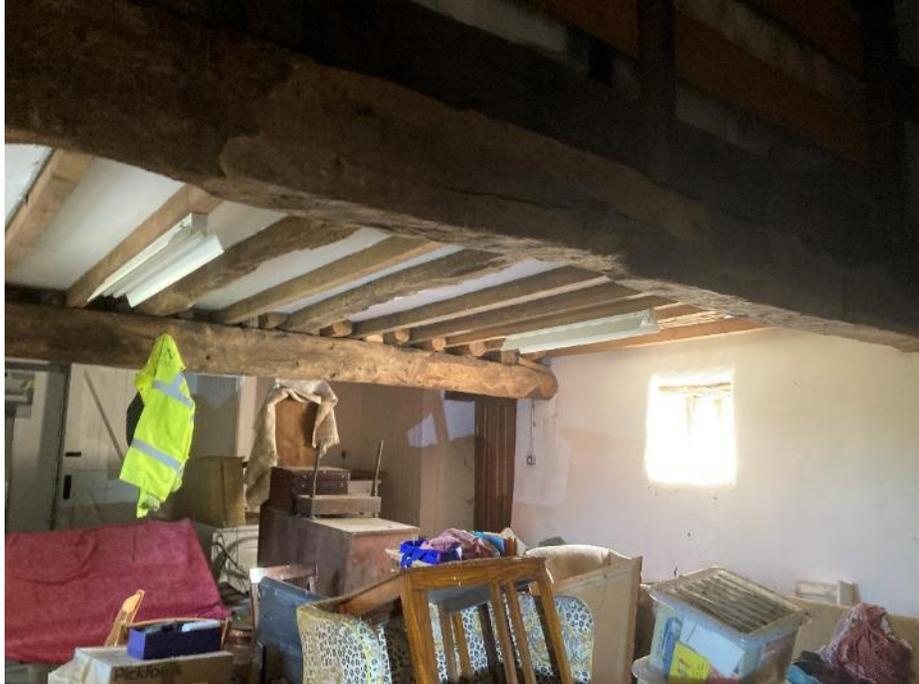
Photo 12: Internal view of the ground level of the stable block.

Internally the building is open to the roof, with a mezzanine floor and wooden staircase present covering ~2/3rds of the internal areas (see Appendix 3, photos 12-15). The majority of the building comprises of a single large dark open space, with the roof being some distance above the floors below, and the

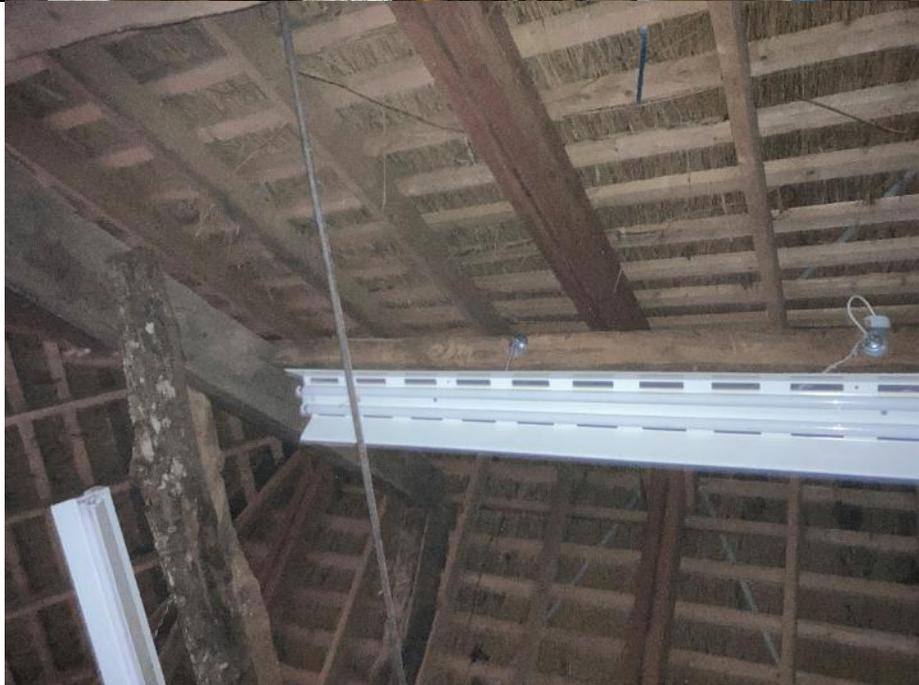
Photo 13: Internal view of the stable block roof structure.

mezzanine floor open above and below. However, a small, segregated toilet is also present on the ground floor. The roof is unlined, with beams, rafters and thatch of the current roof all visible from below. Some traditional beams and rafters are also visible from a previous roof structure. In the east, a dividing wall separates the building from the main house, with this containing small spaces at the sides (directly against thatch). In the west the wall appears particularly thick, resulting in a wide darkened 'shelf' feature that cannot be seen from the ground. This wall also incorporates a crevice feature, suspected to be a former chimney, running up its' height.

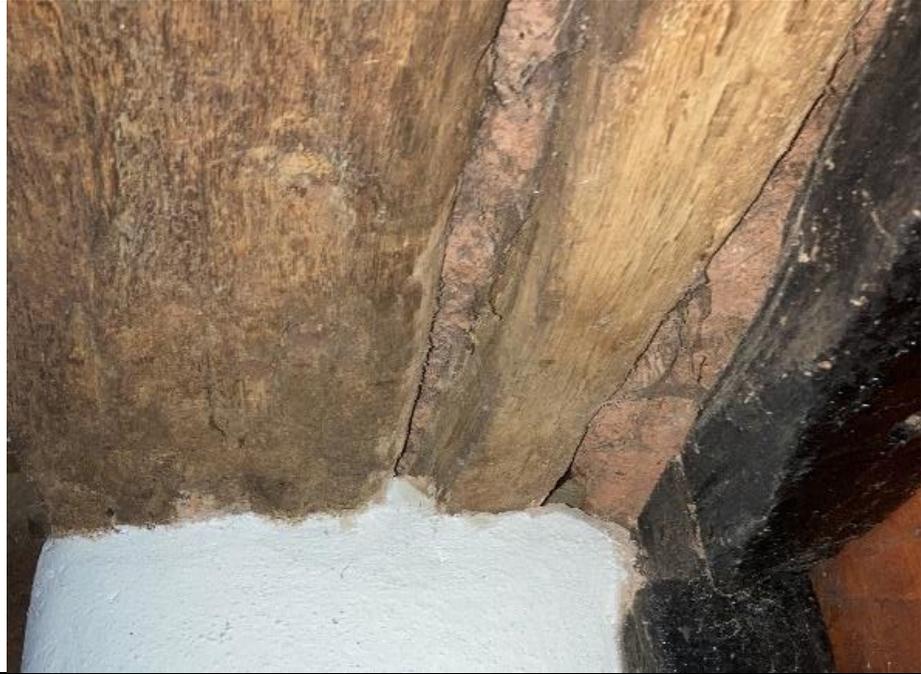
Photo 14: Internal gaps around door lintel.

The roof is in a good state of repair, however, there are believed to be some small gaps between this and the walls below. Externally, doorway and window features occur on the northern and southern elevations (with the western elevation being a bare wall). Two wooden doors occur on the north elevation and one in the south. Small gaps run along the length of door tops (enabling internal access), with further small gaps also occurring around the above timber lintels (some of which go into the stonework: (see Appendix 3, photo 14)). Both elevations also include a single small, glazed window (which appear well sealed), whilst the north also has a traditional wooden shuttered 'window' on the first floor.

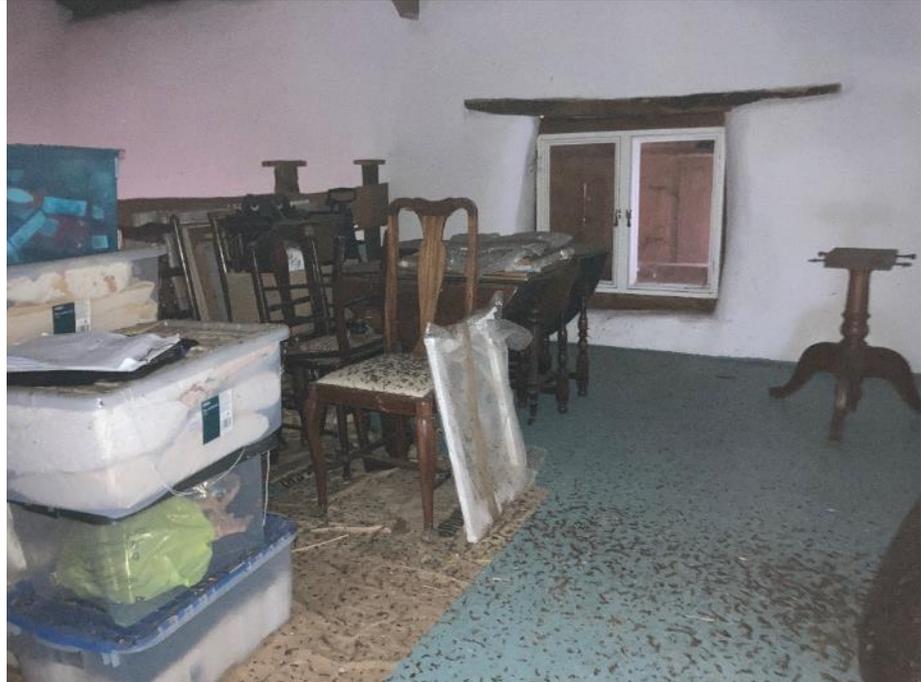
Photo 15: The upper floor area.

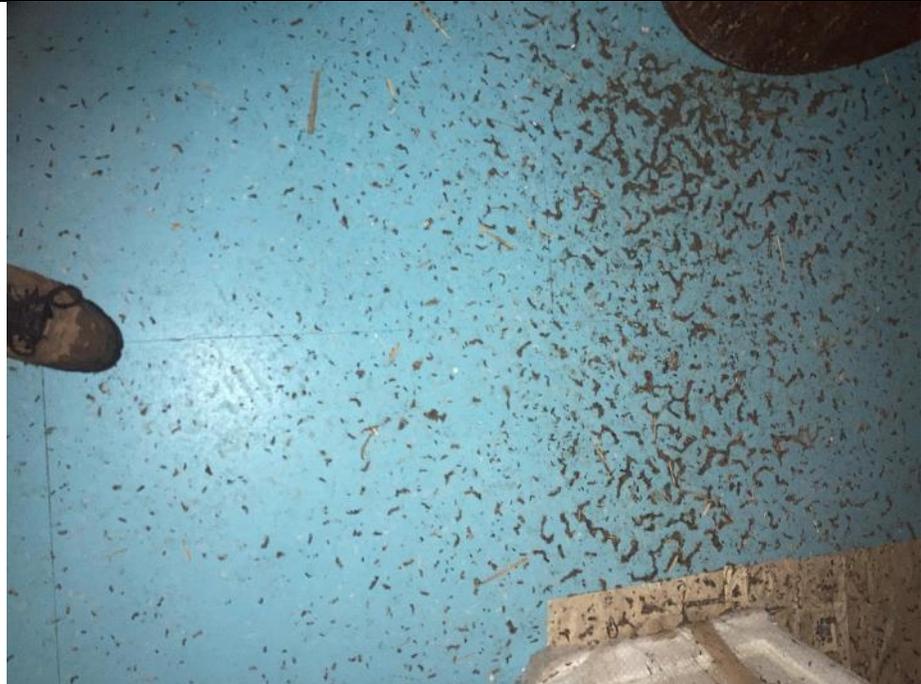
Photo 16: Example concentrated bat droppings beneath ridge.

Several thousand bat droppings were scattered across the floors of the building (see Appendix 3, photos 16-18), with a large concentration in the centre of the mezzanine floor; indicative of bats flying around and roosting within the internal space (most likely around ridge beams and rafters). The droppings were mixed together, containing a variety of ages (including both fresh and old/degraded droppings: the latter particularly within those larger concentrations). Different sized droppings were present, including medium sized (such as from a long-eared *Plecotus* sp.) and smaller specimens (such as from pipistrelle *Pipistrellus* sp. bats).

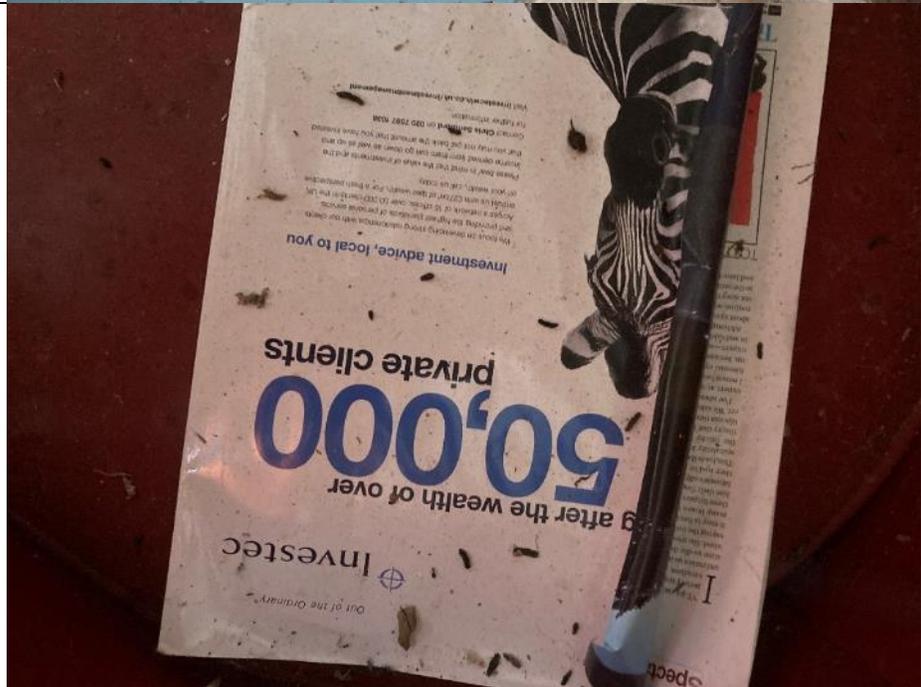
Photo 17: Example scattered bat droppings on stored items.

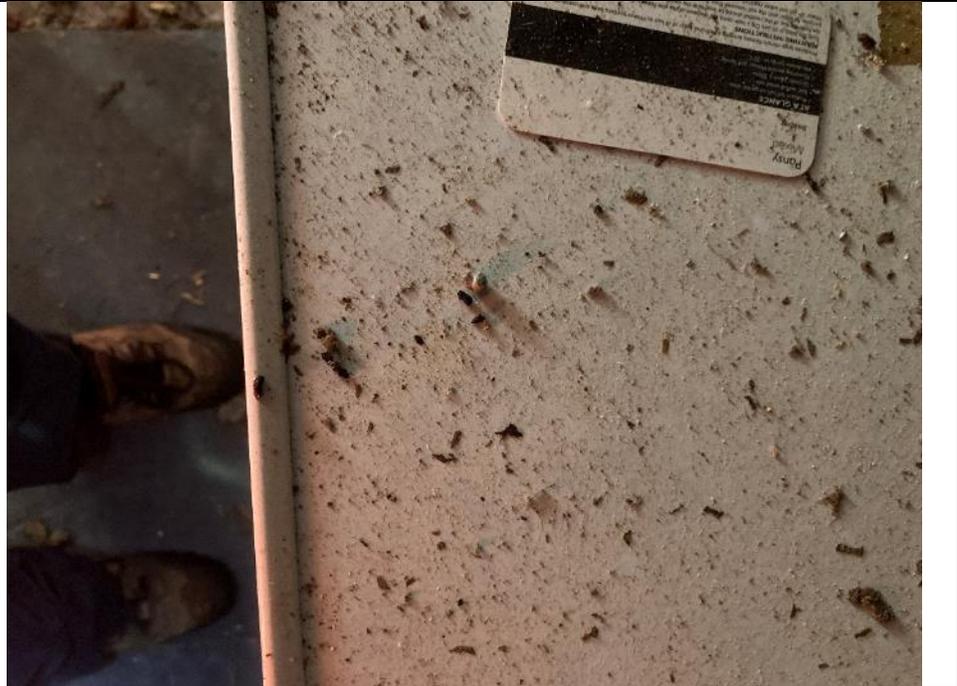
Photo 18: Further example of scattered bat droppings on stored items.
