MIDLANDS LIGHTING SOLUTIONS LTD

Warwickshire Golf Club - Proposed Range Lighting

LIGHTING IMPACT REPORT – MAY 2022

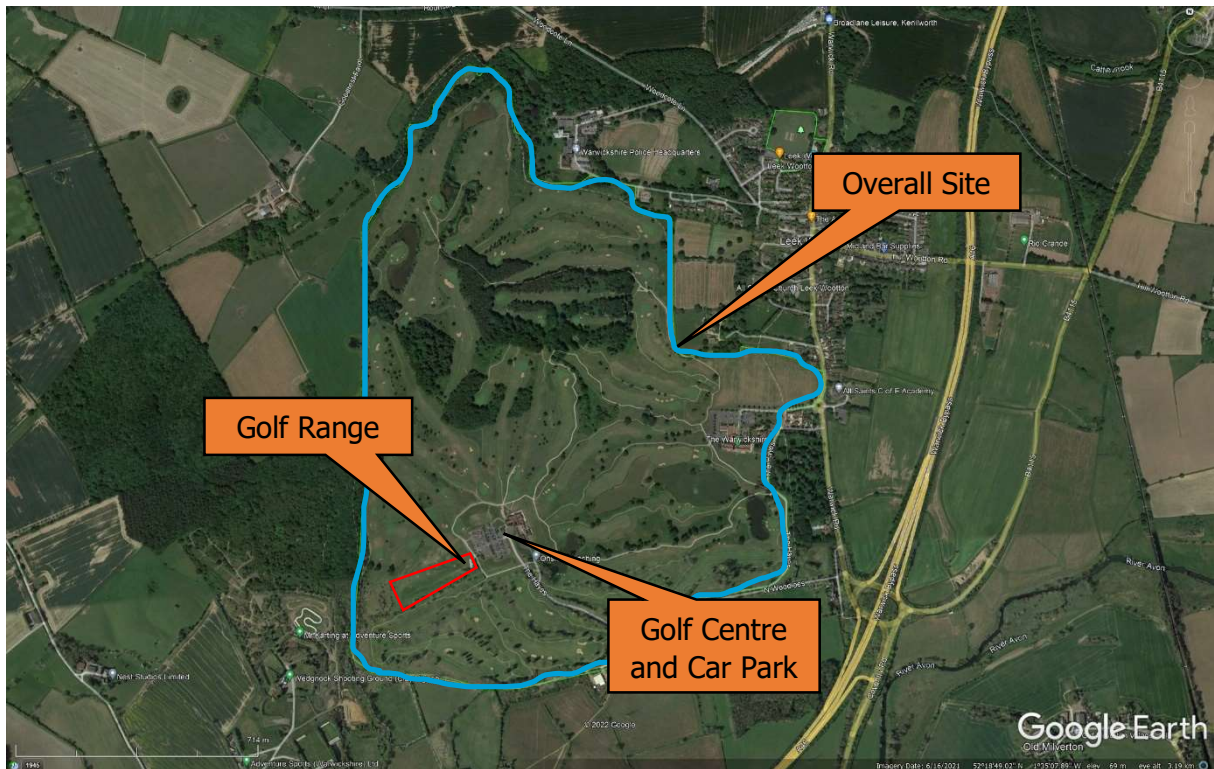
Figure 1 - Location of Golf Range within the Overall Warwickshire Golf Club Site

Due to the type of facility, the site is located in open countryside, the existing range is at the south-western corner as shown in Fig.1.

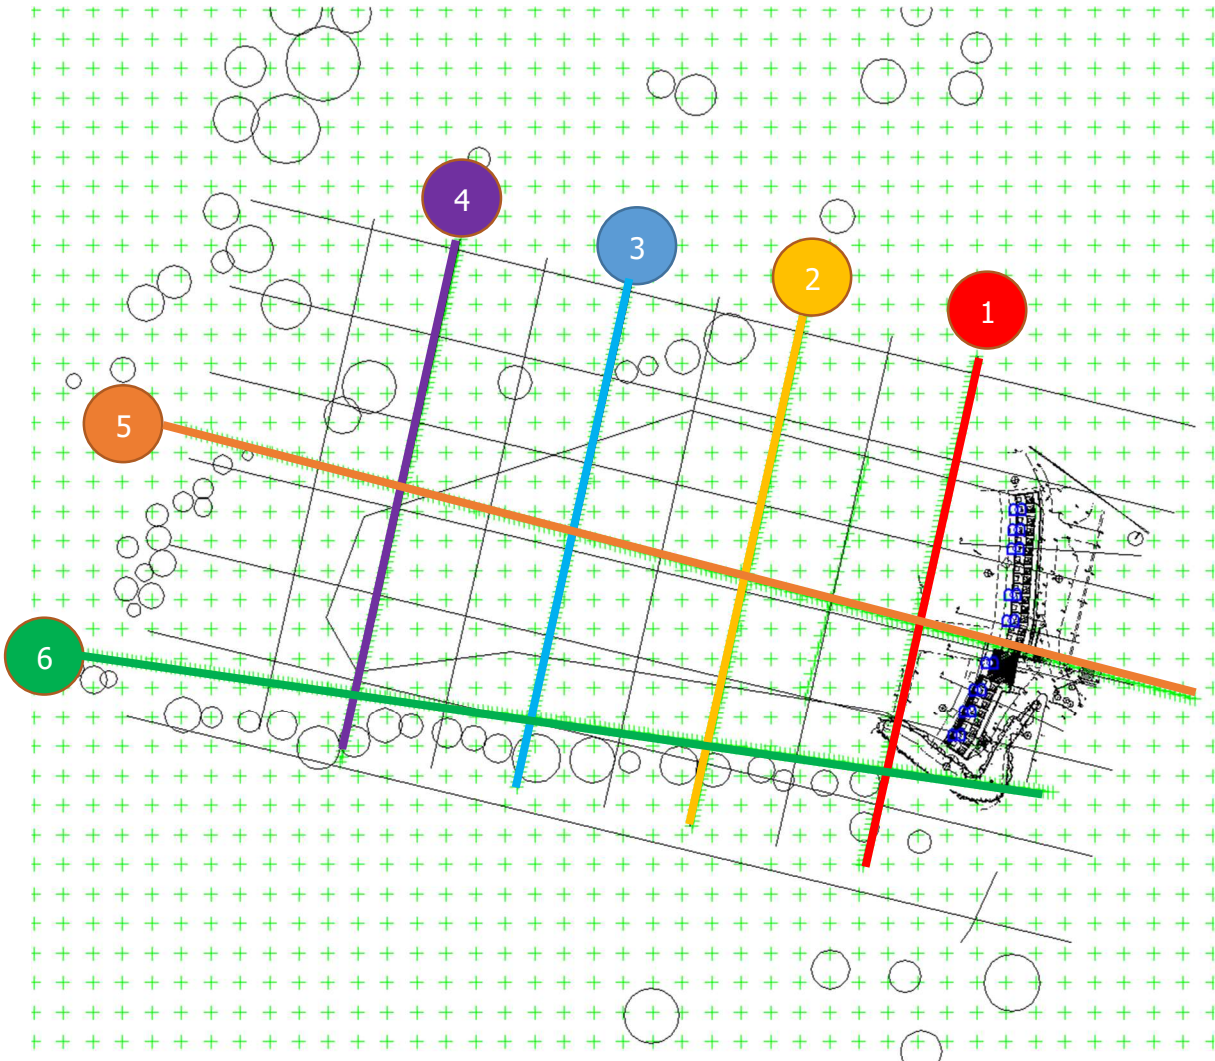
Figure 3 - Calculation grids used for appraisal

Once the lighting system has been modelled correctly, a series of grids have been created to evaluate the effects as noted:

1. Light distribution width & height at 30m from range (shown in Fig 6)
2. Light distribution width & height at 90m from range (See attached calculation)
3. Light distribution width & height at 150m from range (See attached calculation)
4. Light distribution width & height at 210m from range (See attached calculation)
5. Light distribution length & height through centre (See attached calculation)
6. Vertical light spill onto tree line to south of range (shown in Fig 7)

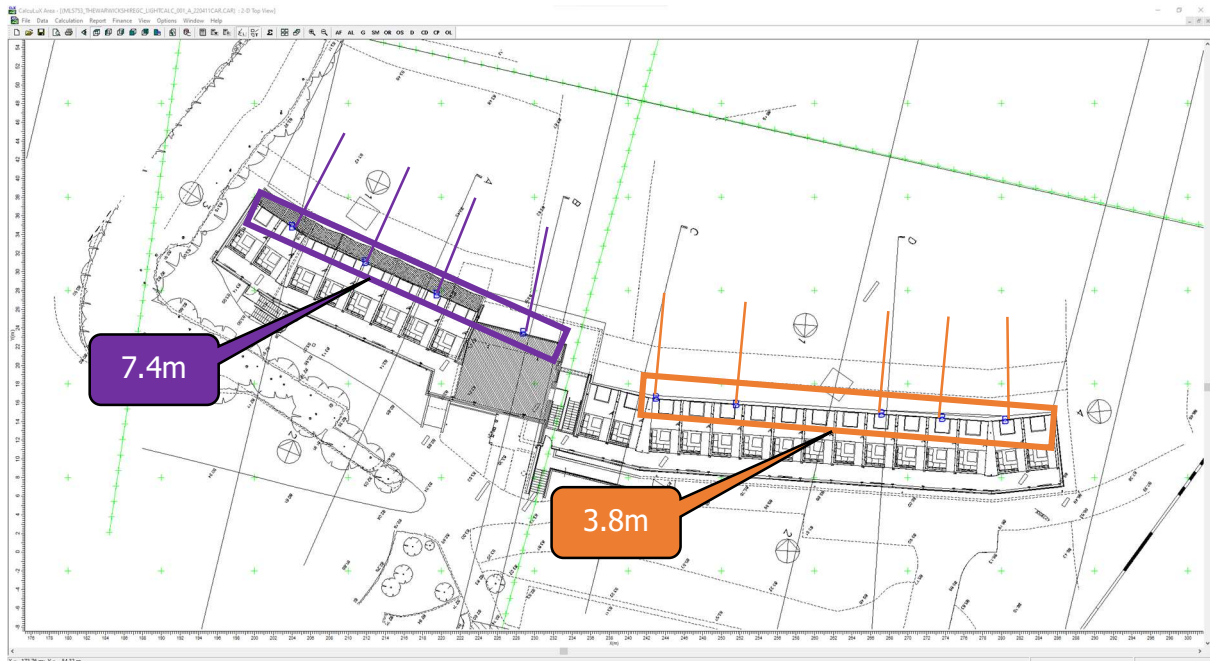
Figure 4 - Proposed layout and mounting height of lights

Based on the revised range layout consisting of a two storey and single storey bay combination, there will be 4 lights installed at 7.4m above the range floor for the 2 storey bays and 5 lights will be installed at 3.8m above the range floor for the single storey bays.

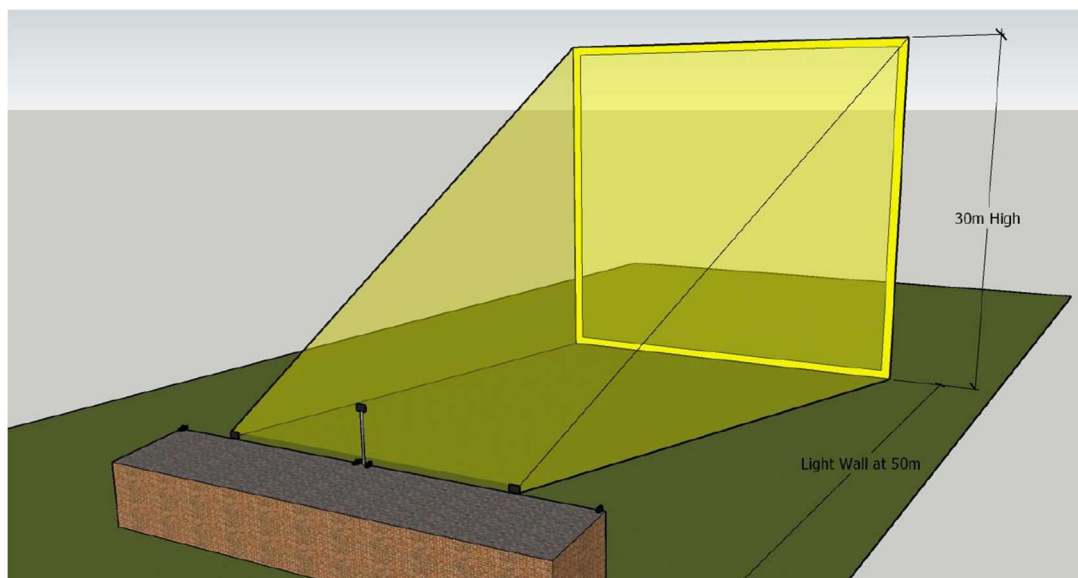
Figure 5 - Toptracer lighting requirement set up

With regards to the lighting element, it is suggested that a minimum 30 lux should be achieved over a vertical grid spanning the range width, 50m in front of the bays and up to a height of 30m as shown in Fig 5.

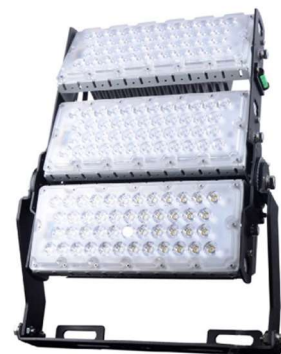
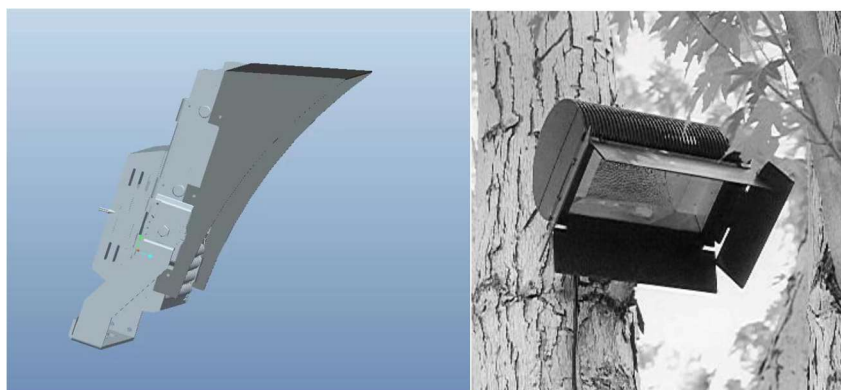
Figure 8 - Images demonstrating additional spill control measures

There are a number of versions and additions that are possible for the proposed light, it should be confirmed that a colour temperature of no more that 4000K should be used, all lights shall have the 'hood' fitted to reduce upward light where possible and 'barn doors' should be installed to reduce the amount of side spill as much as practicable.

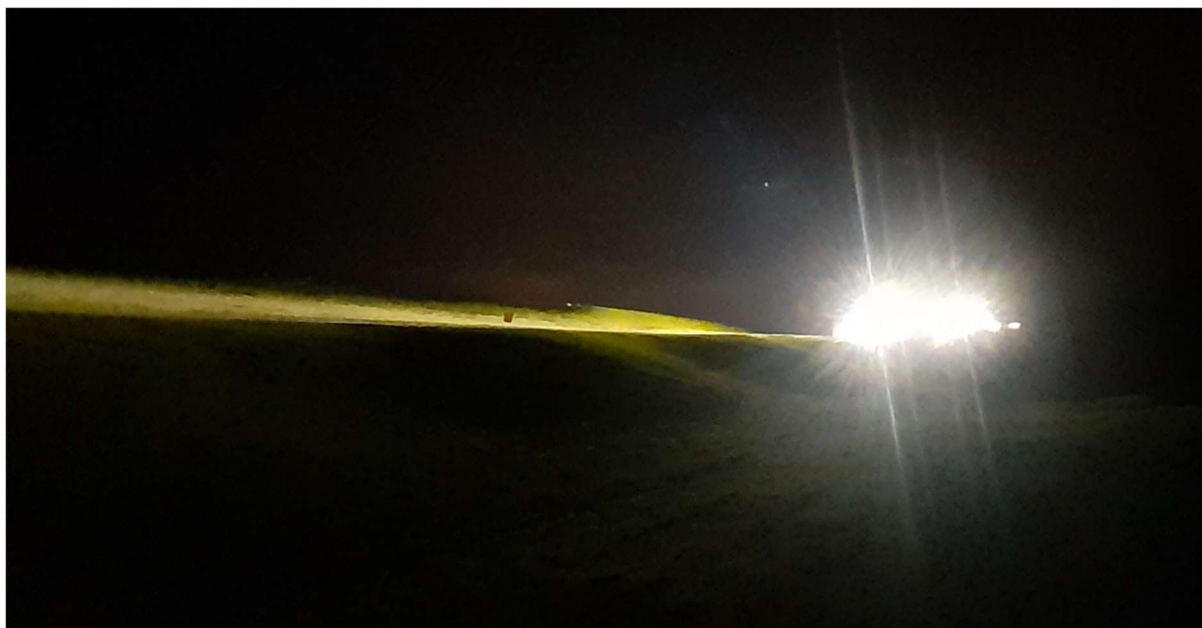
Figure 9 - Phone Camera picture taken from specific tree looking back to the existing range

During our night-time survey, a single measurement was taken at the tree 1.5m above the ground level which was approximately 2m below the range surface due to the topography of the land as seen in Fig 7.

The measured result was 0.5 lux with the existing lighting on, it must be noted that the light closest to the tree line was not operating at the time of the survey as shown in Fig 8. So, the results may be slightly more.

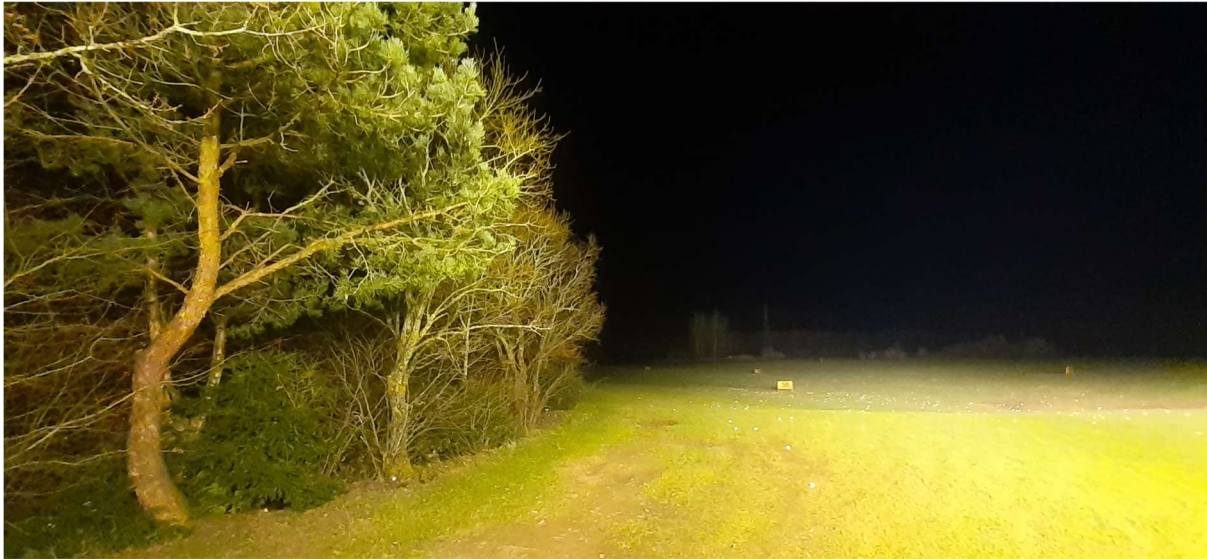
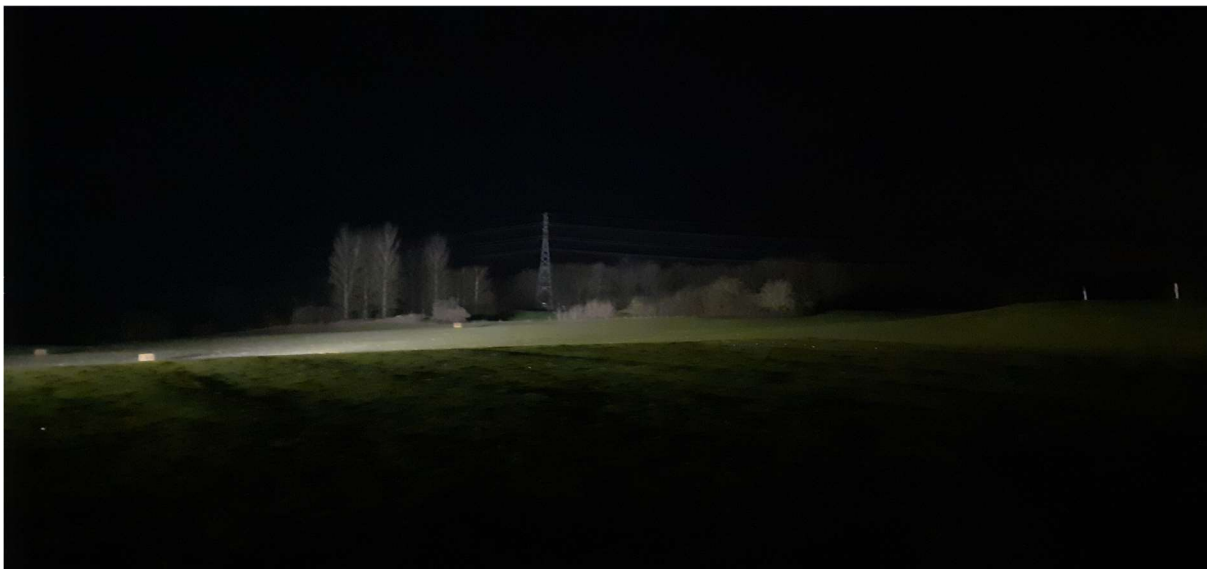
Figure 11 - View from the range looking to the end

Figure 12 - View across the range and to the end

As can be seen the existing lighting is as expected for this type of system and according to our calculations, the proposed system will produce similar results.
