**Bat Survey Report for
55 Fieldgate Lane,
Kenilworth,
CV8 1BT**

55 Fieldgate Lane, Kenilworth – Bat Survey Report

Report Number: 3866-CWS-01

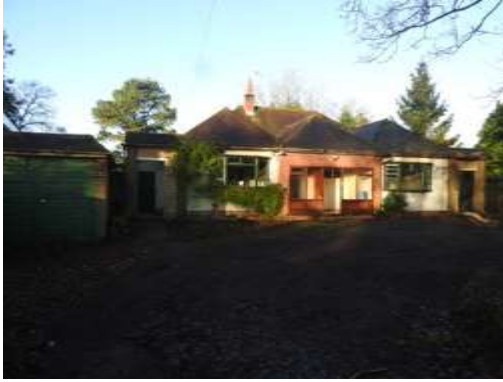
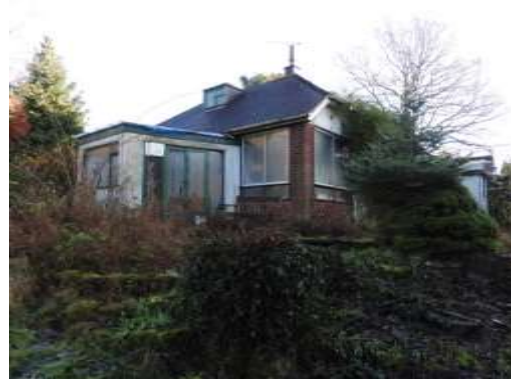
Figs. 1 & 2 Front and rear views of the bungalow

The survey site comprised a detached multi-hipped roofed bungalow with a flat roofed extension to its rear and a flat roofed garage to the south (Figs. 1 and 2 overleaf).

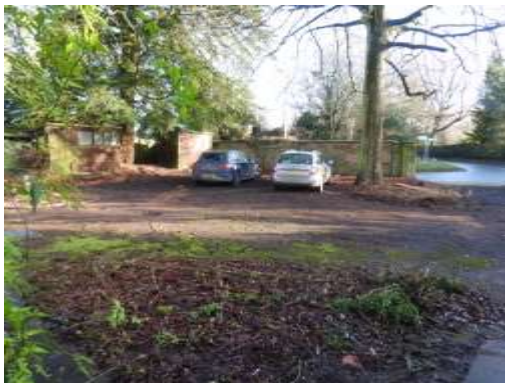
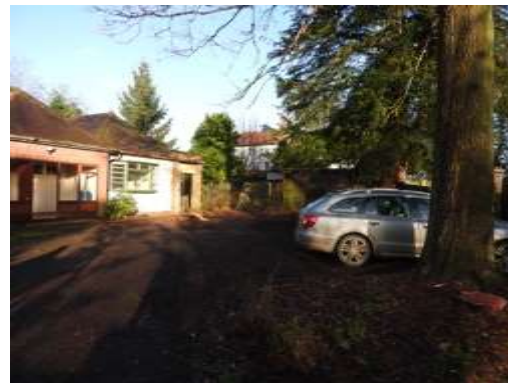
The front of the house was mainly laid to a gravelled drive with two large mature trees (Turkey Oak *Quercus cerris* and Yew *Taxus baccata*) in the garden, and open fields and mature trees beyond (Figs. 3 and 4).

Figs. 3 & 4 Views of the front garden to the east (L) and north (R)

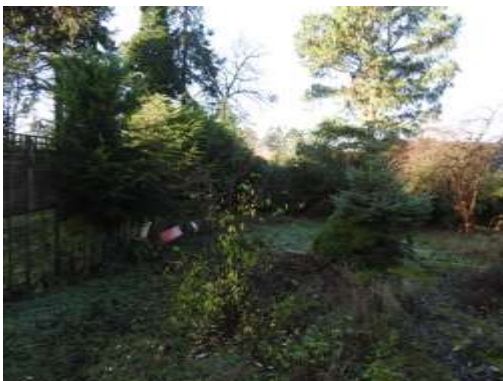
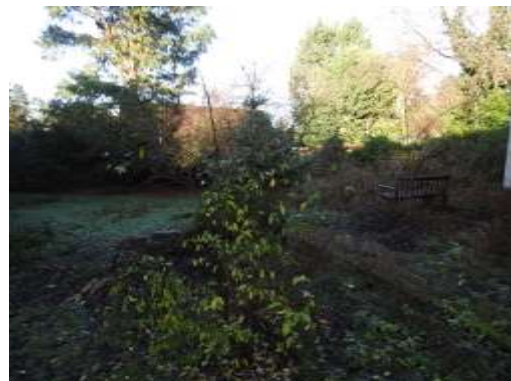
The large rear garden was overgrown with mature trees and shrubs along its boundaries (Figs. 5 and 6).

Figs. 5 & 6 Rear garden with mature trees and shrubs on its boundaries

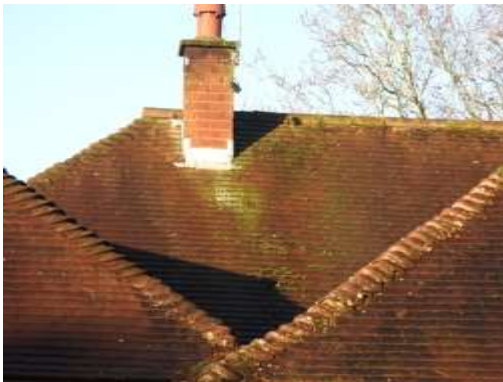
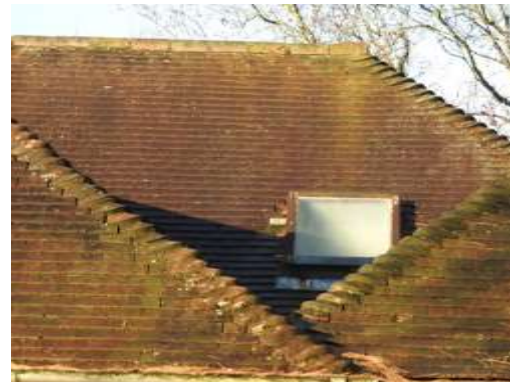
Figs. 7 & 8 Ridges and roof tiles to the front

The ridges and hip ridges were all intact and sealed, with no gaps or crevices, whilst all the roof tiles were tightly overlapping with none broken, dislodged or missing (Figs. 7-16).

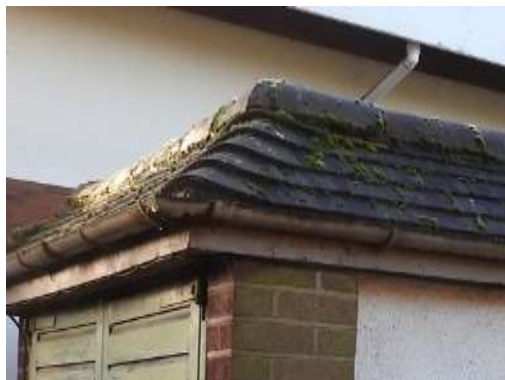
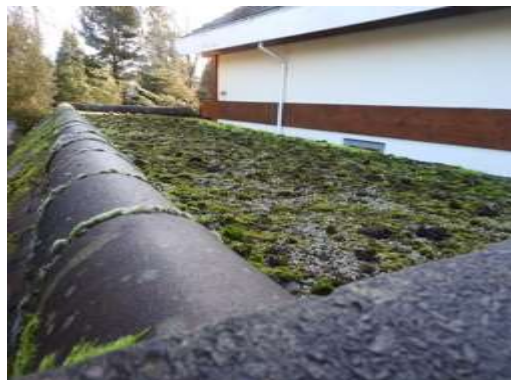
The ridge and roof tiles of the garage were tightly overlapping and sealed, whilst the flat roof was finished with tarred felt and was covered with moss (Figs. 17 and 18).

Figs. 17 & 18 Ridge and roof tiles of the garage (L) and the moss covered flat roof (R)

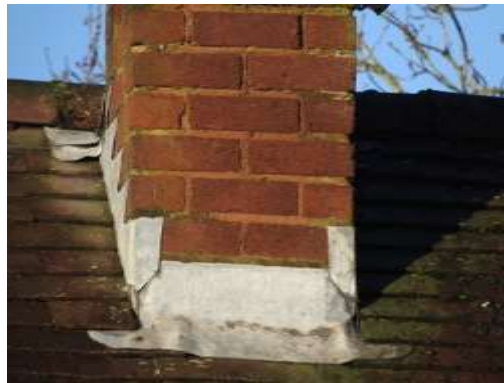
The chimney was finished with tightly moulded lead flashing around its base (Fig. 19).

Fig. 19 Tightly moulded lead flashing around the base of the chimney

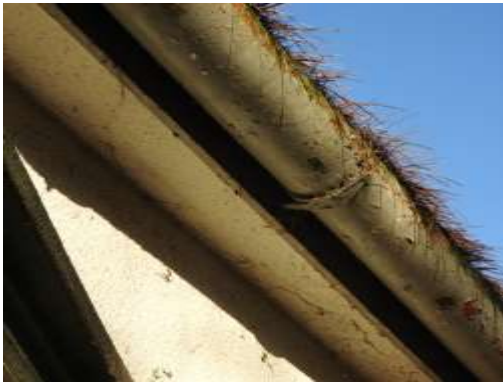
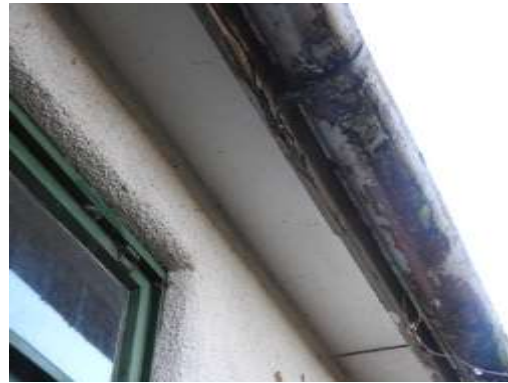
The eaves of the bungalow were finished with tightly fitting against boxed soffits (Figs. 20 and 21).

Figs. 20 & 21 Tightly fitting boxed soffits

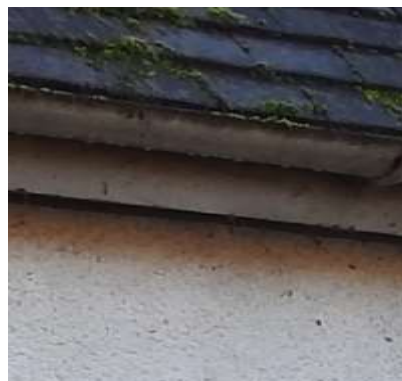
The eaves of the garage were finished with the roof ends tightly fitting against timber fascia boards which were tightly fitting against the garage walls (Fig. 22).

Fig. 22 Sealed eaves of the garage

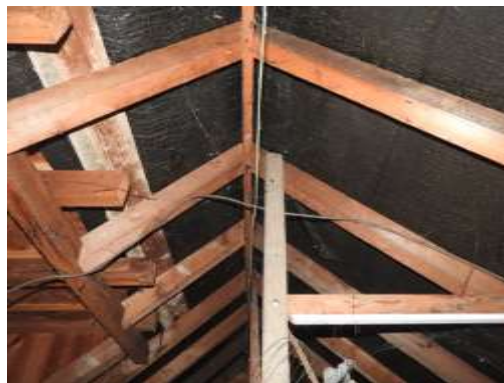
The roof was lined with tarred felt, this in good condition with no holes or tears observed. The ridge and plumb cuts were cobwebbed, this quite thick in several places (Figs. 23-28).

Fig. 23 Cobwebbed ridge of the main roof

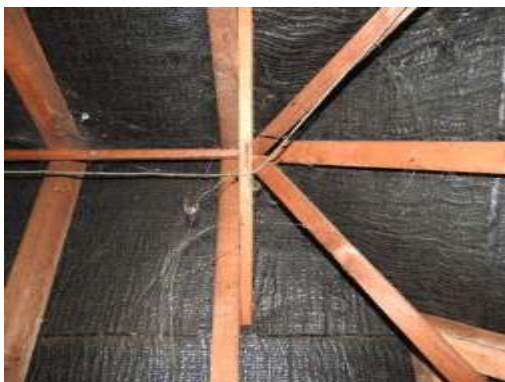
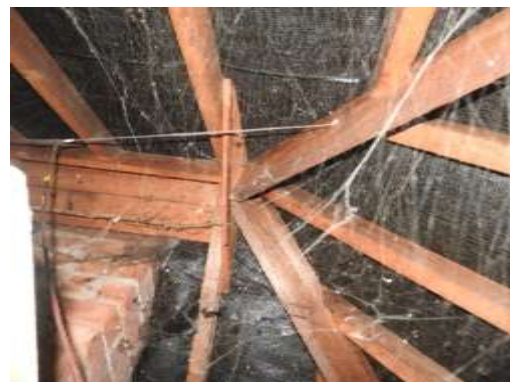
Figs. 24 & 25 Cobwebbed plumb cuts of the main roof

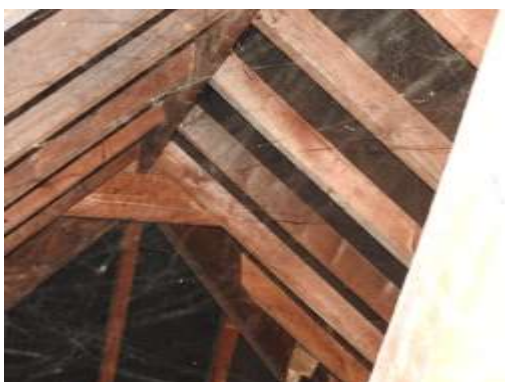
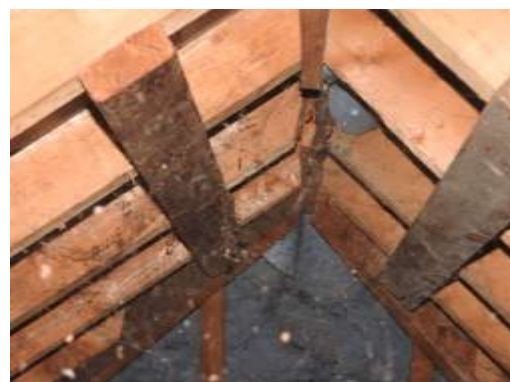
Figs. 26 & 27 Cobwebbed ridge and plumb cuts of the extended hips

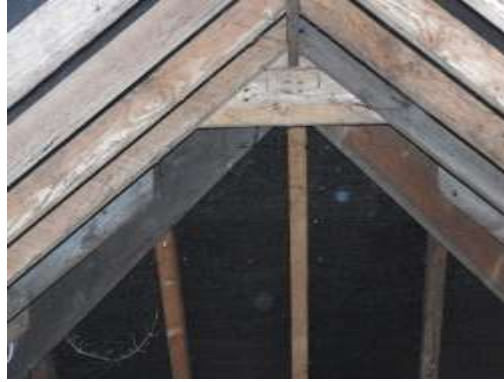
Fig. 28 Cobwebbed ridge and plumb cut of the extended hip to the north

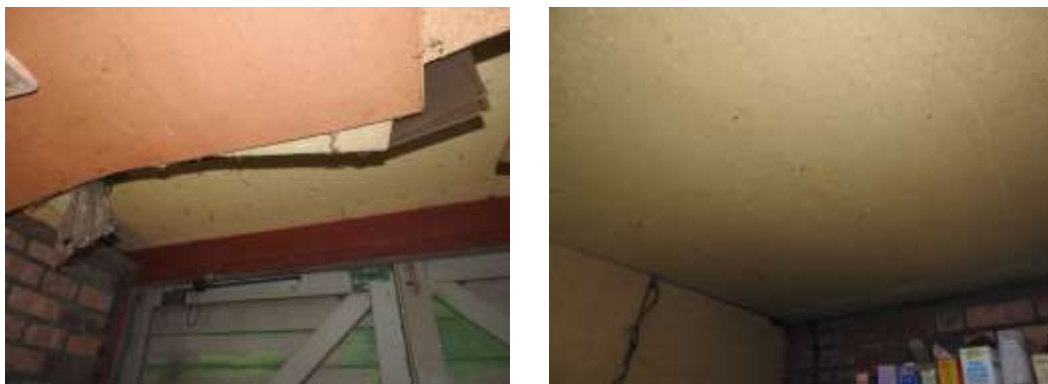
The garage was open to the board lined underside of the flat roof (Figs. 29 and 29).

Figs. 28 & 29 Board lined underside of the flat roof

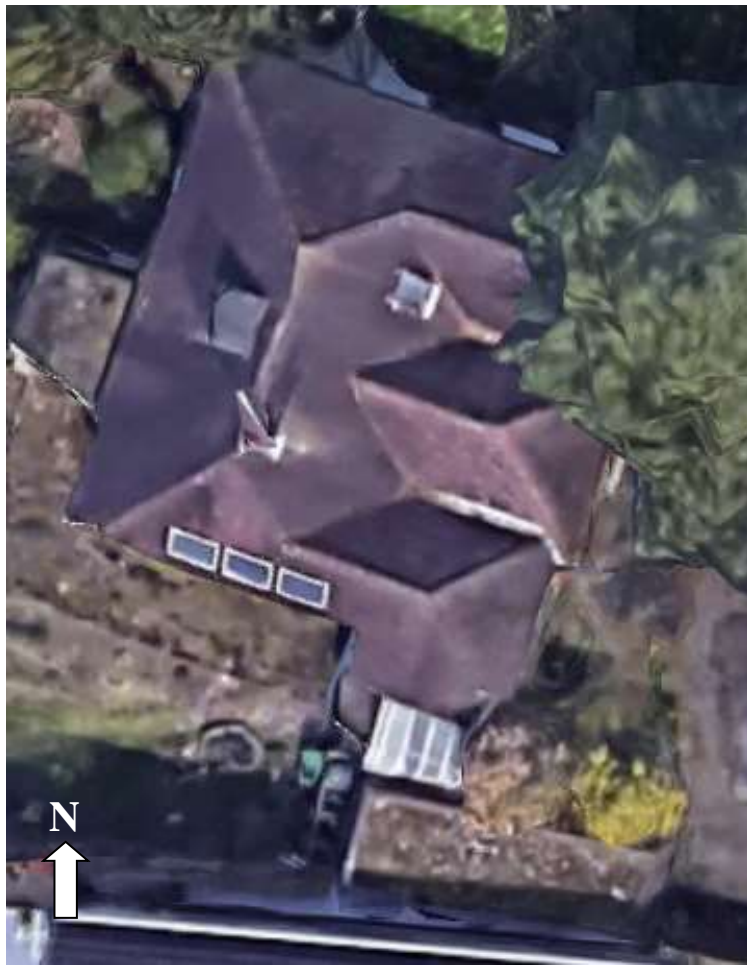
Appendix 2: Site layout

The layout of the site is shown in the aerial photograph in Appendix 2.
