# **Arboricultural Report**

**1 Fir Walk  
RAF Lakenheath  
Brandon  
Suffolk**

**28th July 2022**

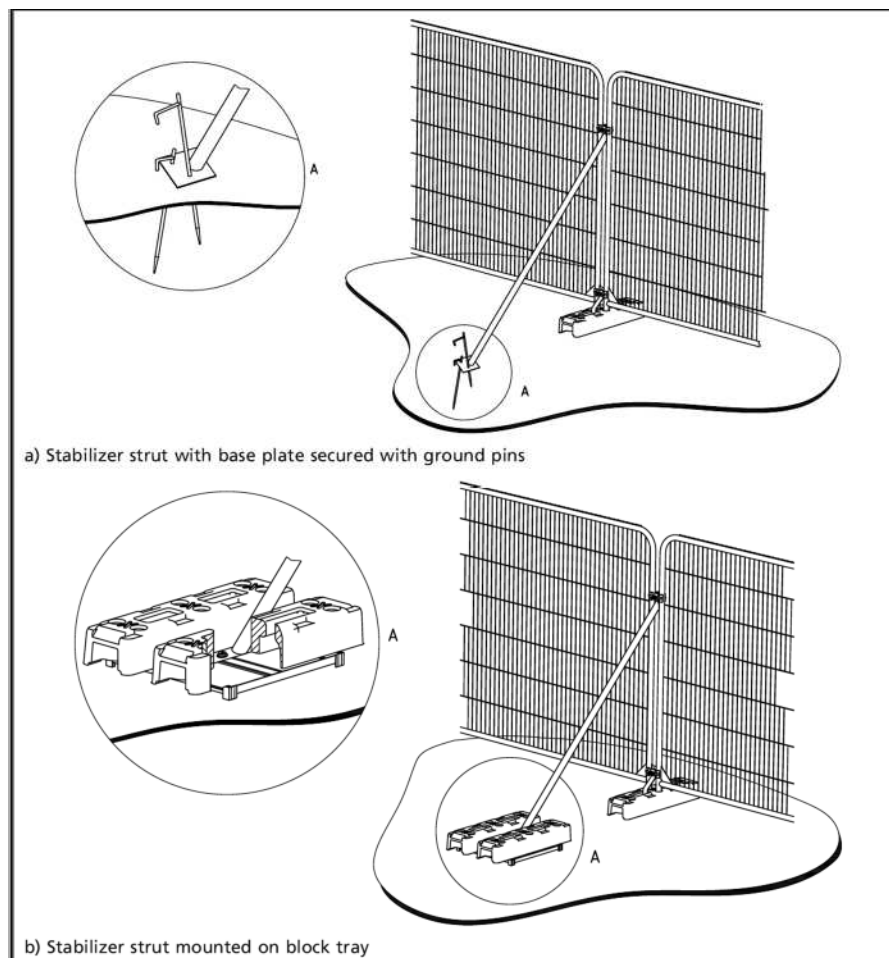
Fig 1: Temporary protective fencing as recommended by the British Standards (2012)

5. Retained trees will be protected by forming Construction Exclusion Zones (CEZ) as shown on the Tree Protection Plan.
6. Temporary barriers will be erected as shown by the thick pink lines on the TPP to form the Construction Exclusion Zone (CEZ). The barriers will consist of 2m tall welded mesh panels (Heras) supported on rubber or concrete feet. The fence panels should be joined together using a minimum of two anti-tamper couplers installed so they can be removed from the inside of the fence. The distance between couplers should be at least 1m and be uniform throughout the fence. Panels should be supported on the inner side by stabilizer struts which should normally be attached to a base plate and secured with ground pins. Where the fence will be erected on hard surfacing or it is otherwise unfeasible to use ground pins the struts should be mounted on a block tray.

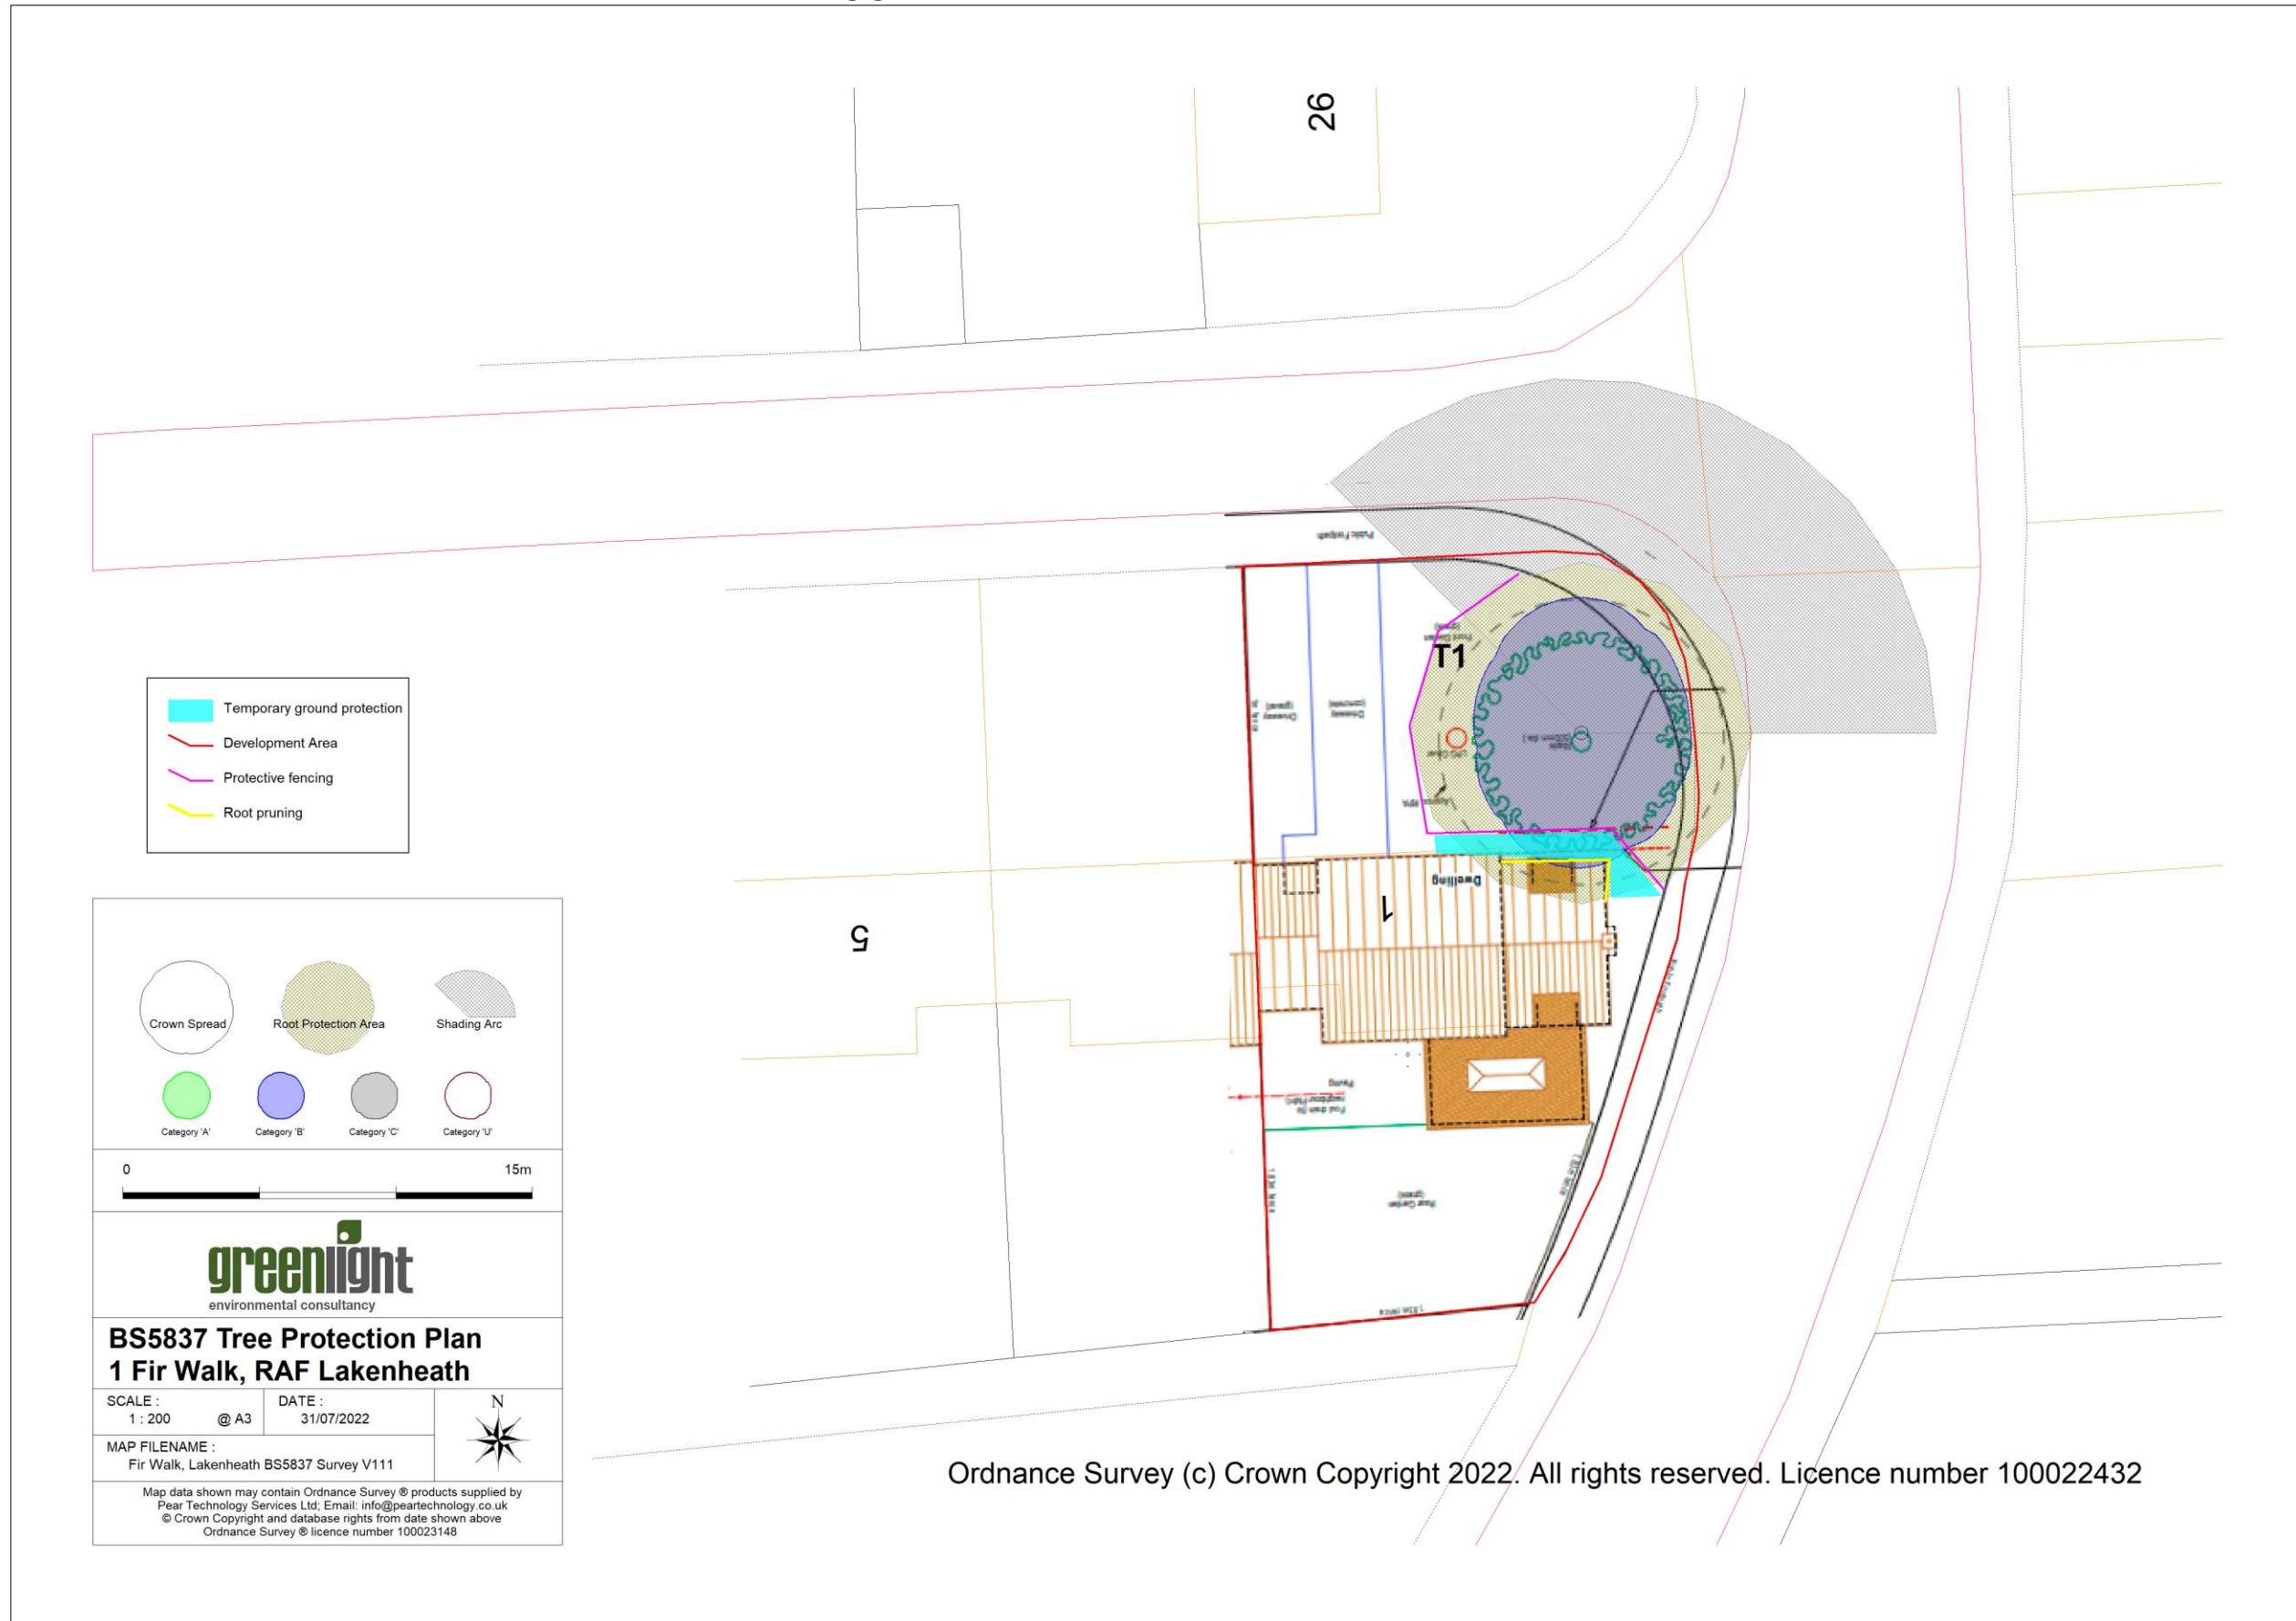
# Appendix E – Tree Protection Plan

- 5.10 The tree protection plan in Appendix E provides an illustration of the location of the protective fencing and further general guidance on tree protection is provided in the arboricultural method statement in Appendix D.

11. Pre-emptive root pruning will take place just outside foundations of the new wall to minimise injurious damage to the root system of the neighbouring trees whilst excavating. The position of this work has been shown as a thick yellow line in Appendix E – TPP.
12. This will be carried out by excavating a trench, at most 500mm outside the line of the strip foundations within the area shown on the TPP, using hand tools or an airspade immediately adjacent to the trees. Any roots under 25mm in diameter found during this
