Preliminary Roost Assessment on a Barn at Ashwell Hall Farm, Great Bardfield, Braintree, Essex

**Prepared for Cabotlane
April 2022**

Site Name	Barn at Ashwell Hall Farm
Report Type	Preliminary Roost Assessment
Client	Cabotlane

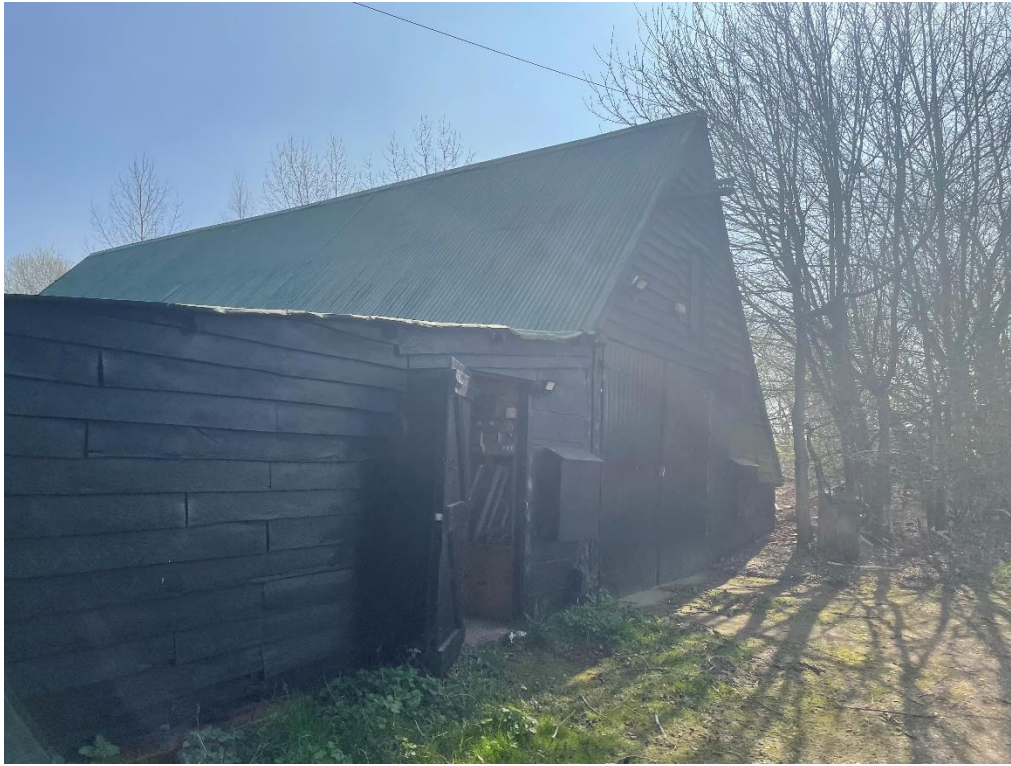
Plate 1 Barn-Front View

Building Name/Number	1			
Building Grid Reference	TL7076330236			
Type of Building	Barn			
Age of Building	20 th century			
Condition of Building	Good			
Wall Construction	Breezeblock and Wood			
Roof Construction	Corrugated Tin			
Roof Type	Gable			
Potential Access Points for Bats	Open access			
Roof Void	Yes	X	No	
Insulation	Yes		No	X
Structure of Roof	Not applicable			
Roof Lining	None			
Estimated Dimensions of Roof Void	20m x 10m x 2.2m			
Suitable Roosting Features	None			
Evidence of Bats	None			
Evidence of Birds	None			
Evidence of Barn Owl	Not applicable			
Potential to Support Roosting Bats	Negligible			
Suitable for Hibernating Bats	No

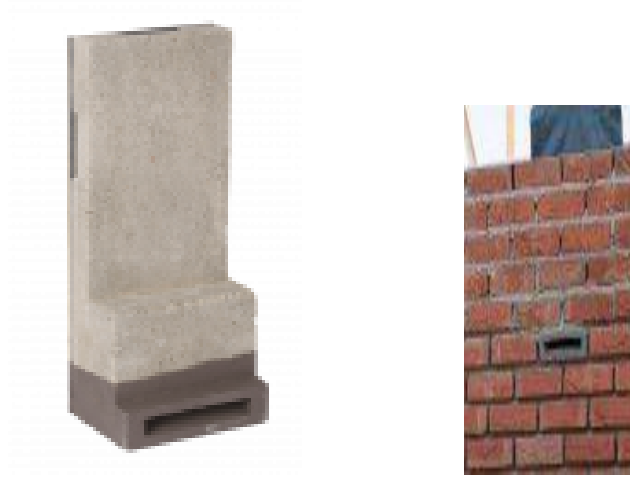
Bat Boxes

The Vivara Pro Build-in WoodStone Bat Box has been specifically designed to fit into the cavity of house walls. It features a slim sized entrance hole which can sit flush in a course of bricks to provide a discreet entry way for bats. It is manufactured from hard-wearing WoodStone and plywood with removable side panels so that several boxes can be placed side by side. Position the box at least 2m above ground level away from artificial light sources. WoodStone is a mixture of sawdust from FSC wood sources and concrete, and it is designed to last for years. It is breathable so there will be no problems with condensation and Woodstone maintains a consistent temperature inside, providing excellent insulation for roosting bats.

7.1 To enhance biodiversity Vivaro Pro built in bat boxes, or equivalent should be installed on the south facing elevation of the barn at a height of at least three metres.

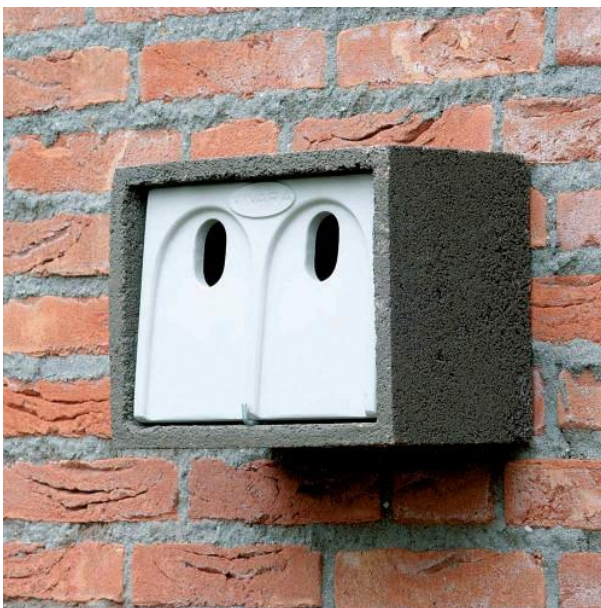
Woodstone Sparrow Nest Box

The House Sparrow Nest Box is from the Vivara Pro range and is manufactured from WoodStone - a mix of concrete and FSC wood fibres. This material is strong and highly insulating which helps to provide a thermally stable environment within the box. It also protects against damage from predators such as woodpeckers, squirrels and cats. It has two breeding chambers making it particularly suitable for house sparrows as they prefer to nest in colonies.

The House Sparrow Nest Box can be integrated into the masonry of a new house or fixed onto an external wall using strong screws and wall plugs (not included). If possible, it should be positioned near to vegetation and at a minimum of 2 m above ground.

7.3 To enhance biodiversity a nest box for House Sparrow, House Martin and Swift should be installed between north and east elevations.

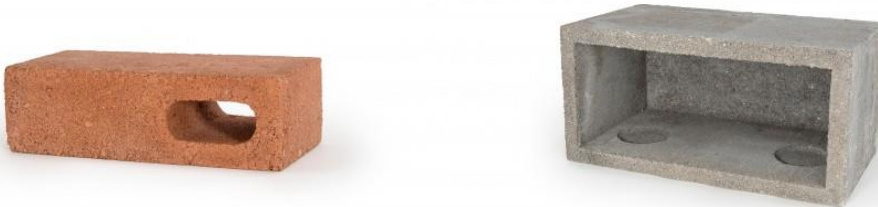
Cambridge Swift Nest Box System x 2

The Cambridge Swift Nest Box system comprises a nesting block built into a standard block or brick wall and faced with either a red or buff brick entrance. The nesting block has two nesting depressions and a large space for the young to exercise. Cost-effective concrete construction.

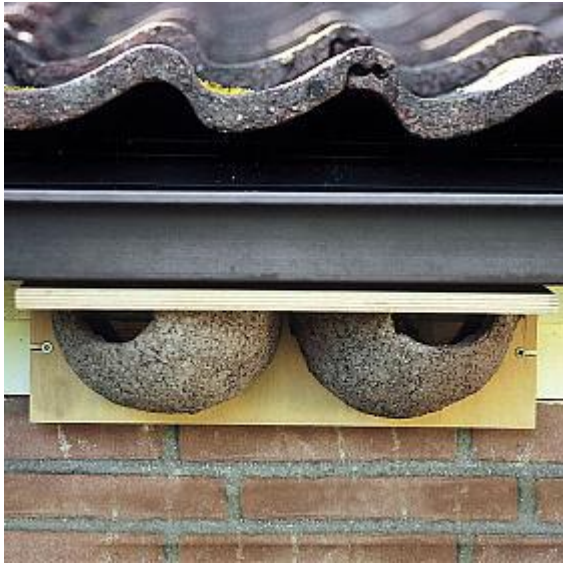
House Martin Nest Box x 2

House Martins build nests constructed from mud under the eaves of buildings often in colonies averaging five nests. Unfortunately, changes to house construction and roof design mean that suitable nest sites have dramatically declined. Providing an artificial nest provides a great alternative and House Martins will readily use artificial nests and encourage other birds to nest nearby. These House Martin Nests have been specially designed to appeal to House Martins and are constructed from exterior grade plywood and WoodStone, a mixture of FSC wood fibres and concrete. The backing to the nests is exterior grade plywood, making them lightweight and easy to fit, but hard-wearing. These nests should be sited underneath the eaves on exterior walls of your house or outbuildings, at a minimum height of 2m above the ground.
