The Red House, Worlingworth, Suffolk

Heritage Asset Assessment

The Red House, Shop Street, Worlingworth, Suffolk

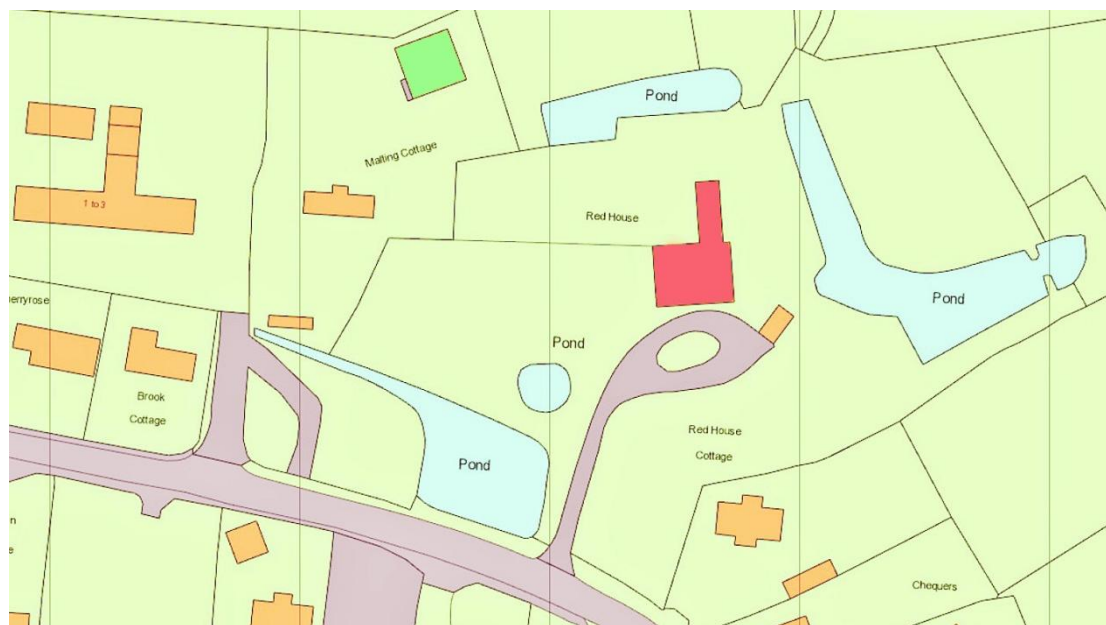
Figure 2. A current site plan highlighting the house in red with linear ponds to the north and east. The now converted maltings lies to the west.

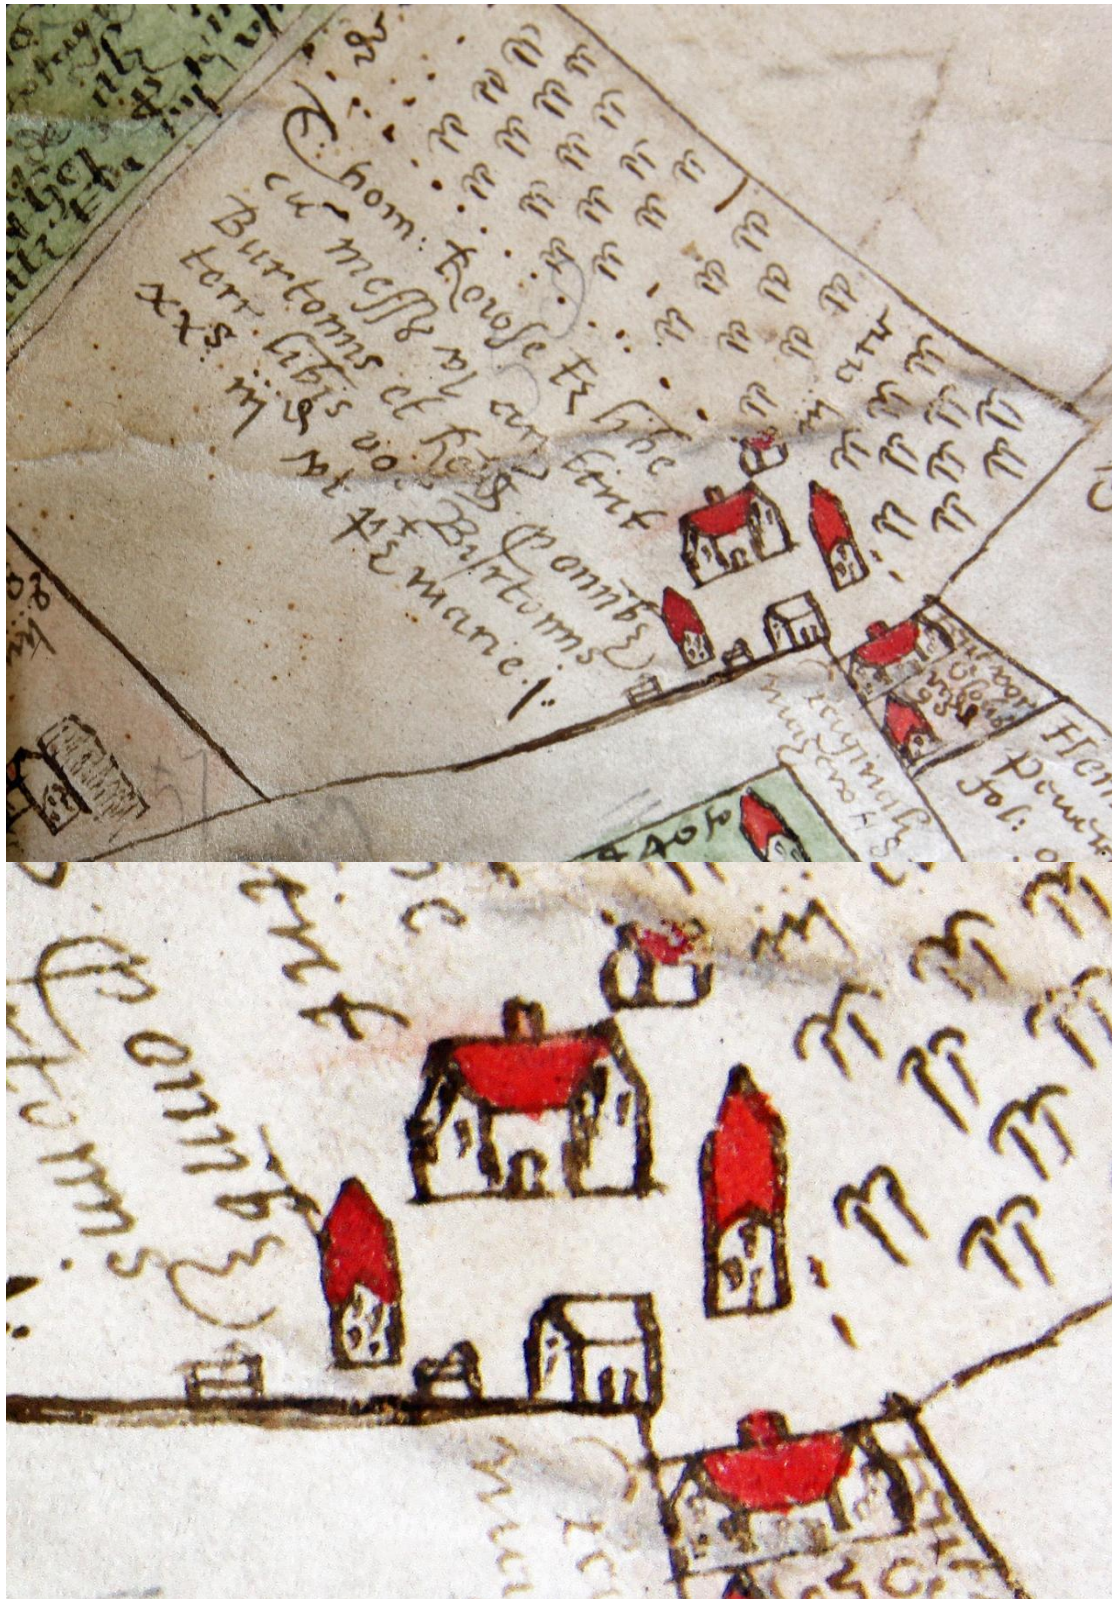
Figure 3. The property called ‘Burtonns’ as depicted on ‘The old mapp of the manor of Worlingworth’ dated to *circa* 1606 by local historian John Ridgard on the basis of internal evidence. (Suffolk Record Office HD 417/33). The buildings on the map are stylised, with most depicted as cross-wing houses, but their general arrangement is likely to be reasonably accurate. The house faced a front yard or ‘base court’ in the medieval tradition, with outbuildings that probably included a barn and stable to the east and west and a possible gatehouse on the street to the south. A small shed lay to the rear.

In order to trace the history of the house backwards from 1714, reference should be made to the map of Worlingworth manor compiled c.1606 (HD417/33). This map recorded that the tenant of the Red House then was Thomas Rowse, who held in free tenure "a messuage with 6 acres of land, tenement Burton's". Rowse was paying 23s.4d. per annum for all the free lands of Tenement Burton's as the Red House was

then called. According to an inscription on the 1606 map, this information could be found in a survey dated 1553-4 it should be noted that the Red House/Burton's did not have a porch in c.1606 (which must therefore date between c.1606 and 1705), but did have two gabled wings projecting southwards from the east and west ends of the house. The out building to the south east existed then, but two other structures disappeared between 1606 and 1743: one of these was a smaller version of the outbuilding (above) which stood a little distance from the south west corner of the house and the chimney stack abutting on the road frontage. Worlingworth is perhaps the best-documented village in Suffolk in terms of medieval and Tudor manuscripts of virtually all categories. The survey of 1553-4 (see above) still exists (S1/2/7.16) but hives its best information in a series of entries added in 1610. This confirms that the tenant was Thomas Rowse (above), but also stated that this property consisted of free lands, which were once held by Elias de Worlingworth and later by John Burton. At least this explains how the Red House came by its earlier name of Burtons. The 1606 survey also recorded that more information could be found in manuscripts dated "the 20th year of Richard 2nd" and "the first and third years of Henry V". These turn out as expected to be entries in manor court rolls and they, also still exist.

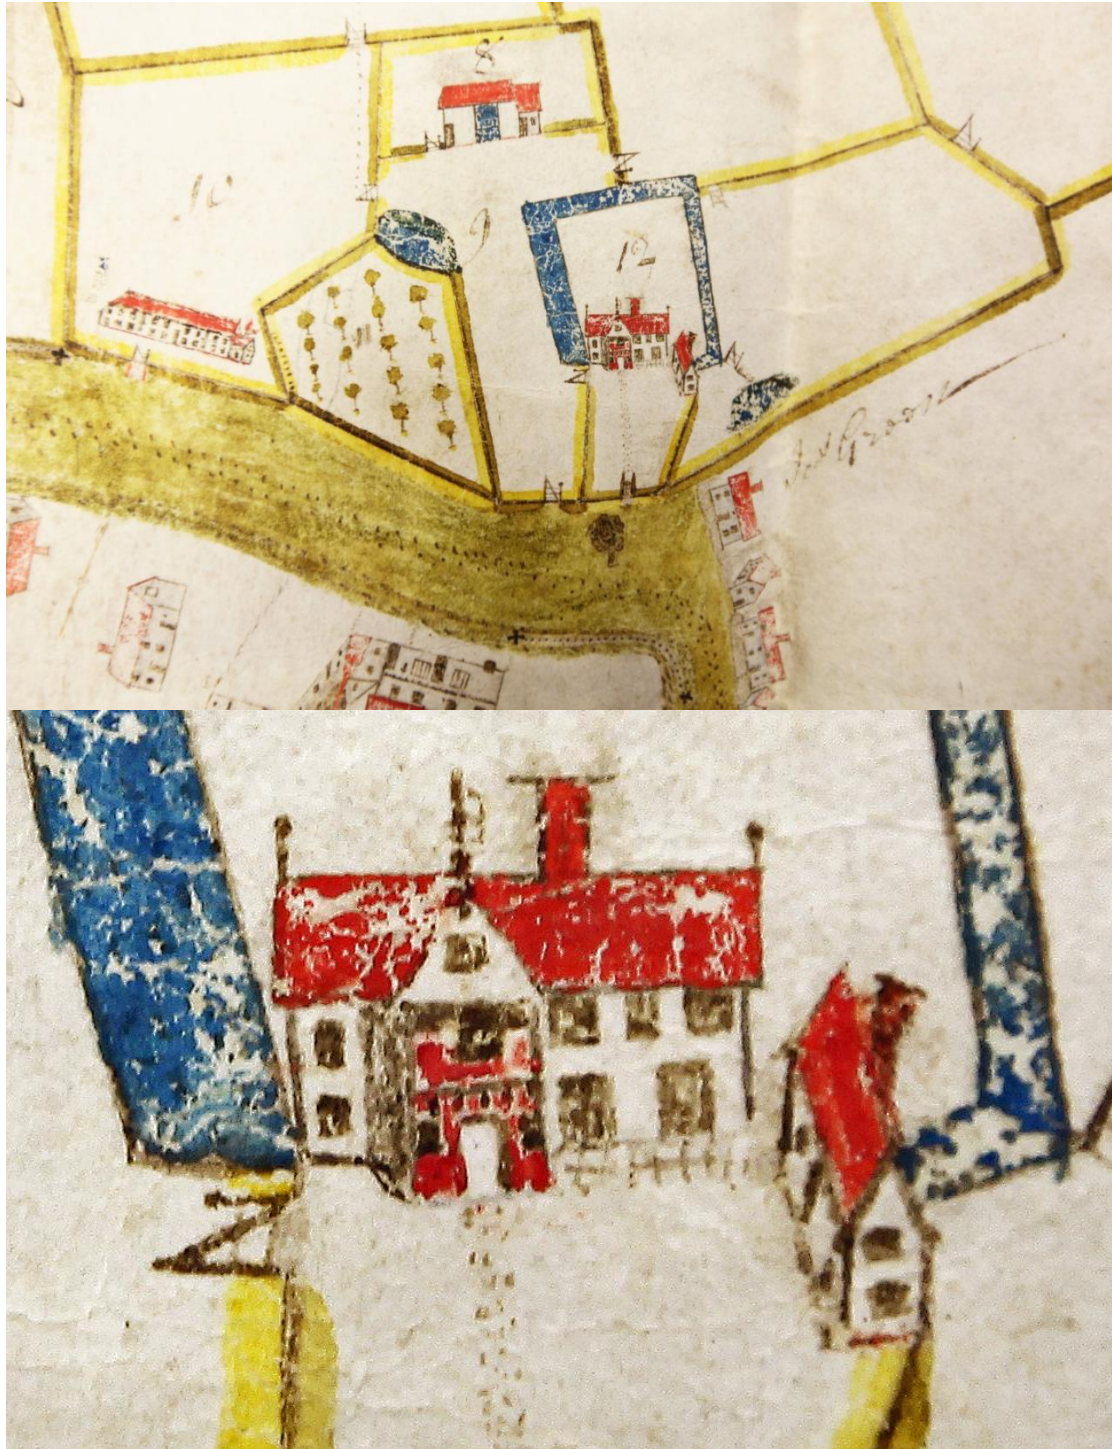
Figure 4. A copy of a map of 1743 kindly supplied by Geoffrey Robinson (SRO HD 89/13). This may be the same as the map of a ‘farm called Button’ in Worlingworth lately belonging to Dunston but now to Richard Marryot Esquire and leased to John Blaxell, SRO HD 417/34. The new maltings is shown to the west, along with a new threshing barn and adjoining stable to the north of a moat behind the house (within which archaeological evidence of a medieval house may survive). Water features were ignored by the 1606 map. This is likely to be an accurate depiction of the house with a large possibly brick porch adjoining the cross-passage and a high-end chimney. Only the outbuilding to the east of the base court survived at this date, with a central door and chimney. It may have been a bake-house or a domestic annex – or both. Its presence could explain the original parlour door.

The map of 1743 depicts the Red House as a traditional Suffolk house of three bays but with a two-storey porch projecting on the front from the southern end of the screens passage. It would be no surprise to discover that this substantial porch was incorporated into the main body of the building later in the 18th Century (or early in the 19th) when the "Georgian" front was added. It should also be noted that a smaller building with chimney still existed in 1743 adjacent to but not quite touching the southeast corner of the Red House (see map attached hereto).

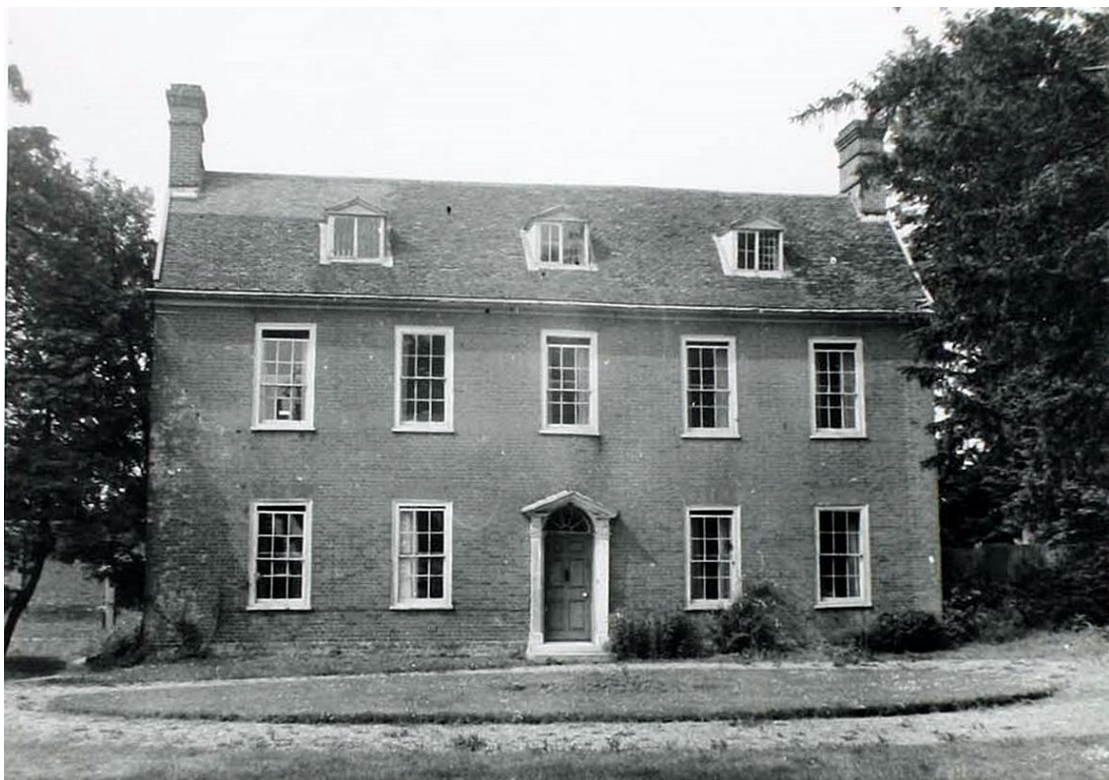
Figure 11. The house in 1949 (Historic England archive). The contrast between the small-paned casement windows of the attic dormers and the sashes below is almost certainly an original feature of the building, although some of the former had been replaced with larger panes at this date. They have since been reinstated.

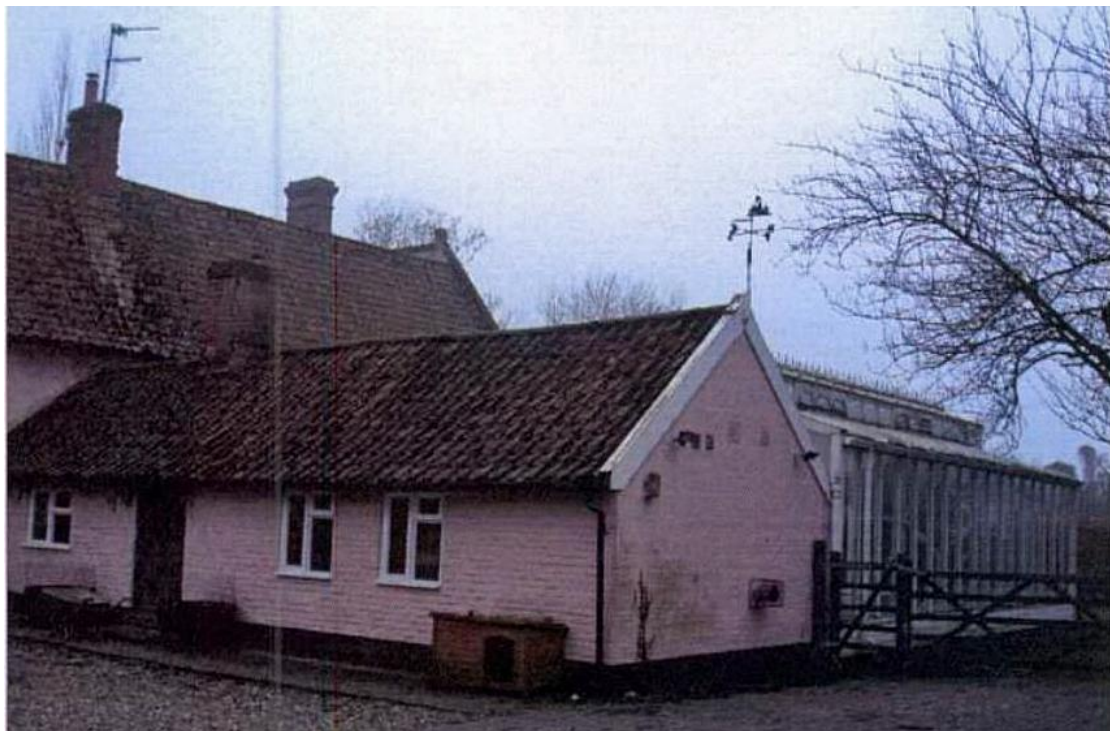
Figure 13. The house from the north-east in 2011 showing the extended service wing before the addition of the present swimming pool in 2011. The previous covered pool of *circa* 2000 is visible behind the house to the right (see figure 13).

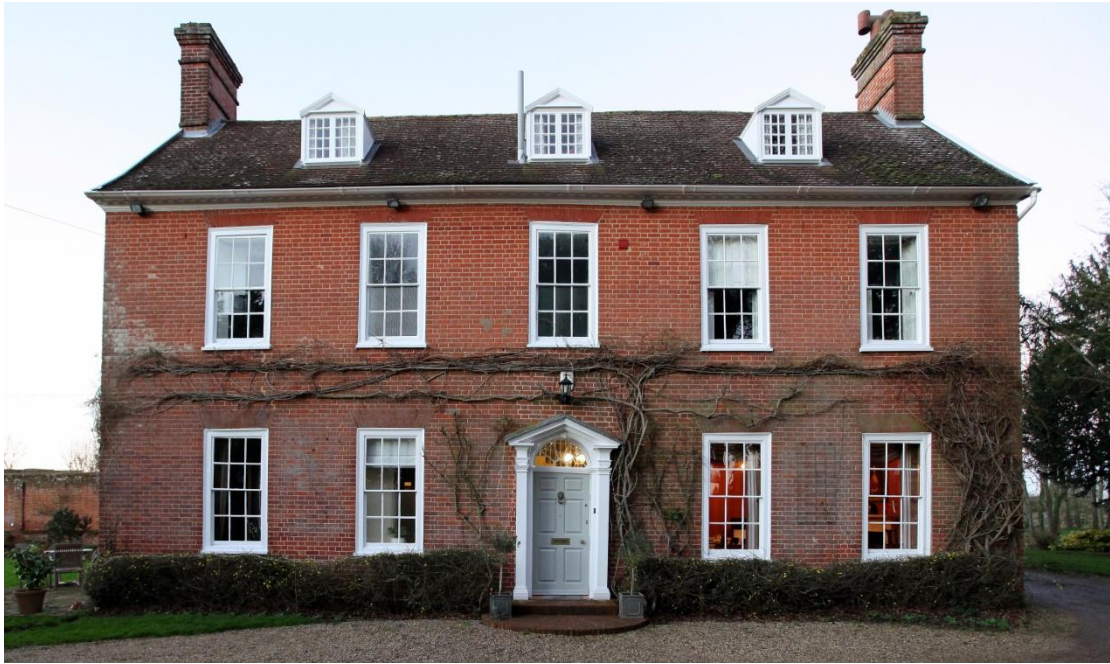
Illus. 1. The handsome, symmetrical late-Georgian southern facade, which remains unaltered since it was built – probably by William Ray the Younger who owned the property between 1768 and his death in 1790.

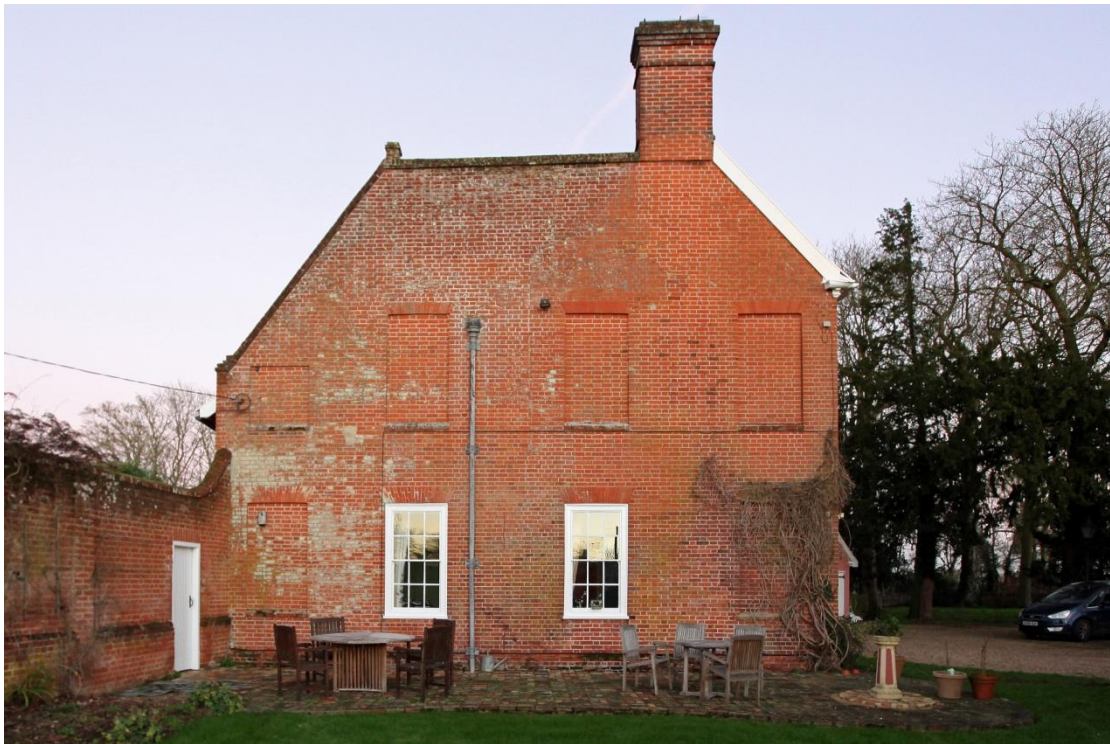
Illus. 2. The remarkable Georgian western gable which disguises the earlier timber-framed structure to the left. Its blind windows were designed as such, and were intended to relieve the considerable expanse of brickwork. They bear no relationship to the Tudor building, and it was necessary to raise the ceiling in the latter's service bay in order to accommodate the ground-floor window to the left. Both first-floor windows to the left of the drain pipe are obstructed by the original tie-beam in illustration 23.

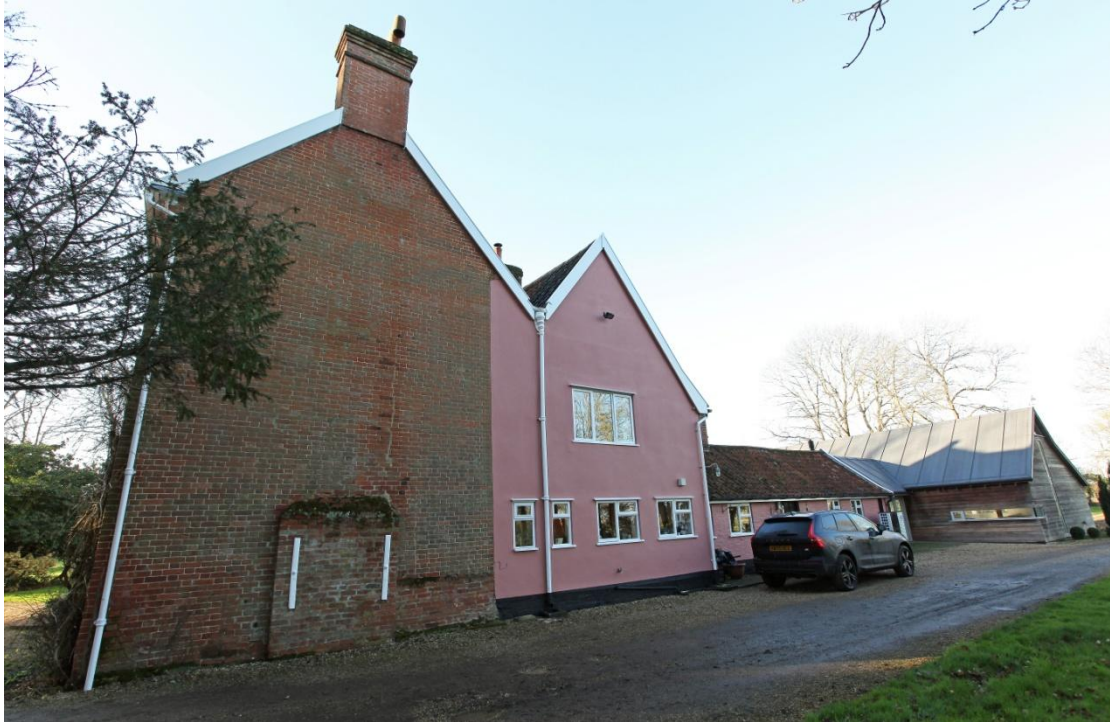
Illus. 3. The eastern gable was not visible from either the maltings or the road and was not disguised in the manner of its counterpart to the west. The rafters of the Georgian front range over lap those of the lower Tudor building giving the earlier gable a false appearance of asymmetry.

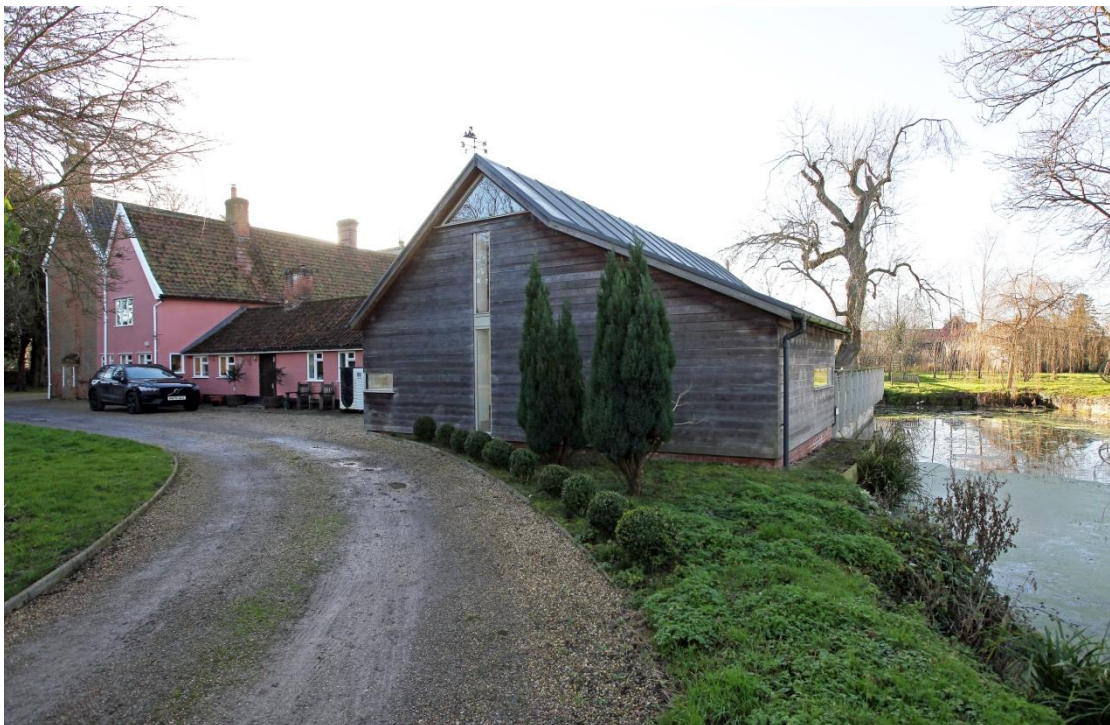
Illus. 4. The house from the north-east showing the covered swimming pool adjoining the single-storied rear service wing adjoining the moat. This was built with planning permission in or about 2011 (MDC 1606/11), replacing an earlier example immediately behind the house that was built without consent in *circa* 2000 by a previous owner, C J Robinson – although retrospective consent was granted in 2003 (MDC 111/03 and LB/17/03).

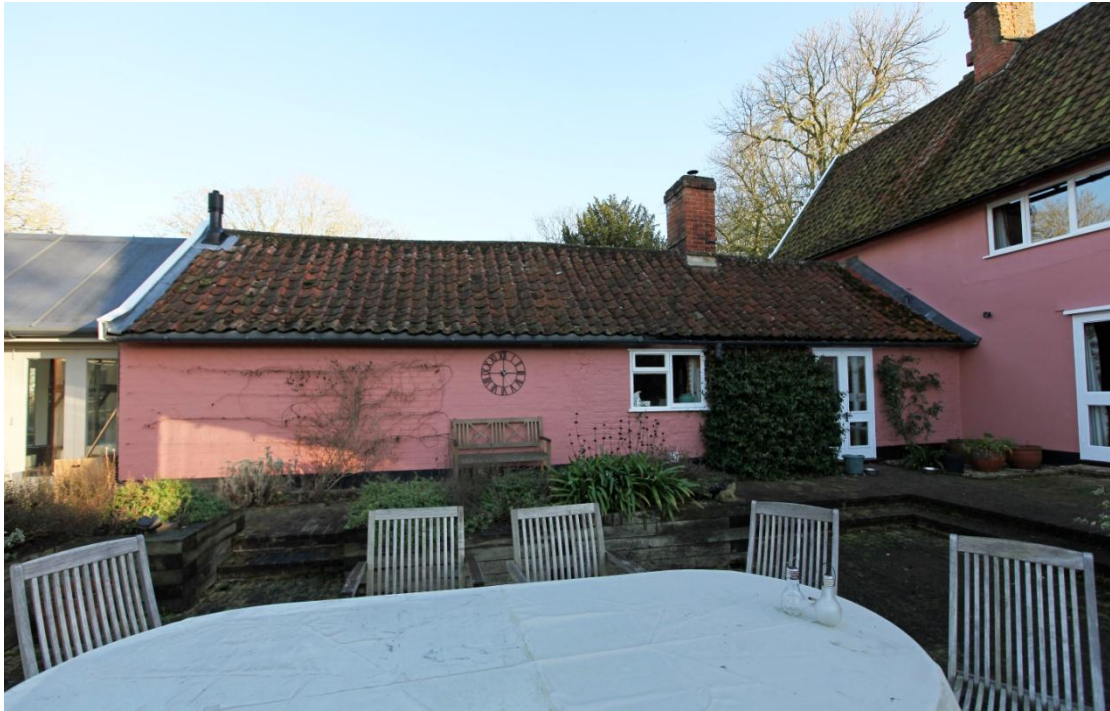
Illus. 5. The brick rear service range from the west with the Tudor house on the right and the addition of 2011 which forms part of the covered swimming pool on the left. The chimney was roughly central to the original structure as shown in figure 12, but it had been extended to its present length by the 1970s. The swimming pool of *circa* 2000 extended from the clock to the northern gable on the left and the new brickwork that filled the wide connecting door is visible to the left of the bench. This rear yard lies in the expected position of the medieval house at the centre of the moat.

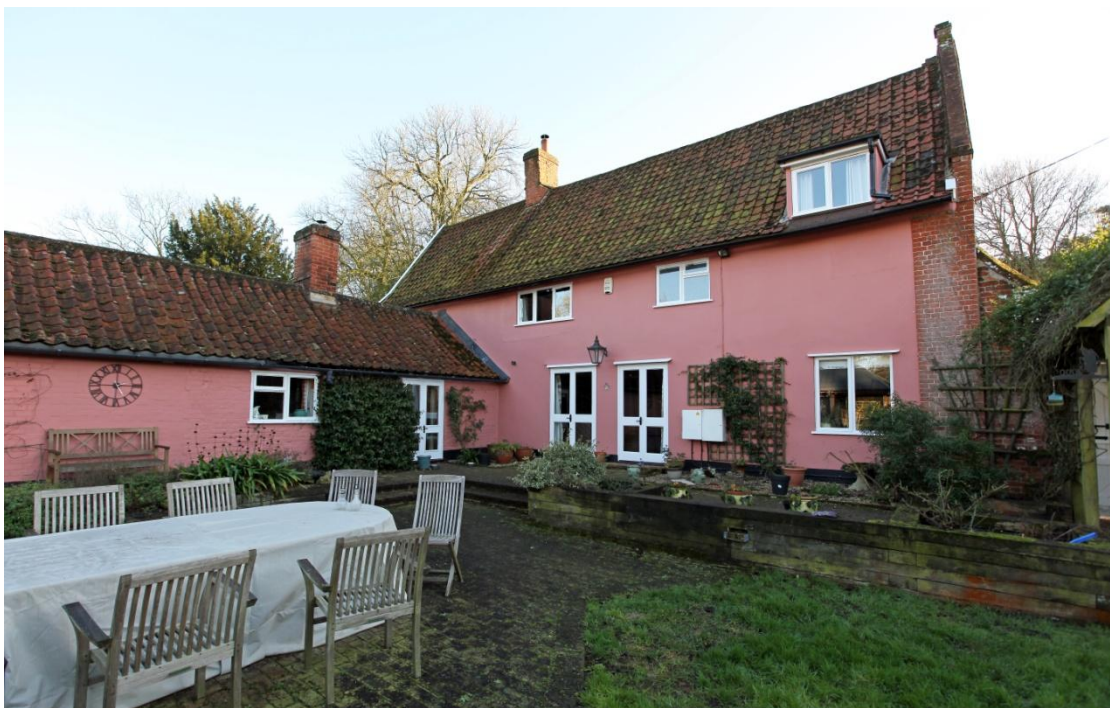
Illus. 6. The rear (northern) elevation of the early-16th century house with the brick western gable in illustration 2 on the right. The windows date from a major late-20th century refurbishment which occurred prior to 1997. Figure 12 shows small-paned casements that may have survived from the Georgian remodelling.

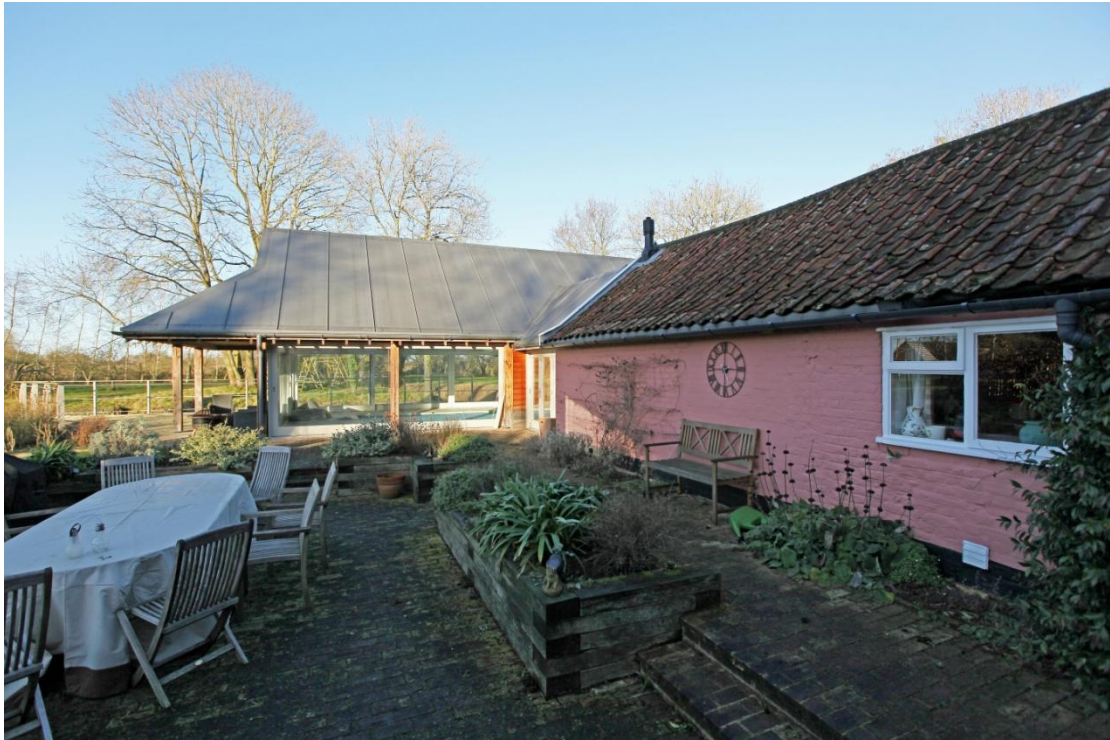
Illus. 7. The rear courtyard from the south showing the covered swimming pool of 2011 adjoining the single-storied service range.

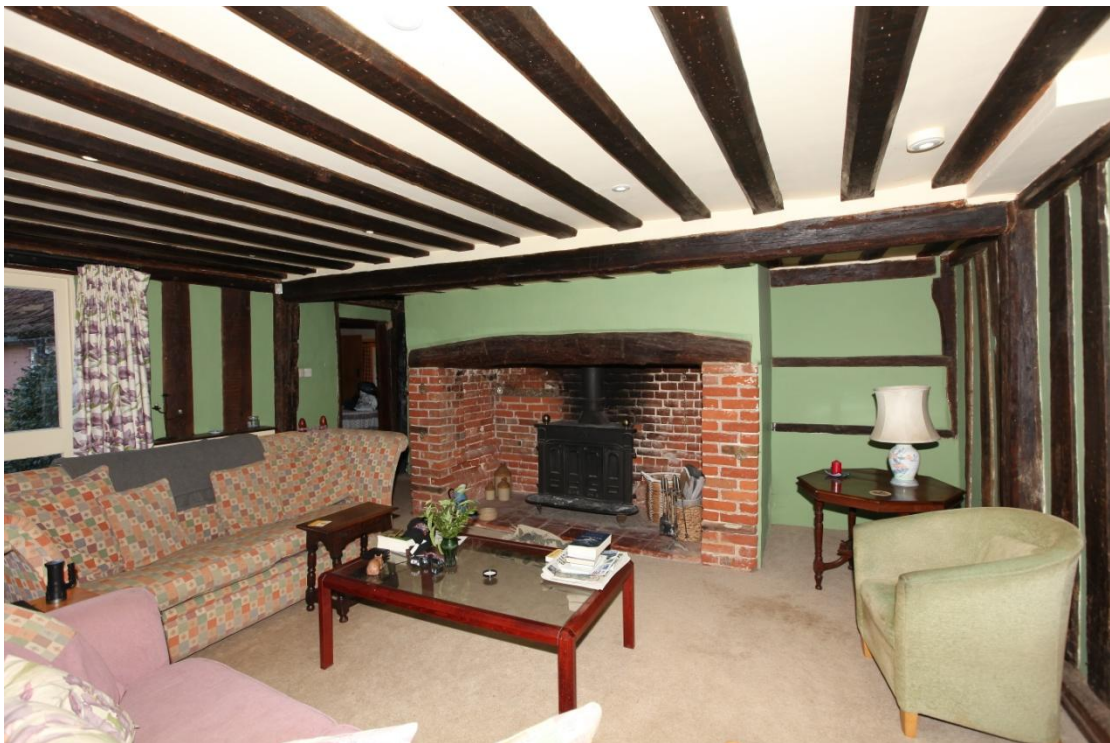
Illus. 8. The early-16th century hall (the living room in figure 15) looking east towards the narrow high-end chimney bay of 1.4 m (4.75 ft) that was probably designed for a single, large fireplace heating the hall but not the parlour. The present fireplace is a reconstruction of the 18th century, and the original brickwork would have adjoined the jambs of doors to the right and left that opened into the parlour and either a cupboard or newel stair respectively. The common joists of this room were hidden by lath-and-plaster as recently as 1997.

The present fireplace at the high end of the hall in illustration 8 is an 18th century replacement in uniform red-brick that differs sharply in character from the variegated painted brickwork of the 16th century. Its larger predecessor would have filled the dedicated narrow bay for which it was designed, abutting the underside of the principal ceiling joist above. This joist contains

mortices for the jambs of missing doors on each side, and the parlour would have been accessible to the front of the stack (i.e. to the right in illustration 8). The existing kitchen door to the left was blocked by a solid wall as indicated by pegged stud mortices in the ceiling joist above (i.e. to the east of the bay). At 1.4 m or 4.75 ft in length the chimney bay probably contained only a single fireplace facing the hall, leaving the parlour unheated. Dedicated bays for chimneys with back-to-back fireplaces are usually 6 ft or more in length, although it remains possible that a shallow fireplace may have faced the parlour – particularly as any mortice pegs for a solid wall in this position are currently hidden by kitchen cupboards. The parlour itself consists of two short bays and extends to 3.7 m or 12 ft in length. Its common ceiling joists are chamfered like those in the high-end bay of the hall, although those of the eastern bay are currently hidden by modern plaster like the ground-floor gable (illus. 12). Unusually, its southern facade contains an original arched door of 0.7 m in width (27 ins), with carved external spandrels as shown in illustration 13. Additional parlour entrances of this kind became common in rural Suffolk during the late-16th and early-17th centuries as these rooms were used increasingly for entertainment in addition to sleeping, but they are rarely seen at the period of the Red House. The close proximity of what appears to have been a heated kitchen/bake-house with its own chimney may offer some explanation (as shown on the early maps), especially as detached buildings of this kind often contained additional domestic accommodation.

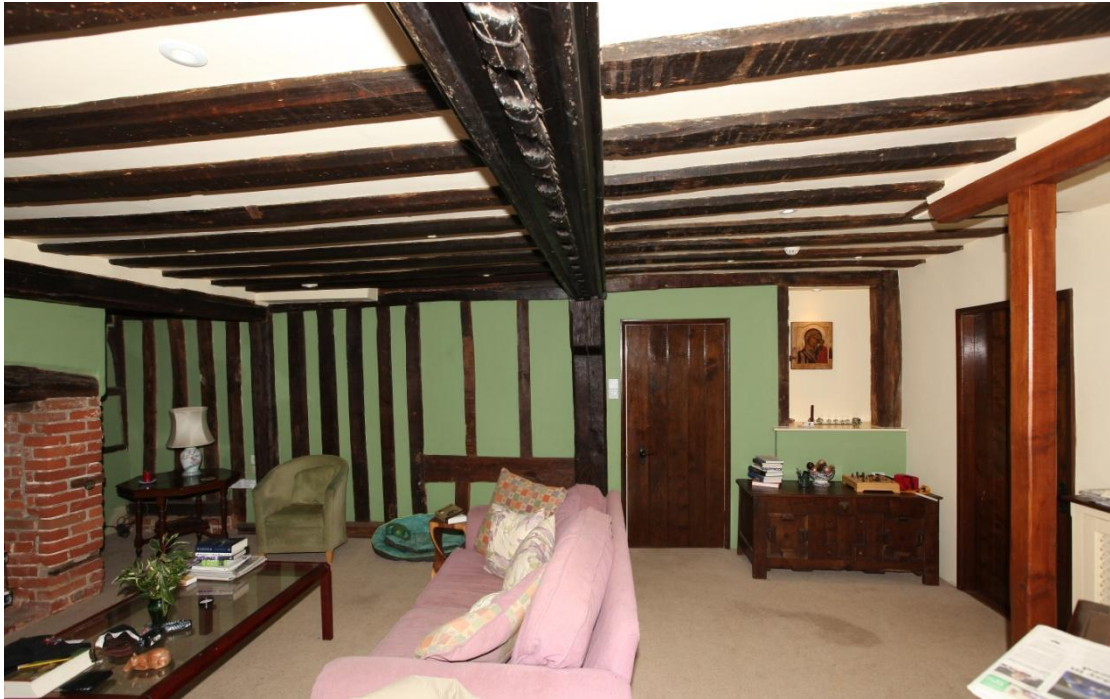
Illus. 9. The front wall of the Tudor hall, which now adjoins the Georgian range. The expensive, closely-spaced studs indicate the building's high status, but those of the upper storey, unseen by visitors, were far less close. This anomaly was originally disguised externally by render. The horizontal timber to the left of the door is the thick sill of a projecting, oriel window. Part of the original arch to the cross-passage entrance survives in the narrow door jamb to the right of the present door, but the hall's corner post has been moved 18 inches to the left of its original position to enlarge the service bay.

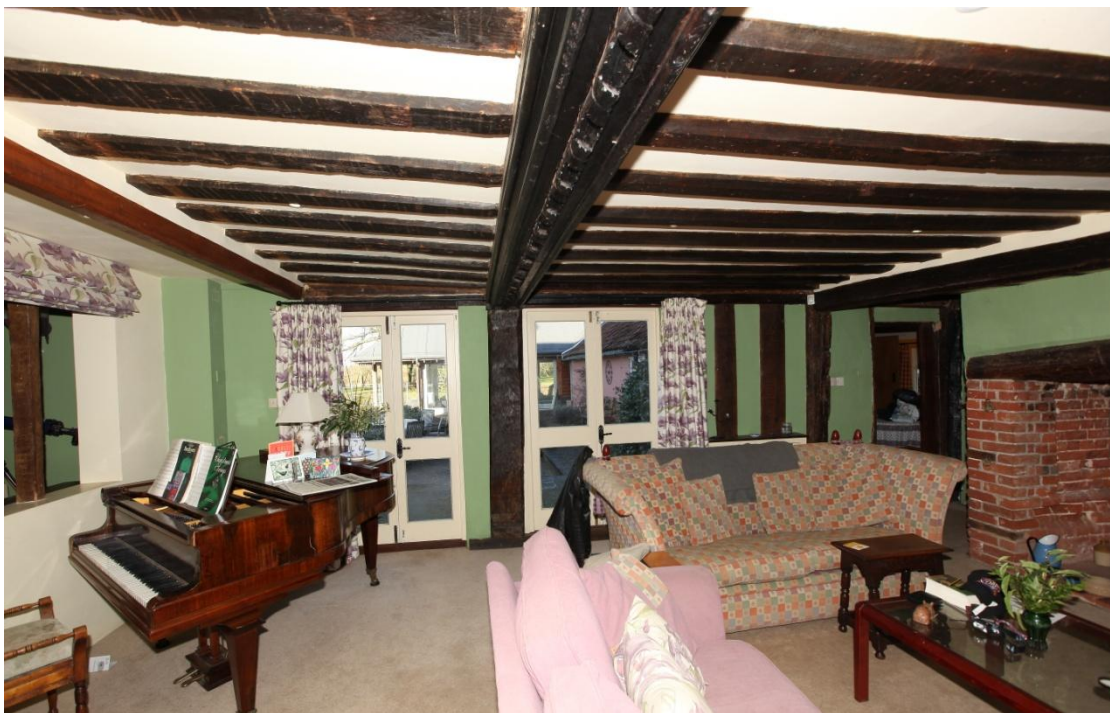
Illus. 10. The rear wall of the hall showing exceptionally large studs of some 9 inches in width to the right of the high-end window, which is now occupied by French doors. The common studs of the high-end bay to the right are neatly chamfered and stopped, but those of the low-end bay to the left are entirely plain.

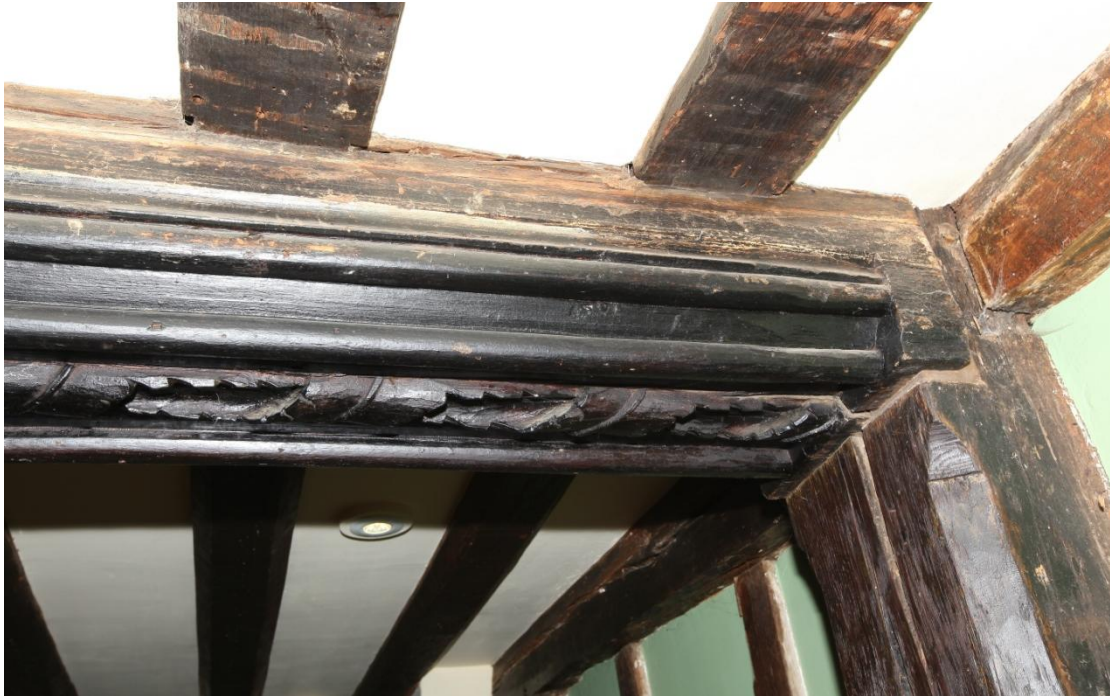
Illus. 11. A detail from the low-end bay of the finely roll-moulded binding joist in the hall, with a foliate-carved scroll to the centre of its soffit. This timber is fully pegged and tenoned to the storey posts and undoubtedly original to the building, although it is unusual to find roll-mouldings of this kind in conjunction with plainly chamfered and unchamfered common joists. The foliate scroll is typical of the 1520s but is crudely carved compared with identical examples found in many merchant houses and churches of the period.

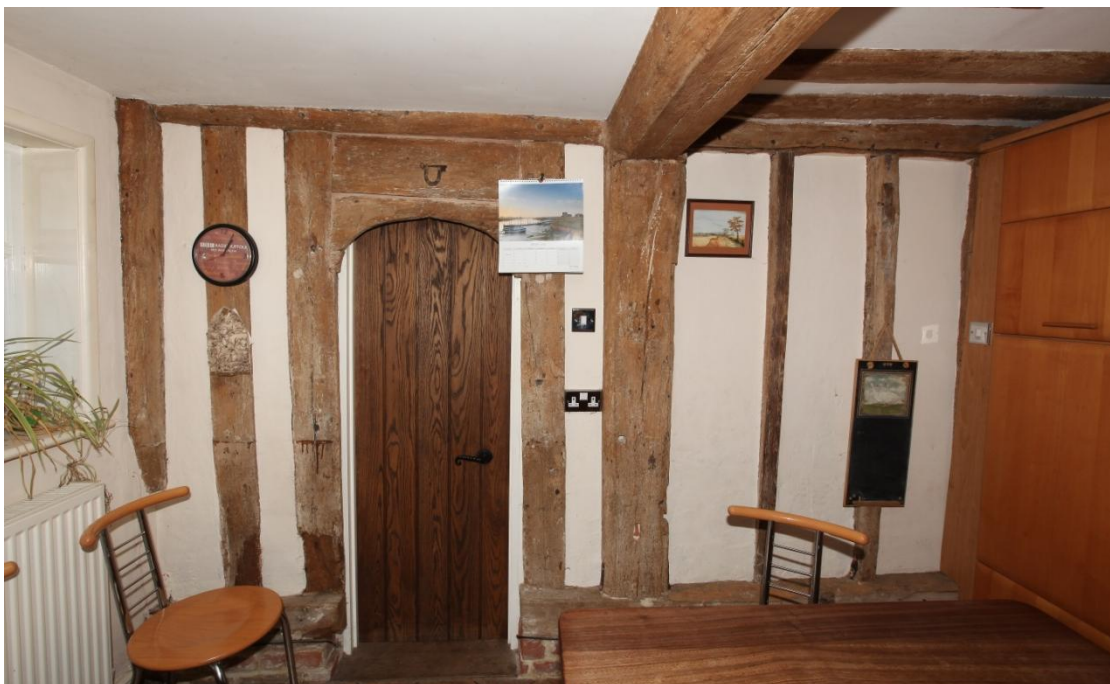
Illus. 12. The front wall of the two-bay parlour (now the kitchen), showing an original arched door to the left and the shutter groove and mullion pegs of a window to the right. Separate parlour entrances became increasingly common as the 16th century progressed but this example is unusually early. It may have been intended to access the adjacent outbuilding shown on early maps.

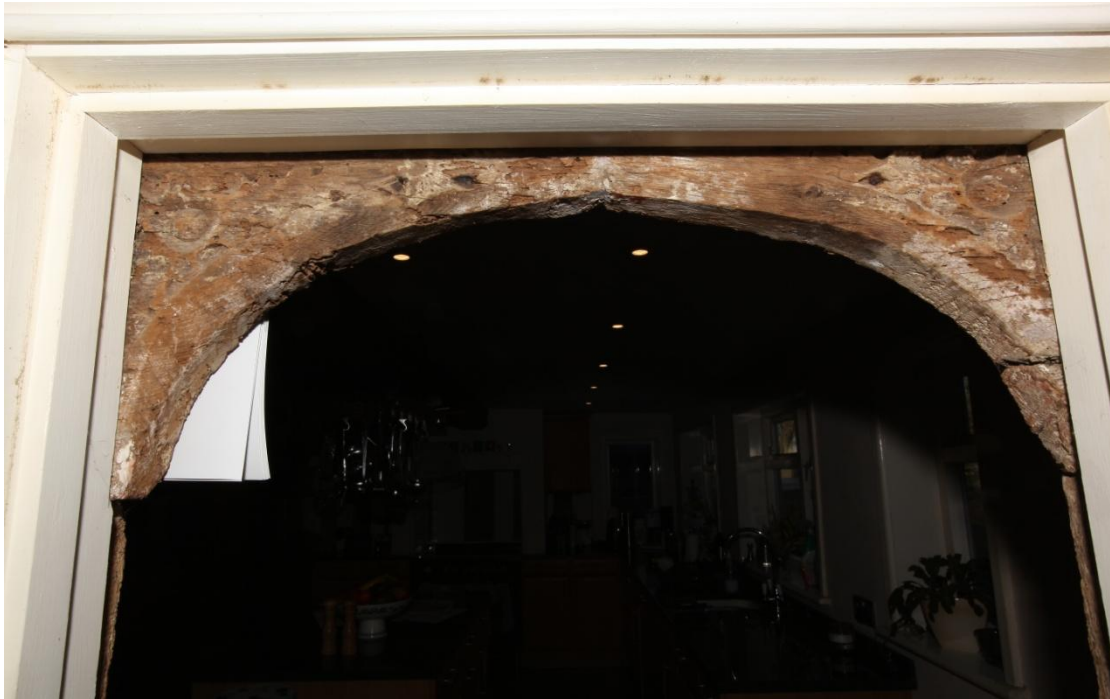
Illus. 13. The foliate-carved spandrels of the parlour door, seen from the Georgian dining room to the south (i.e. to the left in illustration 31). Traces of old red ochre pigment are visible beneath the later whitewash, giving another possible explanation of the property's name.

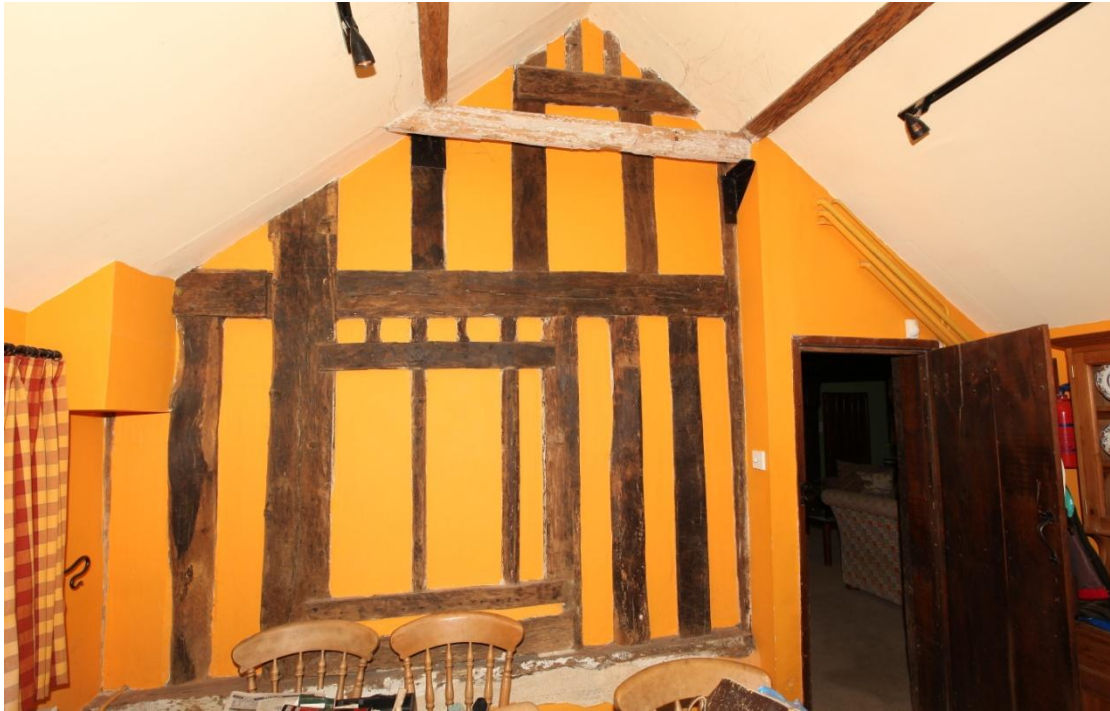
Illus. 15. The rear wall of the parlour, seen from the ostensibly early-19th century brick service range to the north. The central post lies to the left with a ground-floor window to the right. Four original chamfered and pegged window mullions survive above the nailed lintel of a smaller, later window, and the original weathered sill overlaps the post and jamb beneath the later sill. A similar weathered lintel of the first-floor window in illus. 20-21 is visible at the roof apex. Two original mullions have somehow survived within the smaller window. The walls studs are not weathered, with their saw marks still well preserved, and the disparity between the closely-spaced ground-floor timbers and their widely spaced counterparts above would not have been visible.

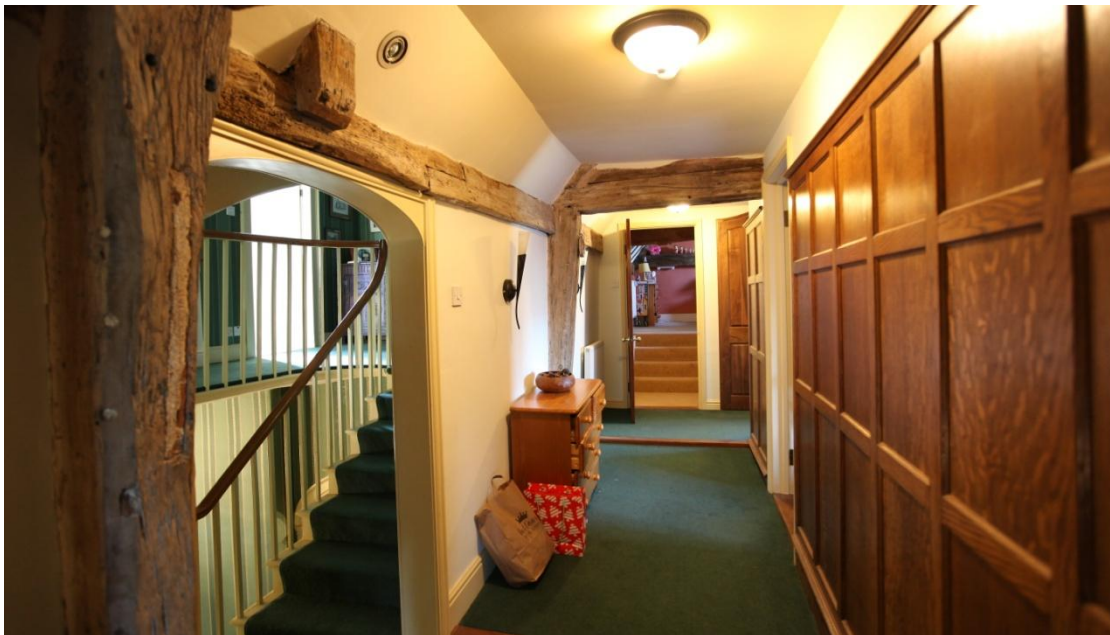
Illus. 16. The first-floor corridor to the south of the hall chamber, as seen from the chimney bay to the east, with the Georgian staircase to the left. Note the steps leading to the service chamber in the rear (bedroom 3), which was raised to accommodate the Georgian window of the western gable. The panelling is modern.

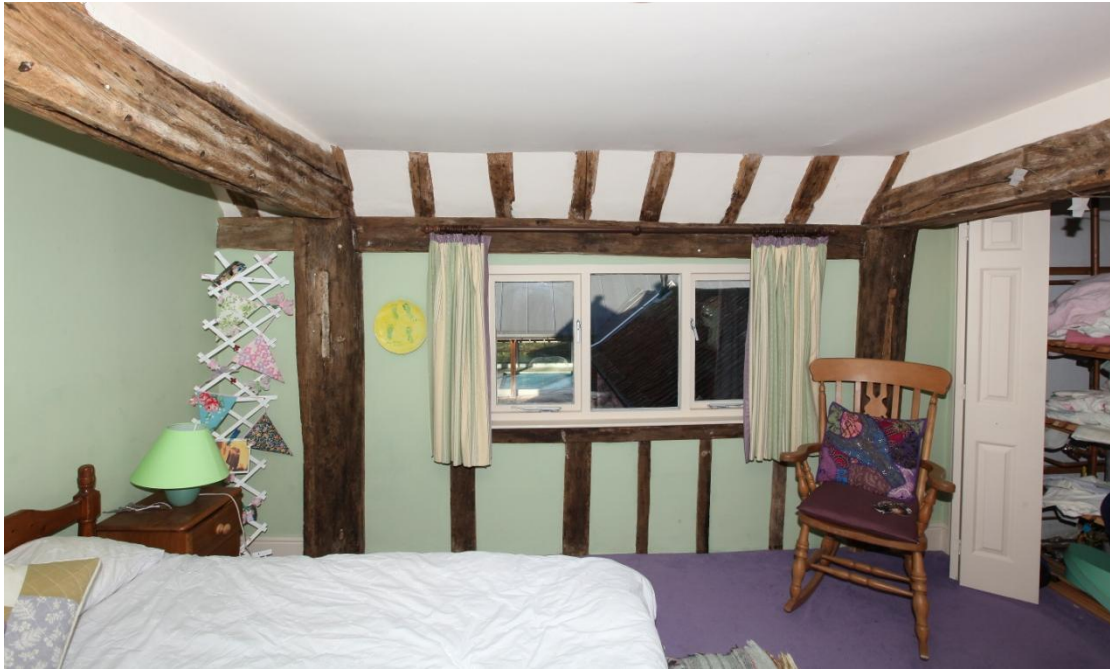
Illus. 17. The northern wall of the hall chamber in bedroom 2 showing the central open truss on the left and that adjoining the chimney bay on the right. Both preserve pegged mortices for missing arch-braces with a distinctly Tudor profile. The sloping flue of the original chimney would have been visible from this space initially. The roof-plate above the modern window contains mortices for diamond mullions as shown in illus. 18.

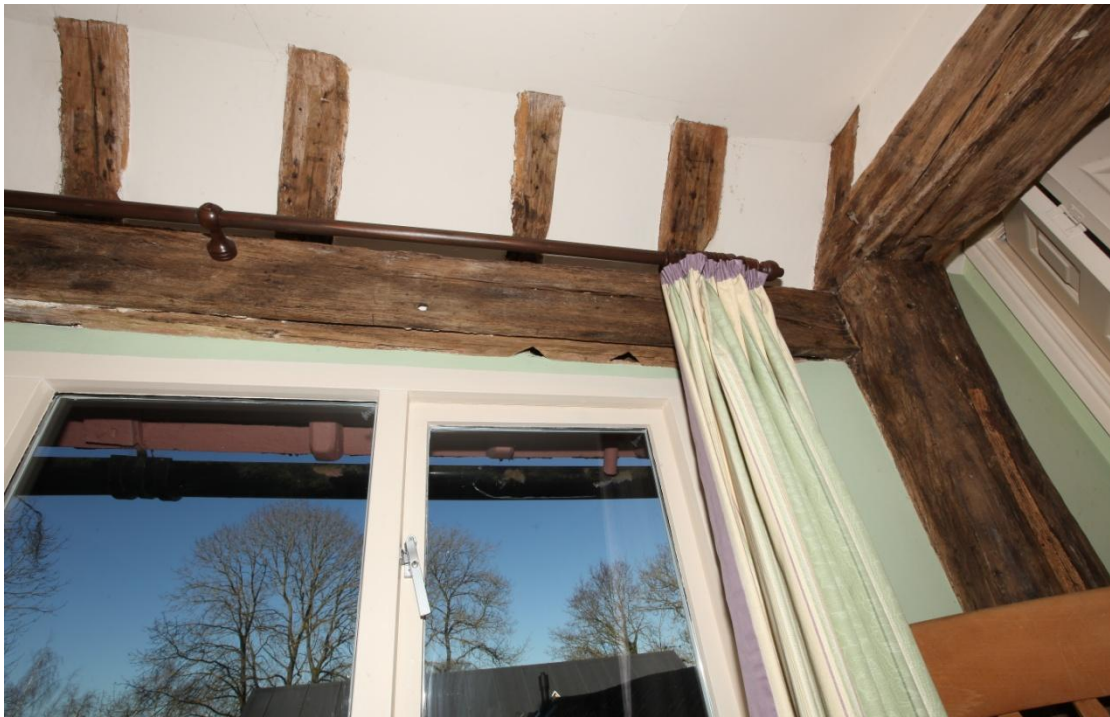
Illus. 18. A detail of the hall chamber's roof-plate in illus. 17 showing empty mortices for diamond window mullions, i.e. square mullions set diagonally in the standard manner of early unglazed windows. These illustrate the utilitarian nature of the space relative to the adjoining parlour chamber which boasts chamfered mullions. Impressive as the roof structure might appear, it was visible from this space and was probably regarded as practical rather than decorative: hall chambers were typically store rooms while parlour chambers were secondary bedrooms.
