The Red House, Worlingworth, Suffolk

Heritage Asset Assessment

The Red House, Shop Street, Worlingworth, Suffolk

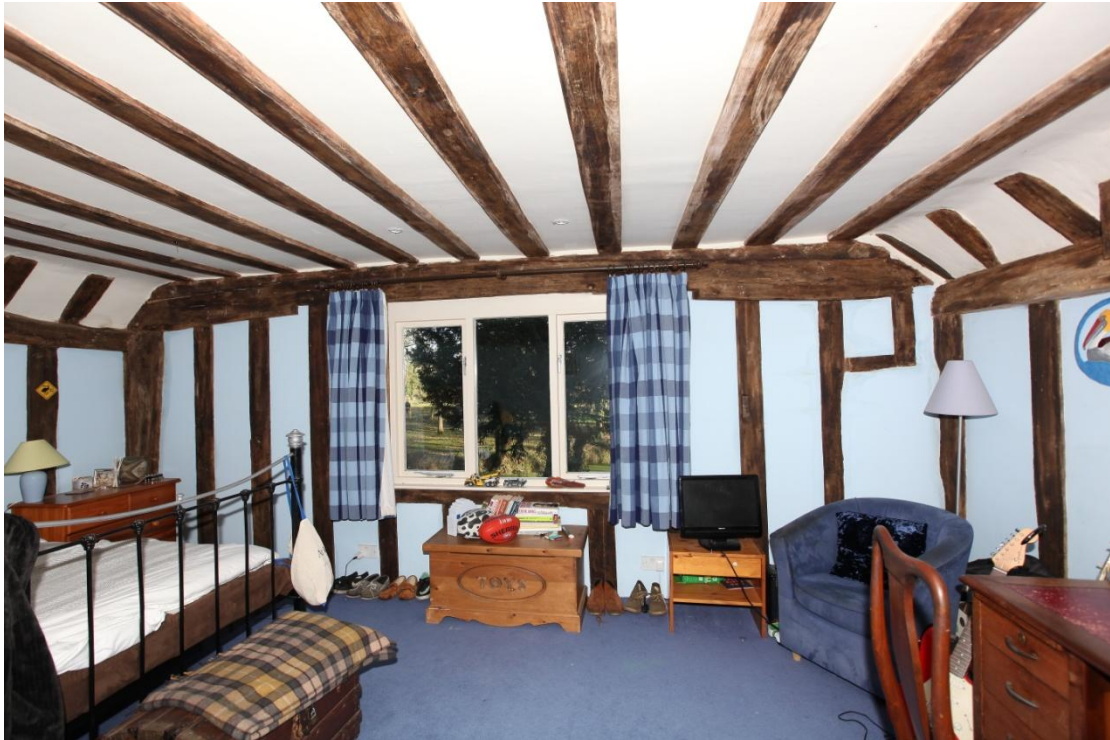
Illus. 19. The eastern gable of the parlour chamber with late-20th century casements in the position of the central window and the intact lintel of an original garderobe (privy) adjoining the corner post on the right. The back of a mortice for the external cupboard-like projection is visible in the adjacent stud to the left. The lintel is pegged at both ends and is just 12 inches long, but the jambs were probably curved to widen the aperture.

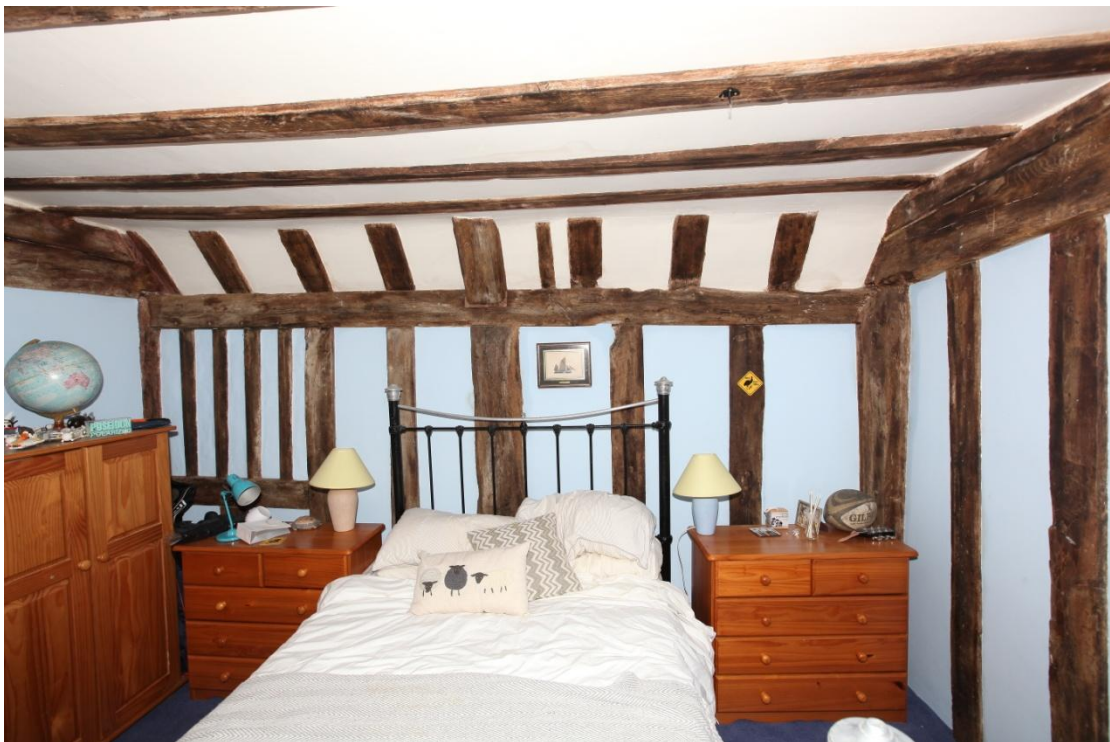
Illus. 20. The northern wall of the parlour chamber (bedroom 1) showing the principal rafter of the A-frame principal roof truss in the centre and an intact original window of chamfered mullions to the left. The truss is shown in illustration 24 and the window in illustration 21.

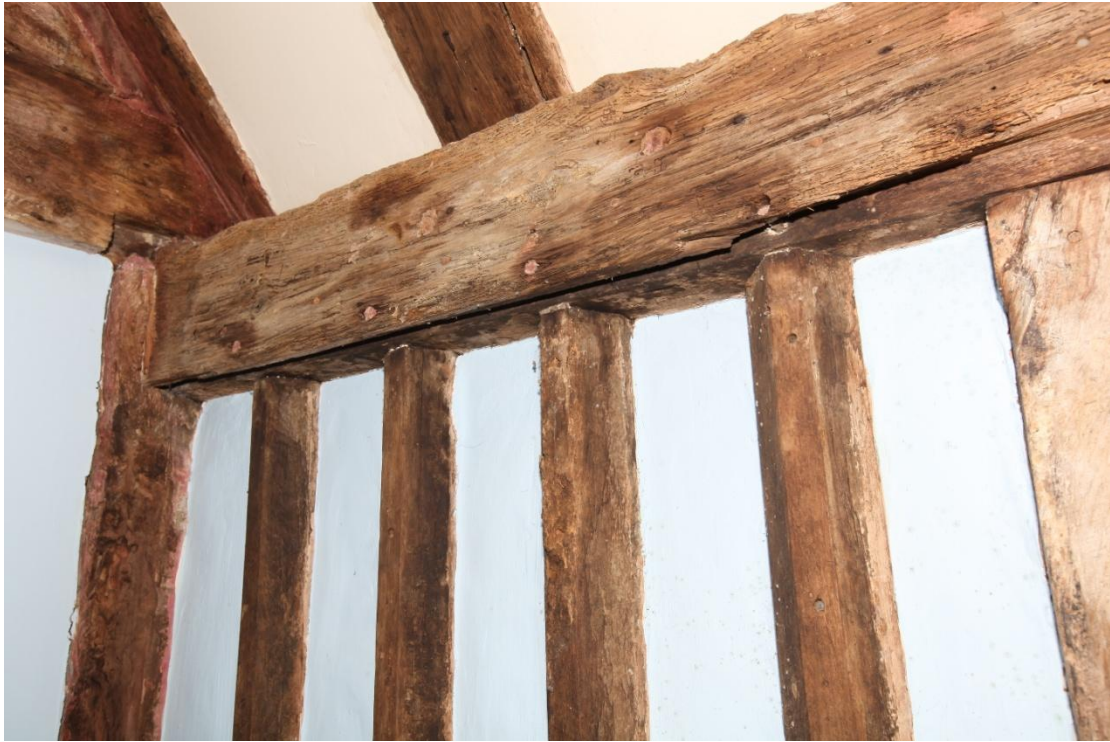
Illus. 21. A detail of the original chamfered window mullions in the back wall of the parlour chamber (illus. 20). Each mullion is tenoned and pegged to the roof-plate, which contains a groove for a horizontally sliding window shutter. Plainly chamfered mullions of this kind are not common and this feature represents a rare survive. Illus. 15 shows its weathered sill that would have projected through the original external render.

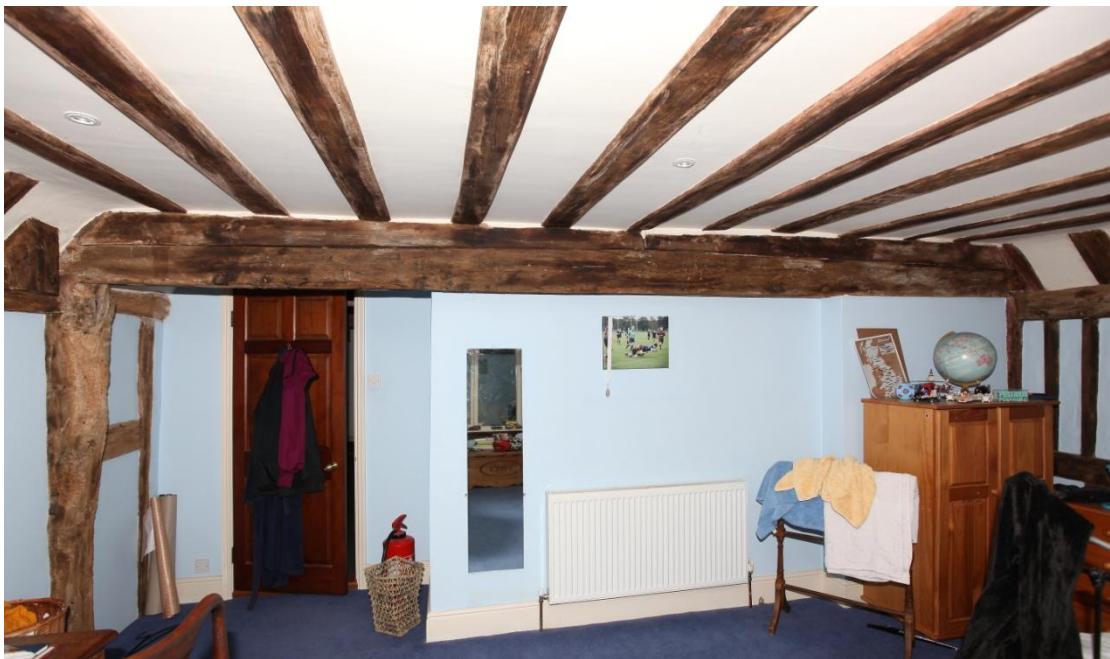
Illus. 22. The tie-beam to the west of the parlour chamber (bedroom 1). This abuts the chimney bay but there is no evidence of a fireplace in this room. The tie contains an unusual variety of pegged mortices, possibly for an arched doorway on the left which provided a link with the hall chamber (lit by the window adjoining the post to the left) and a gap framed by an arch-brace to the right of a central stud that would have exposed the chimney flue.

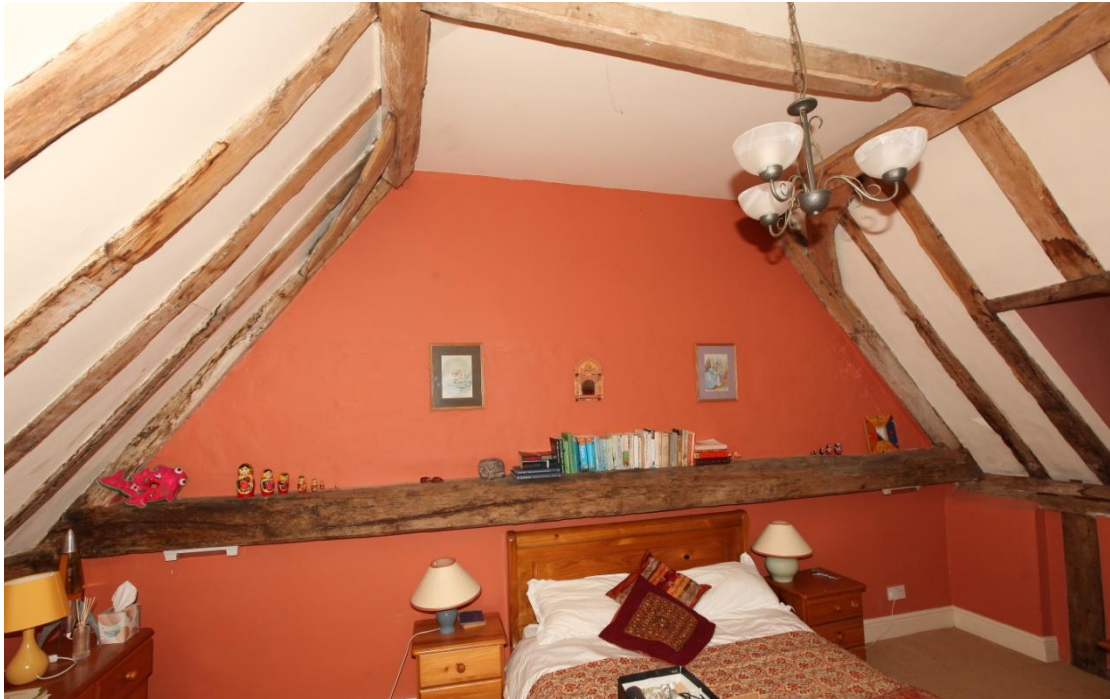
Illus. 23. The western gable of the 16th century building (bedroom 3). The floor level is higher here than at the eastern gable (illus. 19) as the ground-floor ceiling joists have been raised, apparently to match the Georgian ceilings and accommodate the sash window in illus. 2. The tie-beam contains mortices in its lower surface but not its upper, suggesting the roof gable may have projected slightly in the manner of a jetty.

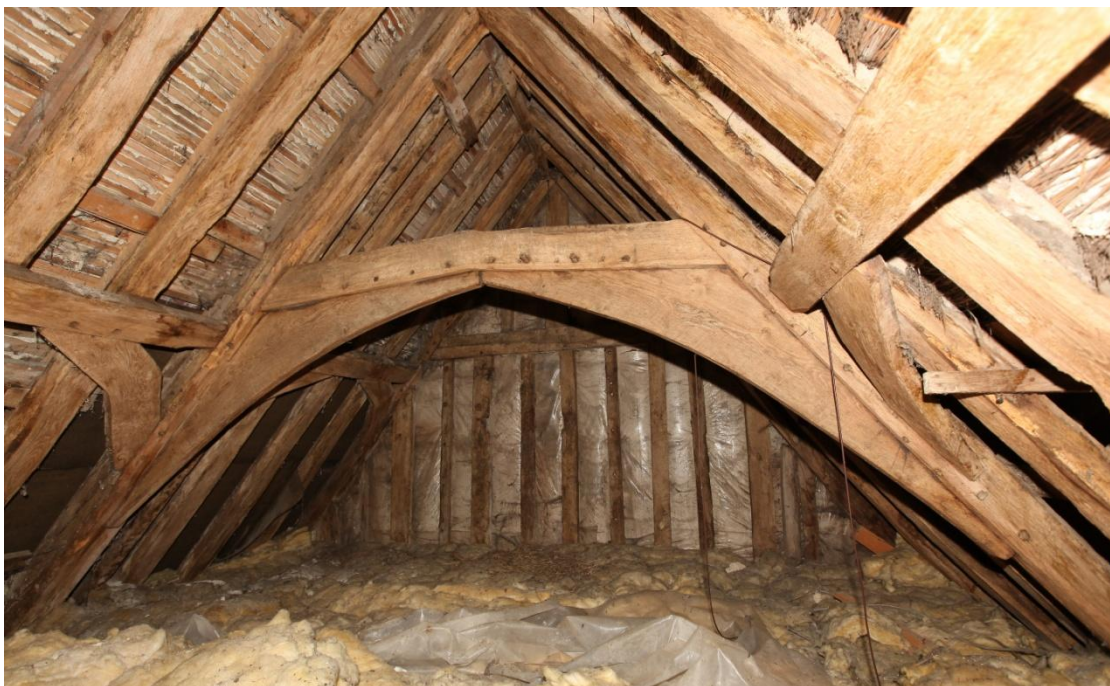
Illus. 24. The open truss of the fully wind-braced butt-purlin roof above the parlour chamber, with the eastern gable in the rear. An identical truss with an arch-braced, cambered collar survives in the centre of the hall chamber, with a flat, unbraced collar to the west of the chimney bay and another in the closed truss against the service bay. There is no principal truss to the east of the chimney bay. The first-floor ceilings are insertions, and this roof was exposed to the upper storey initially. Impressive as it seems, it may have been regarded as utilitarian given the plain mullions in the hall chamber.

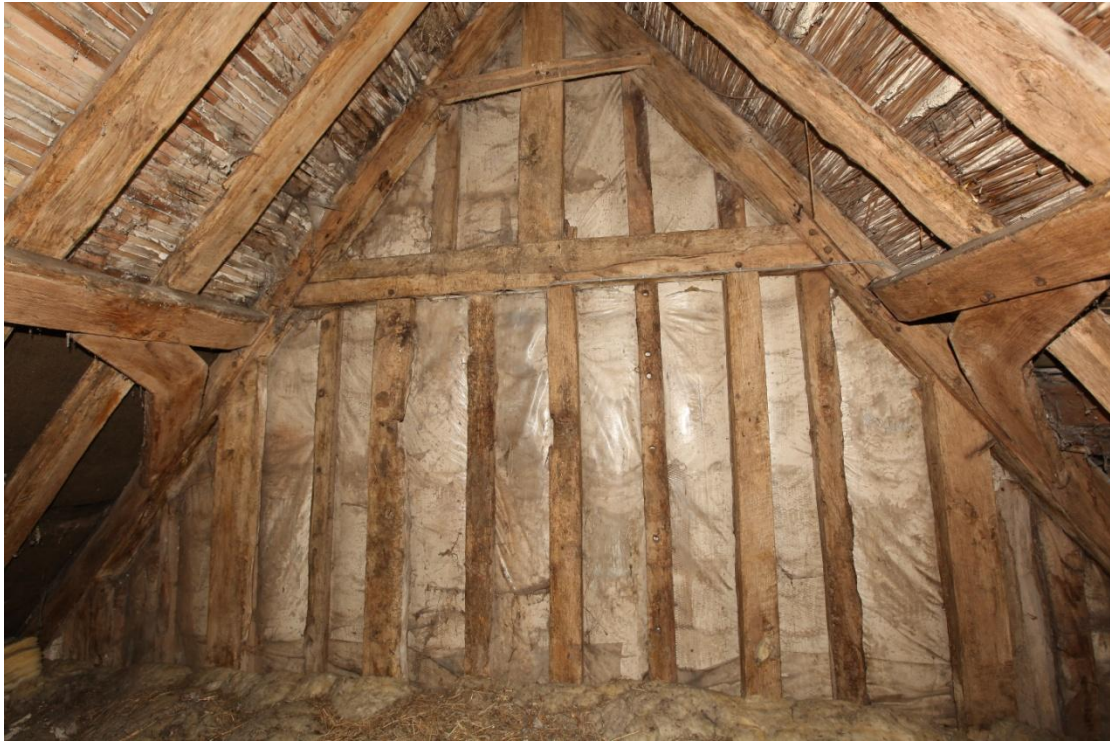
Illus. 25. The framing of the eastern roof gable in illustration 24, with narrow inserted studs between the wider originals which are pegged to the horizontal collar. The collar of the eastern gable is cambered and lacks stud mortices. Two mortices for diamond window mullions are visible to the left of centre, with corresponding pegged and housed sill mortices beneath. The window aperture respects the equal spacing of the studs and it was probably inserted along with the attic floor later in the 16th century.

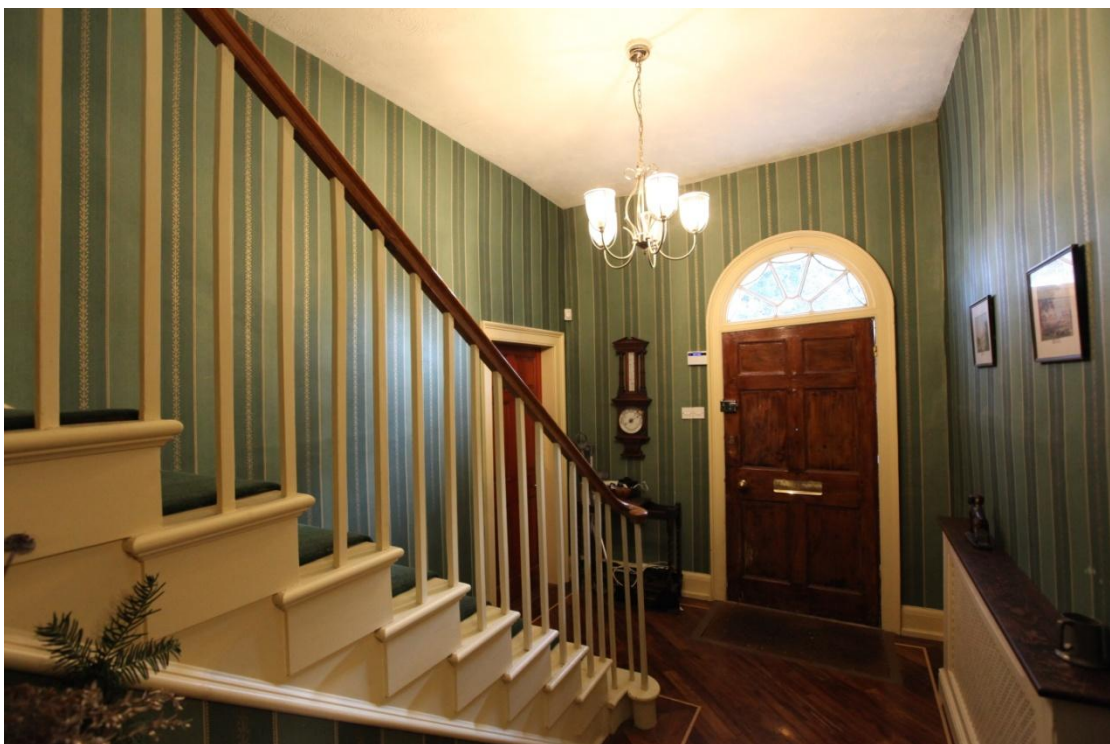
Illus. 26. The central entrance passage of the Georgian addition which retains its original 'stick' baluster staircase and fanlight. The door is slightly offset as usual to accommodate the foot of the stair, and this arrangement is fully original to the building.

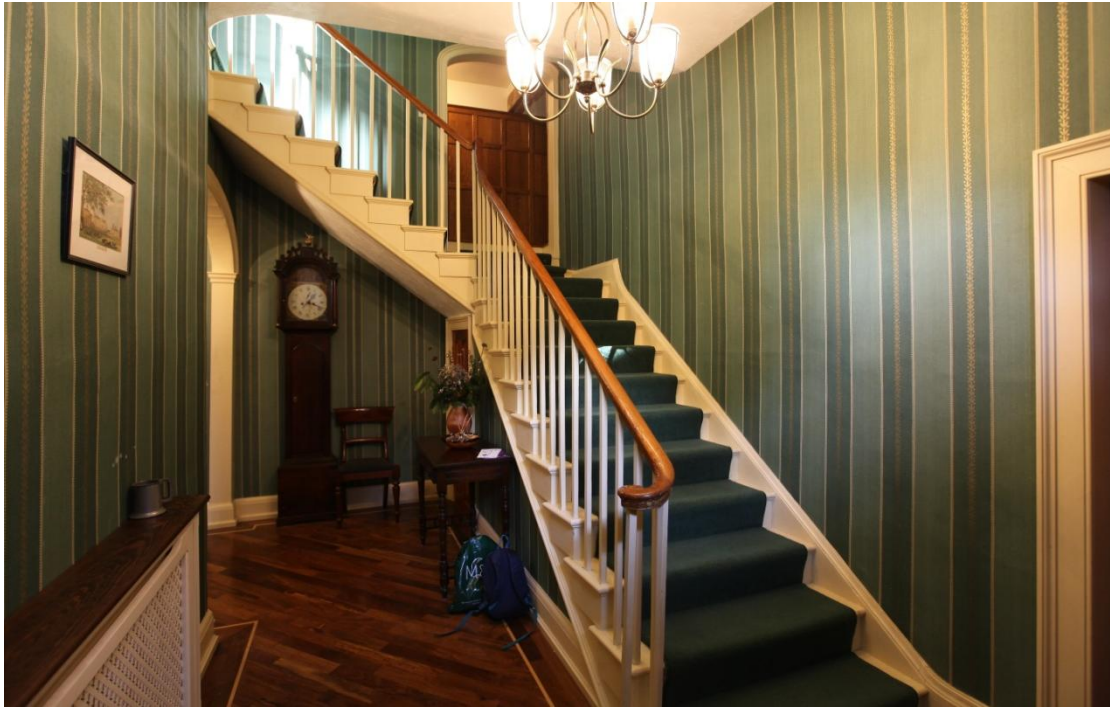
Illus. 27. The Georgian entrance passage from the southern front door, with the arched entrance to the Tudor building on the half landing. The elegant staircase is a fine original feature which rises to the attic storey but is relatively plain with a pine hand rail and no carving to the tread-ends.

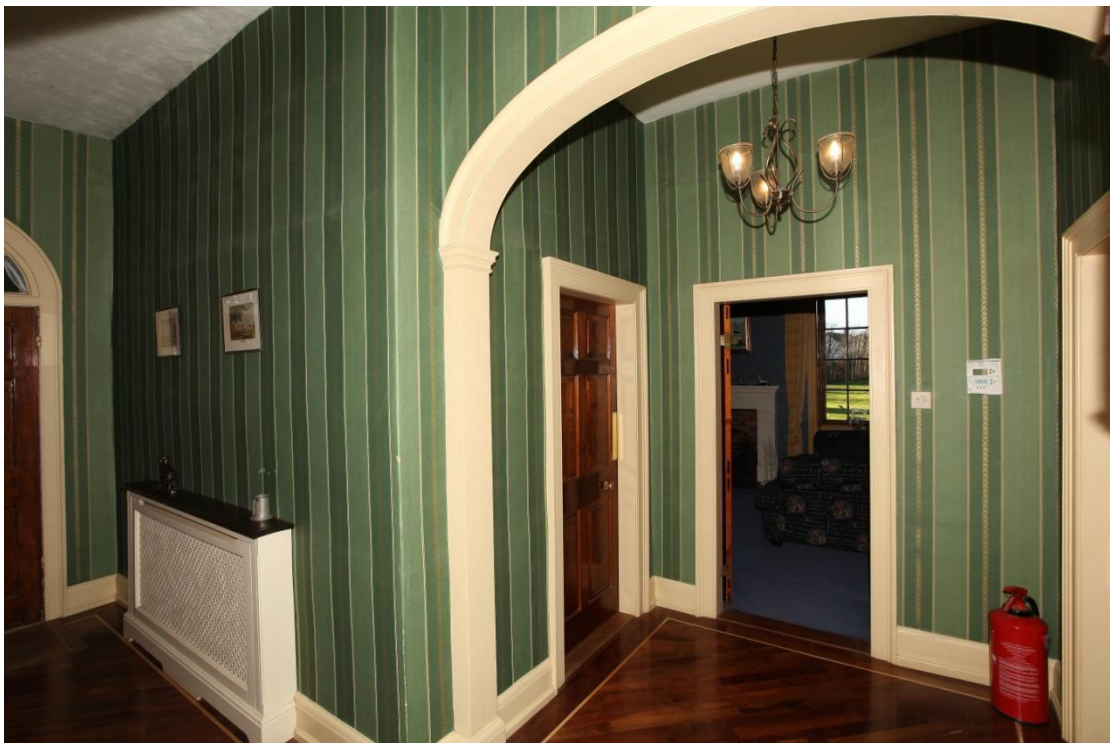
Illus. 28. The arched lobby to the west of the Georgian entrance passage, with the door to the 16th century hall on the right. This unusual feature was necessary to reach the approximate position of the Tudor cross-passage and partly replicates the porch shown in figure 4 – although there is nothing to suggest any of its fabric survives. The partition to the left is original and the central door opens into the modern ‘sitting room’. If the left-hand WC door existed initially it may have served a cupboard or butler’s pantry.

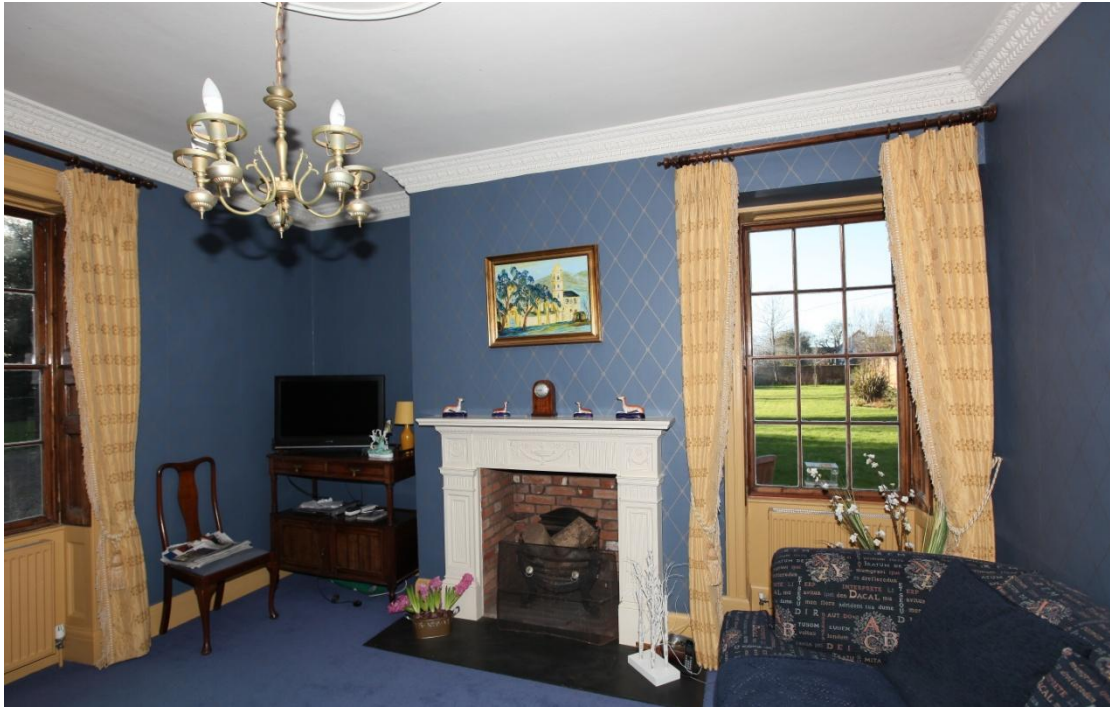
Illus. 29. The fireplace in the western gable of the Georgian ‘sitting room’. The exposed brickwork is modern and the carved fire surround appears to be a copy of an Adam-style original that matches the example in the dining room (illus. 31). The suspiciously sharp cornices of both rooms are also identical, in a way that would not be expected in the 18th century. They are far more elaborate than would be expected in a house of this scale and in conjunction with the relatively plain but clearly original staircase. It would appear that a former owner installed these features as part of a major refurbishment.

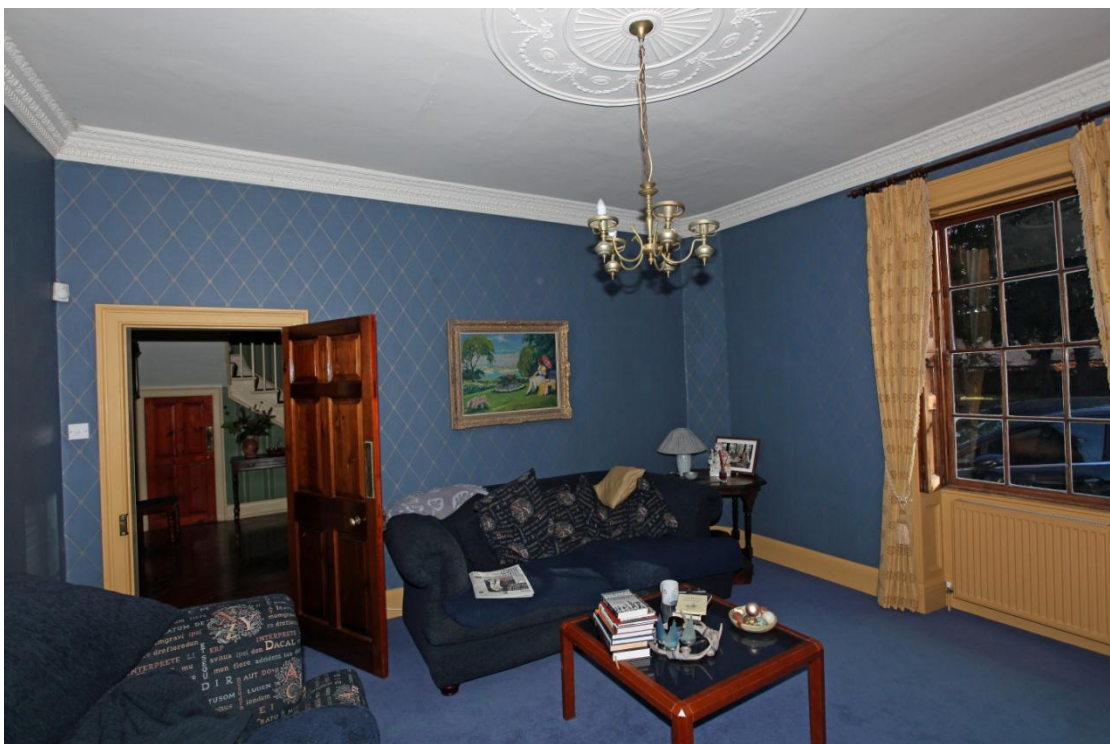
Illus. 30. The ‘sitting room’ from the west, showing the angled corner that avoids the original sash window lighting the WC. The right-hand section of this wall consists of plasterboard and represents a modern insertion, but is respected by the cornice.

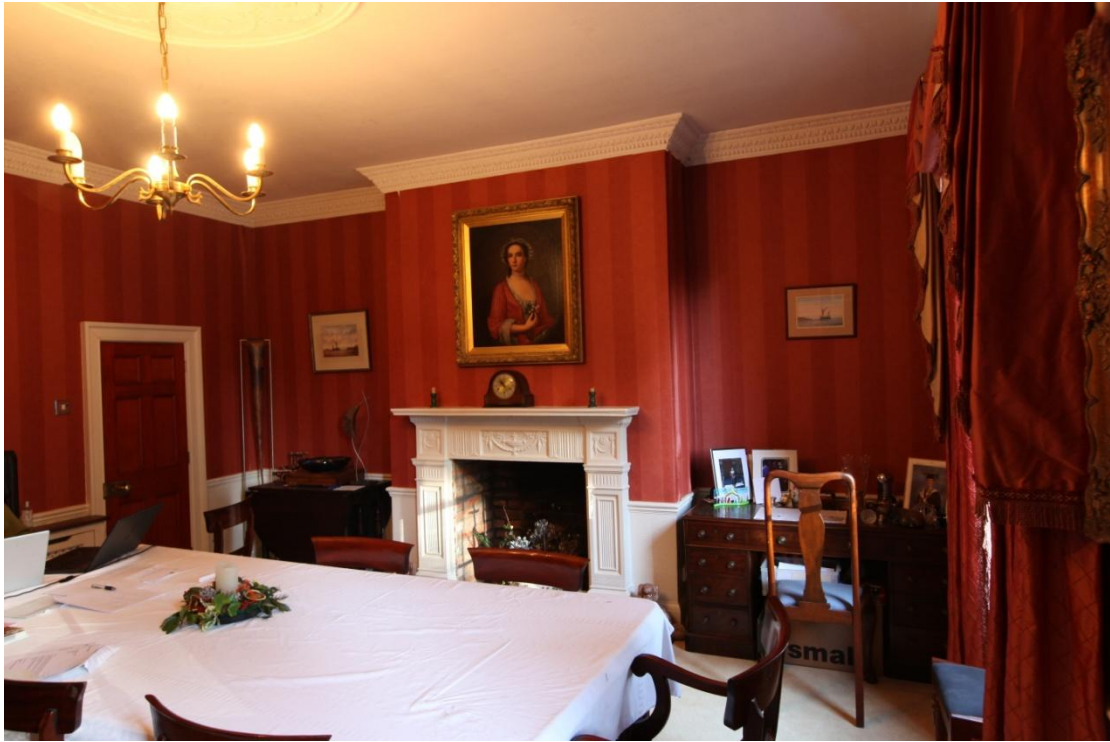
Illus. 31. The eastern gable of the Georgian ‘dining room’, with the arched entrance of the Tudor parlour in illustration 13 hidden behind the door on the left. As in the ‘sitting room’, the fireplace, cornice and plaster ceiling rose appear to be late-20th century insertions. The principal drawing and dining rooms of Georgian houses were rarely decorated in the same way, with the better quality ornament reserved for the latter.

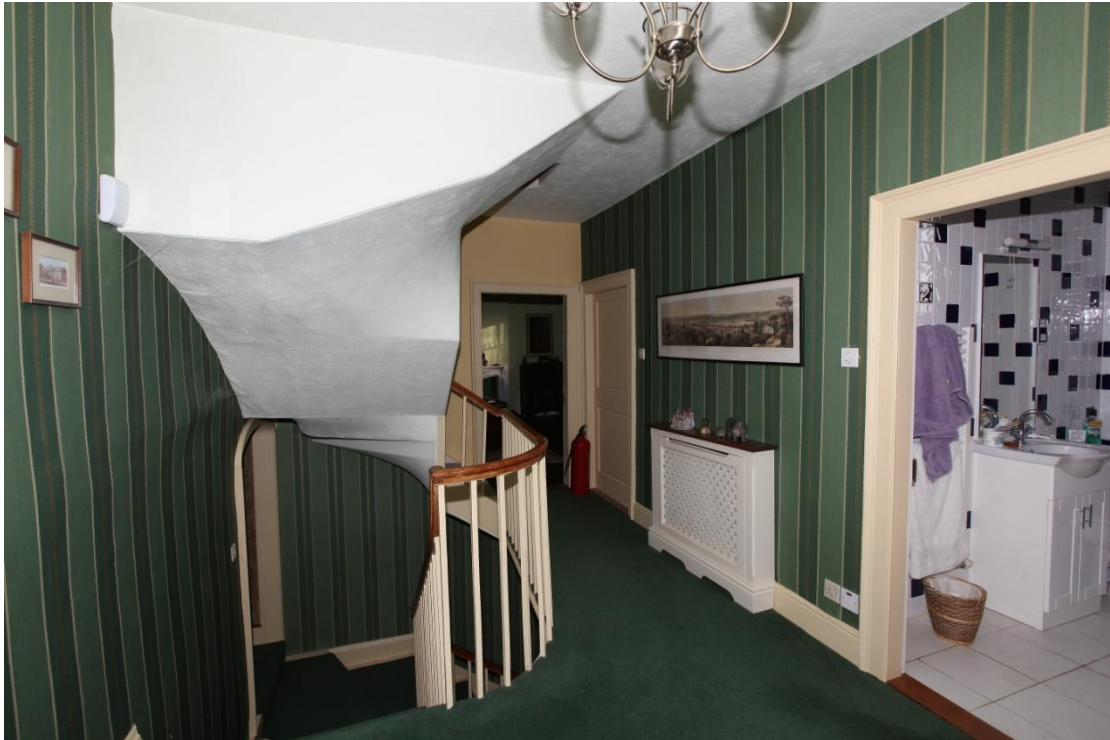
Illus. 33. The first-floor stair landing seen from the west. The flat-faced surrounds of the various doors in the Georgian section of the house are typical of the late-18th century, as are the large-panelled doors, but it is difficult to be certain which are likely to be original and which installed as part of the Georgian-style restoration. The room or rooms adjoining this landing would normally have been designed as linen cupboards.

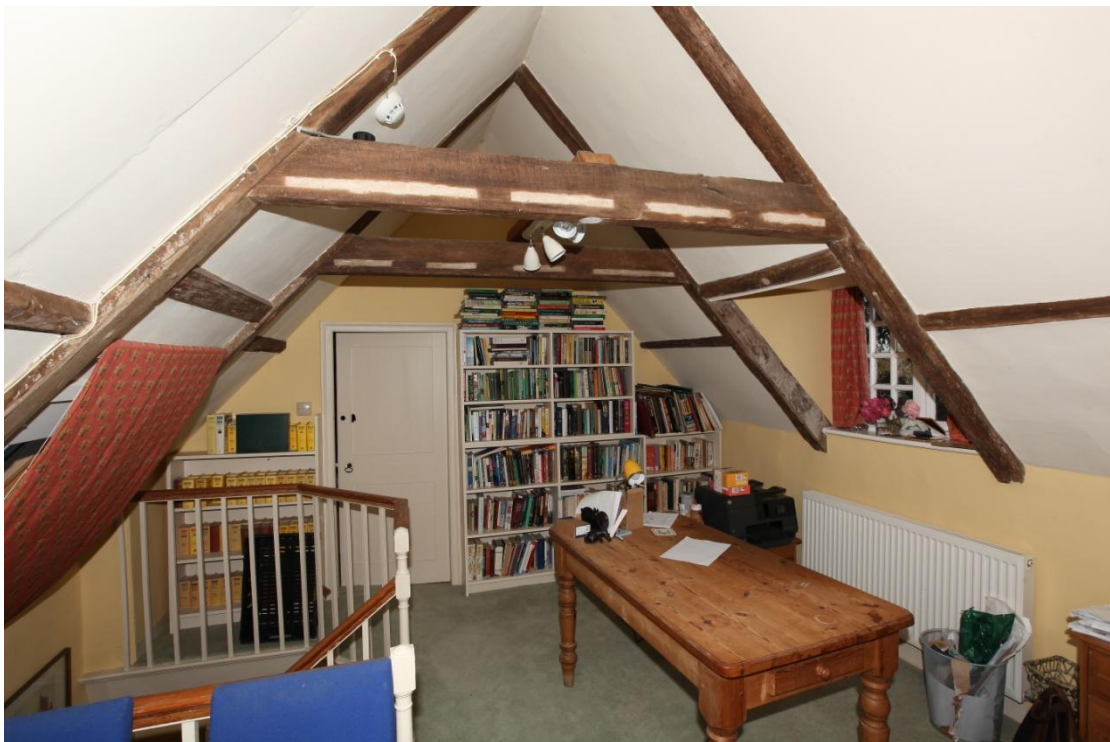
Illus. 34. The roof of the Georgian range, as seen from the west with the staircase to the left. The staggered butt-purlins are clearly original, respecting the positions of the southern dormer windows, but the collars appear to have been re-used and contain wide plaster-filled mortices in their western edges and smaller joist mortices to the east.
