PENELICK
LOOE
PL13 2LX

ECOLOGICAL ASSESSMENT

8 AUGUST 2022

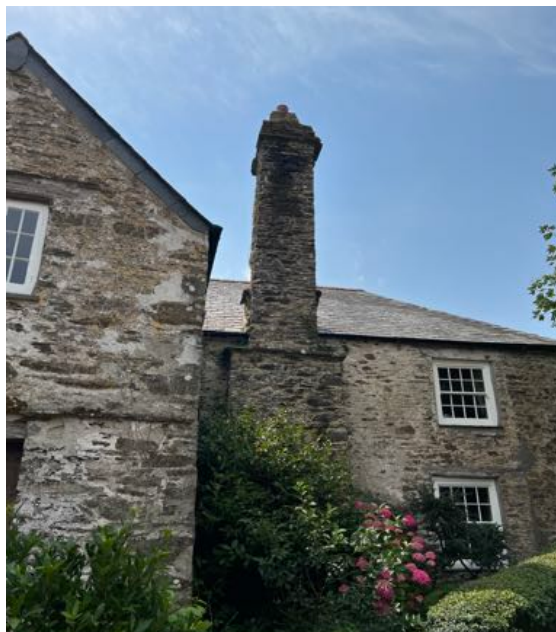
Plate 2. Front, southern elevation

18. A detached, double storey stone house with slate tiled roof surrounded by mature gardens.
19. **Chimney 1.** (Plate 3). Generally well pointed to the stonework however, there were crevices noted to the stone work that were considered to be large enough for wildlife such as bats to potentially gain access. Surrounding roof slates had gaps where they were lifted that may also provide suitable bat access.
20. **Chimney 2.** (Plate 4). Brick built chimney with well pointed bricks without gaps suitable for bat access. Surrounding roof slates had gaps where they were lifted that may provide suitable bat access.

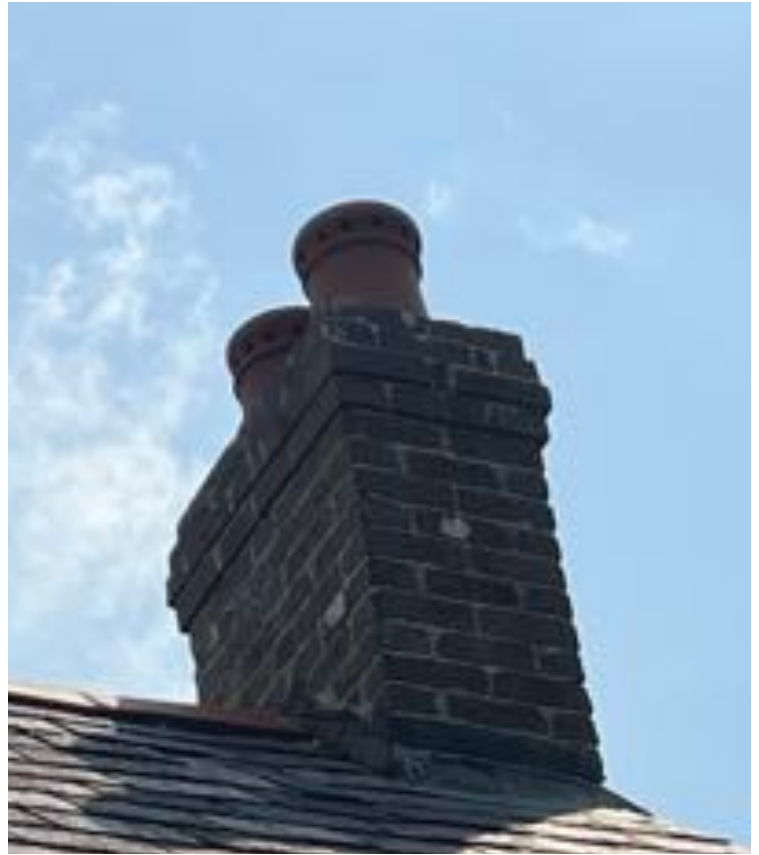
Plate 4. Chimney 2

28. Chimney 1 as identified, is considered to provide some potential bat access sites as do the surrounding roof tiles. Chimney 2, is well pointed to its brickwork and has no access for bats but has access under tile gaps surrounding the chimney. Similarly, Chimney 3 is well rendered without access for bats but has access under tile gaps surrounding it. Accordingly, the chimney or immediate area surrounding them, have some low suitability for roosting bats and therefore a possibility of them being present in these sites, and elsewhere in the roof. It is considered that it would be limited to crevice roosting bats as there was no evidence to suggest an active bat roost was present in the only attic that is present.

29. In assessment of proposals for repair of the chimneys, it is understood that the full scope of works is not known at this time. However, it is considered that proposals for repair of chimneys 2 and 3 would have no risk of impacting bats. There is a risk that pointing of stonework to chimney 1 could block potential bat access sites and therefore there is a low level of risk that bats would be negatively impacted if they were present. Any works to surrounding roof tiles of all chimneys would have greater risk of impacting bats if they were present.

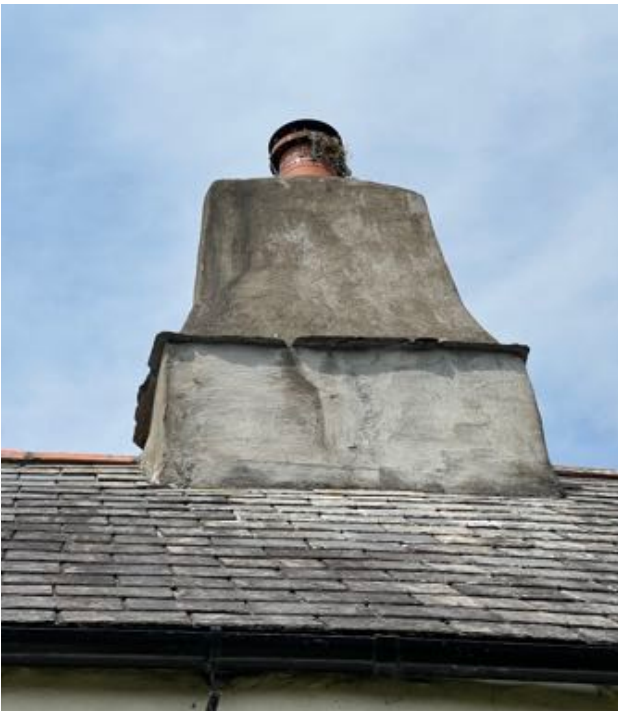
Plate 5. Chimney 3

21. **Chimney 3.** (Plate 5) Rendered stone chimney that is well sealed without bat access. Surrounding roof slates had gaps where they were lifted that may provide suitable bat access.
