ECOLOGICAL CONSTRUCTION METHOD STATEMENT
FOR THE DEVELOPMENT OF
LANGAR-CUM-BARNSTONE VILLAGE HALL
MAIN ROAD
BARNSTONE
NOTTINGHAMSHIRE

July 2022

Report to:	Welham Architects
Report Title:	Ecological Construction Method Statement for Langar-cum-Barnstone Village Hall

Survey Site/Job:	Langar-cum-Barnstone Village Hall, Main Street, Barnstone, Nottinghamshire, NG13 9JP
OS Grid Reference:	SK 7330 3539

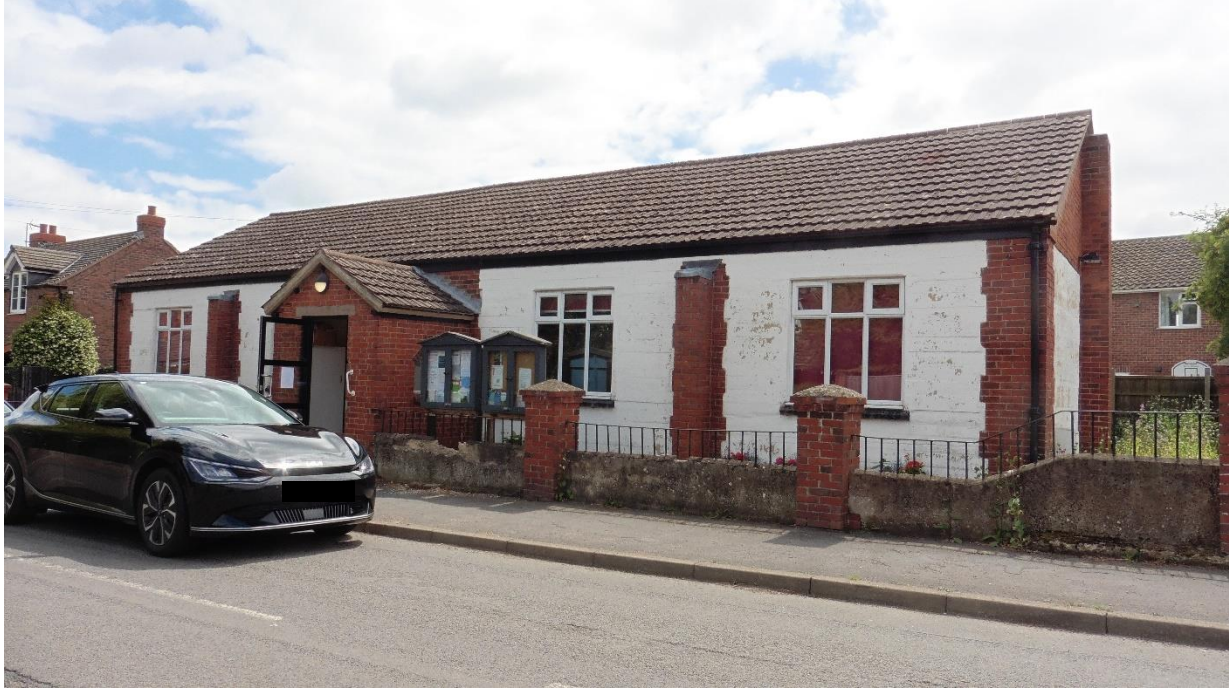
Photograph 1: Langar-cum-Barnstone Village Hall, taken from the north-west, showing the mixed construction of brick and painted ironstone and the porch attached on the northern elevation.

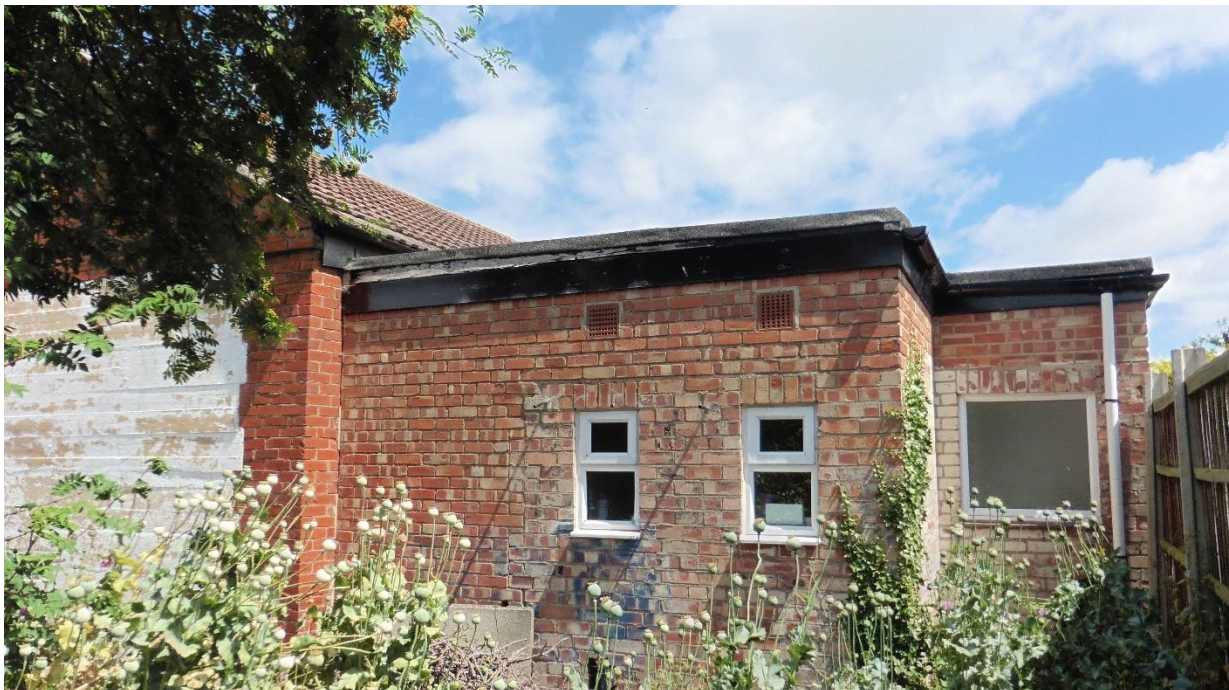
Photograph 2: Langar-cum-Barnstone Village Hall, taken from the south-west, showing the flat roof extension to the rear of the building constructed from cavity brick.

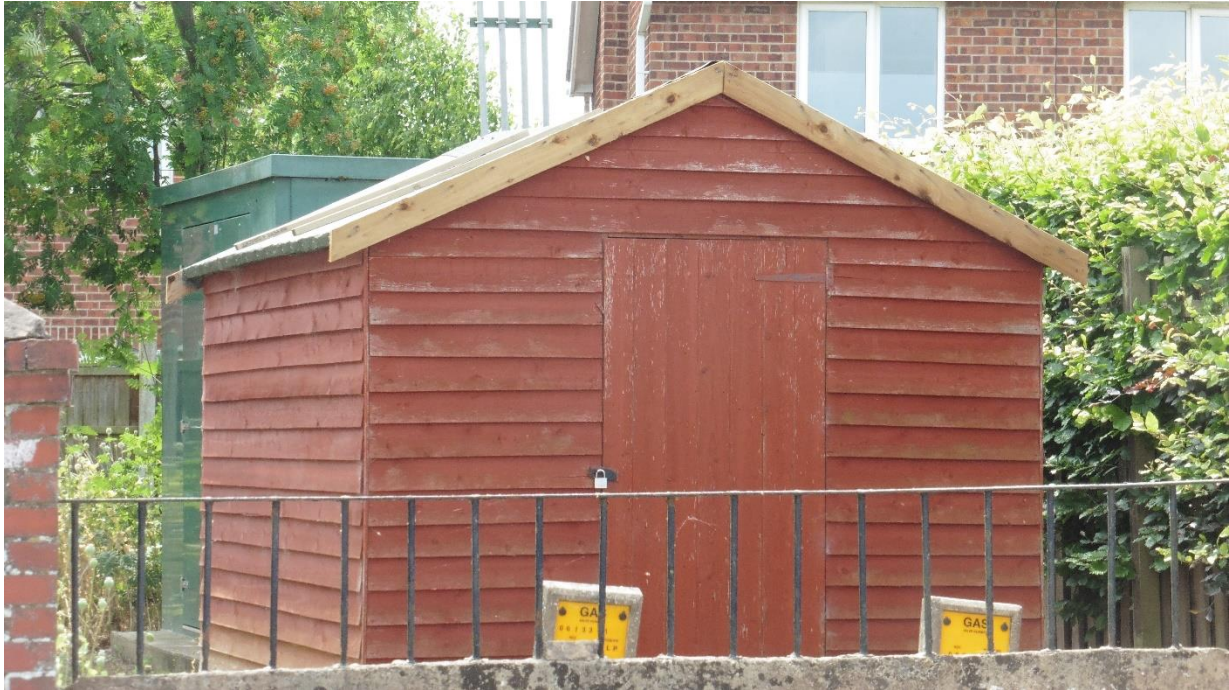
Photograph 3: The timber shed located to the west of the village hall.

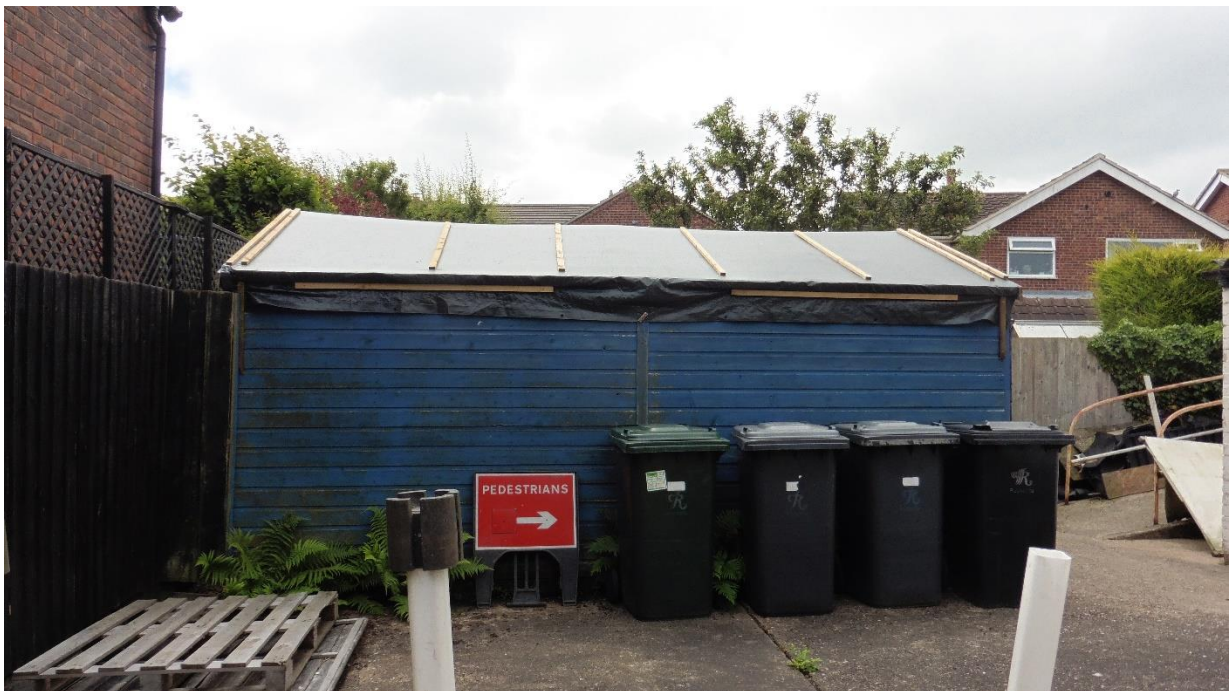
Photograph 4: The timber shed located to the south-east of the village hall.

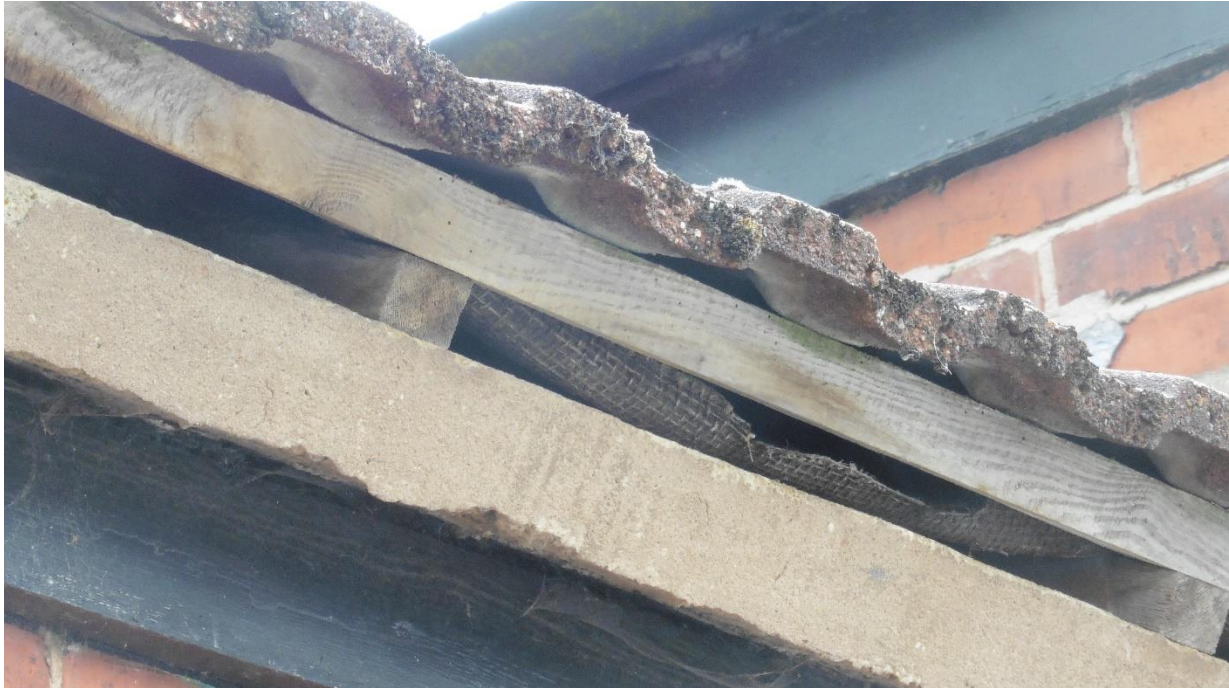
Externally, the surveyor identified evidence of bat roosting in the form of approximately 30-50 droppings within the void between the coping stones of the north-facing porch and its bitumen felt underlining. These droppings were of the typical shape and size of those known to be voided by Long-eared bats, as seen below, the droppings were all even aged and were typical of an animal being in situ for a limited period.

Photograph 5: Evidence of the void between the coping stone of the north facing porch and the roofing frame and bitumen felt underlining.

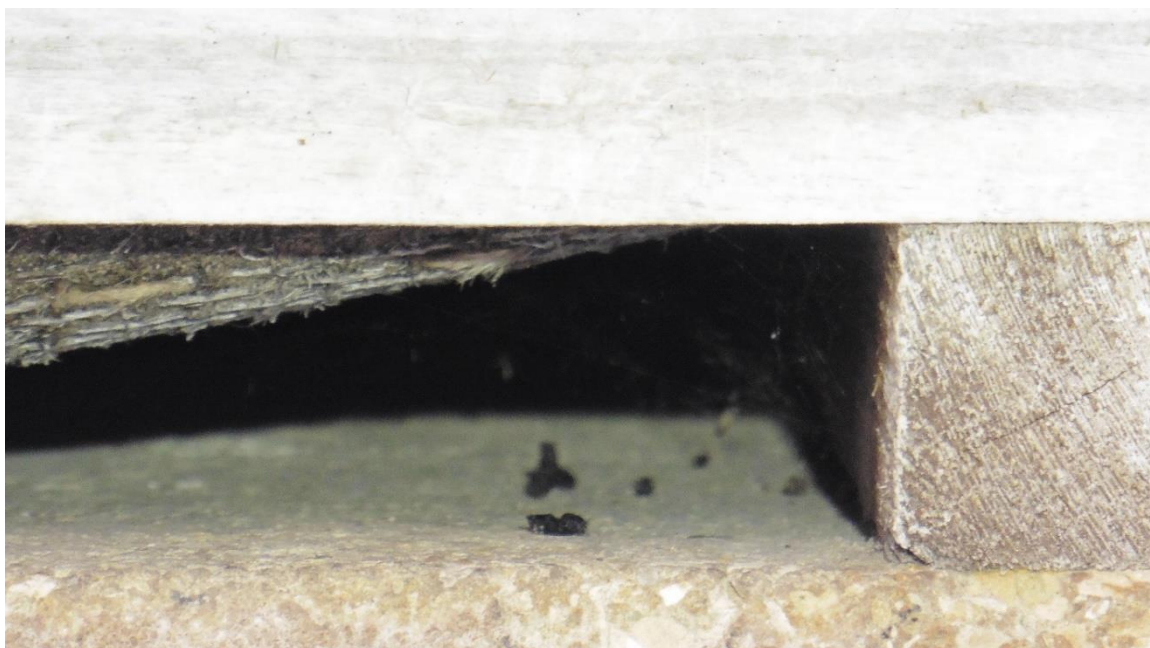
Photograph 6: Dropping evidence from within the void between stone and roofing frame and membrane.

The preliminary bat roost assessment determined the presence of evidence to suggest some low level usage by a bat species, most likely to be the Brown long eared bat (*Plecotus auritus*), in the porch of the village hall. Close examination at this time found no bat present to suggest current roosting and the evidence was of a few evenly aged droppings suggesting transit usage.

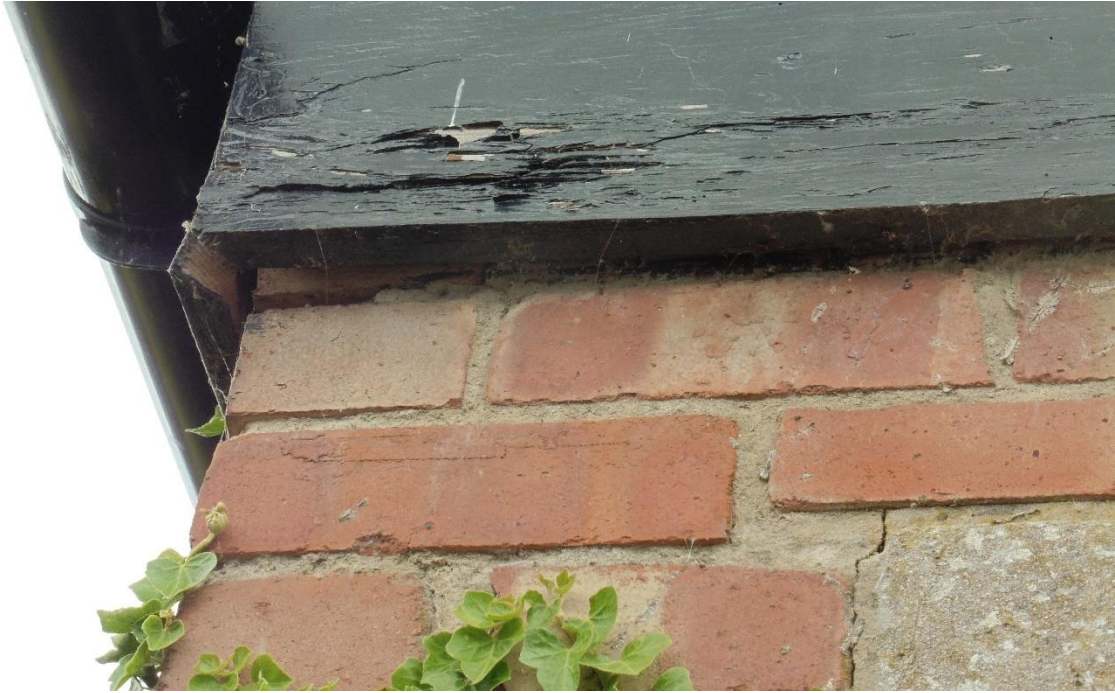
Externally, the building was found to contain a limited number of features suitable for a crevice dwelling species such as one of the Pipistrelle bats. Such features included the feature identified above, along with potential gaps between roof tiles, gaps behind the timber bargeboards, a settlement crack between old and newer sections of the building, missing bedding mortar of end tiles and gaps around roofing timbers.

Photograph 7: Evidence of gaps behind the timber bargeboard on the south-eastern corner of the flat roof section.

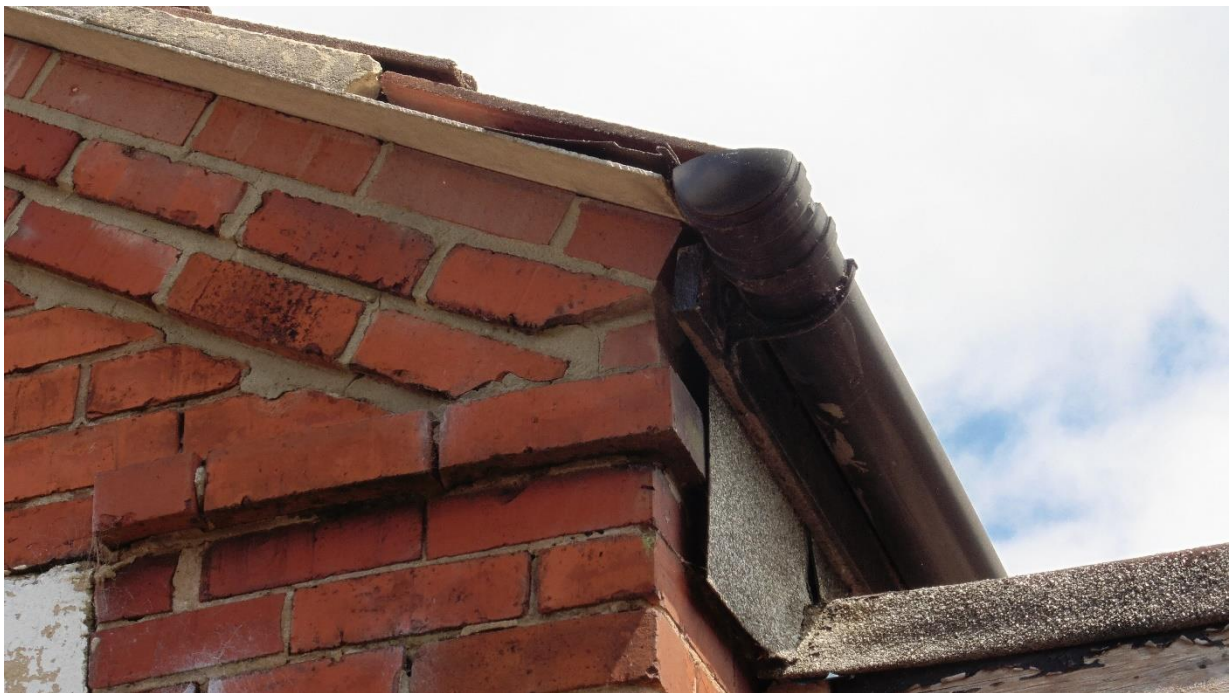
Photograph 8: Evidence of features such as the missing bedding mortar of some end tiles, leading to the exposed timber of the roofing frame, as well as gaps behind the bargeboard and behind a section of felt, all located on the south-western corner of the village hall.

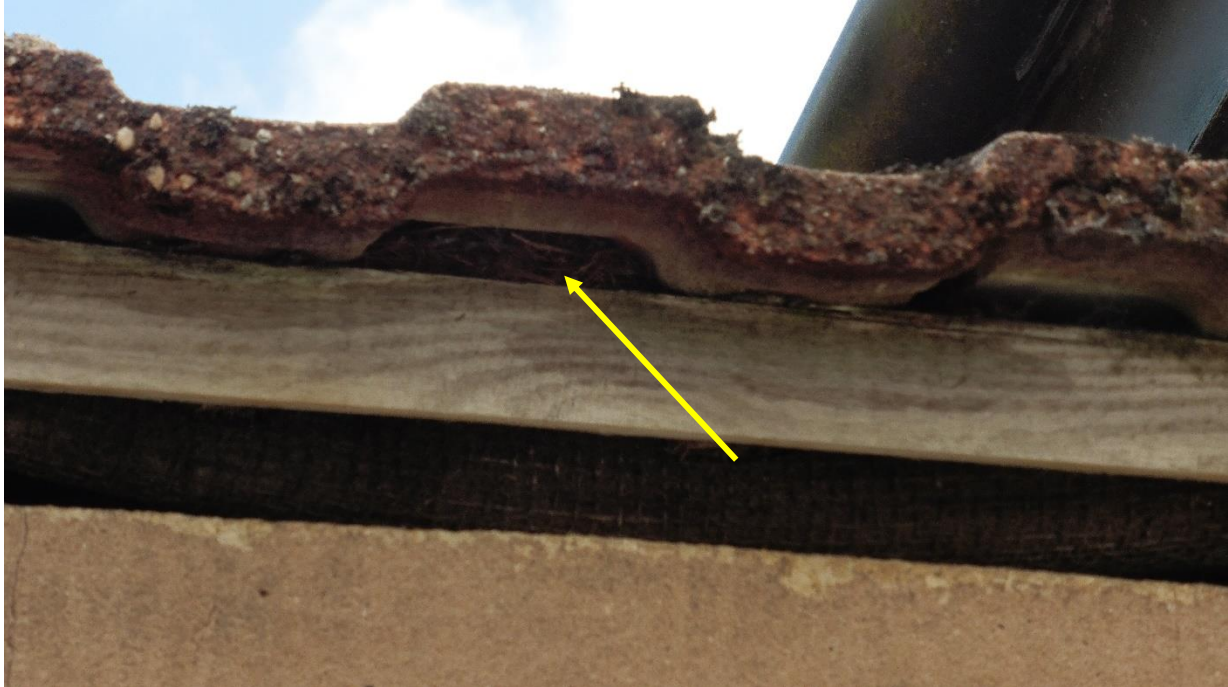
Within the void between the coping stones of the north facing porch and its timber frame and roof covering, the surveyor located evidence of historic nesting by a smaller bird species such as Wren (*Troglodytes troglodytes*) or Blue tit (*Cyanistes caeruleus*).

Photograph 9: Evidence of historic nesting material identified behind the bitumen felt within the void between stone and roofing material on the north facing porch.

To avoid any potential risk of conflict the demolition of the building should be timed for outside of the breeding season, which is variable and runs for the entire period between March and September.

If demolition work is required within the bird nesting season, in this instance before the beginning of September or after March 2023, then in advance a pre-commencement breeding bird check should be carried out by suitably qualified ecologist. Note that if an active nest is found then the nest itself an area of 5 m around will have to remain unaffected and undisturbed until the young have hatched and fledged.

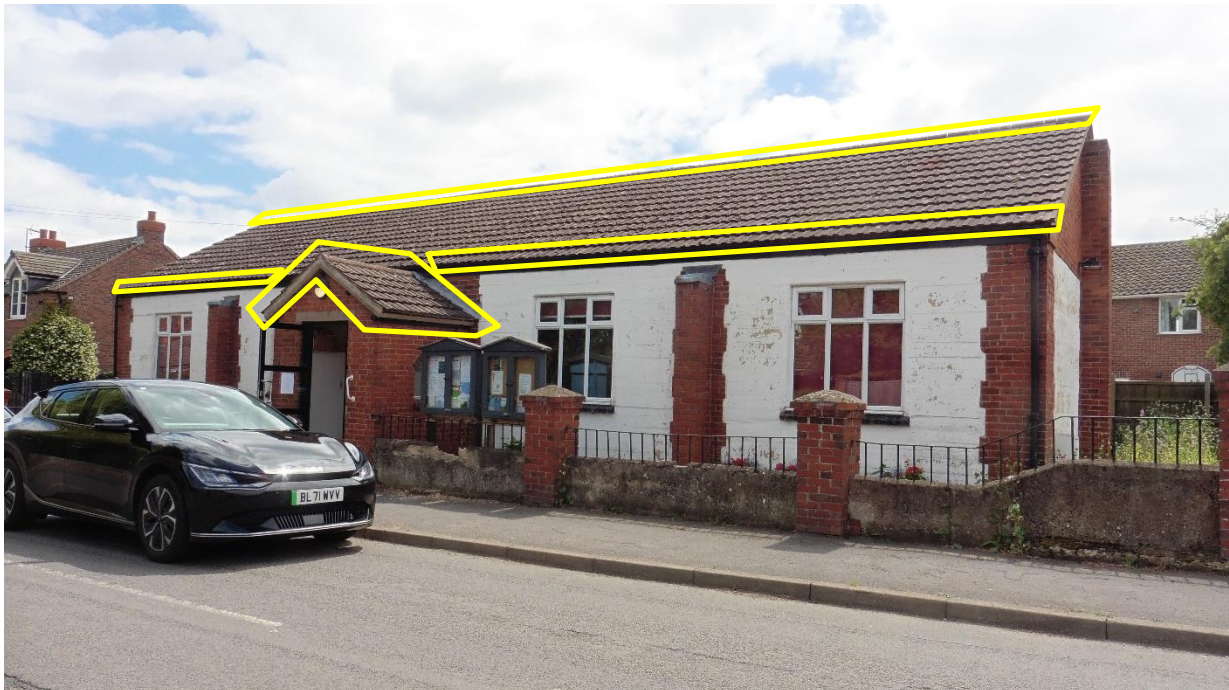
Figure 2 - showing the areas that must be soft stripped by hand in advance of demolition, under the supervision of a bat ecologist (areas highlighted in yellow).

Specifically, this includes for the hand removal of all the ridge tiles from off of the village hall roof and in particular all of the tiles from off of the porch. It then includes all of the tiles from off of the eaves to cover both potential for bats and nesting birds, see below. All the areas requiring this methodology are identified within figure 2 below.

The soft demolition will entail the hand removal of the tiles with care and caution. The tiles must be lifted and not allowed to slip or be lowered again after lifting. The contractor should then check underneath every tile before removing the tile completely.
