Lindsell, Dunmow

Preliminary Roost Assessment Report

**On Behalf of KANE GOODCHILD
PROPERTY LTD.**

Version 1 | August 2022

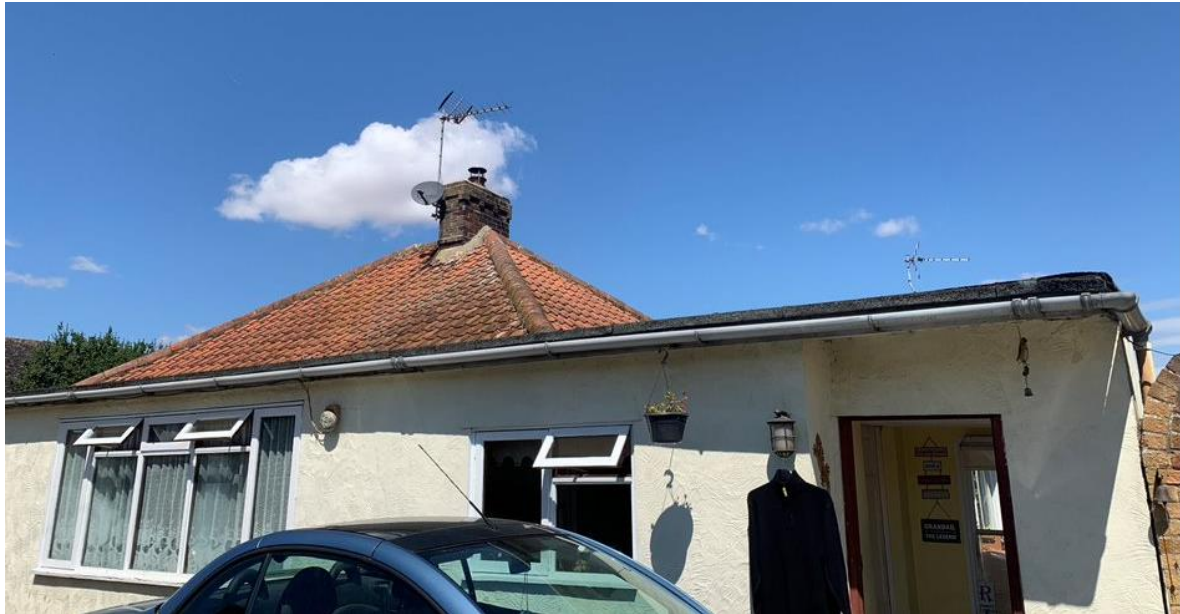
Building 1, Occupied Bungalow Dwelling Onsite.

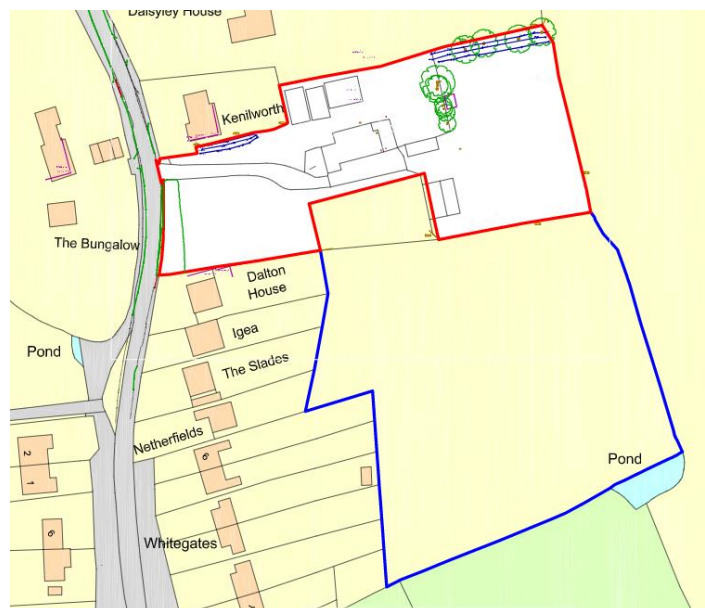
Figure 1: Site Boundary

The site is approximately 0.5ha (central OS grid reference TL 64032 27982, postcode CM6 3QL) and is located in Lindsell, Dunmow in Essex. The site comprises of a bungalow dwelling with outbuildings and car breaking facilities. The surrounding landscape is comprised of the village of Lindsell and predominantly of arable land to the wider area, with areas of woodland, lines of trees and hedgerows. A site boundary (red line) and wider land holdings (blue line) are provided in Figure 1 below.

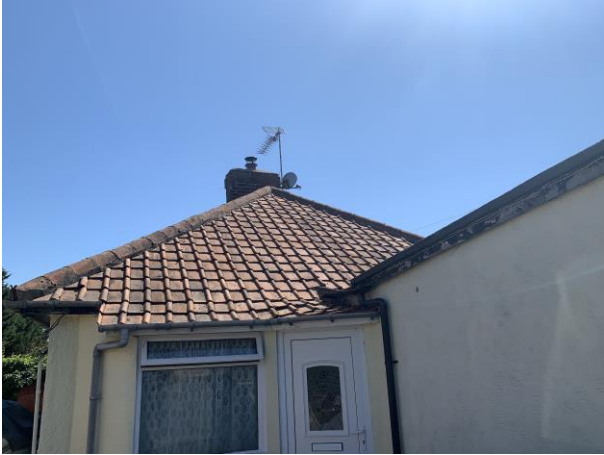
Photo 1: Building 1, west elevation.

External – The bungalow has pale rendered walls, with a predominately hipped tiled roof with flat felt roof extensions to the east and west elevations. The fascias were tightly sealed with wooden soffits. To the north elevation of the building, damage to the soffit box has been fixed with plywood to seal it, although a small hole is present and this was inspected with an endoscope. The inspection revealed the hole leads to an open cavity that does not lend itself to a suitable roosting feature. This damage to the soffit box was not mentioned in the previous report by T4 Ecology Ltd, therefore suggesting the damage and repair of the soffit box is less than two years old. Some of the roof tiles are noted to have lifted, with a birds nest under one revealing the tiles are lifted enough for access.

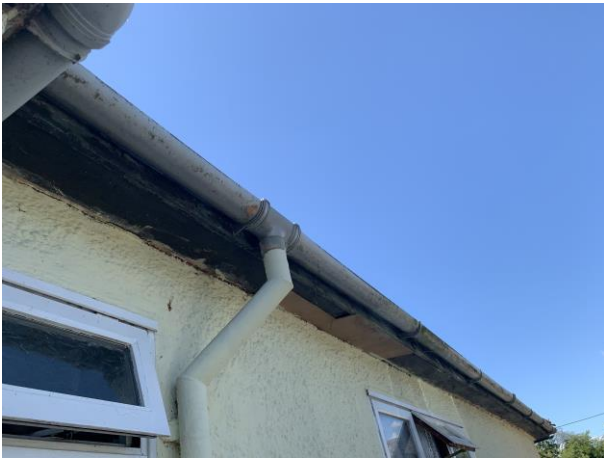
Photo 7: Building 1, soffit box, north elevation.

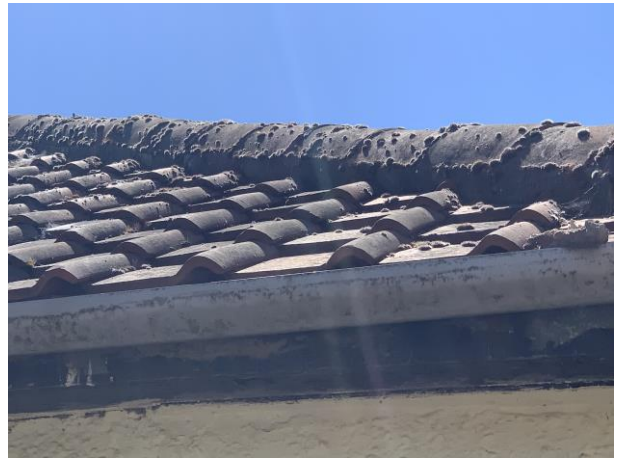
Building 1 was assessed as having ‘**low**’ suitability for roosting bats, which means the building has suitability for a low status roost to be present

Evidence of a house sparrow (*Passer domesticus*) nest under a lifted tile of Building 1 was noted. Therefore, Building 1 is considered to provide nesting opportunities for small passerine birds, such as house sparrow.

Photo 8: Building 1, tiles w/ house sparrow nest under (N)

A precautionary method statement should be produced and followed during works, to mitigate any residual risk to Building 1 which is assessed as having low suitability. This will include soft stripping the building by the removal of any suitable features, namely the roof tiles, by hand under the supervision of a suitably qualified bat worker. If evidence of bats is found, then work must stop, and advice of an ecologist obtained.

Demolition of Building 1 and 2 should be undertaken outside of the nesting bird season (the nesting bird season is considered to run from March to September, inclusive, but does vary depending on weather).

If this is not possible and works are undertaken during the nesting season, then it should only be undertaken within 24-48 hours of a nesting bird check undertaken by a suitably experience ecologist. Should nests be encountered then clearance around the nest will be paused, and a reasonable buffer installed until young have fledged the nest.

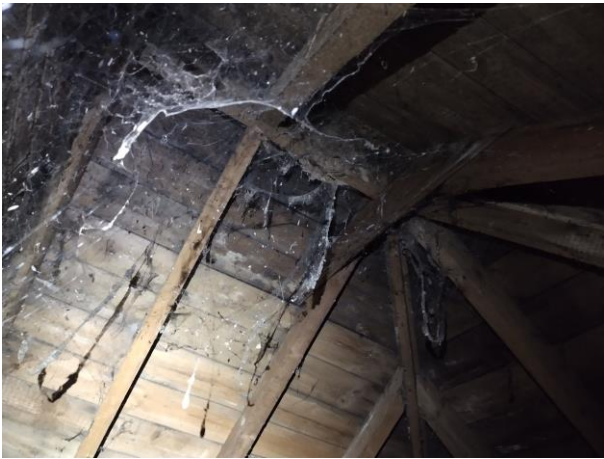
Internal – The loft void in the bungalow, contained a water tank taking up a significant amount of the roof space. Light ingress is noted coming from the north and west elevations and the eaves are covered with a metal mesh. No evidence of bats is noted such as a scattering or accumulation of droppings and is heavily cobwebbed suggesting the space is not utilised although there may be access points to the void through the gaps creating light ingress.

Photo 9: Building 1, loft void. Heavily cobwebbed.

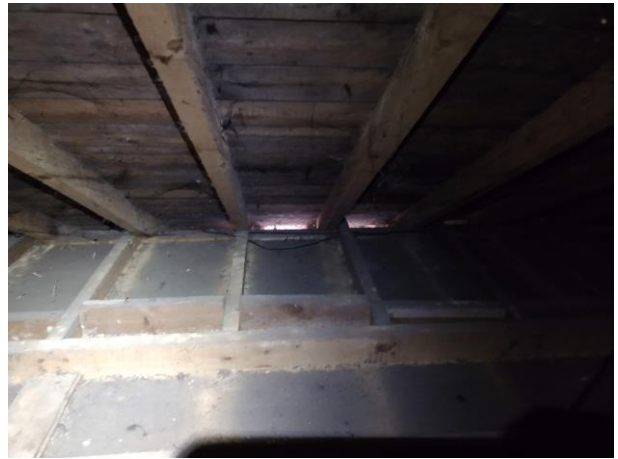
Photo 10: Building 1, loft void. Light ingress.

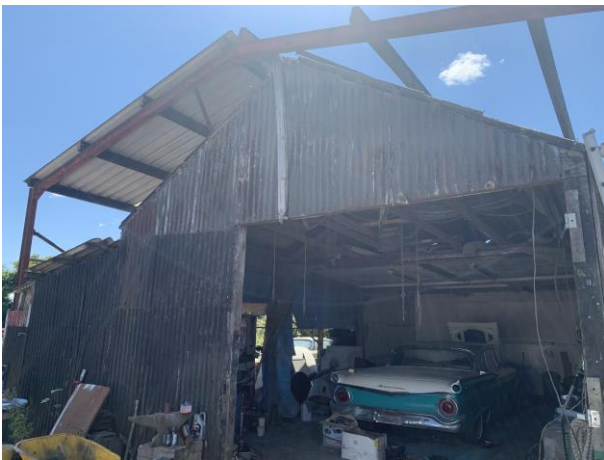
Photo 11: Building 2, north elevation.

External – An outbuilding that is used as a spray/paint shop. A structure with an asbestos roof, corrugated roof and metal sheet and framed structure with internal wooden beams and open entrances on its north and east elevations is situated inside a larger open metal frame. Externally there are no potential roost features on either the building structure or the outside frame.

Building 2 was assessed as having ‘**negligible**’ suitability for roosting bats.

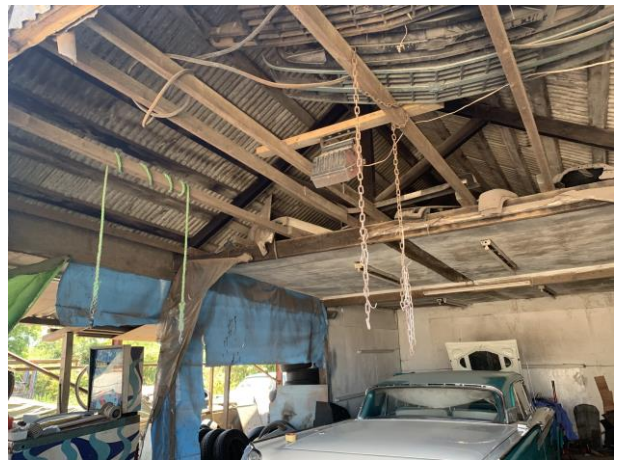
Photo 12: Building 2, internal.

Internal – Internally there are no potential roost features and the openness of the structure along with the light ingress makes the structure unsuitable for roosting bats.

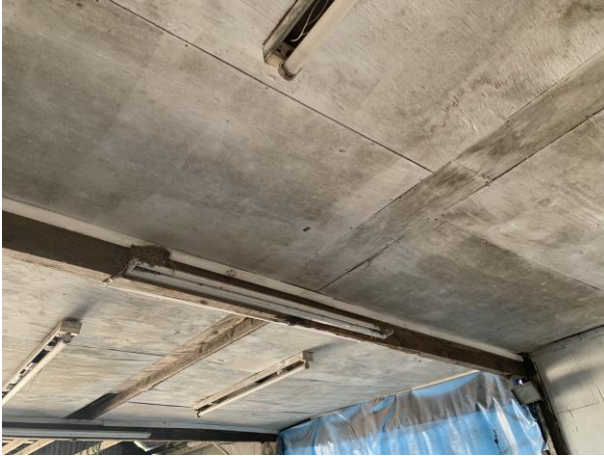
Within Building 2, at least three old house martin (*Delichon urbicum*) or swallow (*Hirundo rustica*) nests were present within the structure, within the frame and above a light fitting. Therefore, Building 2 is considered to provide nesting opportunities for Hirundinidae.

Photo 13: Building 2, old house martin/swallow nests.

Installation of two house sparrow terrace and two general purpose boxes as compensatory nesting habitat. These should be mounted at least 3-4m above ground with a clear line of flight. If it is not suitable to mount all the bird boxes onto the new dwellings, then the general hole fronted boxes should be pole mounted and placed near retained trees.

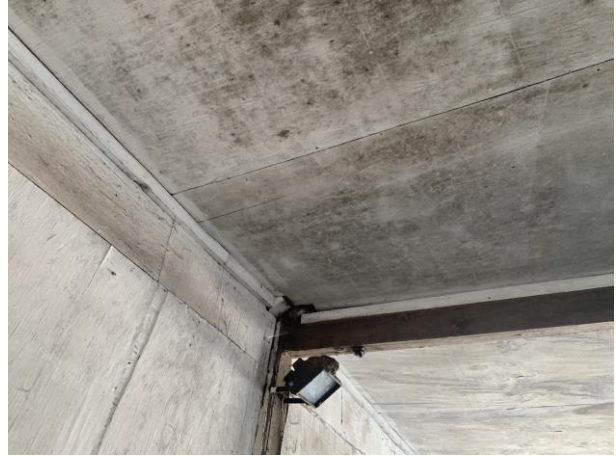
Photo 14: Building 2, old swallow nest.
