**Preliminary Roost Assessment and Preliminary
Ecological Appraisal at Chambers Farm,
White Cross Road, Wilburton**

Prepared for Morton and Hall Consulting Ltd

August 2022

Site Name	Chambers Farm, Wilburton
Report Type	PRA and PEA
Client	Morton and Hall Consulting Ltd

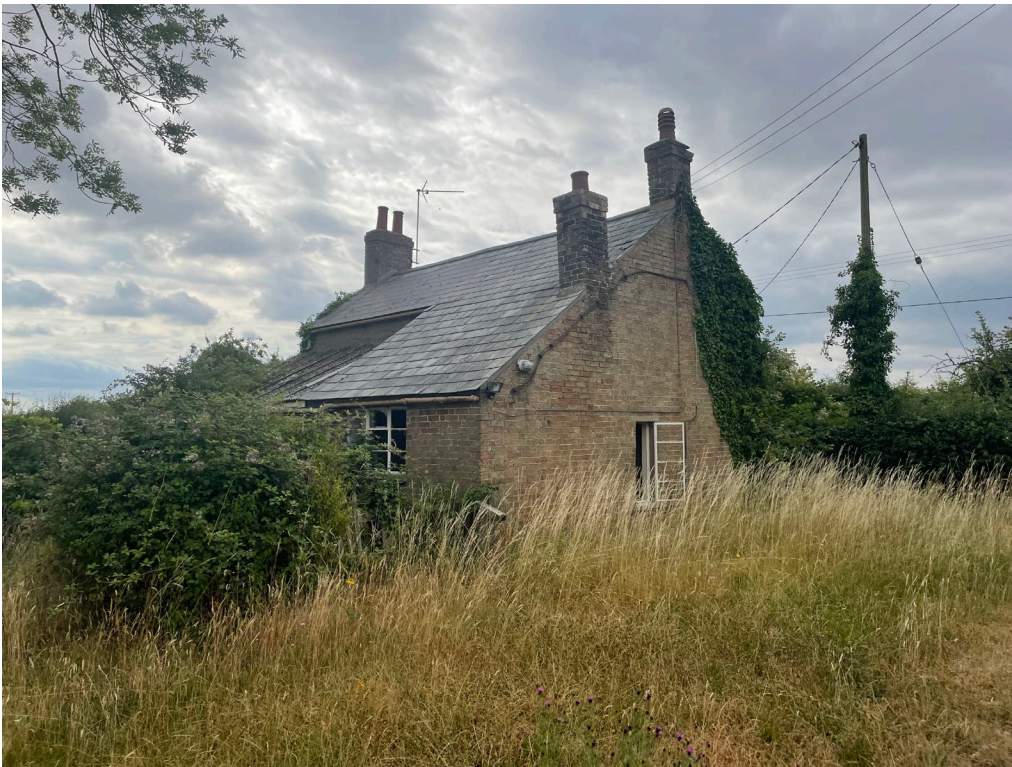
Plate 1 Dwelling-End View

5.4 The dwelling indicated negligible potential to support roosting bats with no evidence of bat usage and no suitable roosting features identified.

6.1 The dwelling has negligible potential to support roosting bats due to an absence of evidence of bat usage, roosting features and an unstable microclimate, due to the poor condition of the building.

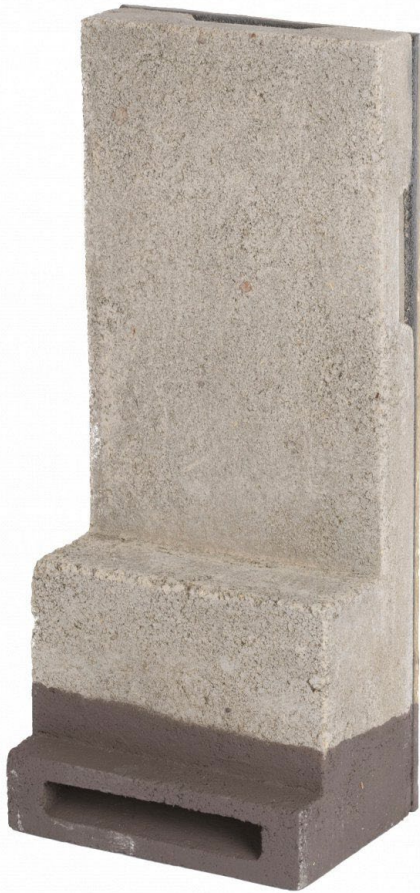
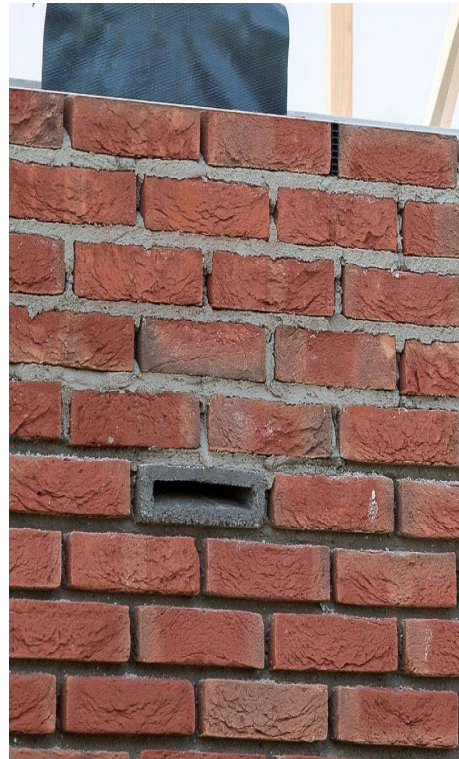
Vivara Pro Build-in WoodStone Bat Box 4

The Vivara Pro Build-in WoodStone Bat Box has been specifically designed to fit into the cavity of house walls. It features a slim sized entrance hole which can sit flush in a course of bricks to provide a discreet entry way for bats. It is manufactured from hard-wearing WoodStone and plywood with removable side panels so that several boxes can be placed side by side. Position the box at least 2m above ground level away from artificial light sources. WoodStone is a mixture of sawdust from FSC wood sources and concrete, and it is designed to last for years. It is breathable so there will be no problems with condensation and Woodstone maintains a consistent temperature inside, providing excellent insulation for roosting bats.

7.1 To provide enhancements Vivara Pro Build-in bat boxes should be installed in new builds; advice on the number and location should be sought from the ecologist.

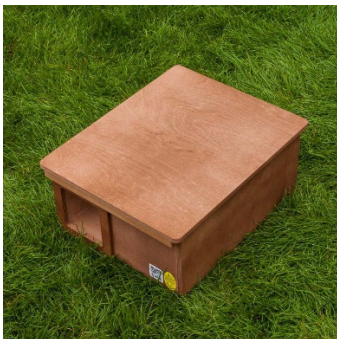
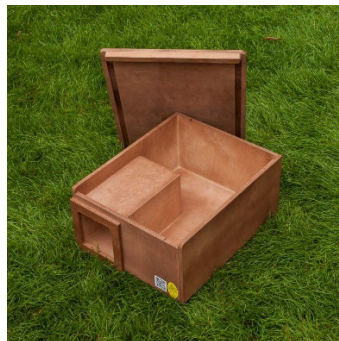
Hedgehog Homes

A completely redesigned hedgehog nest that incorporates all the best features of previous nests, is far safer for the hedgehog, and eliminates loose entrance tunnels and plastic pipes by building all these features into one robust design.

- * Fully built-in tunnel with 5" square access for even the largest hedgehog to avoid unwanted visitors.
- * Raised 'step' at entrance to enable the box to be partly buried.
- * Totally safe nesting area well away from the tunnel entrance.
- * Lower roof to enable the hedgehog to build a snug nest.
- * Specially designed inbuilt "unlockable" ventilation to provide just the right temperature and humidity without draughts.
- * Totally removable roof for easy inspection and cleaning.
- * Underfloor runners letting air to the underside of the box but allowing the box to be pushed easily into place in undergrowth, etc.
- * Reinforced and strengthened corners making a sturdy nest box.
- * One compact unit easy to position.

Exterior quality 12mm resin bonded ply. The box remains untreated on the inside. Best situated in a quiet corner of the garden and covered with leaves and other garden debris. Removable lid for cleaning purposes and reinforced corners, manufactured with surface sunk nails to resist rusting.

Nest box size: Height 22cm x Width 38cms x Length 47cm

7.5 A Hedgehog home should be installed.
