July 2022

Brooks Hill Farm, Calmore Relocation of Farm Buildings

Agricultural Needs Report

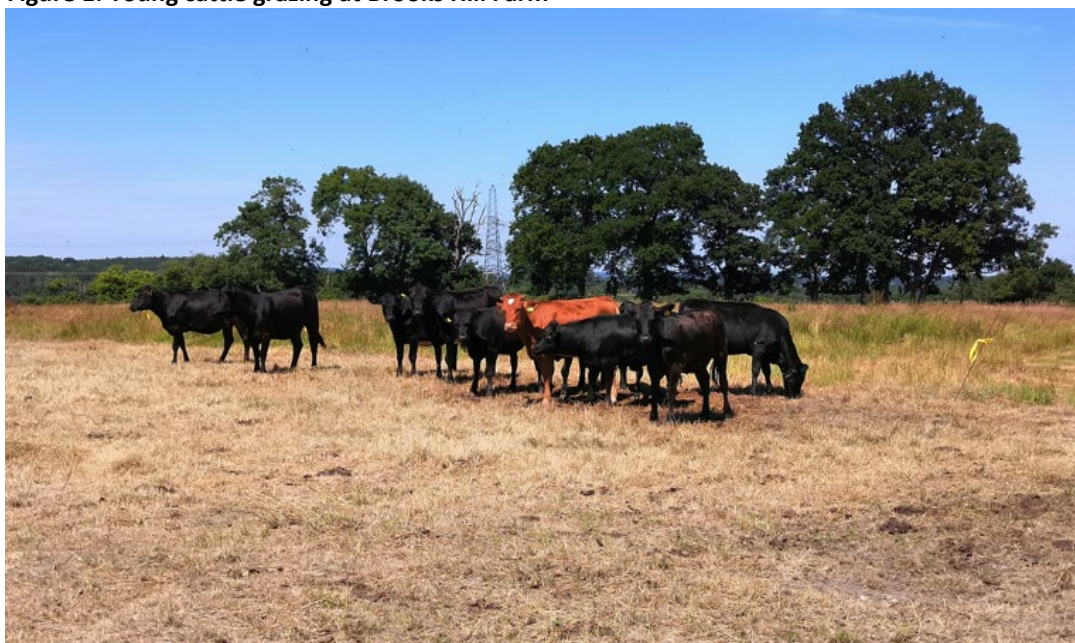
Figure 1: Young cattle grazing at Brooks Hill Farm

- 2.4 The main enterprise at Brooks Hill Farm is cattle rearing, with batches of 15-20 young calves purchased at Salisbury or Frome markets or from dairy farms in the locality and reared to strong stores at approximately 24 months of age, when they are sold to specialist finishing units.

2.5 There are currently 108 cattle grazing but total numbers are commonly around 160 which need to be housed over winter, usually from the end of October to April as the ground is too wet to support them without destroying soil structures. Most of the cattle are housed for two winters before being sold, with straw bedding bought in and stored in the yard, and wrapped forage made and also stored in the yard.

- 5.9 The second yard enables the undercover storage of the substantial volumes of hay and straw that are produced and used on the farm or sold. The two areas shown on Figure 1 as storing wrapped forage amount to about 600m² on their own, irrespective of other areas within the yard also used for wrapped forage. The proposal will result in a very substantial reduction in the volume of plastic film used for wrapping forage, as well as visually containing the bulky material within a building.

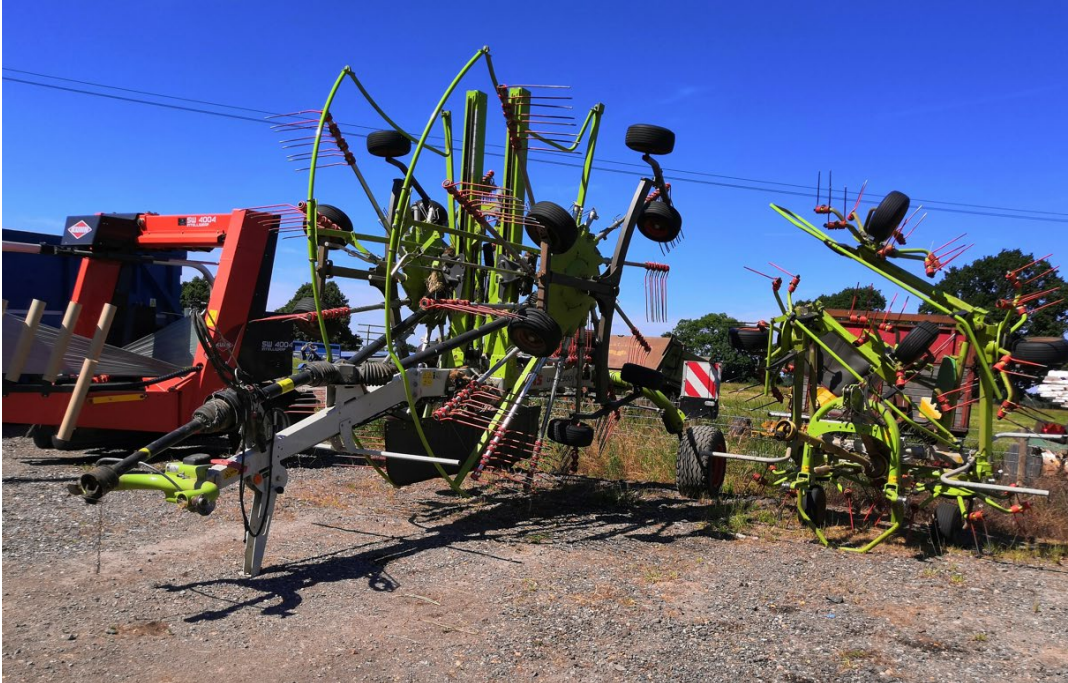
Figure 2: Agricultural equipment stored on the outdoor yard

2.8 Mr Alford also runs an agricultural contracting business, concentrating on harvesting, baling and wrapping forage, cultivations, seed drilling, muck spreading and hedge cutting which services a large area of agricultural land in the locality. The agricultural machinery for this operation is also stored outside on the yard at Brooks Hill Farm, with examples of the equipment shown in Figure 2.

- 5.10 There are also a number of key items of machinery that should be stored under cover whenever possible but which are currently stored outside, as shown by the examples in Figure 2. These include tractors, a telehandler, a square baler, a wrapper, a mower, a topper and a tedder. Storing these items under cover when space is available within the hay and straw barns and workshop will prolong their lives.

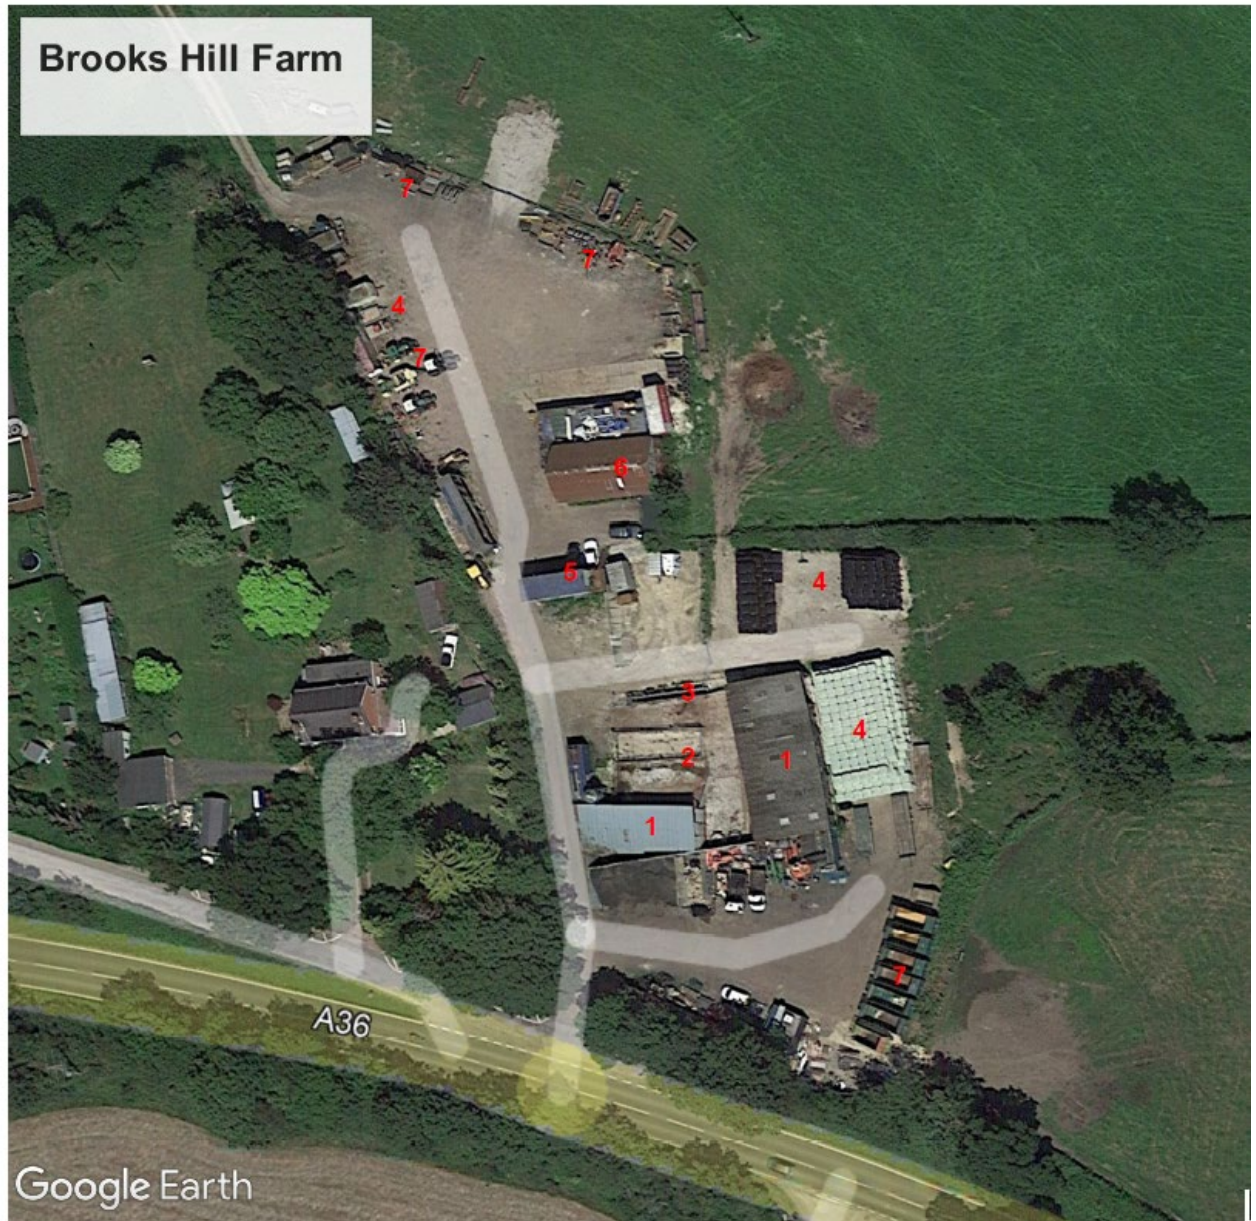
Figure 3: Farm buildings at Brooks Hill Farm

3.1 The layout of the existing farm buildings is shown in the Google Earth image at Figure 3 below.

Building	Description
1	Cattle sheds, 420m ² and 260m ²
2	Open cattle yard
3	Cattle race/handling facilities
4	Wrapped bale storage
5	Farm office
6	Farm workshop
7	Outside machinery and equipment storage

- 3.2 The overall yard extends to approximately 7,630m², of which the cattle sheds, open cattle yard and cattle handling facilities amount to slightly more than 1,000m².
- 3.3 A record of condition survey of the buildings was carried out by Mr J Farquhar in the mid-2000s. This described the western cattle shed as:

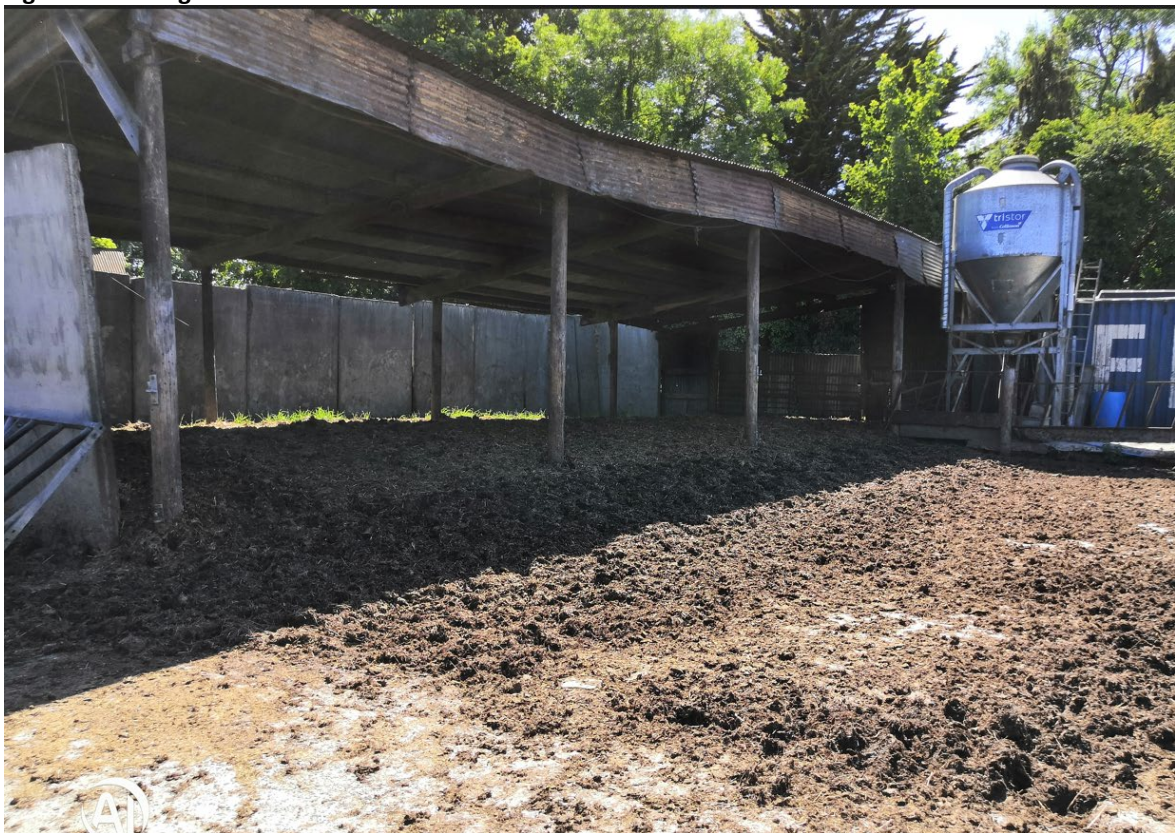
Figure 4: Existing cattle shed to west

“Lean-to pole barn with corrugated iron roof. North elevation brick and south elevation open with gates. West end open with gate and east end open with 2 gates overlapping. Floor could not be inspected as covering of dung over.

Structure - Timbered poles of some age.

Roof - Corrugated iron rusting and of some age with some holes and some sheets loose.

Brick wall - Brick and blockwork opening blocked up, not that sound, of some age.

Generally - Building of poor construction, gates rusting serviceable but not fixed. Electrics believed not working.”

- 3.4 The current condition of this shed is shown in Figure 4:

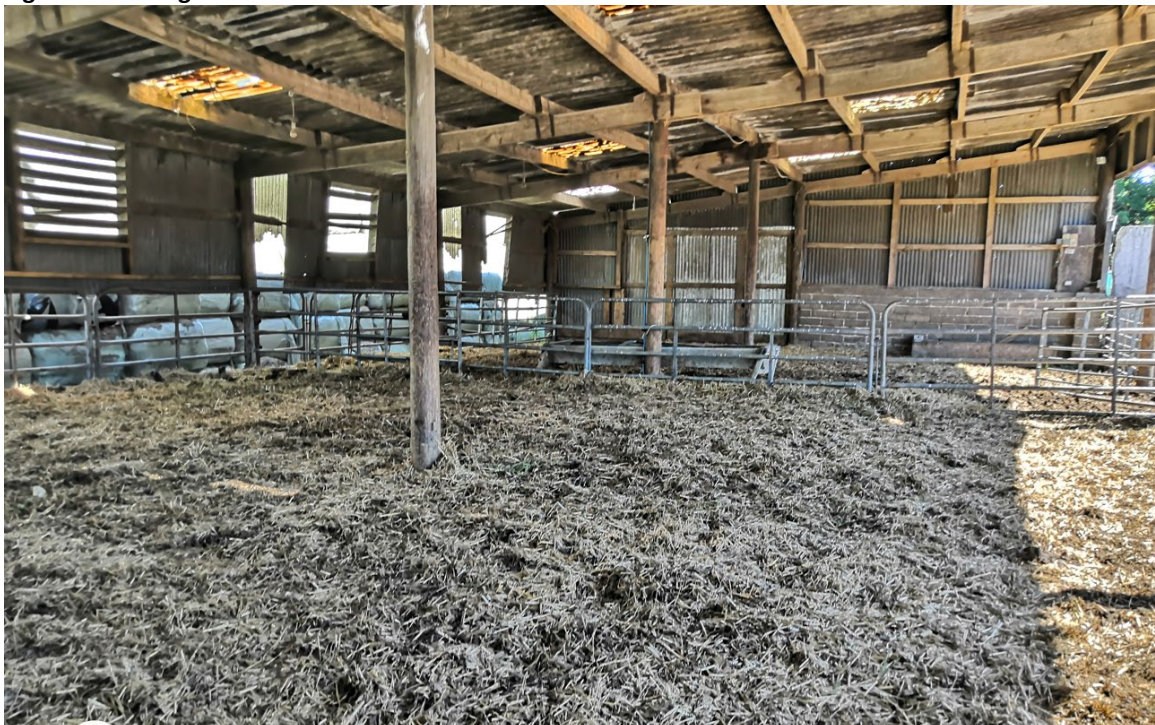
Figure 5: Existing cattle shed to east

3.5 The cattle shed to the east of the open yard was described as follows:

“Monopitch pole barn for hay and straw storage. The barn constructed of timber poles with asbestos/cement roof sheeting with roof lights, blockwork wall to approximately 5 ft and corrugated iron above. Floor covered with dung and debris and could not be inspected.

Structure - Pole barn with timber supports. Southern gable end post damaged. All posts old and of some age, but serviceable.

Roof - Asbestos/cement fibre sheeting all satisfactory, but of some age. Roof lights complete.

Walls - North east corner block walling damaged and collapsed and block work elsewhere moved and out of true. C.1. tin rusting and some loose but serviceable. Slatted ventilation on back wall all in poor order and damaged.

Guttering and downpipes loose and requiring refixing. Water trough in sound order.

Building generally serviceable for storage purposes but is old.”

3.6 This building is shown below in Figure 5.
