# **ECOLOGICAL IMPACT ASSESSMENT**

**and Bat Activity Surveys**

**Byways,**

**Penrhos,**

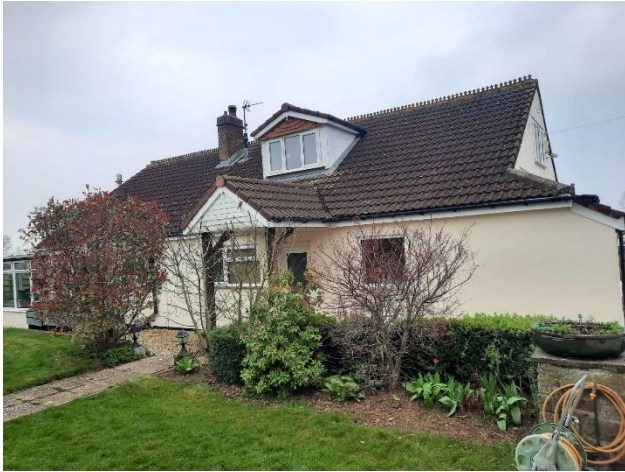
Plate 1: Northwest elevation and garden.

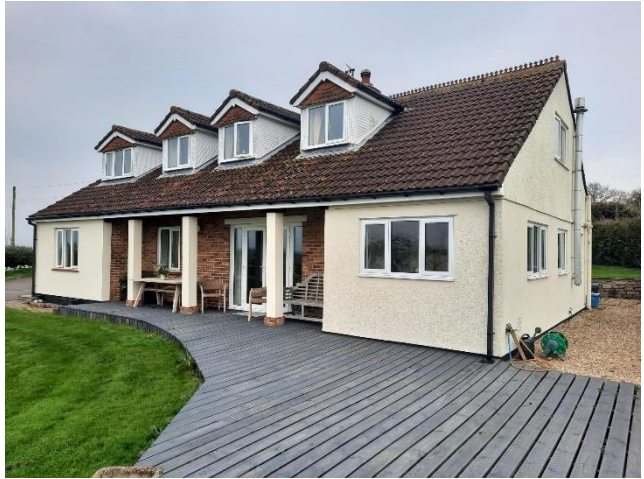
Plate 2: Southeast elevation showing decking against lawn.

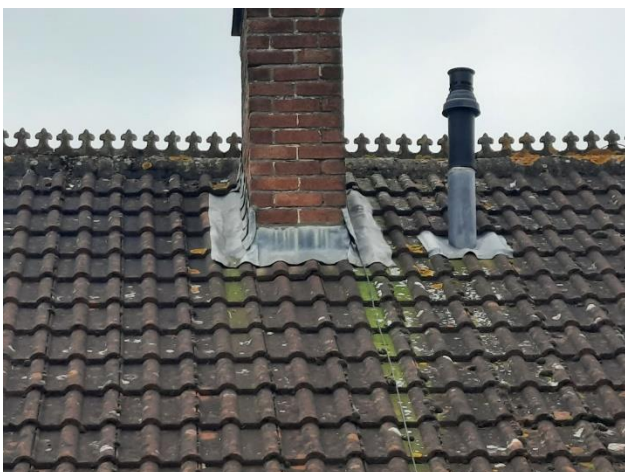
The Site is orientated northeast-southwest along the ridgeline. The roof is pitched and clad in interlocking tiles. The tiles are in place, there are gaps leading under tiles against the chimney and against the dormer windows. There is a single dormer window on the northwest elevation and four on the southeast elevation. Each dormer window has hanging tiles with gaps and crevices in the dormer features.

Plate 3: Roof tiles and chimney on the northwest elevation. Plate 4: Northwest elevation.

There are gaps and crevices within the roof tiles, particularly against the chimney, and at both gable ends under the end cap tiles. All five dormer windows have tiles with lifted edges, and crevices associated with the lead work and hanging tiles.

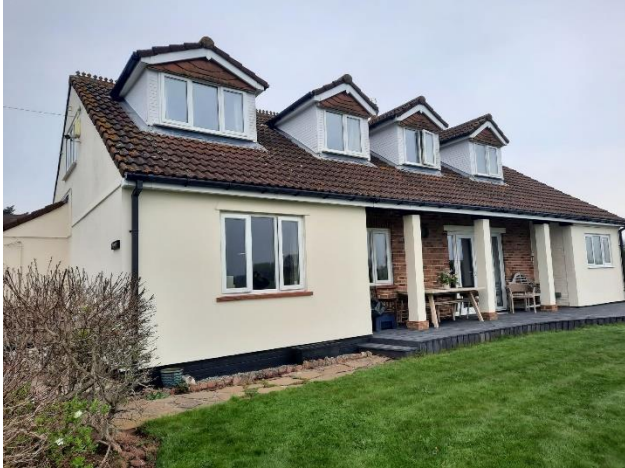
Plate 5: Southeast elevation.

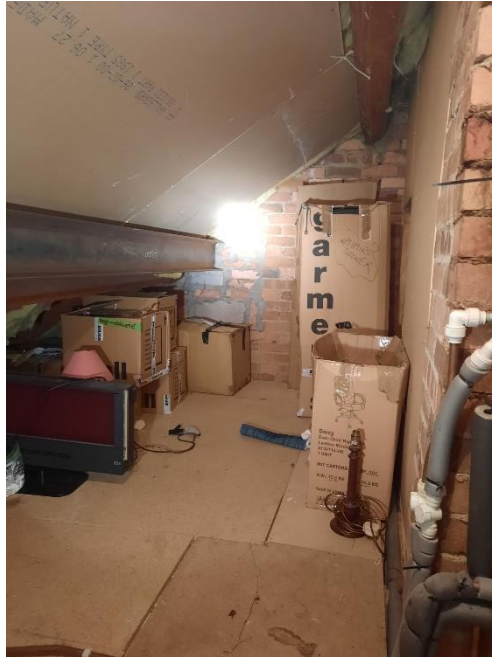
Plate 6: Side loft against chimney breast.

Internally there are rooms within the roof space, there is a sealed void above the height of the purlins. There is a single side loft on the northwest elevation. The loft is a small room against the chimney breast.

Bat droppings were found on the chimney breast in the loft. The droppings have fallen through a gap in the insulation from crevices associated with the chimney and bitumen felt. The droppings appear old (over 1 season old).

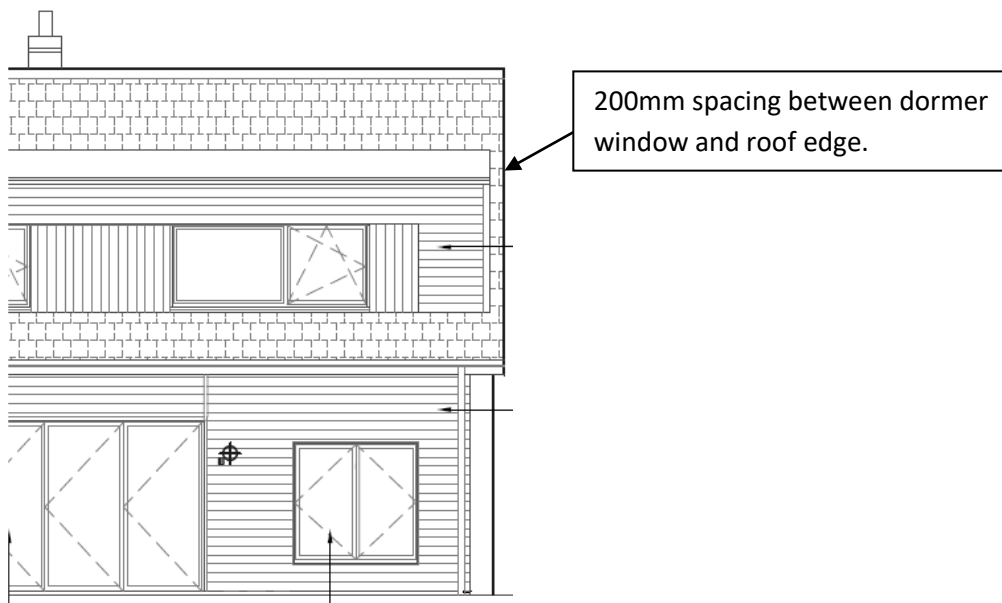
Figure 2: Northeast elevation showing proposed dormer window and edge of roof detail. Not to scale.

All four roost locations will be located 200mm from the edge of the proposed dormer window, Figure 2. The tile end caps that create the roost will be removed through the proposed works. The roof tiles will be replaced with slate tiles without overhanging end caps.

There is potential for roost crevices to be created in similar locations at the gables through the addition of bargeboards. Bargeboards would create similar crevices to the endcap tiles and would have no contact with breathable roofing membrane which is harmful to bats.

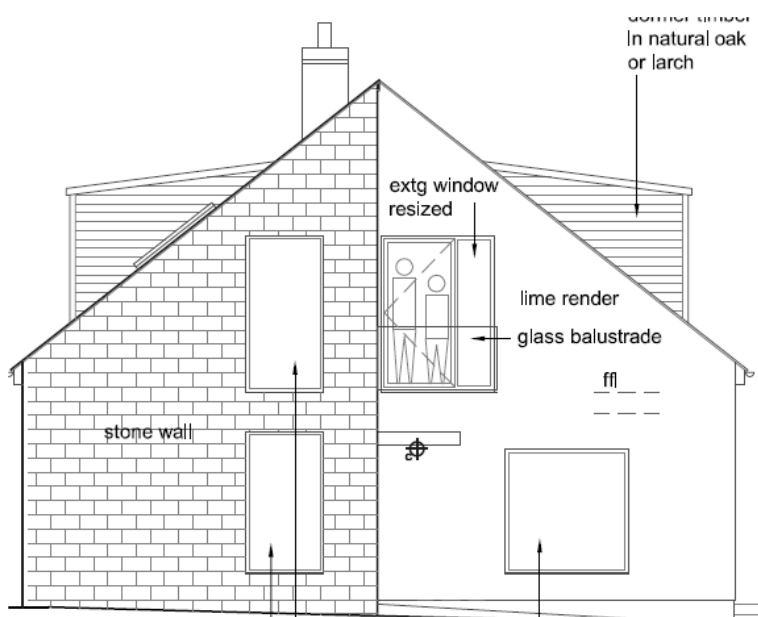
**Southwest gable:** There are two common pipistrelle and one soprano pipistrelle single bat non-maternity roosts along the north edge of the gable. These three roost locations will be lost through the proposed southwest gable extension (Figure 3).

Figure 3: Proposed southwest gable. The left half of the gable will be extended, with loss of existing roost locations. The right half of the gable will be retained with the roof replaced with a change in materials.

There are two common pipistrelle single bat non-maternity roosts along the southern edge of the gable. These two roost locations will be located 200mm from the edge of the proposed dormer window. The tile end caps that create the roost will be removed through the proposed works. The roof tiles will be replaced with slate tiles without overhanging end caps.

There is potential for roost crevices to be created in similar locations at the gables through the addition of bargeboards. Bargeboards would create similar crevices to the endcap tiles and would have no contact with breathable roofing membrane which is harmful to bats.

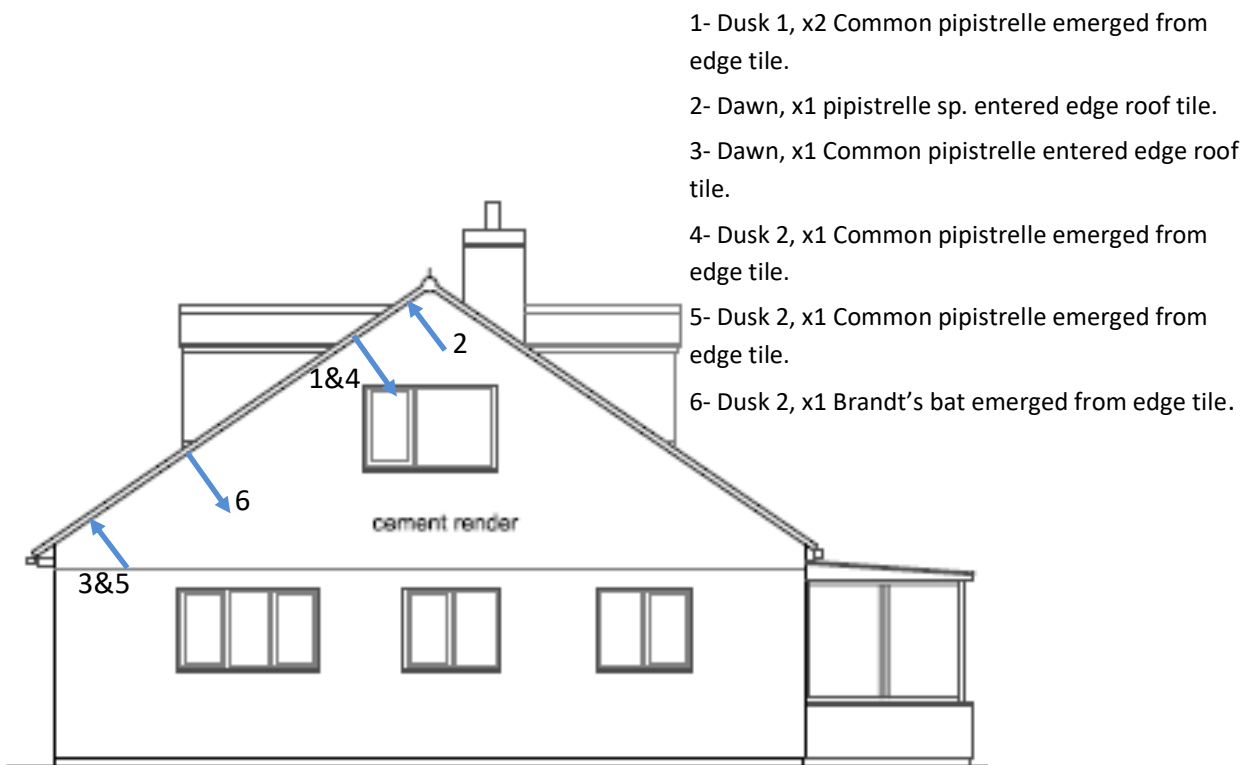
**Summary:** Two common pipistrelle emerged from the northeast gable end of the Site, from under a tile cap.

Figure 4: Northeast gable showing emergence and entry activity to bat roosts. All bats emerged and flew west to hedgerow.

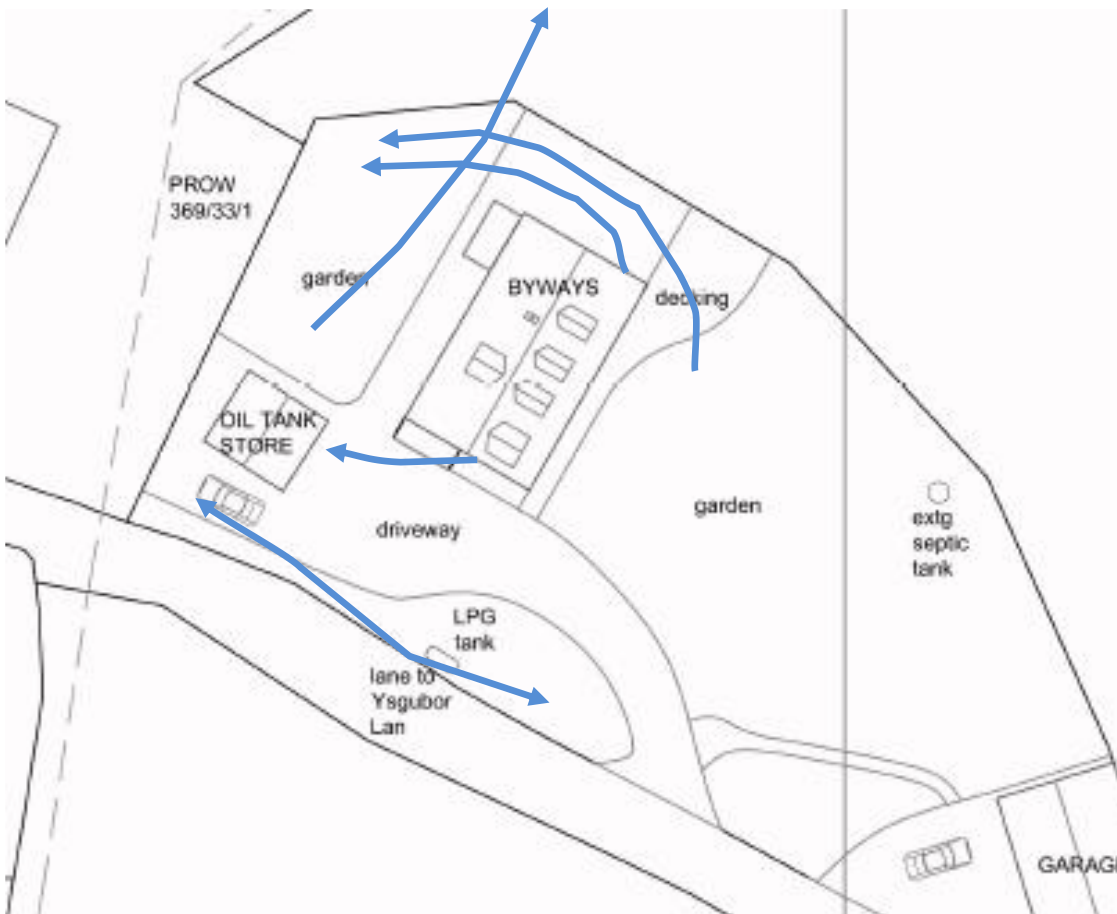
Figure 7: Showing key flight paths observed during the three roost activity surveys.

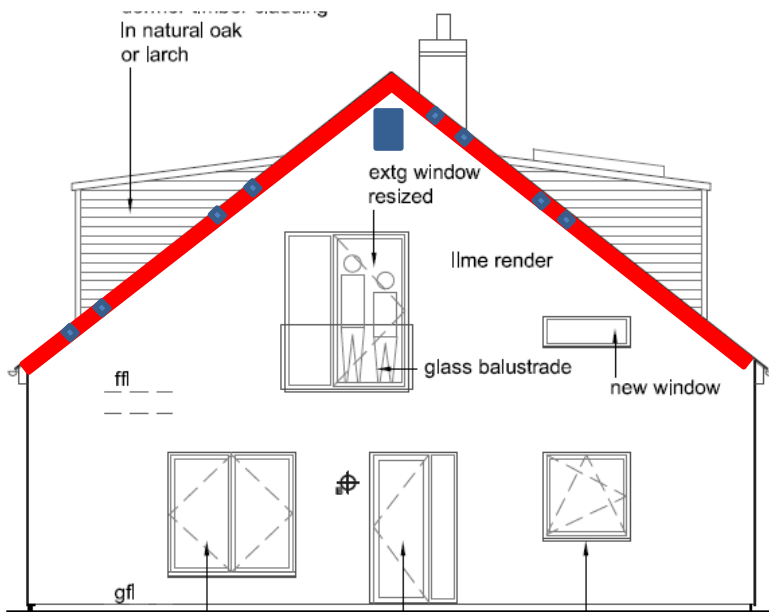
Figure 8: Northeast gable showing bargeboards and location of bat box.

Blue blocks over bargeboard indicate wooden blocks fitted under the bargeboards to create 160mm wide crevices.

Wooden blocks, the width of the bargeboards, will be fitted at intervals under the bargeboards to form x4 crevices 160mm x150mm x20mm in size. This will create crevices with varying environmental conditions.

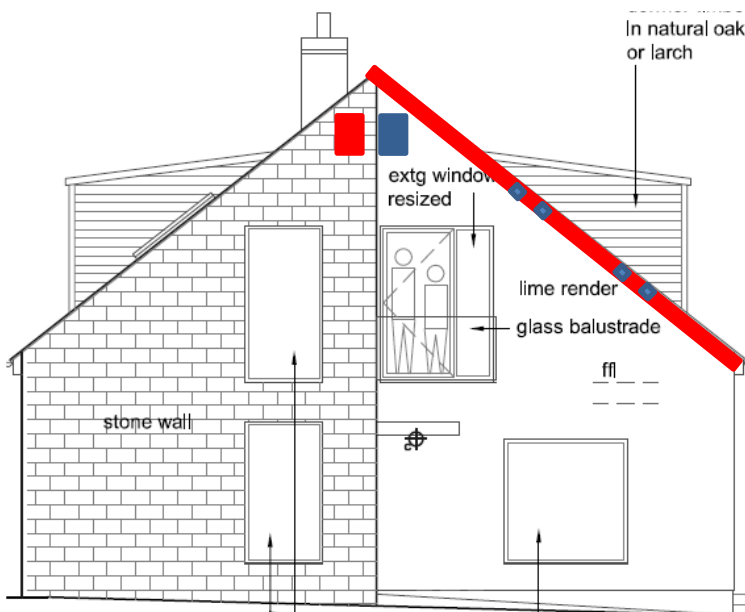
Figure 9: Southwest gable showing bargeboard and locations of bat box (red indicates compensation, blue indicates enhancement, built-in box).

Note: Blue blocks over bargeboard indicate wooden blocks fitted under the bargeboards to create 160mm wide crevices.

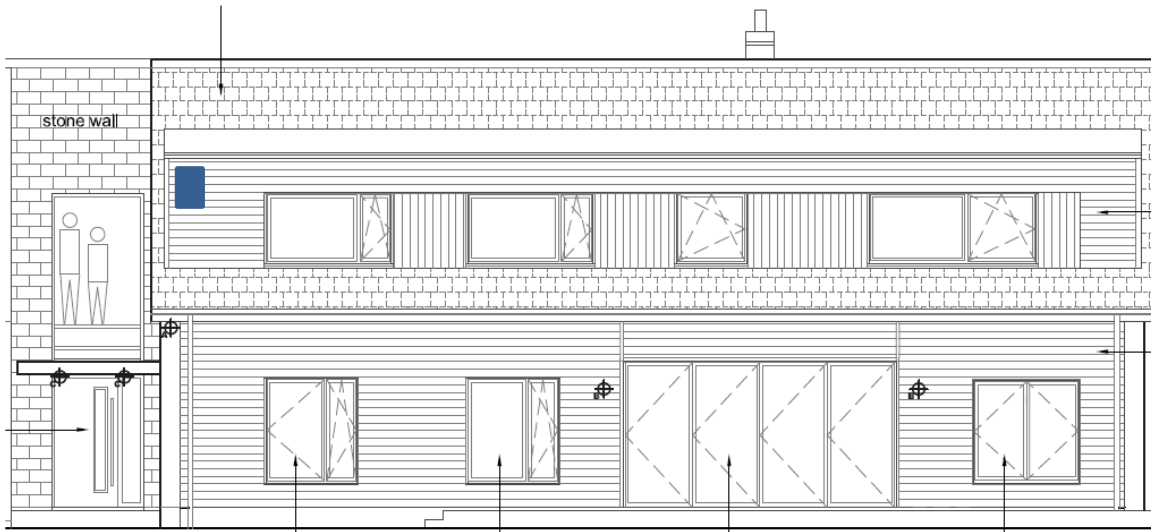
Figure 10: Southeast elevation showing location for Kent-style bat box on dormer window.
