A Preliminary Ecological Appraisal & Mitigation Strategy for The Barns, at Parkend Lodge Farm.

Aim: To establish the presence or absence of bats & birds in the building & importance of adjacent habitats.

Mr. & Mrs. Downton
Parkend Lodge Farm
Castle Lane
Moreton Valence
GL2 7NE

Reference: 1RD\Bat & bird's survey.doc
15th August 2022

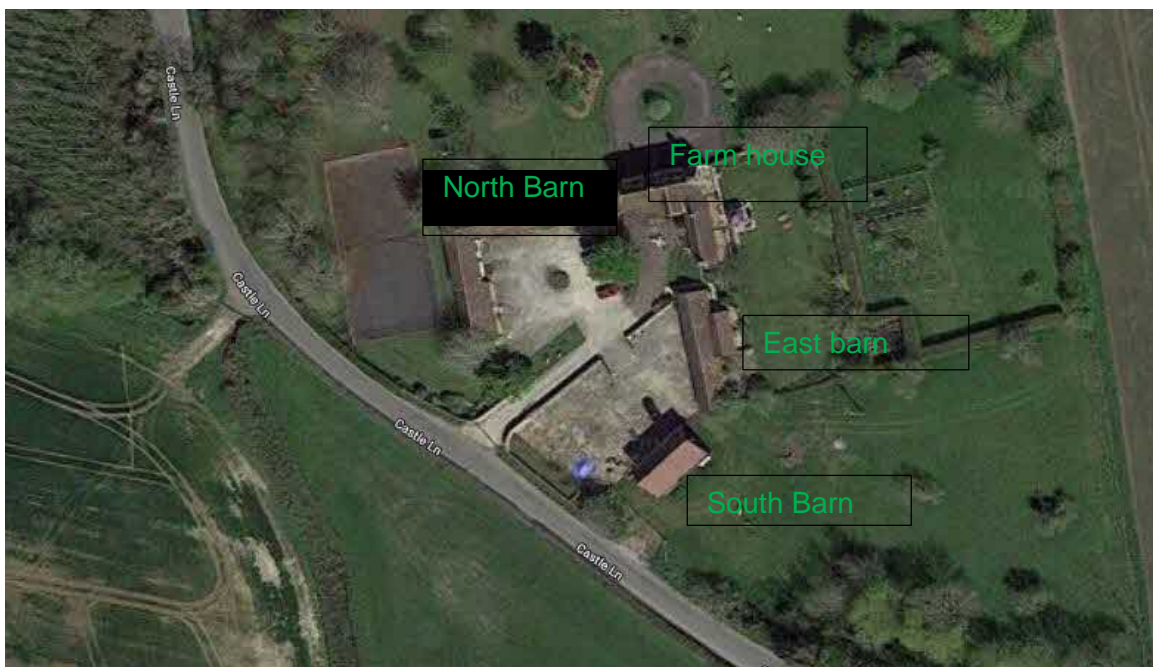
Figure 1 –The Barn buildings for reference (Google 2022)

South Barn is the most southerly two storey barn & **East Barn** is a single storey barn building attached to another smaller single storey building & **North Barn** is an L shaped barn furthest north of the site, situated by the tennis court & attached to the Farmhouse on the eastern elevation as shown above in figure one.

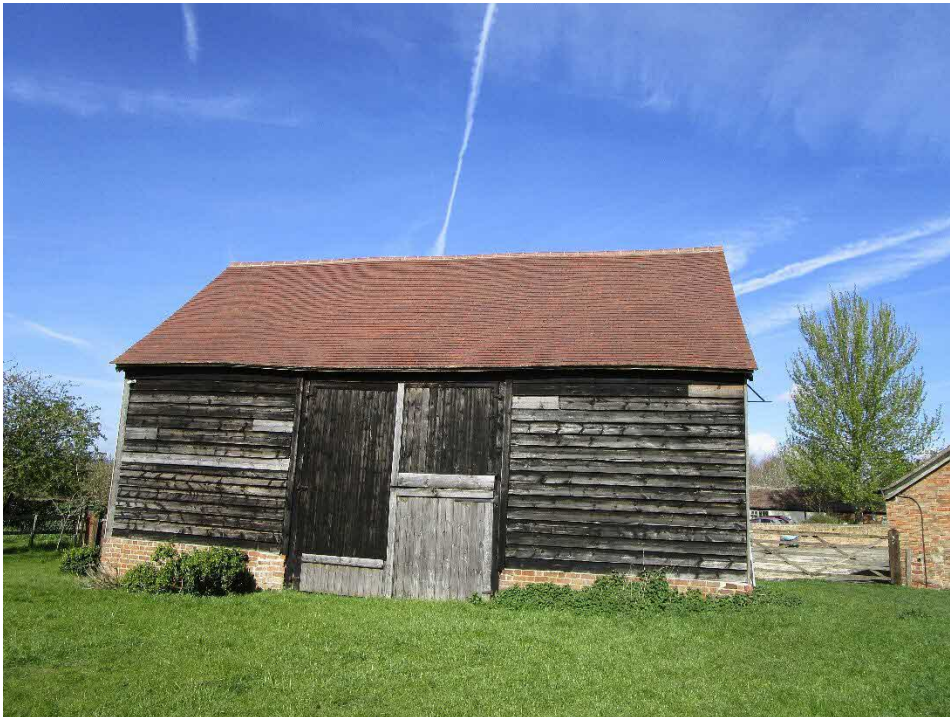
Figure 2 – The South Barn (rear elevation)

The southern barn is two storey timber framed barn with single skin timber treated (originally creosoted) clad walls on a brick base with large timber doors on the front & rear elevation & flood lights as shown below in figures two & three. The roof was reroofed with new clay tiles & well mortared at the edge & lined with modern membrane approximately five years ago as shown below in figures two & three.

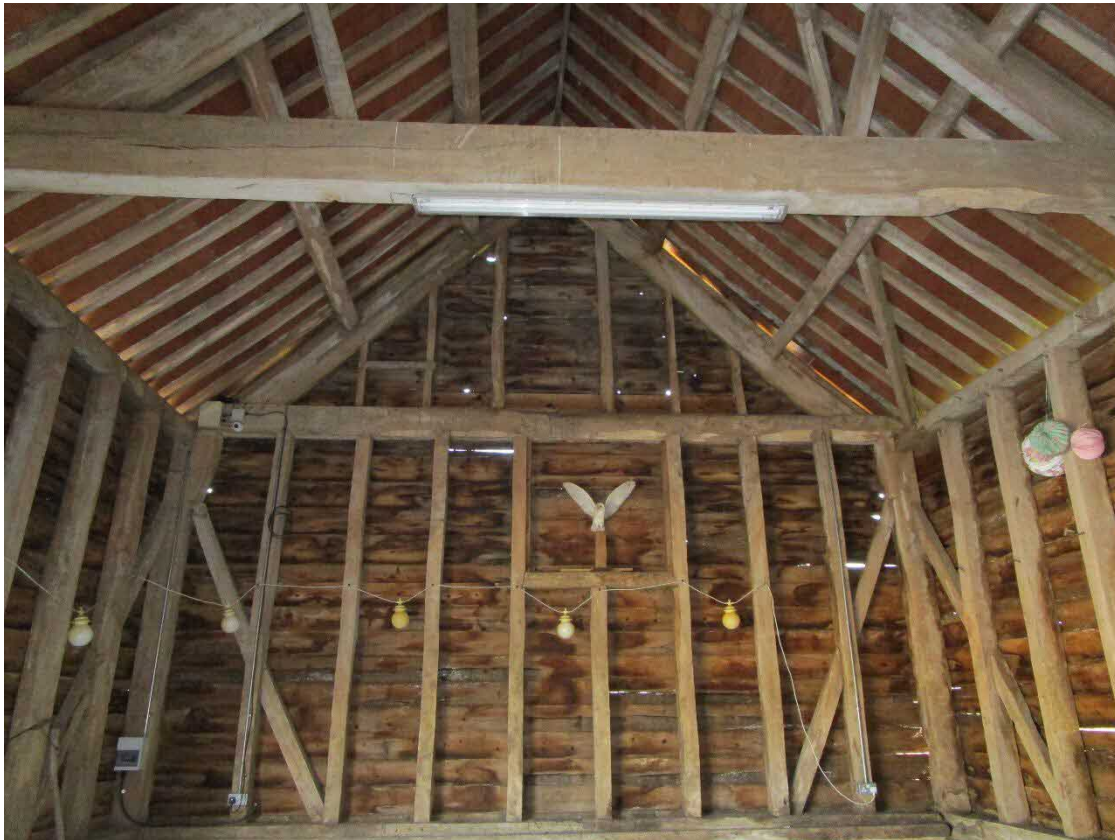
Figure 4- internal view of the south Barn

Internally the **South Barn** has exposed timber framed walls & roof, with the underside of the roof having been lined with wooden boards & the walls being unlined single skin timber cladding as shown in figure four below.

The **South Barn** is naturally well lit throughout the barn as there are gaps at the edge of the roof & in-between some of the timbers as well as having a series of strip lighting & some decorative party lanterns as shown above in figure four. The barn Owl shown on the Gable end wall is not a live barn owl but a stuffed figure. Although there is a Triangular Owl box on the external NE gable end wall there was no evidence of use by nesting birds in the South Barn.

The barn has a concrete floor & low numbers of bat droppings were found on the floor as such droppings were collected using a sterile sampling kit for laboratory eDNA analysis.

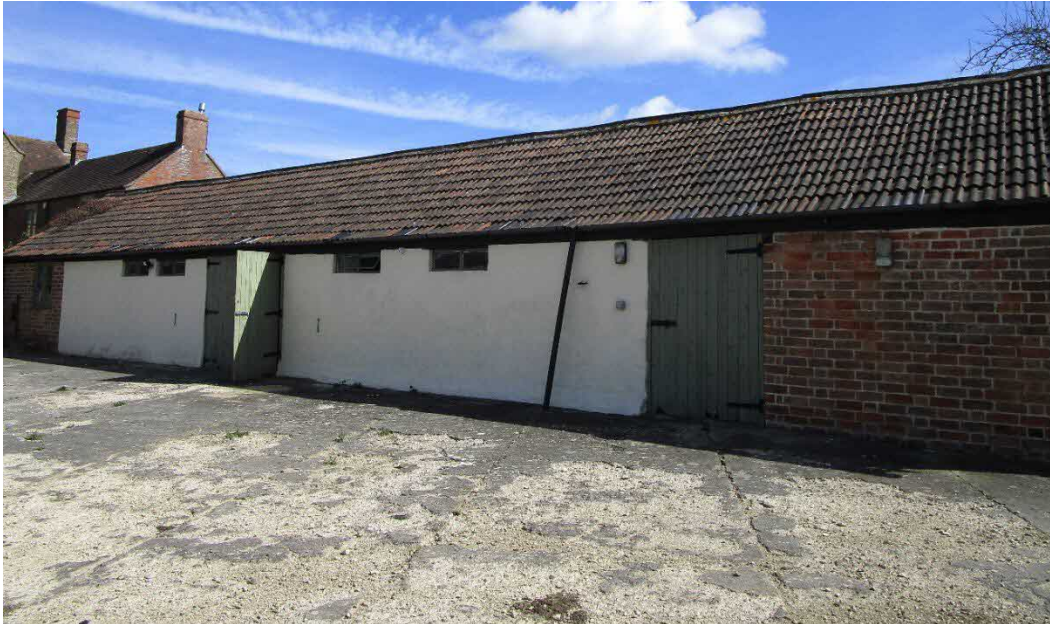
Figure 5 – External view of the East Barn

The East Barn is a single storey barn with a pitched roof that has red brick walls that have been rendered & painted in sections interspersed with timber framed glazed windows & has double painted timber doors as shown below in figure five. The pitched roof is covered in double ridged clay tiles with painted barge boards at the edge of the roof as shown below in figure five.

Bat tiles should be incorporated into the design of the replacement roofs for both the East & North Barns to help retain the bat roosts identified in the roof of the East barn & encourage bats to use the North Barn.

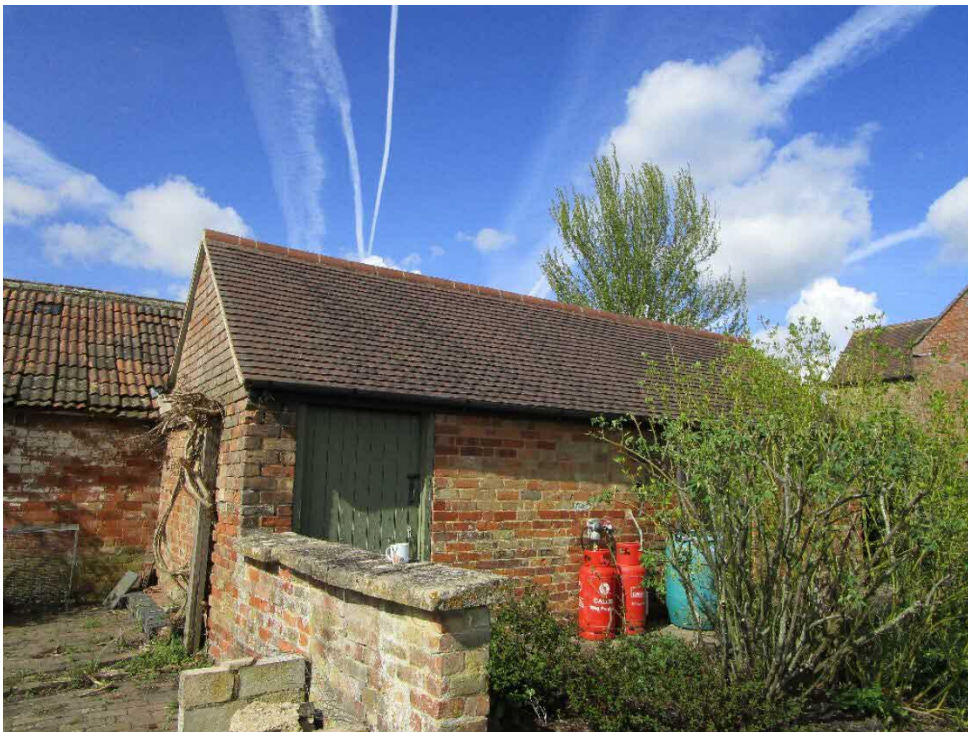
Figure 6– External view of the building adjacent to the East Barn

Adjacent to the eastern side of the East Barn there is another small building that is used to house the large oil tank & as a wood store this was reroofed five years also & lined with modern membrane.

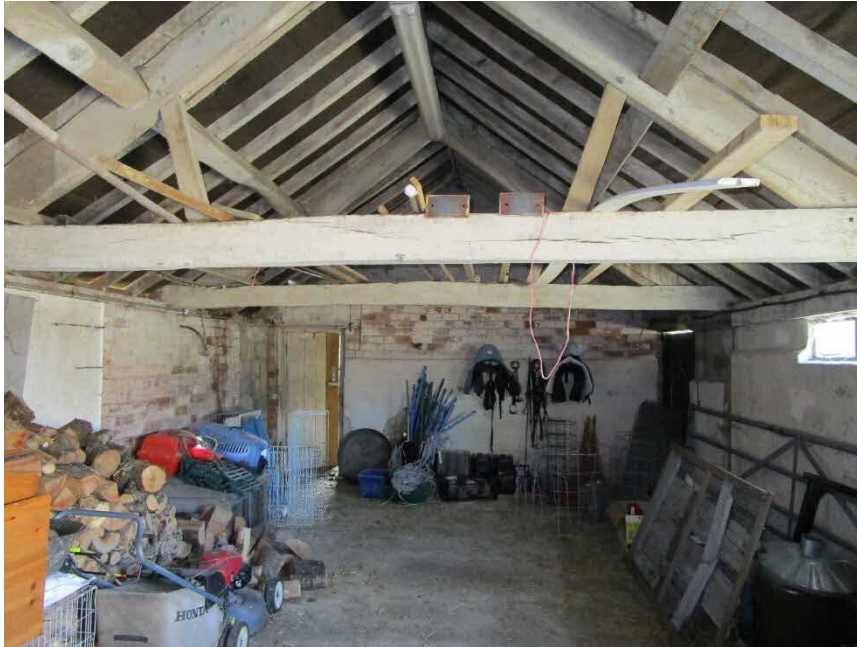
Figure 7 – internal view of East Barn

Internally the East Barn has been divided into three separate sections with a concrete floor & a traditional felt lined roof throughout as shown below in. The northern section (closest to the farmhouse) is used as a Chiropodist office & practice room & has been painted & plastered throughout & is completely sealed. The largest central section has white washed walls & is naturally well lit with electric lighting throughout & used for storage as shown below in figure seven.

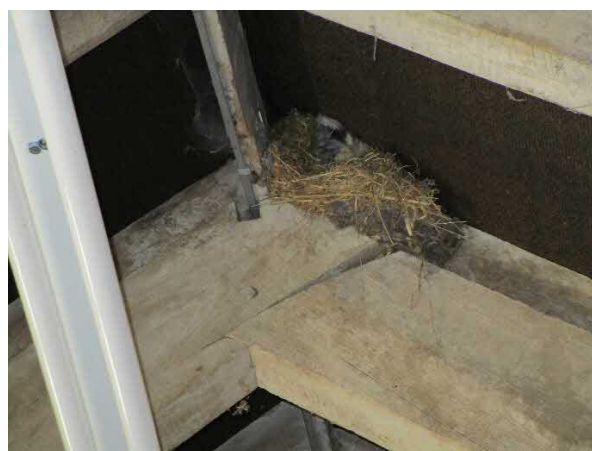
Figure 8 – Birds nest in East barn

The last smallest southern section of the East Barn is used by sheep for shelter & has an open doorway directly into the field adjacent to the southern gable end of the barn. The door shown above in figure seven leads directly into this section of the barn used by stock (sheep at the time of the surveys). Whilst no evidence of bats was found during the daytime survey of East Barn, a bird's nest was found in the roof rafters as shown below in figure eight below.

The daytime surveys found evidence of birds using the East Barn, a re-lined nest was recorded that would suggest use by a robin. The evening bat activity surveys confirmed the presence of bats & found that the East Barn was in use by low numbers of (2) Common Pipistrelle (CP) & South Barn had one Brown long eared bat (BLE) & three Common Pipistrelle & one Soprano Pipistrelle (SP) & one Whiskered bat. Although the North L shaped Barn had no bats emerge from it, on one of the evening surveys a Lesser Horseshoe bat was seen to fly into the open roof bay & hang up briefly. As such it is confirmed that East Barn is a Day Roost for 2 CP bats & South Barn C is a day roost for up to 3 CP, 1SP, 1 BLE & 1 Whiskered bat.

Due to birds' nests being found in the East Barn, open front nests boxes will be incorporated into or on the side walls of East & North barns & a swift box erected on to the field side of the South barn as shown in appendix five.

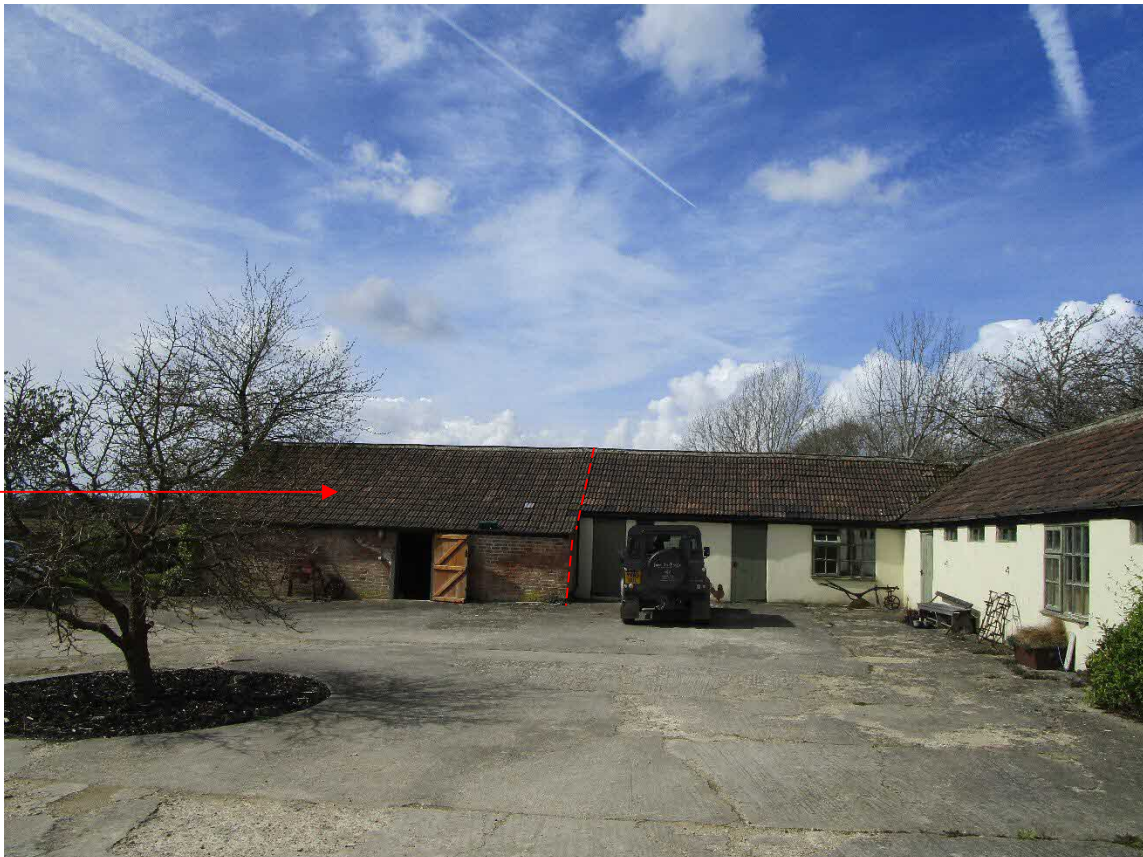
Figure 9 – The North L shaped barn

The North Barn is a single storey L shaped barn building comprised of brick walls that have been predominately rendered & painted interspersed with painted timber framed glazed windows as shown below in figure nine. The roof is the same as the East barn with double ridged clay tiles lined with bitumastic roofing felt & painted bargeboards. There are two bright flood lights on the external walls with an additional external light.

The brick walled part of the North Barn shown below will be retained as a store building for the farmhouse & not included as part of the conversion proposals for the rest of the North Barn.

As such the part of the North Barn for conversion will be confined to the rendered & painted wall parts of the barn as shown below in figure nine & on the photo on the front cover of this report.

The North barn is accessed by a series of single painted timber doors as shown above in figure nine. There is a small section of open roof bay that adjoins the single storey barn to the farmhouse gable end wall, this covers the hard surfaced turning circle to the rear of the north barn as shown in figure one.

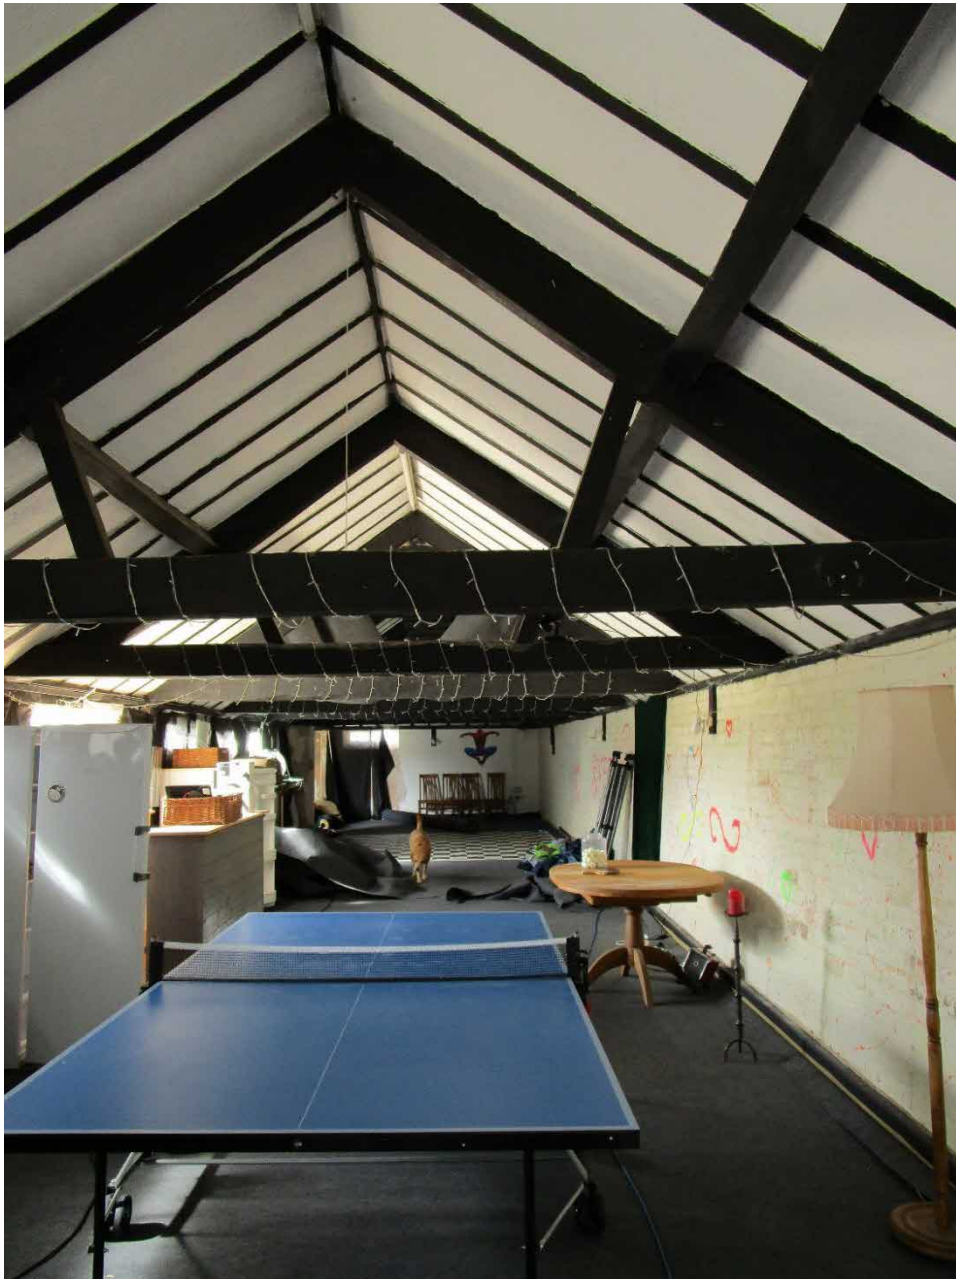
Figure 10 – The open plan area within North Barn

Internally the barn is naturally well lit throughout by the series of glazed windows along the walls & the roof has been lined with painted boards between the painted timbers which add to the light levels in the North barn. Internally the whole barn is electrically lit throughout & is regularly used as a play & party barn so as a high degree of disturbance throughout as shown below in figure nine.

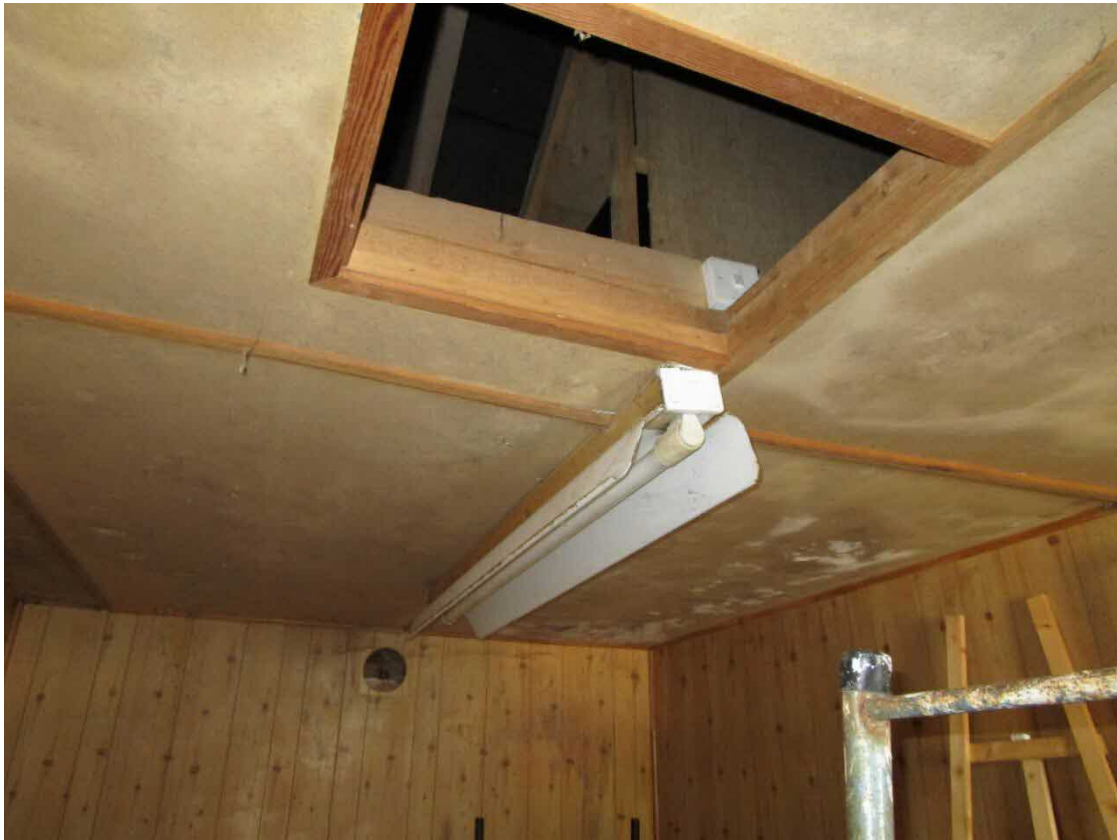
Figure 11 – internal view of the small loft area in the North barn

At the opposite end in the corner section of the L shaped North Barn there is a small, enclosed loft area but there was no evidence of bat or bird usage within the loft area as shown below in figure eleven. However there had been a problem with squirrels in the roof space of North barn causing damage to it.

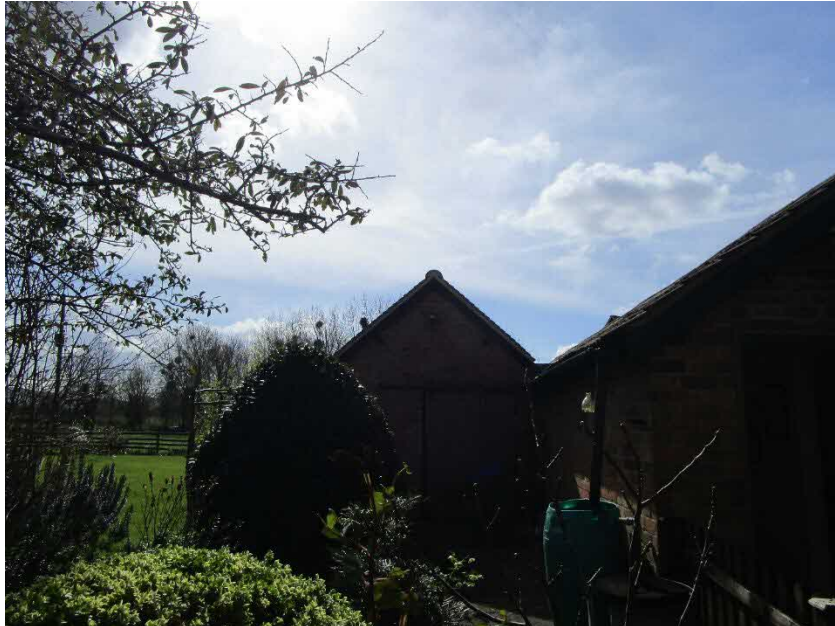
Figure 12 – the formal farmhouse garden

Adjacent to all the Barns is the hard standing parking areas as shown in Figures one, three, five & nine. To the side of the East Barn is the farmhouse Garden which is comprised of a close mown garden lawn & formal flower borders as shown below in figure twelve.

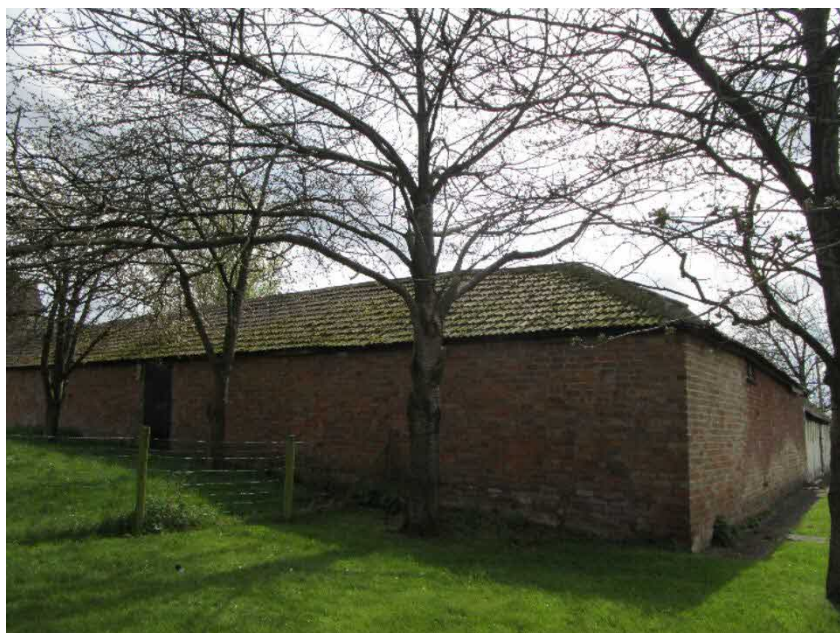
Figure 13 – the area to the rear of North Barn

To the rear of the South Barn is a tightly grazed pasture field as shown in figure two. To the rear of the North Barn is an area of tightly grazed & mown grassland that has a group of planted trees that is adjacent to the tennis court as shown in figure one & below in figure thirteen.

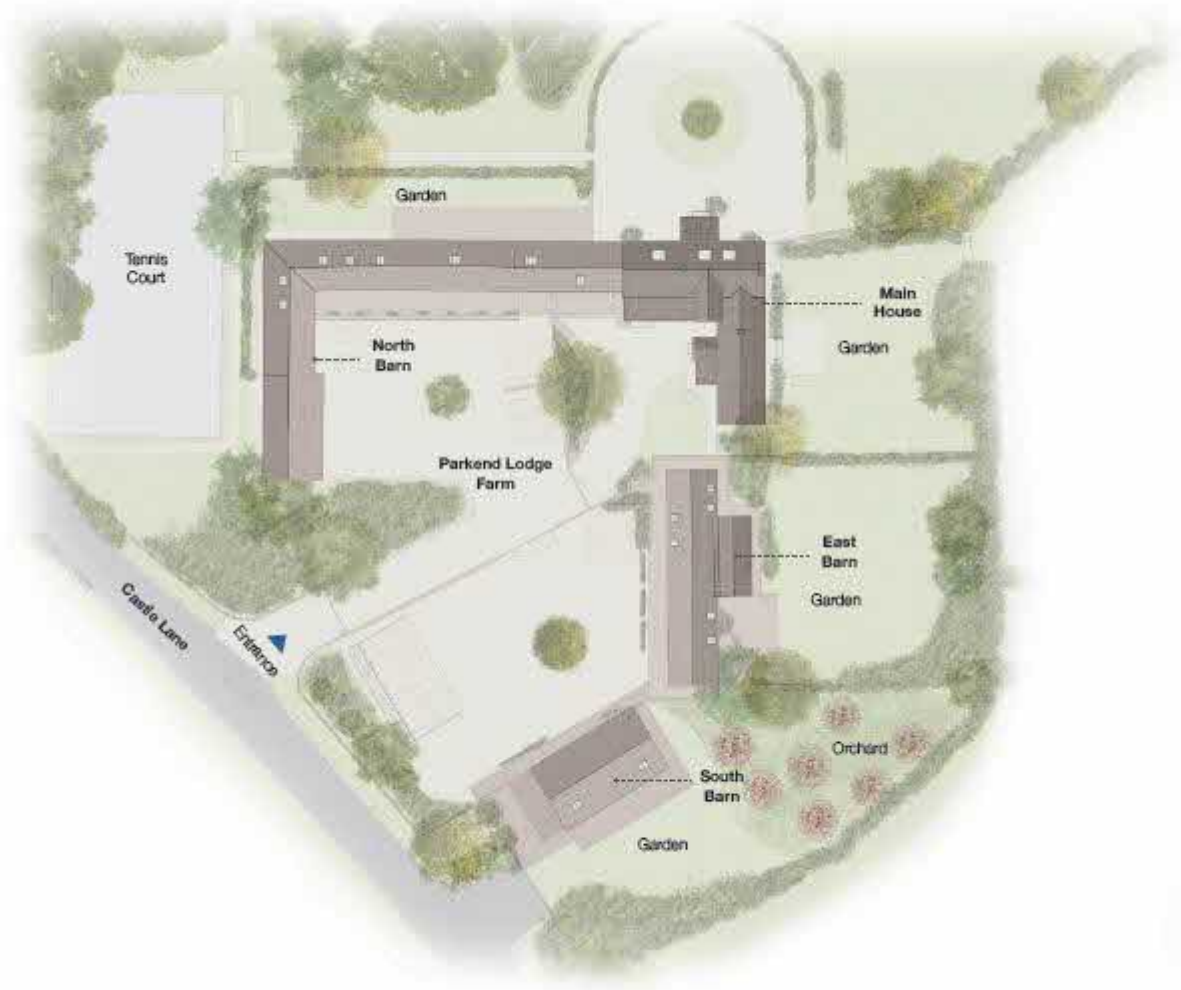
See elevation plans showing Bat Access slate tiles X4 on East & North Barn and Bat Eco Habitat box x 2 on South Barn & open fronted nest boxes x2 on top of walls on East & North Barn & swift box x1 on South Barn details over the page
