### 1.0 Introduction & Context 1.1 Introduction

This report has been produced to accompany a planning submission by Mcloughlin Planning for the development of the three barns associated with Parkend Lodge farm. The owners of Parkend Lodge have lived in the property for a number of years and would now like to convert the barns to create additional accommodation for family members as well as holiday lets to provide additional accommodation.

Barns at Parkend Lodge Farm | 13.07.22 | Design and Access Statement

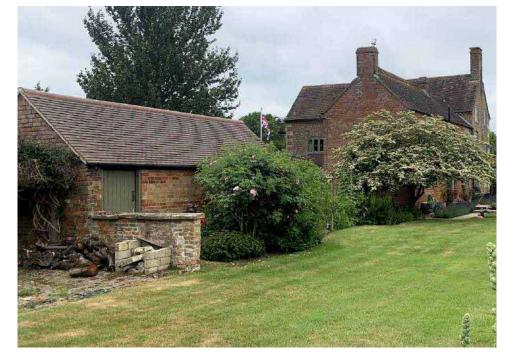
East Barn West Elevation

The east barn is a single storey barn dating from the same period as the north barn and is constructed from brick under a tiled roof. The elevation facing west appears to have been open-fronted originally and later infilled with render and domestic windows. It is proposed to reinstate the open-frontage using timber posts and large sections of glazing in a similar manner to the north barn.

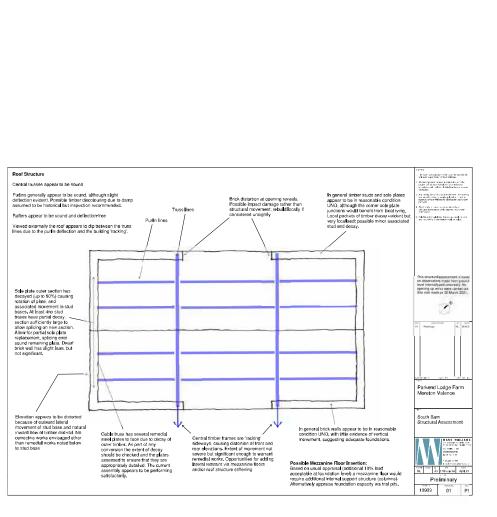
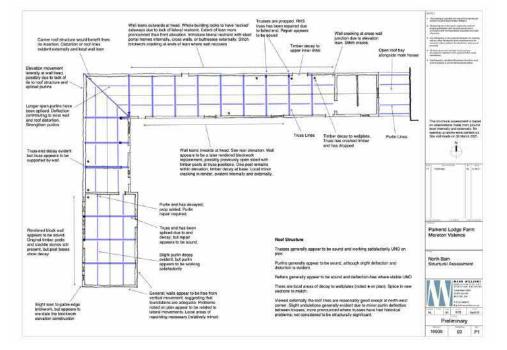
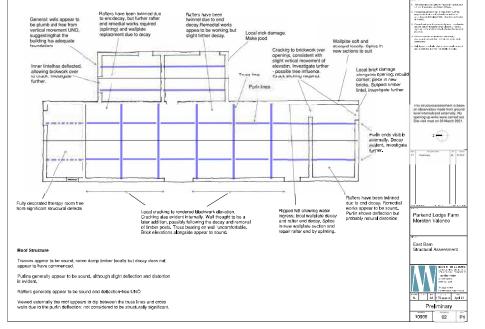
Structural Engineer's Drawings - Refer to Appendix A

The central timber frames appear to be racking slightly to the south; this could be remedied by stiffening the roof structure, or, should a mezzanine floor be considered, it could be detailed to enhance the lateral stability of the barn as a whole.

Otherwise there are local pockets of timber decay in the frame, necessitating local repairs such as stud base splicing and sole plate splicing.

Water ingress through the roof has created areas of timber roof structure decay; rafter end repairs and wall plate remedial works are envisaged, but relatively locally.

Possible tree influence where cracking is apparent; further investigation required.

Similar to the south barn, there is slight racking of the central section of the north leg of the barn. There are several possible remedial solutions, such as building compartmentation or buttressing, but the existing fabric can be retained. Otherwise there are areas of minor timber decay or weakness in the roof structure, where minor remedial works are required."

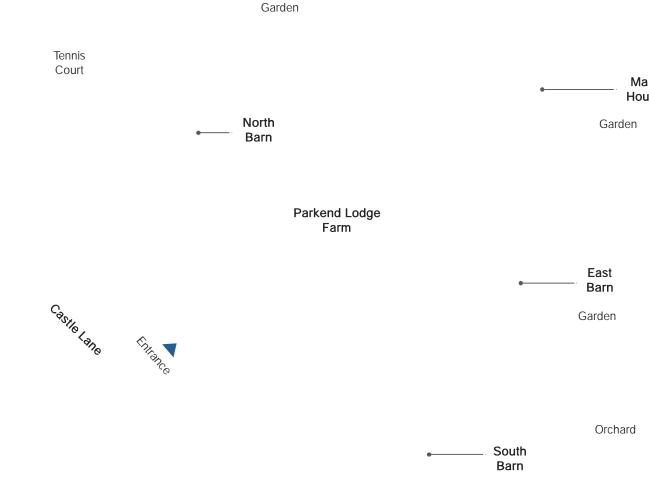
Proposed Site Plan

The proposals are to create three dwellings, one in each barn, accessed via a shared driveway and courtyard. The barns are quite distinct from each other in terms of their form, material palette and orientation therefore each one is described individually on pages 11-13. However, there is a common set of principles that have been used to influence the design these are summarised below:

- Divide the north barn to form one dwelling and a storage area.
- Convert the east barn into a three-bedroom dwelling for a member of the family.
- Convert and add a small lean-to extension to the south barn to create a two-storey dwelling for a family member.

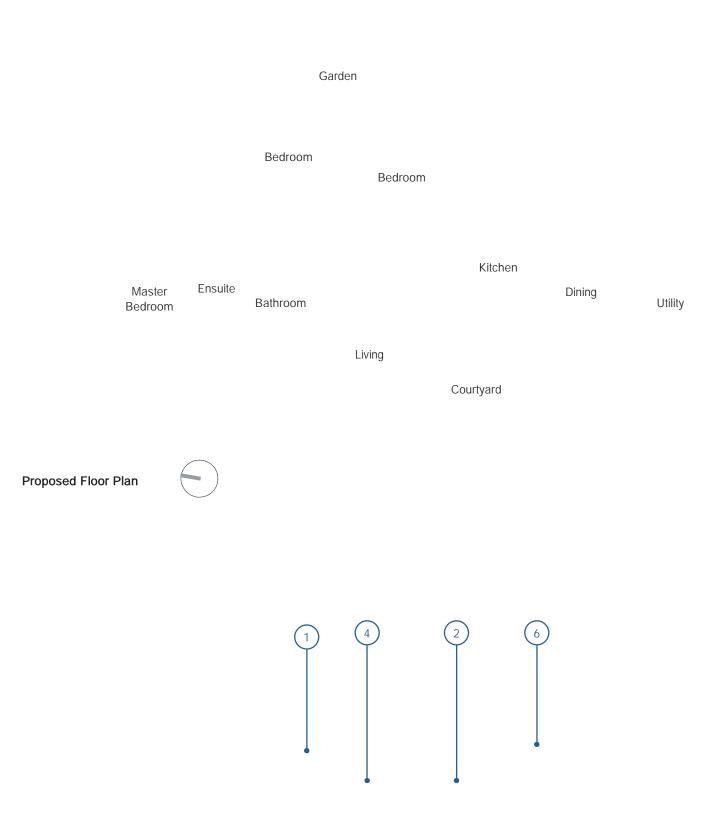
**Proposed East Elevation**

The east barn will be converted into a three bedroom dwelling with an open-plan living space located in the southern section of the barn. The master bedroom and bathrooms are located in the northern section of the main space, two other bedrooms are located in the eastern lean-to section of the barn. The design intent is to celebrate the simple utilitarian form of the barn, minimising the amount of new openings and using existing openings where possible. The old timber doors will be re-hung in the open-position to act as shutters, all other openings will be retained to form windows, minimising the impact on the visual appearance of the barn. A combination of slimiline aluminium windows and a minimal number of conservation-style rooflights are proposed in order to increase the amount of light in the barn. The barn will be re-tiled to match the main house and south barn, incorporating access tiles and a membrane suitable for bats.

- Conservation Style Rooflight
- Metal Windows and Doors 2
- Brick (3)
- **Timber Cladding** 4
- Old Timber Doors re-hung as Shutters
- (6) Plain Tiles

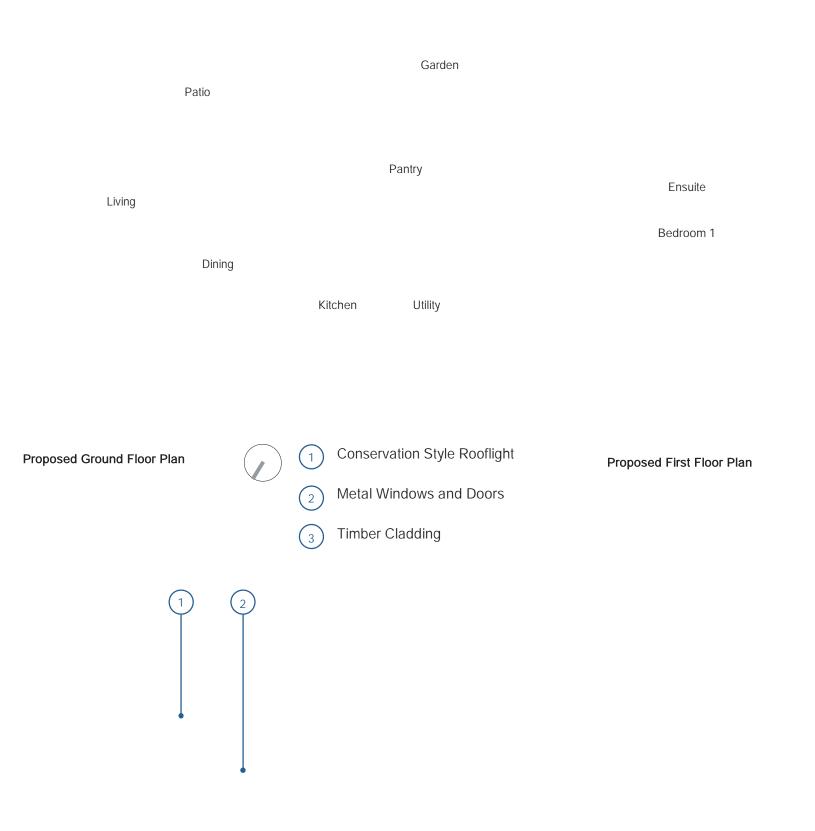
This barn is quite different in character from the other two barns, it appears to date from the c18th and is a timber-framed threshing barn with vertical proportions. The design approach for this building is similar to the other barns, following a minimal intervention approach. The layout of this barn consists of an open-plan kitchen/ living /dining area on the ground floor with a bootroom and utility contained in a new lean-to addition proposed to the west elevation. A new floor will be inserted providing two bedrooms and bathrooms at first floor level.

The new addition is modest in size and has a similar architectural language and material palette to the barn. The addition will be clad in horizontal timber ship-lap boarding, on a brick plinth, under a roof covered in plain tiles to match the barn.

New openings in this barn will be kept to a minimum with windows added to each gable at first floor level, and new glazing inserted in the large threshing openings to provide light and views to the central living area. Two new roof lights are proposed on the south east roof slope, these will be conservation-style and sit flush with the tiles to ensure they sit discreetly within the roof slope. A bat loft will be provided within the apex of the roof and 2no. bat boxes on the south west elevation.
