BAT SURVEY 2016 & 2022

**WELL HILL STABLES
DUNTISBOURNE ABBOTS, GLOUCESTERSHIRE**

WELL HILL STABLES DUNTISBOURNE ABBOTS, GLOUCESTERSHIRE

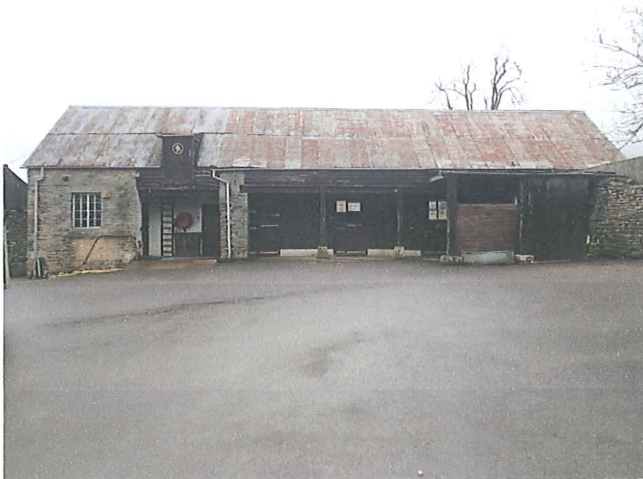
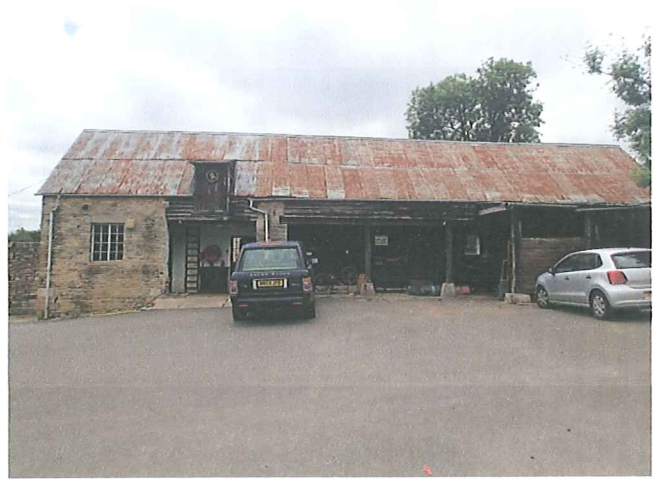
Photo 1 The surveyed building

The stone stables are unchanged since 2016 – except the stalls on the ground floor are now used for storage. The hay loft remains disused and what few items that had originally been stored in it have gone. The open-sided stables to the rear have since been rebuilt as open stabling (19/01078/FUL) and no-longer abut the building.

Exterior	<p>Walls – mortared Cotswold stone & in good condition. Partly a single skin of timber panels at the front.</p> <p>Doors & windows – windows glazed & doors/windows in good condition. Except an open window with a wooden lintel in the hay loft at the western end.</p> <p>Roof – twin pitched with a skin of corrugated tin sheets & a tin ridge. Weather boards at the eastern gable end verge – with gaps between the boards & wall. A stone chimney in the eastern wall.</p>
Interior	<p>Stalls & locked room on the ground floor. 1st floor room locked.</p> <p>Hay loft accessed via a wall ladder & open hatch at the front exterior porch. Tin roof underside exposed in the loft with an irregular hollow along underside of the tin ridge above a ridge board. Tin sheets fitted to a timber close-coupled frame – frame joints tight. Mix of wide & tight gaps between roof sheets & the verge wall tops. Gaps into end walls where the ridge board enters it. Large open window in the western wall. Mortar partly missing in the western wall. Moderately dark & airy in the loft.</p>

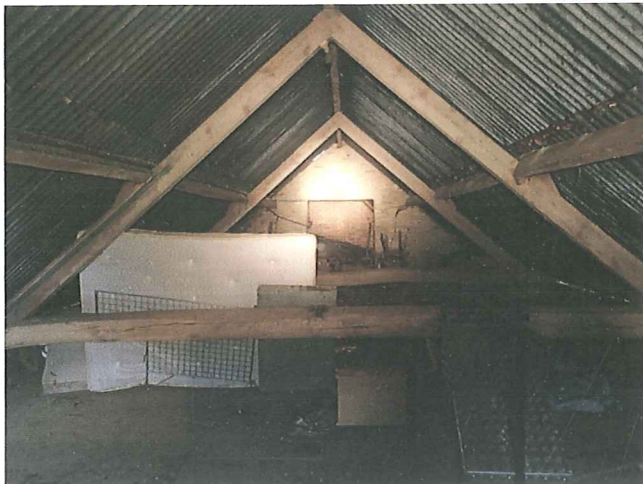
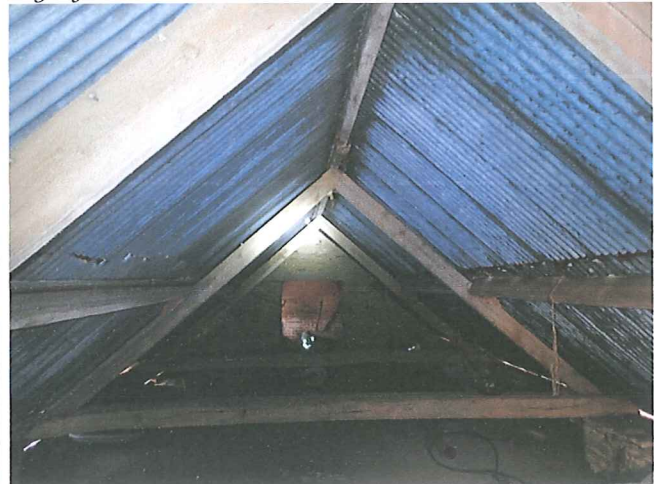
Photo 2 Hay loft

Signs of bats:	<p>Ground floor: Nil.</p> <p>Hay loft: A few individual small-medium bat droppings randomly scattered on the floor & a small concentration under the ridge towards the western (darker) end. DNA analysis identified the latter concentration to be brown long-eared bat droppings.</p> <p>Two long-dead desiccated Natterer's bats on the loft floor more-or-less</p>

<p>below the ridge. Age difficult to discern, but certainly not pups. Identification based on a characteristic fringe of stiff bristles along the trailing edge of the tail membrane.</p> <p>A few additional fresh individual bat droppings were found in the loft through the summer survey period and moth wings below the ridge (potential bat feeding remains).</p> <p><u>2022</u></p> <p>There were a few individual bat droppings in the hayloft, more towards the western darker end in the feed store room. DNA analysis confirmed these to be from Natterer’s bats.</p> <p>There were moth wings, characteristic of bat feeding-remains, in the most easterly of the stalls on the ground floor.</p>
<p>Potential for roosting bats</p>	<ol style="list-style-type: none"> 1. Use of the building by bats is conclusive. 2. Potential roost(s) in the hay loft.
