PRELIMINARY ROOST ASSESSMENT

3 Killiebrigs, Heddon-on-the-Wall, NE15 0DD

July 2022

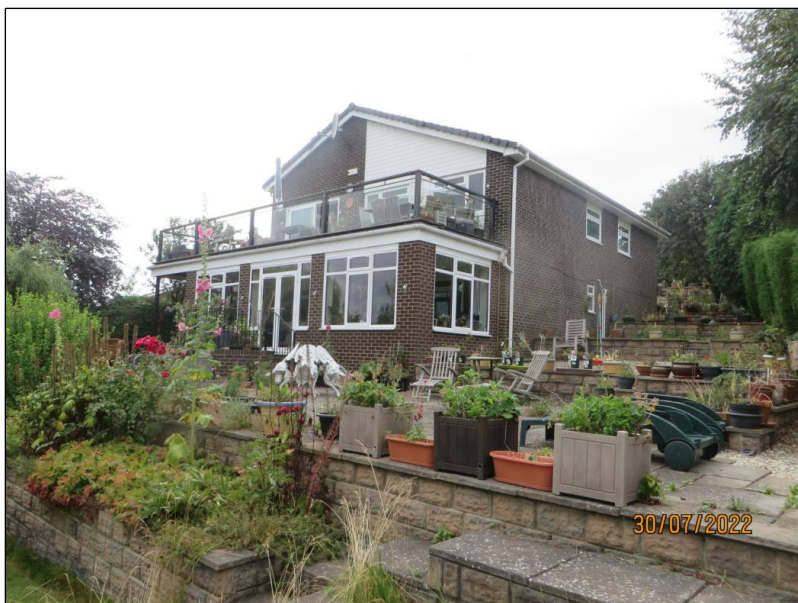
An upper floor balcony area is present on the south eastern elevation (**figure 9**). Some elevations have vertical plastic sheeting present, which appear to be flush to the wall.

Figure 9. Rear (south eastern) and side (north eastern) elevations.

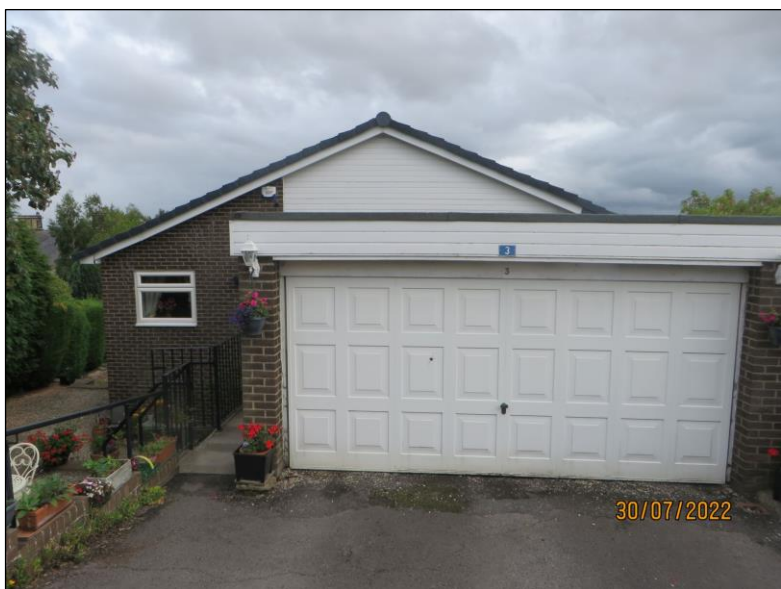
The property is of brick-and-breezeblock construction and is a detached dwelling with an integrated garage (**figure 10**). The roof tiles appear to be in place (however there is limited viewing of the roofline unless at a distance from the property) – see **figure 13**. The hips were capped off with plastic end tiles, which provide gaps down to the ends (**figure 12**).

Figure 10. Front (north western) elevation.

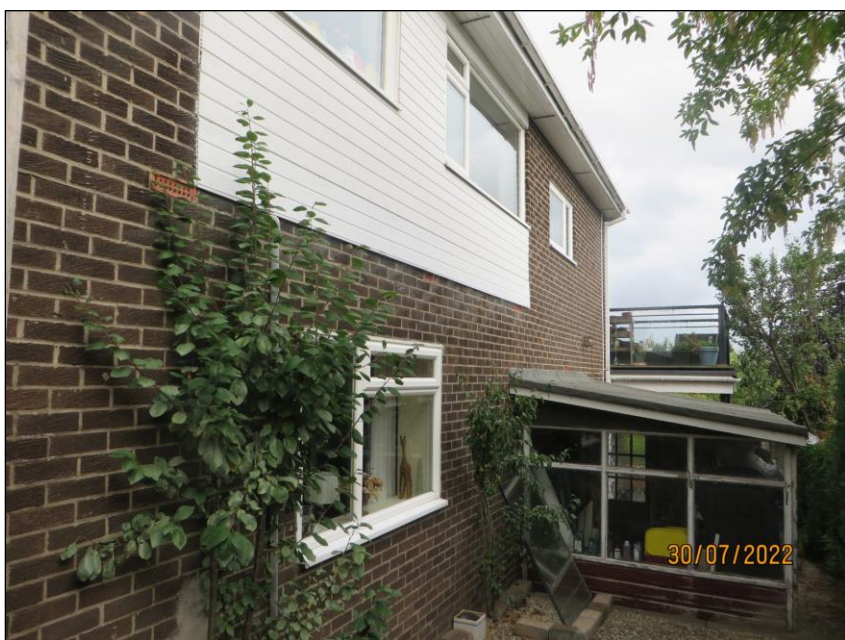
A small lean-to and wooden porch (**figure 11**) are present on the side (south eastern) elevation. No Potential Roost Features were noted in this region.

Figure 11. South western elevation showing wooden porch area.

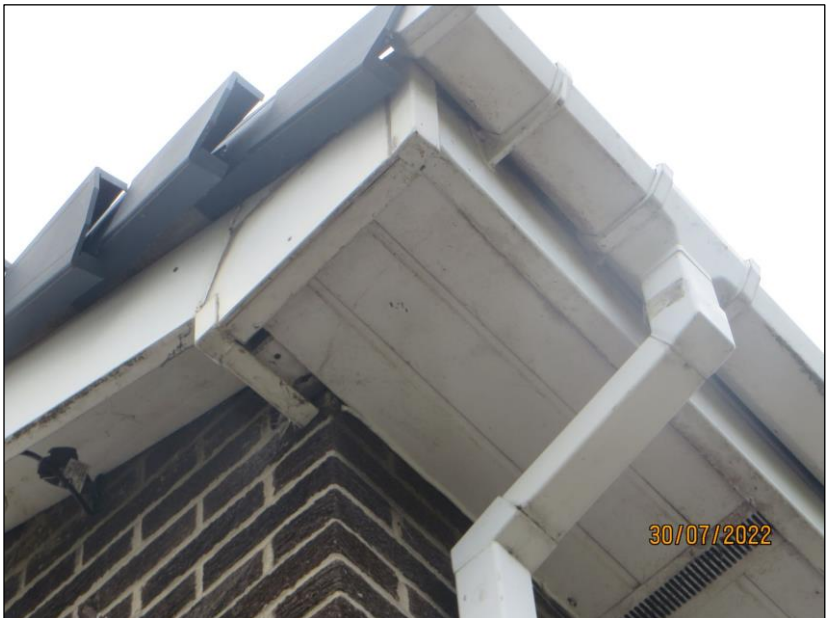
The windows are uPVC double glazed. Soffit boxes (of uPVC construction) are present, gaps are present into the soffits (**figure 12**).

Figure 12. Gaps into soffit boxes and plastic cap tiles.

The building is in a reasonable state of repair and is deemed to have **low-medium potential for roosting bats**. Potential Roost Features (PRFs) include:

- Gaps into soffit boxes.
- Gaps beneath plastic hip tiles that may lead into roof space.

- **Bat survey(s) should therefore be undertaken between May and August to get an understanding of the use of the building by bats (if any). This is in accordance with the Bat Conservation Trust (2016) 'Bat Surveys Good Practice Guidelines'.**

- Roofing and wall features including tiles, soffits and flashing to be removed by hand, carefully checking for bats.
- If bats or signs of bats are found, then work must stop, and the project ecologist contacted for advice.

- Any external paint used should be checked to ensure it will not cause harm to bats or birds.
- Integrated features suitable for bats (such as bat access tiles) are recommended to be incorporated into the proposed development to ensure No Net Loss of bat roost potential.

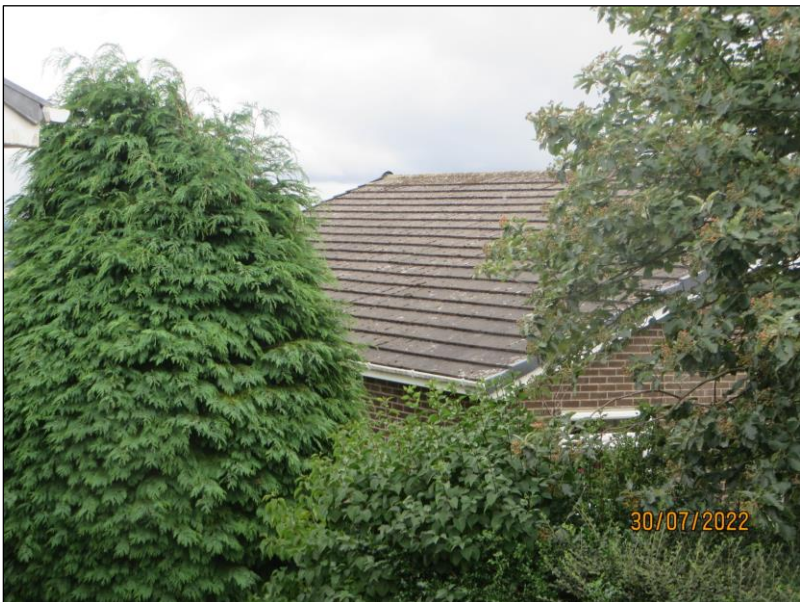
Figure 13. Roofline.

The roofline (tiles) was only partially viewable and at some distance from the property.

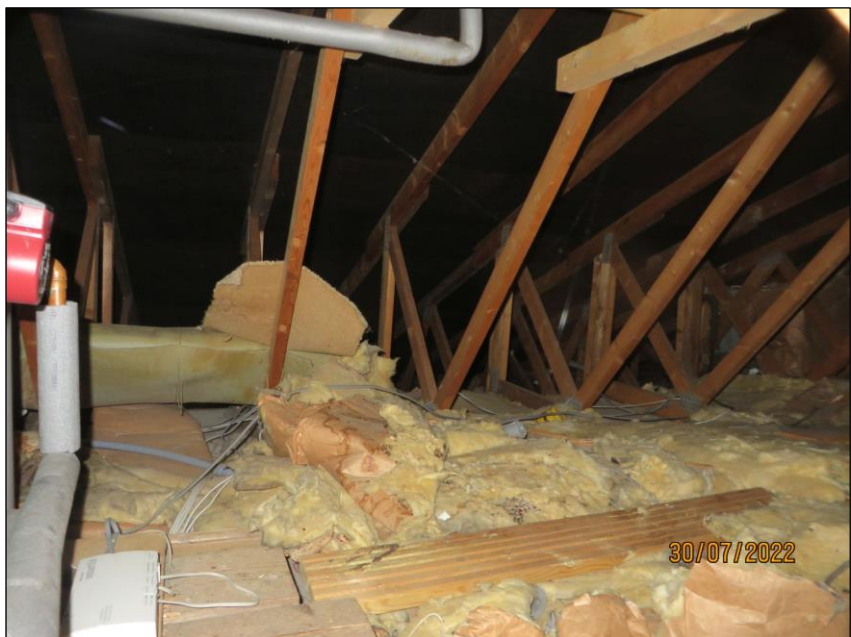
A large loft void is present (**figure 14**). This has insulation laid down throughout and bitumen felt present below the tiles. Droppings, consistent with bat droppings (they crumbled when handled) were found near a wall at the south eastern end (**figure 15**). A sample has been collected.

Figure 14. Loft void.

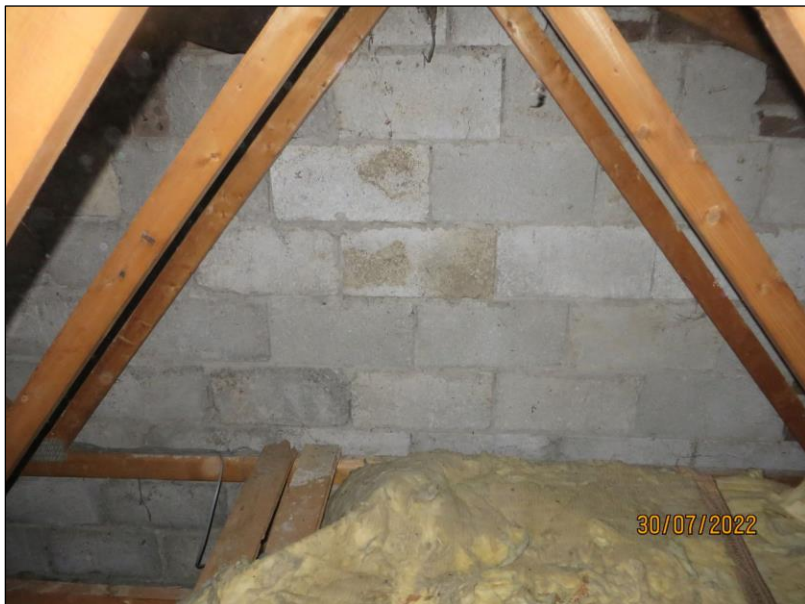
Figure 15. Wall with droppings present in the loft void.

Droppings consistent with bat droppings (they crumbled upon handling) were found within the loft void. A sample has been taken for DNA analysis, if required. The building is therefore likely used by roosting bats.

- **No work should be carried out prior to these survey(s) being undertaken on the building. This is to reduce any impacts on any bat roosts present, which could constitute a legal offence.**

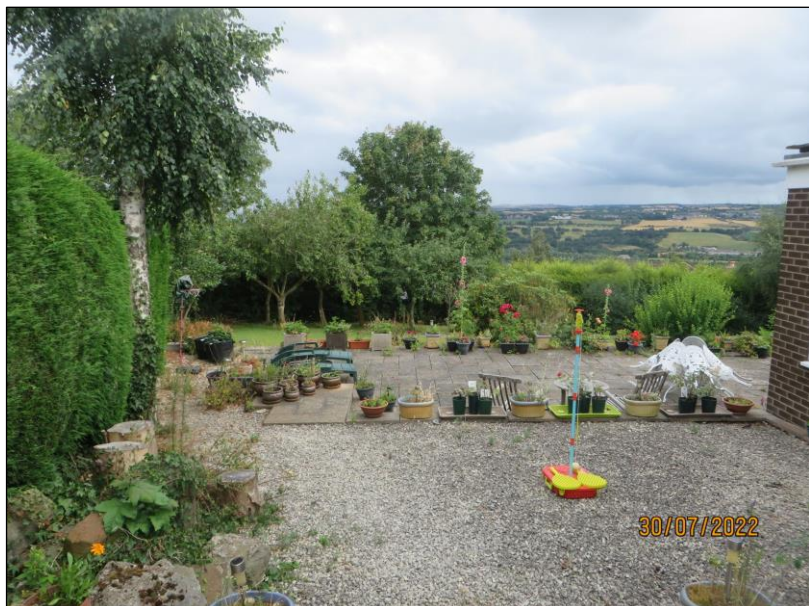
The rear garden is laid to lawn with species present of no particular note. Young apple trees (**figure 17**) are present in the garden. The trees will not be affected by the proposed development. The front and sides of the property have gravelled areas present with some ornamental planting (**figure 16**).

Figure 16. Gravelled area of the garden.

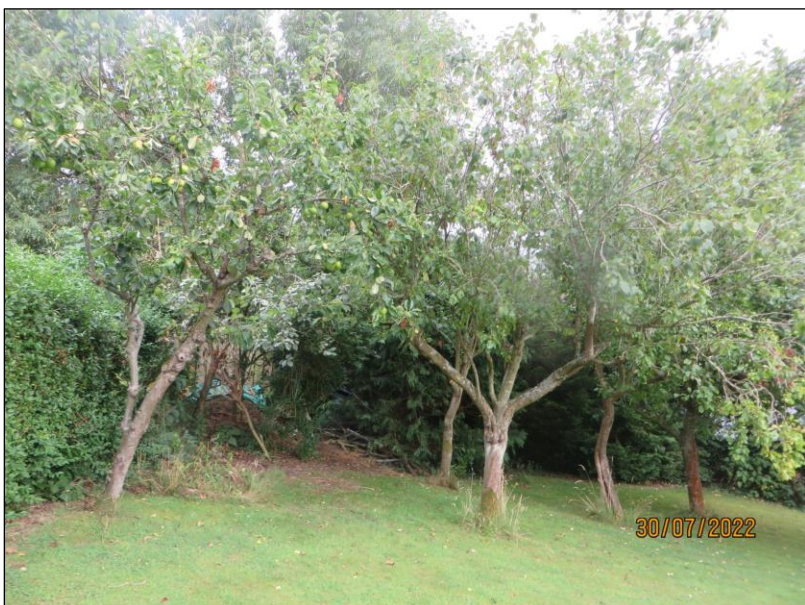
Figure 17. Apple trees in rear garden.
