**RESULTS OF FURTHER BAT SURVEYS OF A BARN AT  
TRETHERWEY FARM, RUMFORD, PADSTOW**

**May / July 2022**

**Report No:** 21-102\_Further\_Bats\_Trethewey\_Farm\_Barn

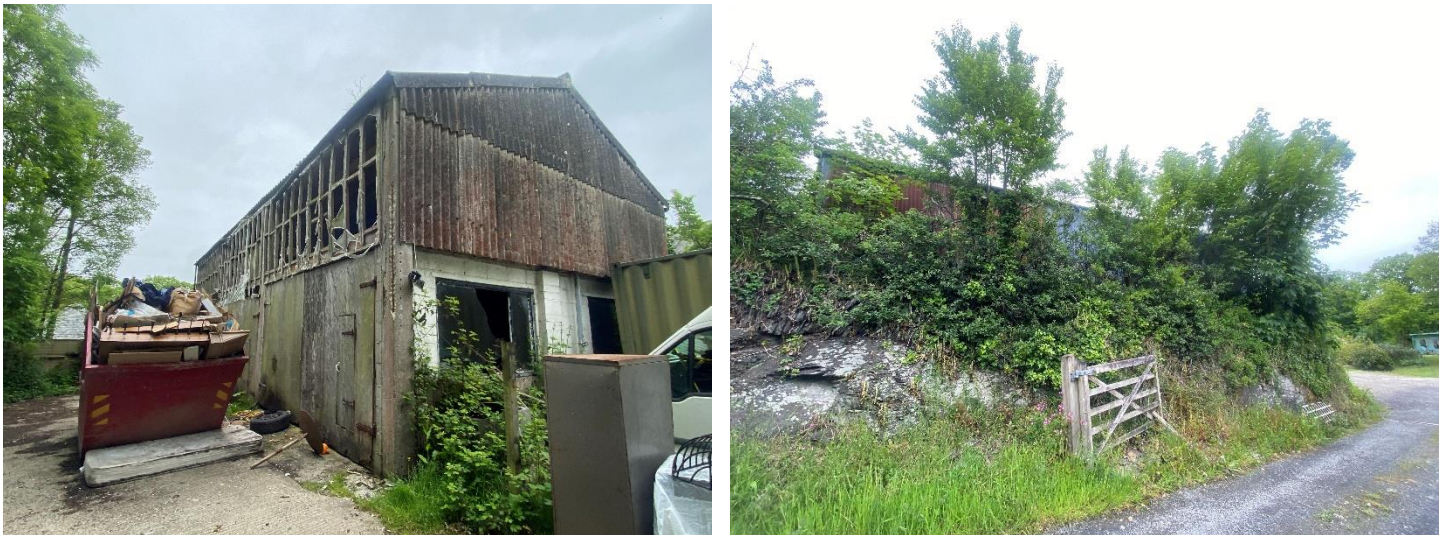
**Figure 1: The southern aspect and western end (left) and the northern aspect of the building behind a hedgebank (right).**

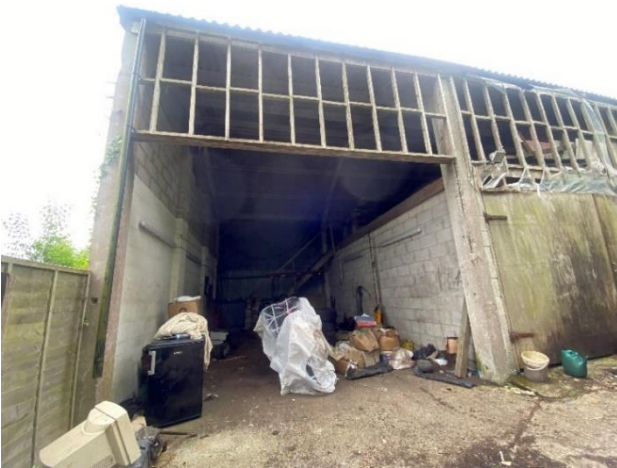
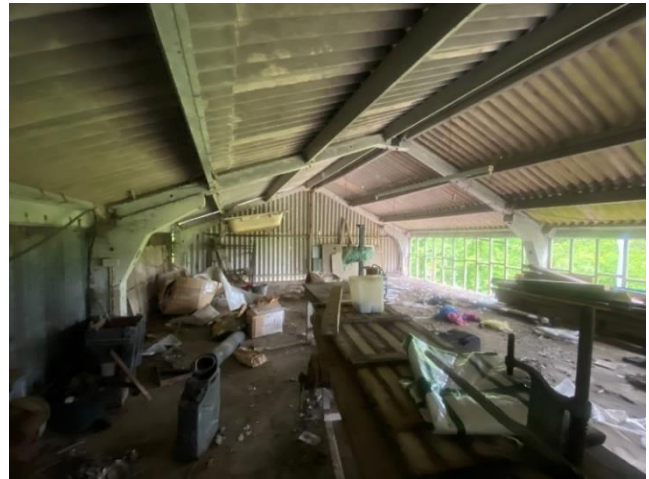
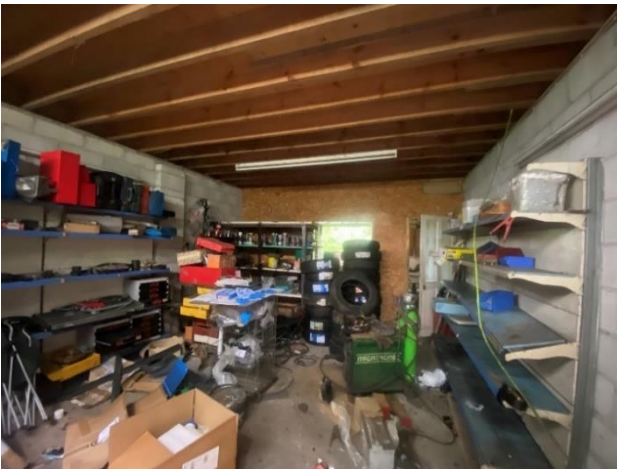
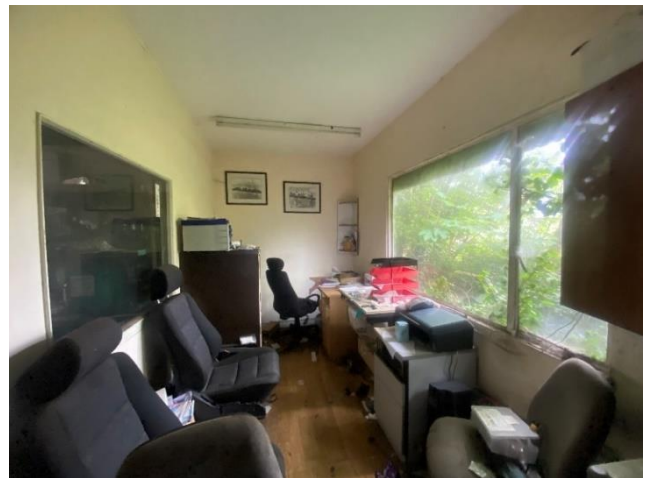
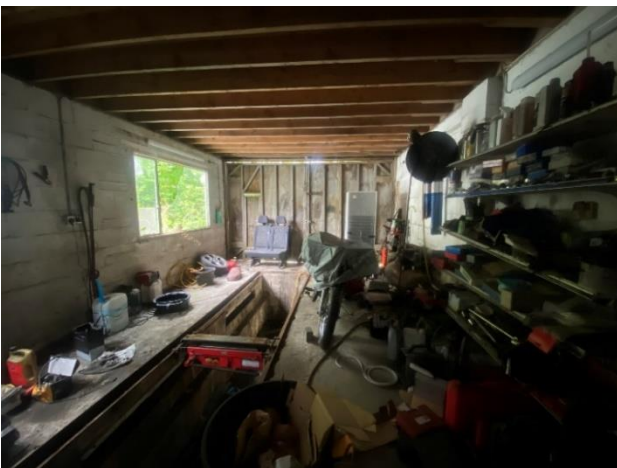
**Figure 2: Top level - The open room to the east and an example of the mezzanine floor.  
Middle level – The middle room used for storage and the office to the rear of this.  
Lower level – mechanic garage to the west of the building.**

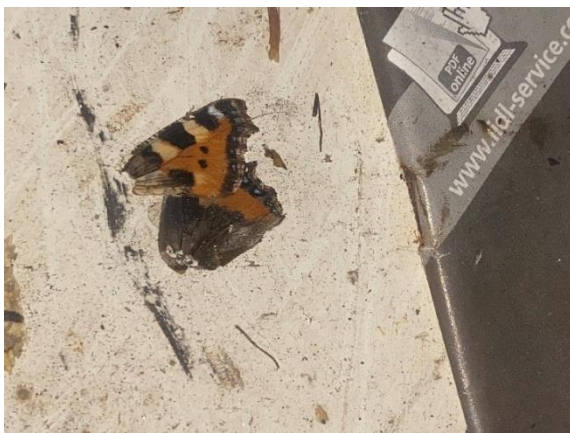
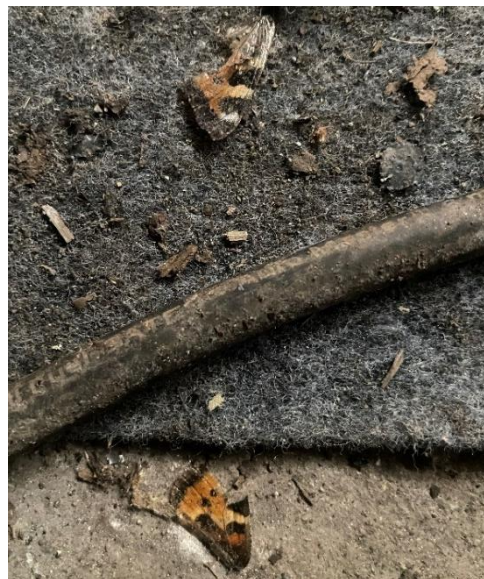
No bat droppings were seen, however, approximately 10 Lepidoptera wings were discovered within the middle room used for storage indicating that it may be used as a night roost by bat species. This room is also the darkest room, with limited light spill from the office window to the south.

**Figure 4:**  
 Evidence of foraging thought to be from rodents within the middle room

The small, dark central room is used as a night feeding perch by Brown Long-eared bats and will be lost during the development of the building. A replacement of this roost should be erected to fulfil this ecological function. This can be provided through one of the following:

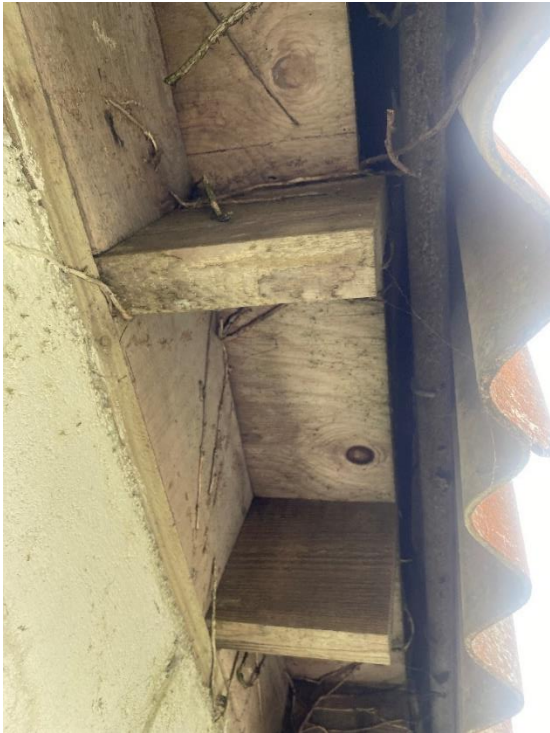
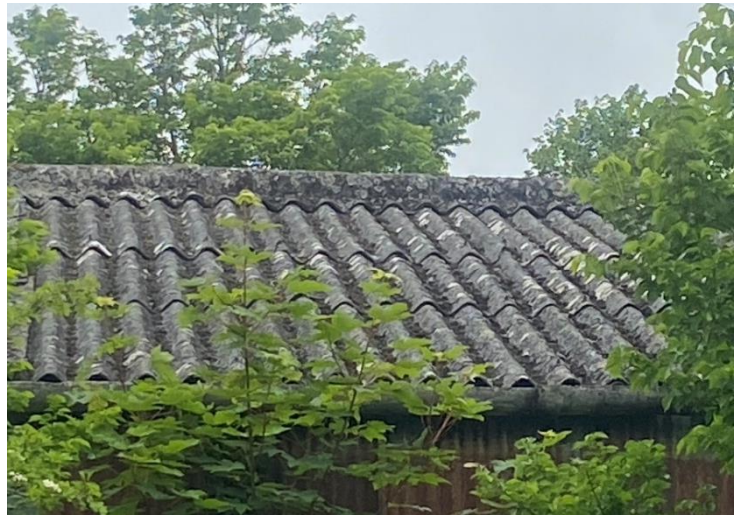
Where the metal corrugated sheeting ends on the west end of the building, the joists for the mezzanine floor are visible. As such, the sheeting is slightly stepped away from the wall. There are gaps here giving access behind the sheeting and up the side of the building which bats could use. On the eastern end the sheeting is sitting to the wall, however, the gaps between the corrugations on the sheet provide gaps for bats. There are also several gaps underneath the roofing sheets and continuous ridge tile.

**Figure 5: Gaps leading to the mezzanine floor and up behind the corrugated sheeting (left), and gaps underneath the roofing sheets and ridge tiles (right).**

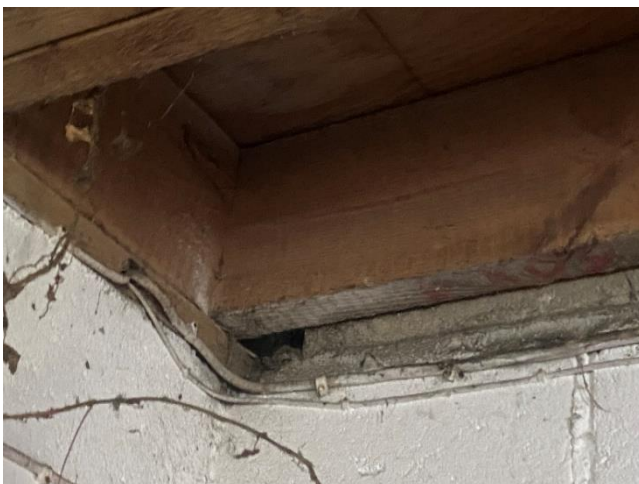
Within the western garage room there are gaps along the wall tops on the southern side which lead into a cavity wall. These may provide suitable areas for bats to roost; however, the room receives high levels of daylight and is open.

**Figure 6: An example of the gaps at the wall top in the western room providing access to a cavity wall.**

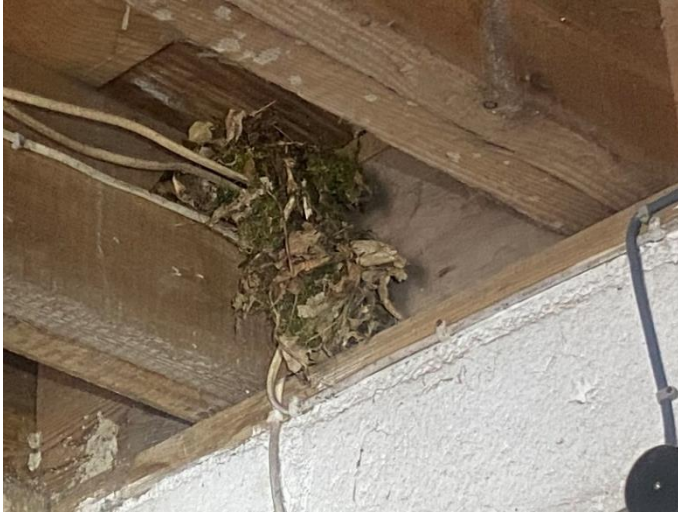
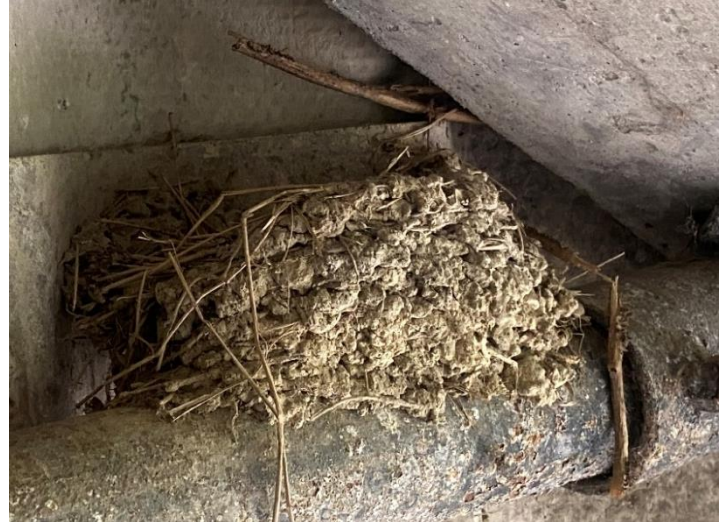
Two bird nests were recorded within the building. One Barn Swallow nest on the western end of the mezzanine floor and one Wren nest which was within the rafters of the western garage room. Both nests were disused.

**Figure 7: Old Wren nest within the western garage room (left) and Barn Swallow nest on the mezzanine level (right).**

When the proposed works commence, care should be taken to ensure birds are not nesting in the buildings. A careful inspection of the buildings for nesting birds should be carried out prior to works commencing to ensure no nesting birds are present. If nesting birds are found to be present, works should wait until the chicks have left the nest. This is because birds are protected by law whilst nesting.
