# Preliminary Bat Roost Assessment Report

Lynridge,  
Holme Lane,  
Sutton-in-Craven,  
BD20 7LL

31.08.2022

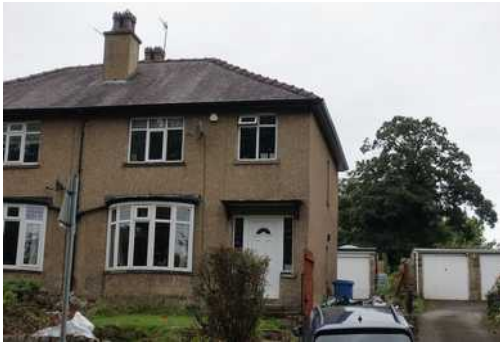
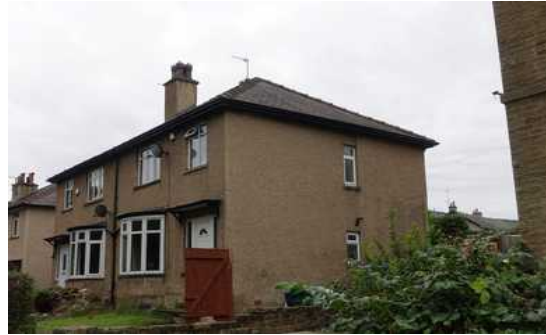
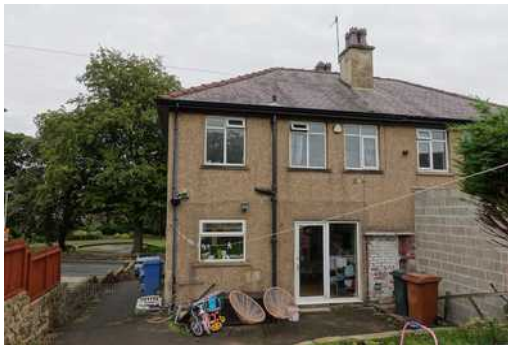
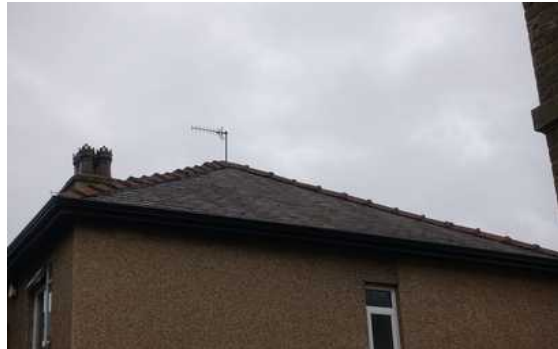
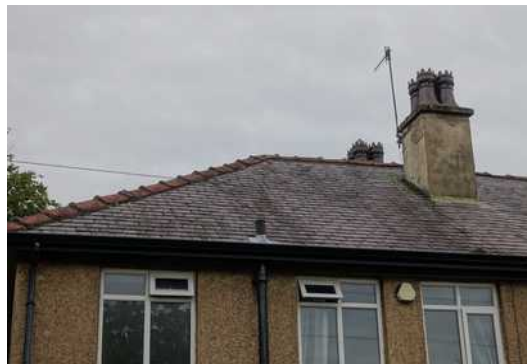
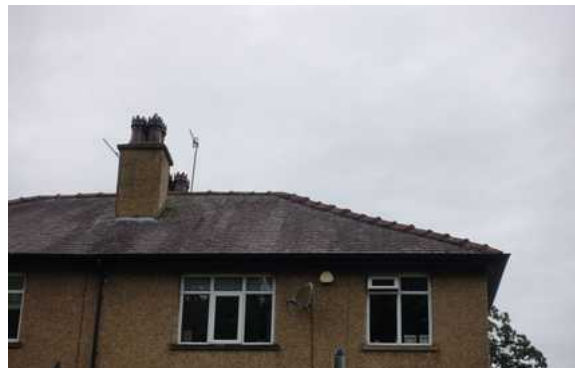
The property consists of a semi detached house with a hipped slate roof. External walls are rendered and pebble dashed with no cracks, crevices or cavities present. Soffits are close fitting and well sealed.

Roof slates are close fitting with no obvious slipped, missing or lifted slates. The ridge is well sealed. Lead flashing is close fitting where present.

The property can be considered to offer negligible bat potential.
