**Bat Survey Report for  
Barn at Barn Cottage,  
The Green, Bledington,  
Chipping Norton, OX7 6XQ**

**Cotswold Wildlife Surveys**

**28<sup>th</sup> April, 27<sup>th</sup> June and 11<sup>th</sup> & 25<sup>th</sup> July 2022**

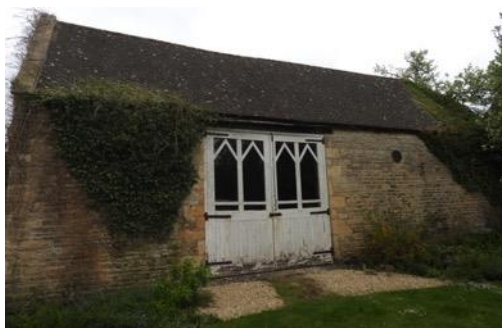
The survey site comprised a large detached pitched roofed barn (Fig. 1).

**Fig. 1 West facing aspect of the barn**

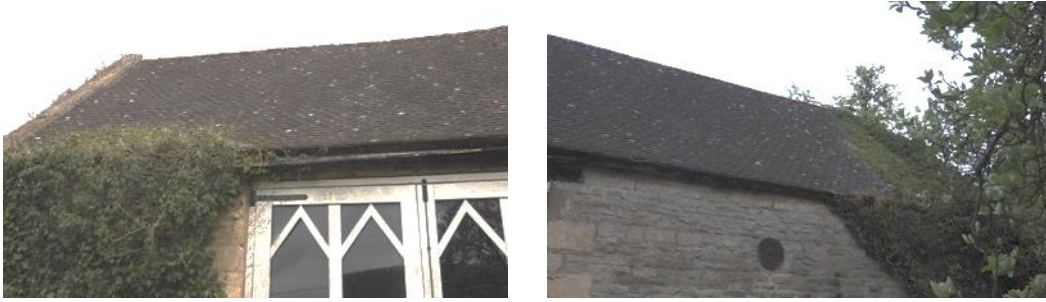
The ridge was intact and sealed and all the roof tiles were tightly overlapping (Figs. 5-8).

**Figs. 5 & 6 Ridges and roof tiles to the west**

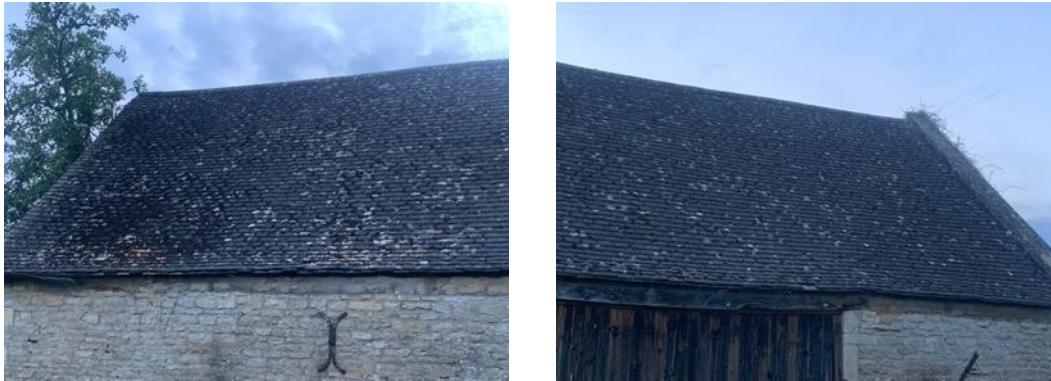
**Figs. 7 & 8 Ridge and roof tiles to the east**

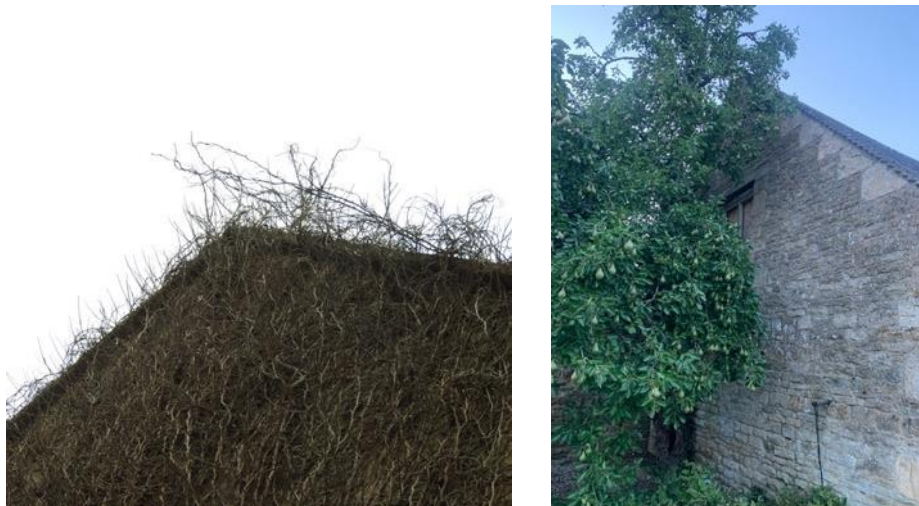
Both gables were finished with the roof verges cement sealed to the gable wall plates, the northeast gable was covered with vegetation (Fig. 9). The southwest gable had a partially boarded window with a fruit tree growing close by (Fig. 10).

**Figs. 9 & 10 Northeast gable (L) and southwest gable (R)**

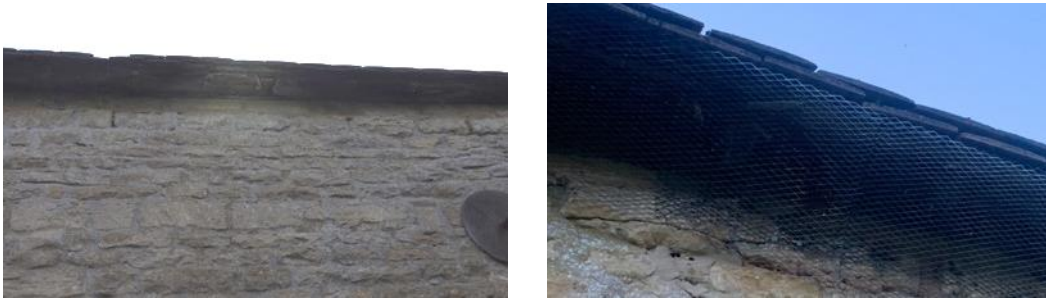
The eaves were finished with the roof ends tightly fitting against the wall plates.

The southeast facing eaves also had chicken wire netting installed for the length of the barn (Figs. 11 and 12).

**Figs. 11 & 12 Sealed eaves to the west (L) and east (R)**

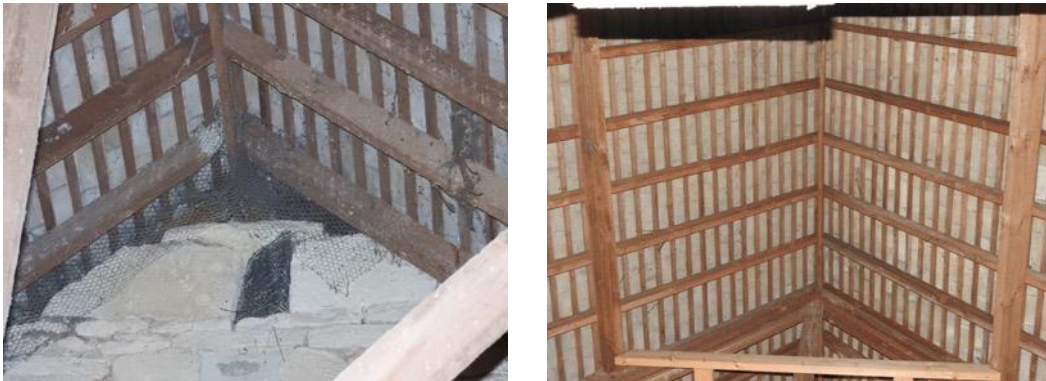
Internally the barn was open to the torched roof. The ridge was lightly cobwebbed all over, although some sections of the ridge were cobweb-free (Fig. 13 and 14).

**Figs. 13 & 14 Cobwebbed ridge and gable end**

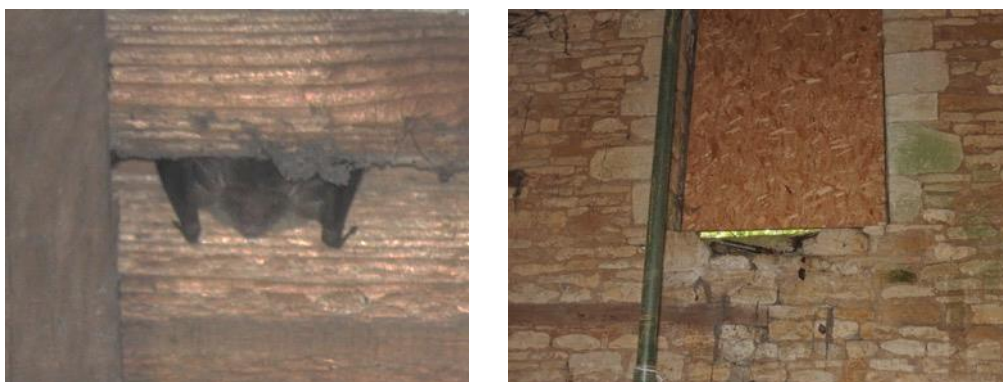
In one section of cobweb-free ridge, a Brown Long-eared Bat was observed at roost, with c10 Brown Long-eared Bat droppings underneath (Fig. 15). The partially boarded window in the southwest gable wall had a suitable gap at its base for bat access (Fig. 16).

**Figs. 15 & 16 Brown Long-eared Bat at roost (L) and gap at base of southwest gable window (R)**

Since the proposed works will cause the loss of the bat roost, a licence from Natural England will be required.

Given the low status of the roost, the site is eligible for registration under Natural England's Bat Mitigation Class Licence (BMCL) scheme.

Mitigation measures will include a 'toolbox talk' by a Registered Consultant (RC) to contractors about bats and what to do if one is unexpectedly encountered, a pre-works inspection of the roof void by the RC, and supervision of any destructive roof works by the RC, the latter undertaken by hand.

To provide an alternative roost site, a Large, Multi-Chambered Bat Box will be installed on a tree in the garden in which to relocate a bat if one is discovered before or during works. The box will be retained in position for a minimum of five years.

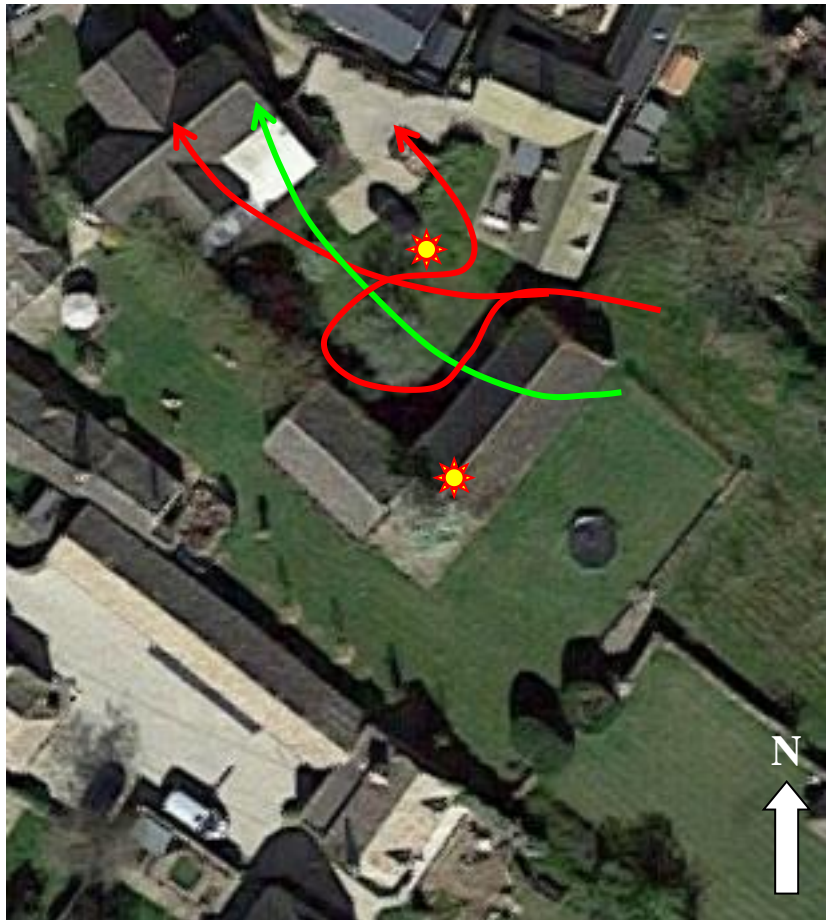
**Plan 1 Bat flight paths at emergence on 27<sup>th</sup> June 2022**

No roosting bats were found inside the barn, but small numbers of Common Pipistrelles flew round the front garden, with a Noctule Bat passing over the site.

The bat flight paths at first emergence are shown on Plan 1 overleaf.

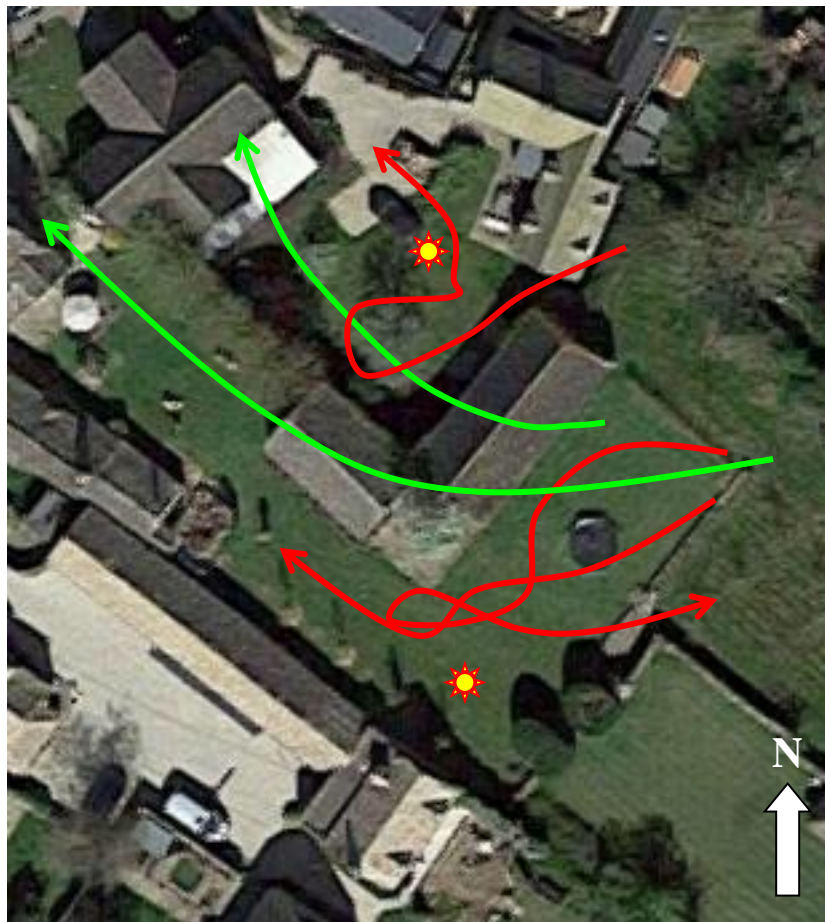
**Plan 2 Bat flight paths at emergence on 11<sup>th</sup> July 2022**

Access to the rear of the barn was allowed, so the second surveyor covered the opposite side of the building. Small numbers of Common Pipistrelles flew around and over the site, with Noctules passing over the site.

No bats emerged from the barn.

The bat flight paths at second emergence are shown on Plan 2 overleaf.

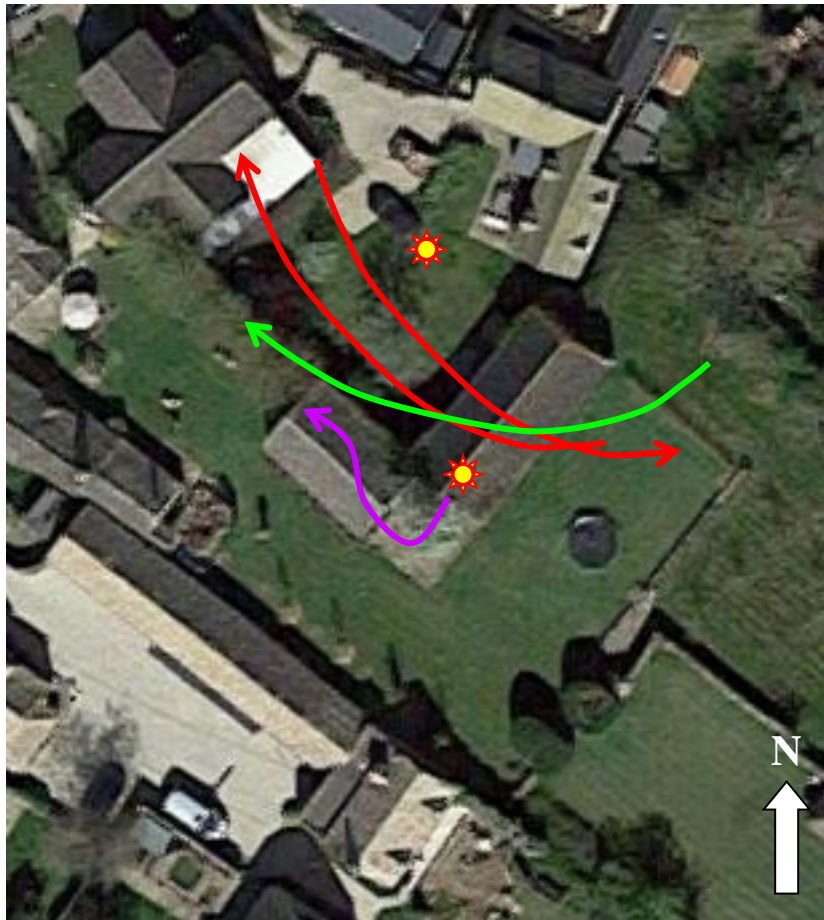
**Plan 3 Bat flight paths at emergence survey on 25<sup>th</sup> July 2022**

No access was possible to the rear of the barn, so the second surveyor stood inside the building against the southwest gable wall. A Brown Long-ed Bat was observed at roost inside the barn before the survey began. Common Pipistrelle and Noctules flew around and over the site. The Brown Long-eared Bat subsequently emerged through the open window in the southwest gable.

The bat flight paths at third emergence are shown on Plan 3 overleaf.

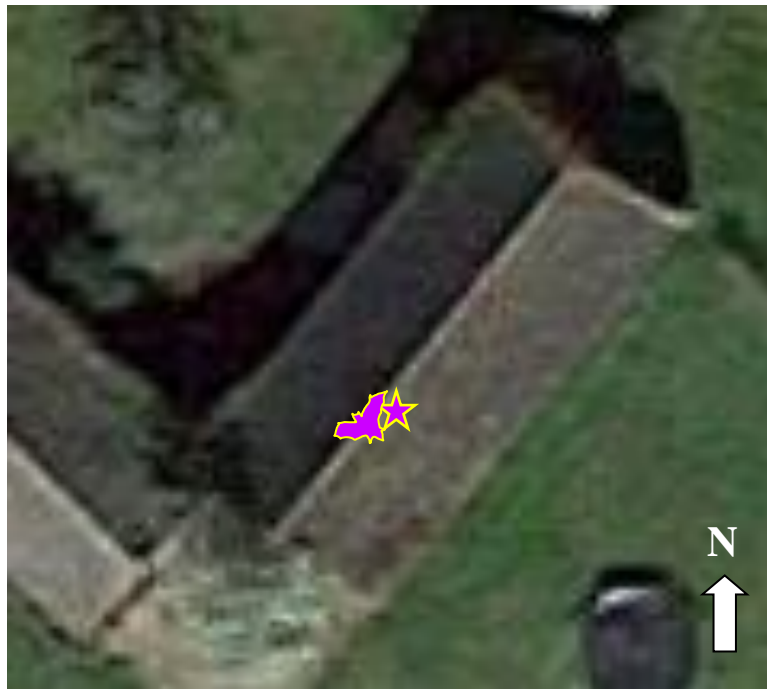
### Appendix 3: Locations of bat droppings and bat at roost

The location of the droppings and roosting bat are shown in Appendix 3.

Brown Long-eared Bat droppings ★

Brown Long-eared Bat at roost 🦇
