Ecological Appraisal of land at Halcyon House, Worlingworth IP13 7NT

I am writing to provide a summary of the findings following a survey of the site by myself on the 6 September 2022, to inform a planning application for the conversion of a small outbuilding (B1) at Halcyon House (TM 23225 68538, Figure 1) to provide ancillary room to an existing cart lodge and workshop with home office/studio (B2) which has approval (Ref: DC/21/05914) for the conversion into a residential annex. A lobby will be constructed to link the two buildings.

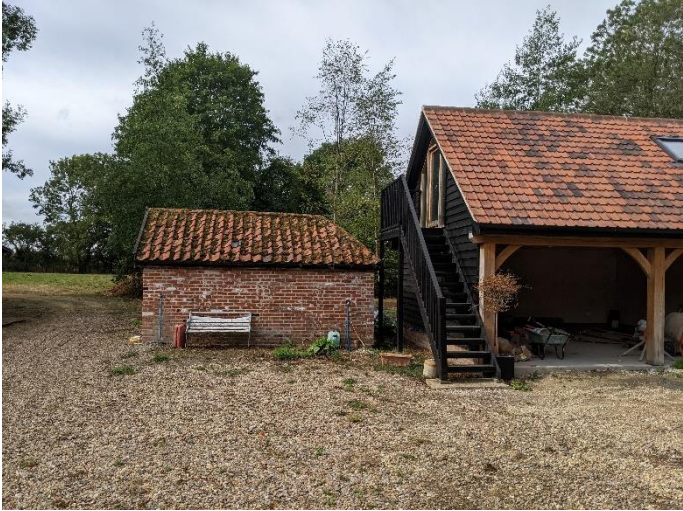
The single storey shed is of brick construction with a pantile roof with bitumen underfelt (Photos 1 to 2), with a 2 storey cart lodge and workshop immediately to the north (Photo 1). An area of hardstanding exists to the east of the buildings. Lawn is the dominant habitat to the west of the shed and the adjacent cart lodge.

Photo 1 East elevation of outbuilding and cart lodge

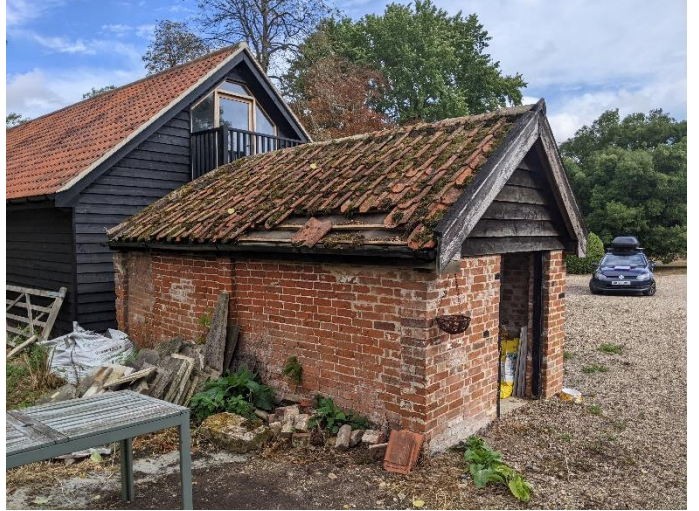
Photo 2 South and west elevations

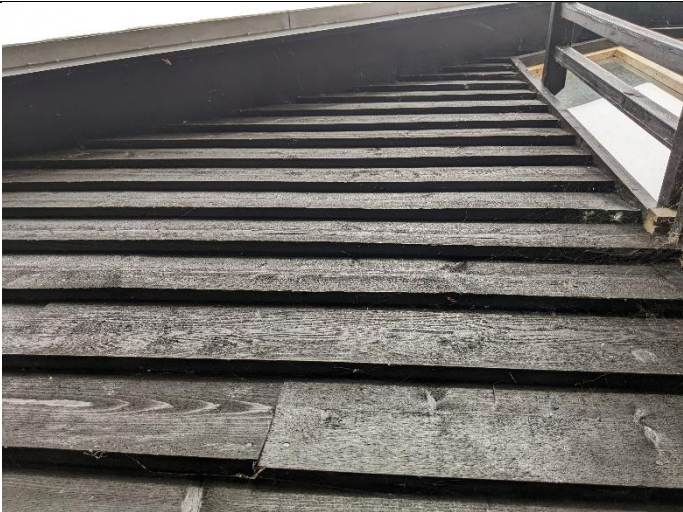
An internal inspection found no evidence of roosting bats with no droppings or feeding remains found. The building has several gaps along the ridge (Photos 4 and 5) allowing water ingress whilst it is heavily cobwebbed indicating no bats have flown inside the building. An inspection of the south gable of the cart lodge where the link will require removal of some cladding and the creation of a doorway found no warped cladding which could allow bats to enter to roost.

Photo 3 Tight fitting boards on south gable of cart lodge

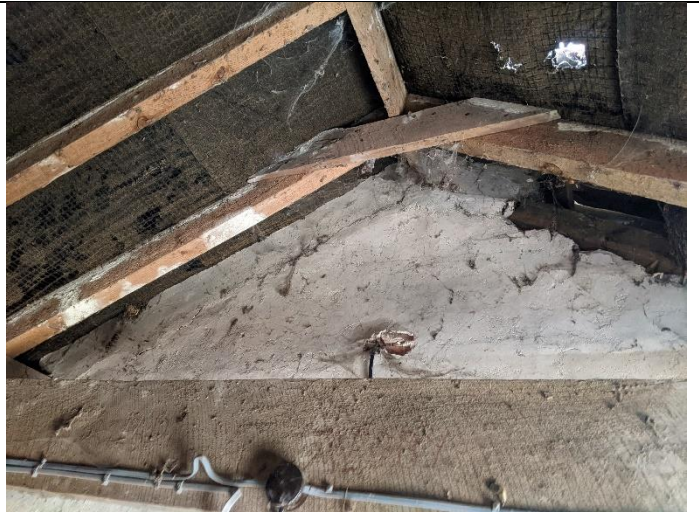
Photo 4 Cobwebby ridge and holes in roof

A bat friendly roofing membrane (e.g., bitumastic Type 1F or a breathable roofing membrane that has passed a bat safety test) recommended to ensure no entanglement issues if bats return to roost under roof tiles.

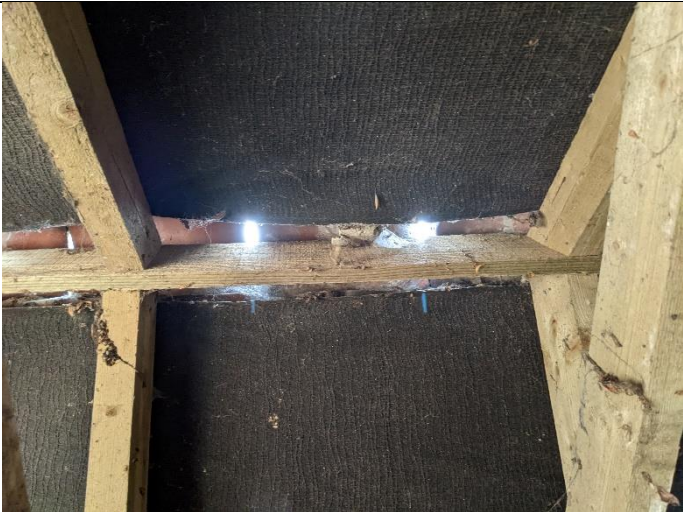
Photo 5 Holes in the ridge

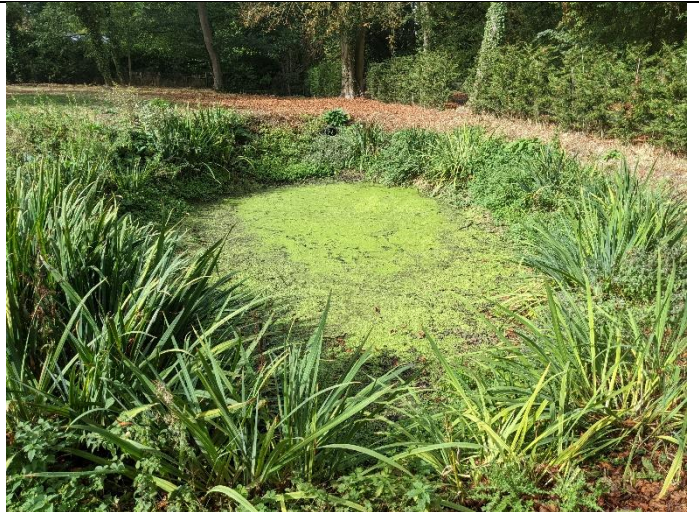
A pond P1 (Photo 6) exists to the north which is covered in duckweed (*Lemna sp*). It has the potential to support great crested newts and common amphibians. Historical records exist for ponds within Worlingworth for within 1km of the site such that the ponds on site could support the species.

Photo 6 Pond P1

Lighting on the converted cart lodge/workshop should avoid illumination of the nearby pond P1, trees and hedgerows, whilst any lighting to the front should be PIR operated set on a short timer.
