Denny Cottage, Denny Wood, Lynhurst, SO43 7FZ

Phase I Bat Report

**Denny Cottage
Ecology 8091
Version 01**

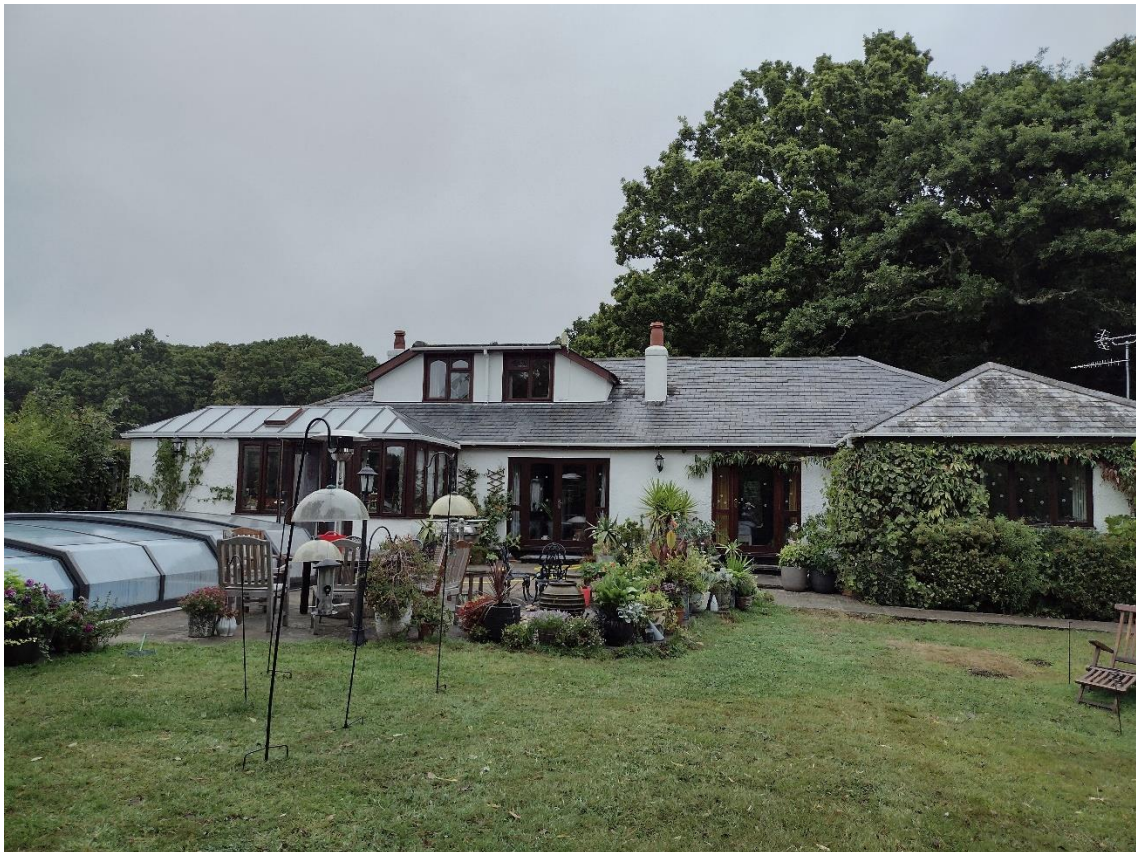
- 4.3 The property comprises a chalet bungalow with a single storey conservatory on the southern elevation (**Figure 1**). The building is constructed from brick with a white render with a pitched and hipped roof comprising slate roof tiles and concrete ridge tiles.

Figure 1: Southern elevation and single storey extension

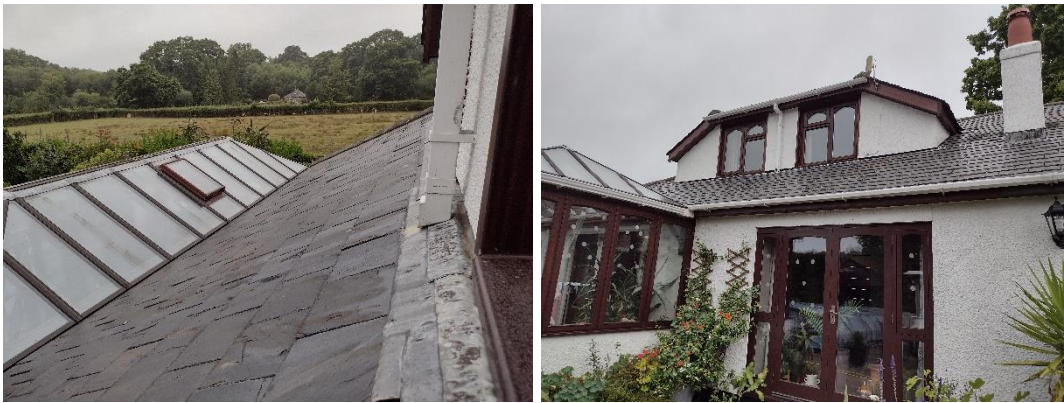
- 4.4 The roof was in good condition with no lifted tiles or missing mortar identified in the proposed works area (**Figure 2**). Some lifted slates and missing mortar were recorded in other areas of the building, however, these are outside the works area and will not be impacted (**Figure 3**).

Figure 2: Roof tiles in the proposed works area. **Figure 3:** Lifted roof tiles around chimney

- 4.8 As the building is a chalet bungalow there is no roof void and any flank voids were not accessible.
- 4.9 There are some features suitable to support low numbers of bats therefore the building is considered to hold **low potential** to support roosting bats. However, these were recorded away from the proposed works area. The proposed works are minor alterations to the property, and it is considered highly unlikely any works will impact the potential roost features identified. No further surveys are required.

- 5.1 The property at Denny Cottage is considered to hold **low potential** for roosting bats. However, the suitable roost features identified were recorded away from the proposed works area. The proposed works are minor alterations to the property, and it is considered highly unlikely any works will impact the potential roost features identified.
- 5.2 If a bat is unexpectedly encountered works should stop, the roosting feature re-instated (if safe to do so without harming the bat) and an ecologist contacted for further advice.
